# Knit Moon Ltd. (11332)

Plot # S-10, BSCIC Industrial Area, Kalurghat, Chittagong

07.July.2014

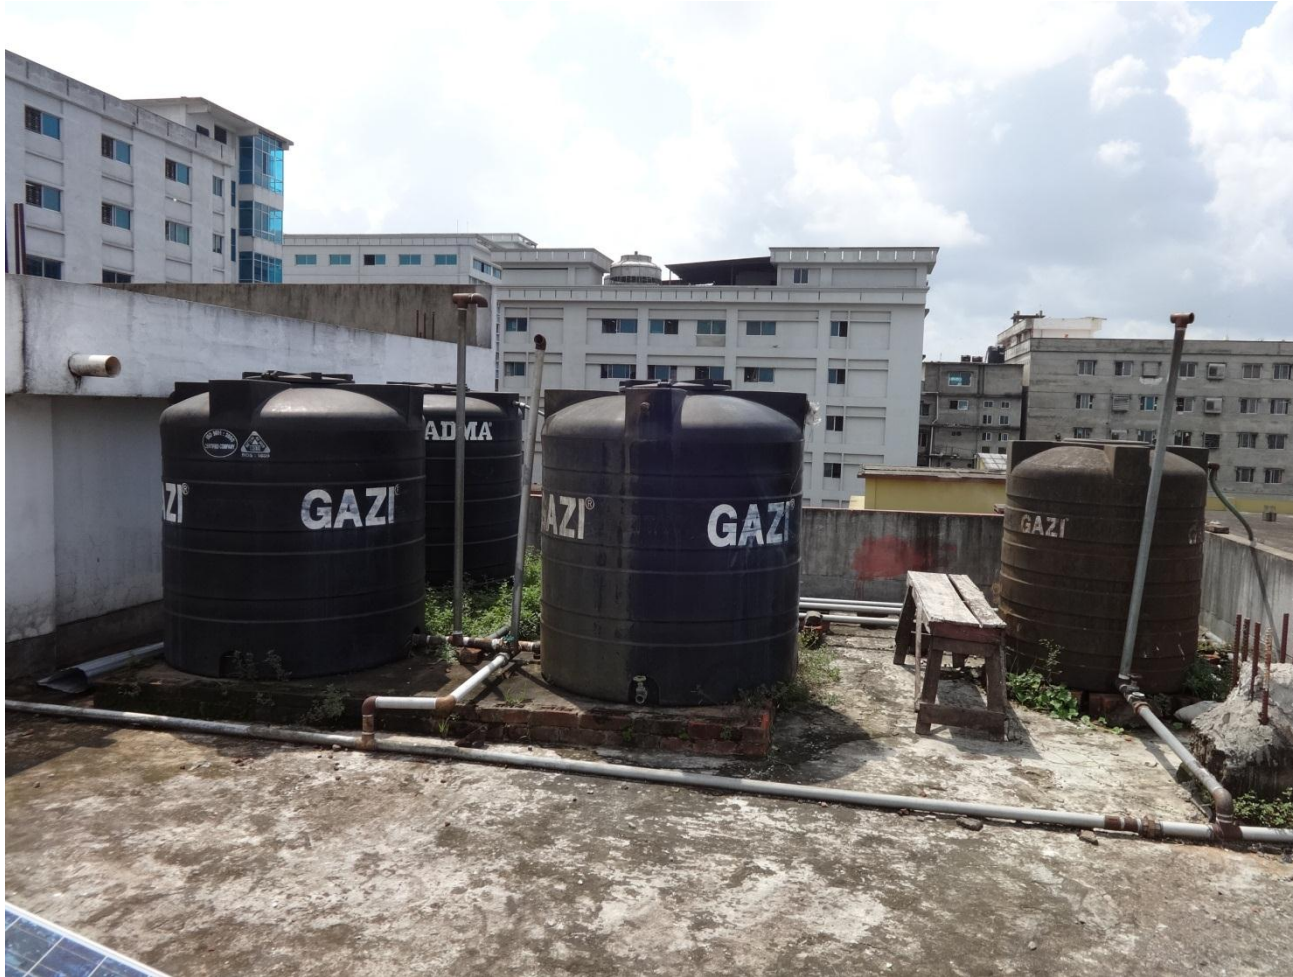
## 1<sup>st</sup> Priority 1 Concern

Concentration of “temporary” water tanks on the roof sited on 150mm plinth. Cracking of beam underneath.

| Item No. | Observation | Recommended Action Plan | Recommended Timeline |
|---|---|---|---|
| 1 | 1st Priority 1 - Concentration of “temporary” water tanks on the roof sited on 150mm plinth. Cracking to beam underneath. | Drain all water from the central 2,000litre tank. | Immediate – Now |
| 2 | 1st Priority 1 - Concentration of “temporary” water tanks on the roof sited on 150mm plinth. Cracking to beam underneath. | Relocate tanks around the roof to spread out the load. Consult the factory engineer for exact locations though close to columns is preferable. | 6-weeks |

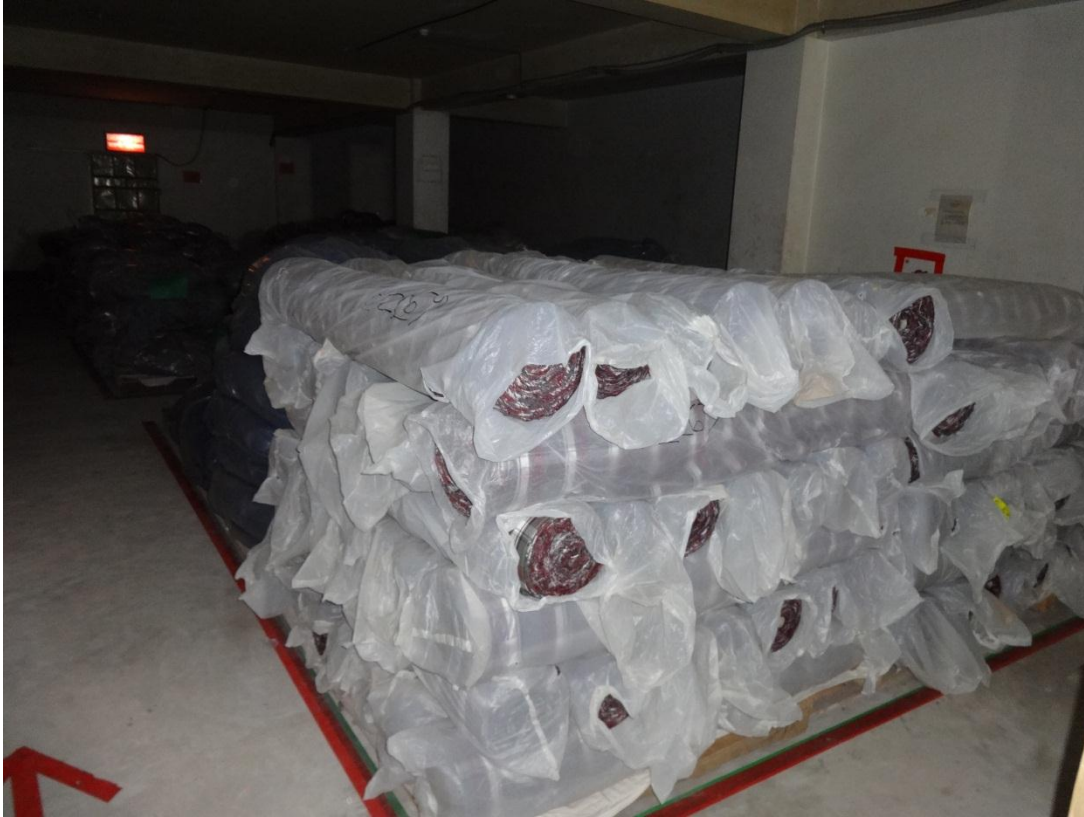
## 2<sup>nd</sup> Priority 1 Concern

Uncontrolled storage in bonded warehouse and localised overloading.

Rolls of yarn were calculated to weigh up to 4.16kPa. (86psf)

Mass of 1 roll – 26.5kg  
Stacked up to 6 rolls high  
Dimensions 1500mm long, 250mmØ  
$$[(26.5 \times 9.81)/(1.5 \times 0.25)] \times 6 = \underline{4.16\text{kPa}}$$

| Item No. | Observation | Recommended Action Plan | Recommended Timeline |
|---|---|---|---|
| 3 | 2nd Priority 1 - Uncontrolled storage in bonded warehouse and localised overloading. | Do not load the slab above 3.0kPa (60psf) in storage areas and bonded warehouse. | Immediate – Now |
| 4 | 2nd Priority 1 - Uncontrolled storage in bonded warehouse and localised overloading. | Carry out an Engineering Assessment on the building to establish what load each floor can safely support. | 6-weeks |
| 5 | 2nd Priority 1 - Uncontrolled storage in bonded warehouse and localised overloading. | Produce accurate loading plans for each level based on the Engineering Assessment.<br>Ensure that these plans are displayed and actively managed. | 6-months |

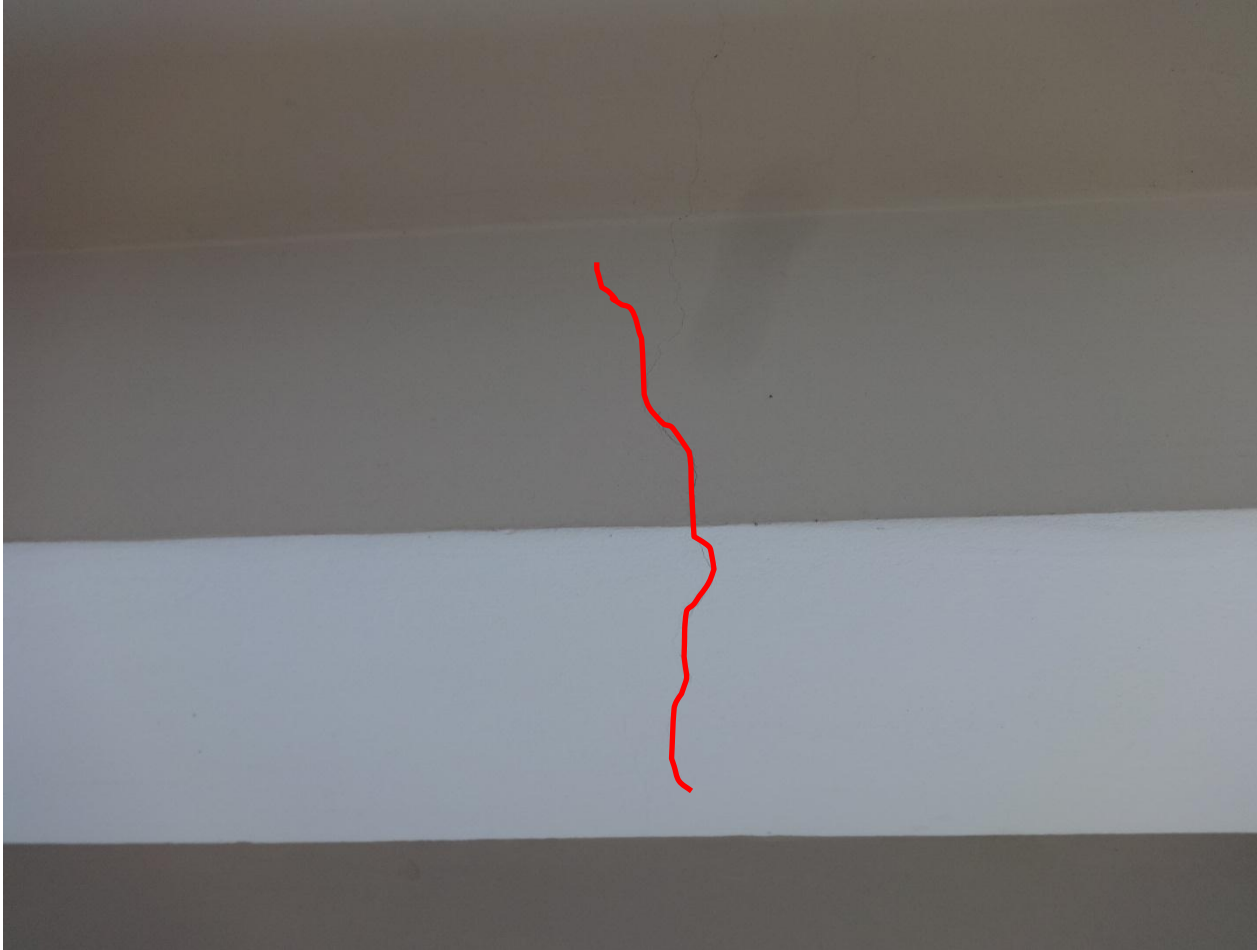
## 1<sup>st</sup> Priority 2 Concern

Cracking of several beams supporting the roof and third floor.

| Item No. | Observation | Recommended Action Plan | Recommended Timeline |
|---|---|---|---|
| 6 | 1st Priority 2 - Cracking of several beams supporting the roof and third floor. | Monitor cracking over a 6 month period to establish if cracks are propagating. | 6-weeks |
| 7 | 1st Priority 2 - Cracking of several beams supporting the roof and third floor. | If no further movement is detected repair cracks with a suitable chemical resin.<br>If cracks are propagating carry out an Engineering Assessment to determine the exact cause and provide remedial measures. | 6-months |

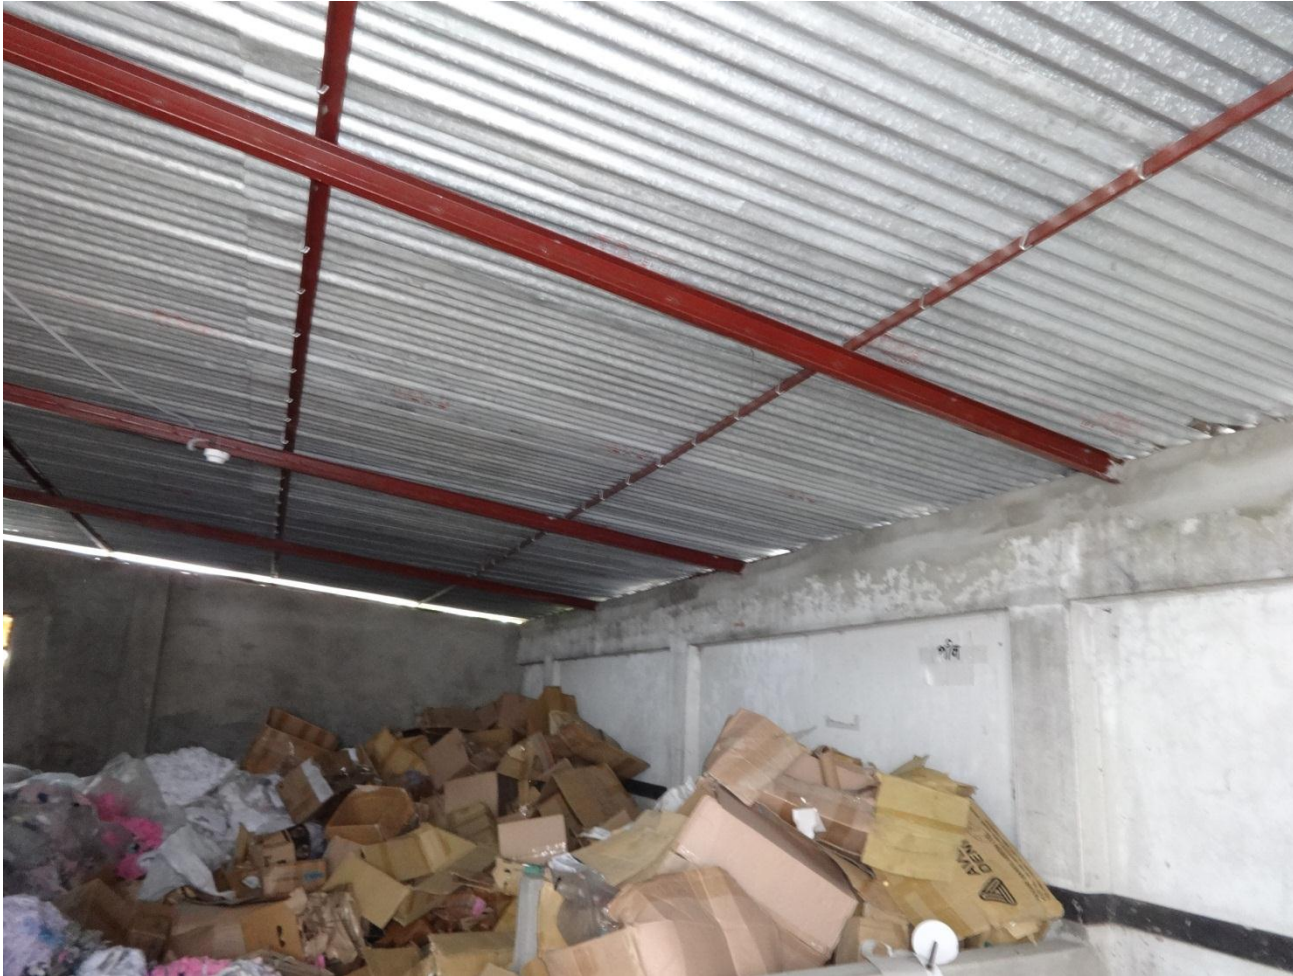
## 2<sup>nd</sup> Priority 2 Concern

Inadequate detailing to steel roofs above stairs and over the waste shed.

| Item No. | Observation | Recommended Action Plan | Recommended Timeline |
|---|---|---|---|
| 10 | 2nd Priority 2 - Inadequate detailing to steel roofs above stairs and over the waste shed. | Carry out Engineering Assessment on steel roof to determine if any strengthening works are required. | 6-weeks |
| 11 | 2nd Priority 2 - Inadequate detailing to steel roofs above stairs and over the waste shed. | Carry out recommendations highlighted in Engineering Assessment. | 6-months |

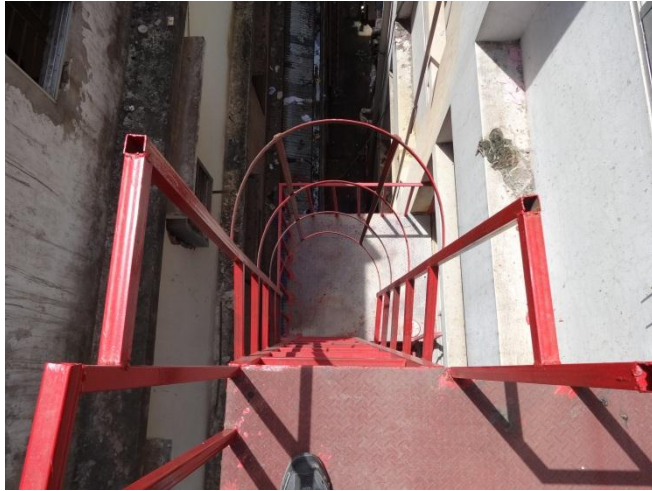
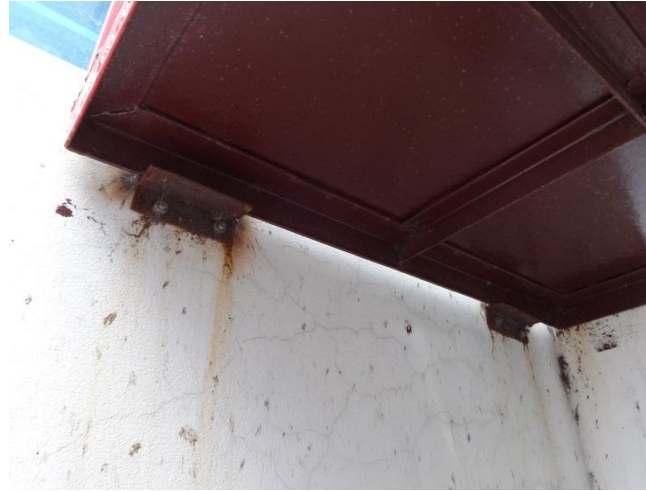
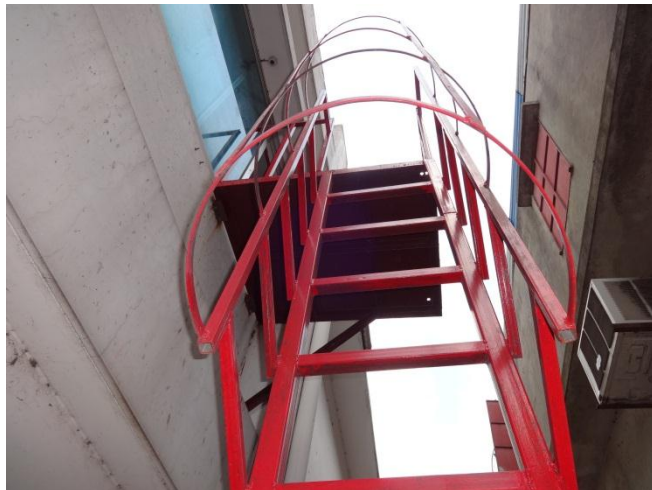
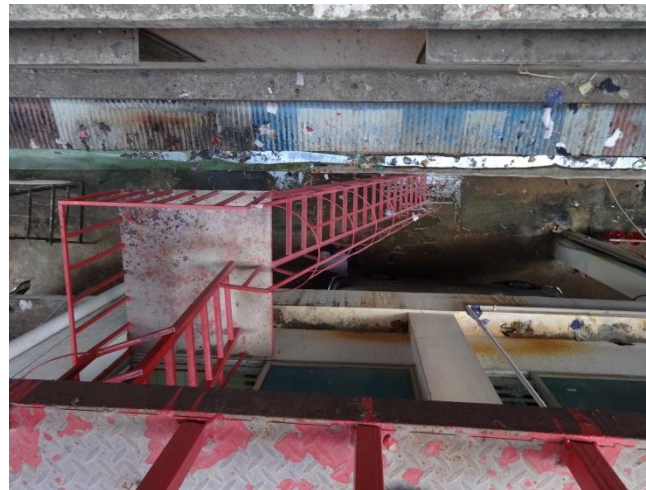
### 3<sup>rd</sup> Priority 2 Concern

Inadequate fixing details to the fire escape ladder.

| Item No. | Observation | Recommended Action Plan | Recommended Timeline |
|---|---|---|---|
| 12 | 3rd Priority 2 - Inadequate fixing details to the fire escape ladder. | Await results of fire safety survey to determine if escape is a suitable size for the factory. | Immediate – Now |
| 13 | 3rd Priority 2 - Inadequate fixing details to the fire escape ladder. | Carry out an Engineering Assessment on escape, or replace if it does not pass fire safety survey. | 6-weeks |
| 14 | 3rd Priority 2 - Inadequate fixing details to the fire escape ladder. | Carry out actions highlighted in the Engineering Assessment as required. | 6-months |

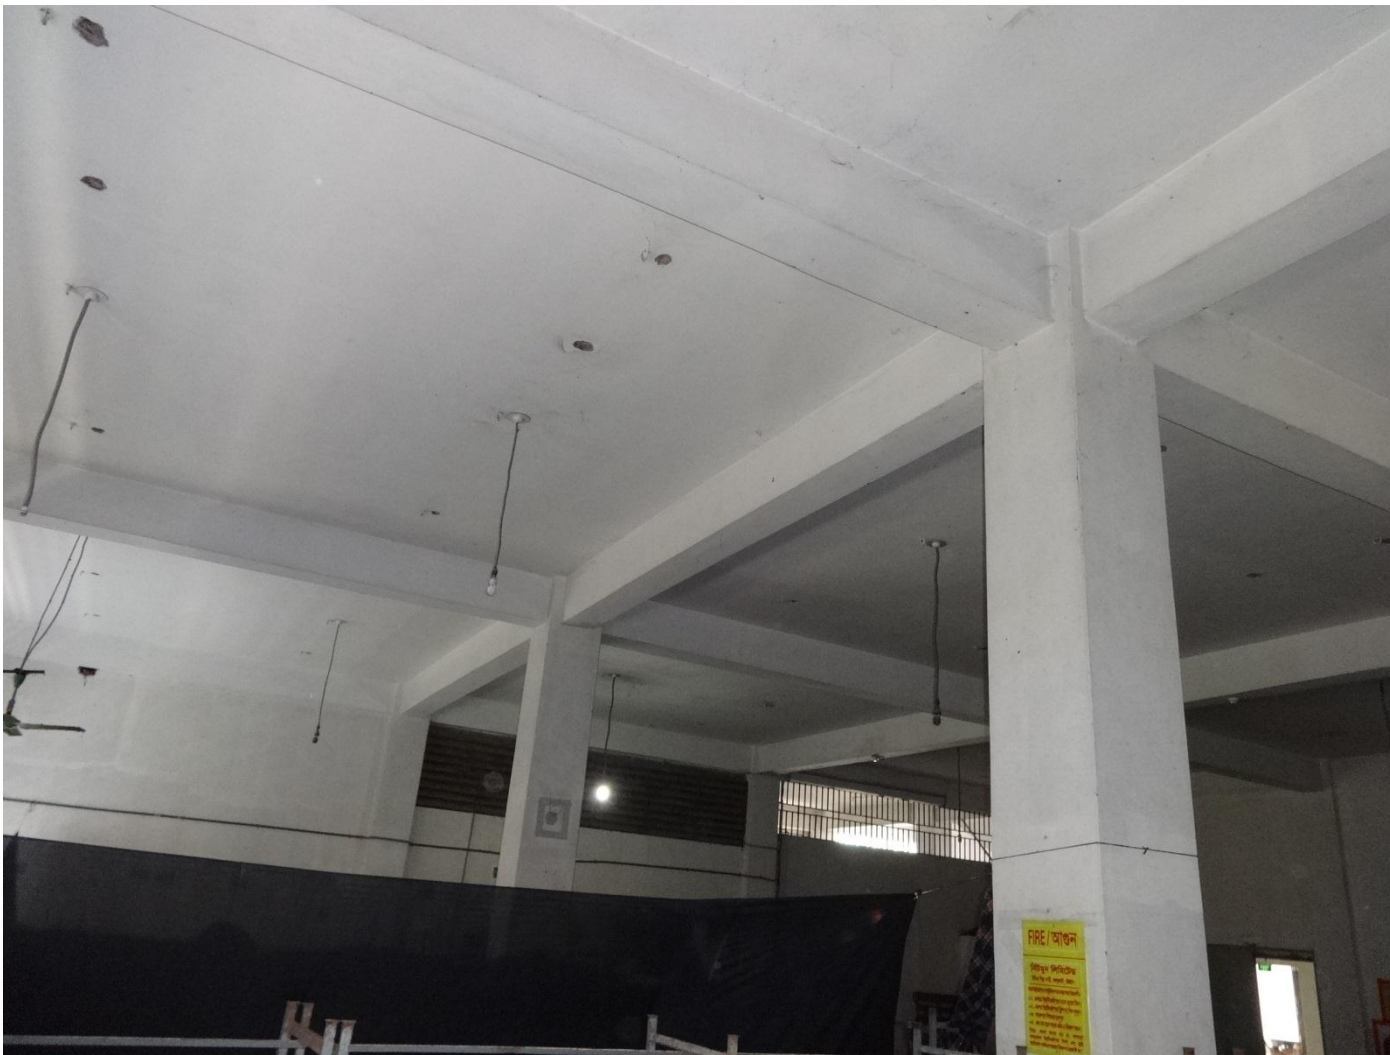
# Overall Stability System

The building did not feature any core or shear walls. Stability was achieved through sway action between beams and columns and masonry infill walls.

We require that these items be investigated in an Engineering Assessment.

| Item No. | Observation | Recommended Action Plan | Recommended Timeline |
|---|---|---|---|
| 8 | No obvious stability system to the building. | Carry out an Engineering Assessment on the building to verify that it is stable under lateral loading specified by BNBC. | 6-weeks |
| 9 | No obvious stability system to the building. | Carry out all recommendations of the Engineering Assessment. | 6-months |

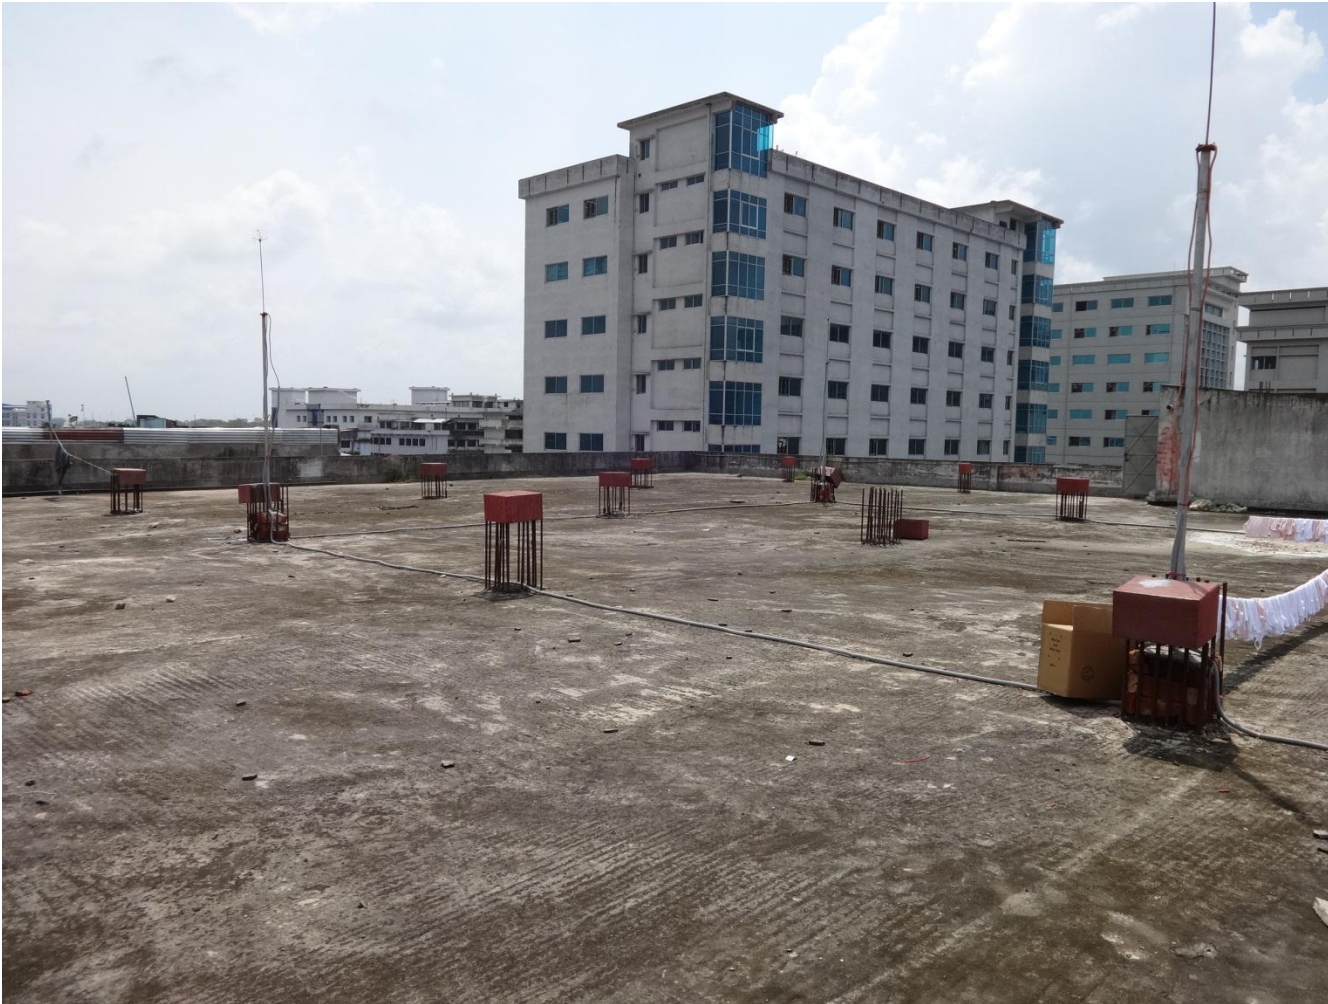
# Water Ingress at Roof Level

No waterproofing membrane was visible on the roof of the building. This means that any cracks in the surface finishes on the roof will allow water to seep into the concrete slab beneath the finishes, and cause corrosion of the reinforcing steel.

| Item No. | Observation | Recommended Action Plan | Recommended Timeline |
|---|---|---|---|
| 15 | No waterproofing membrane to the roof. | Install temporary waterproofing system on the roof if an additional story is going to be built within 1 year.<br>Or install a permanent waterproofing membrane to the present roof if construction is to stop for more than one year. | 6-months |
