# NRG Knit Composite (9359)

Enayetnagar, Bholail, Fatullah, Narayanganj

08.July.2014

# Identified Priority 1 Concerns

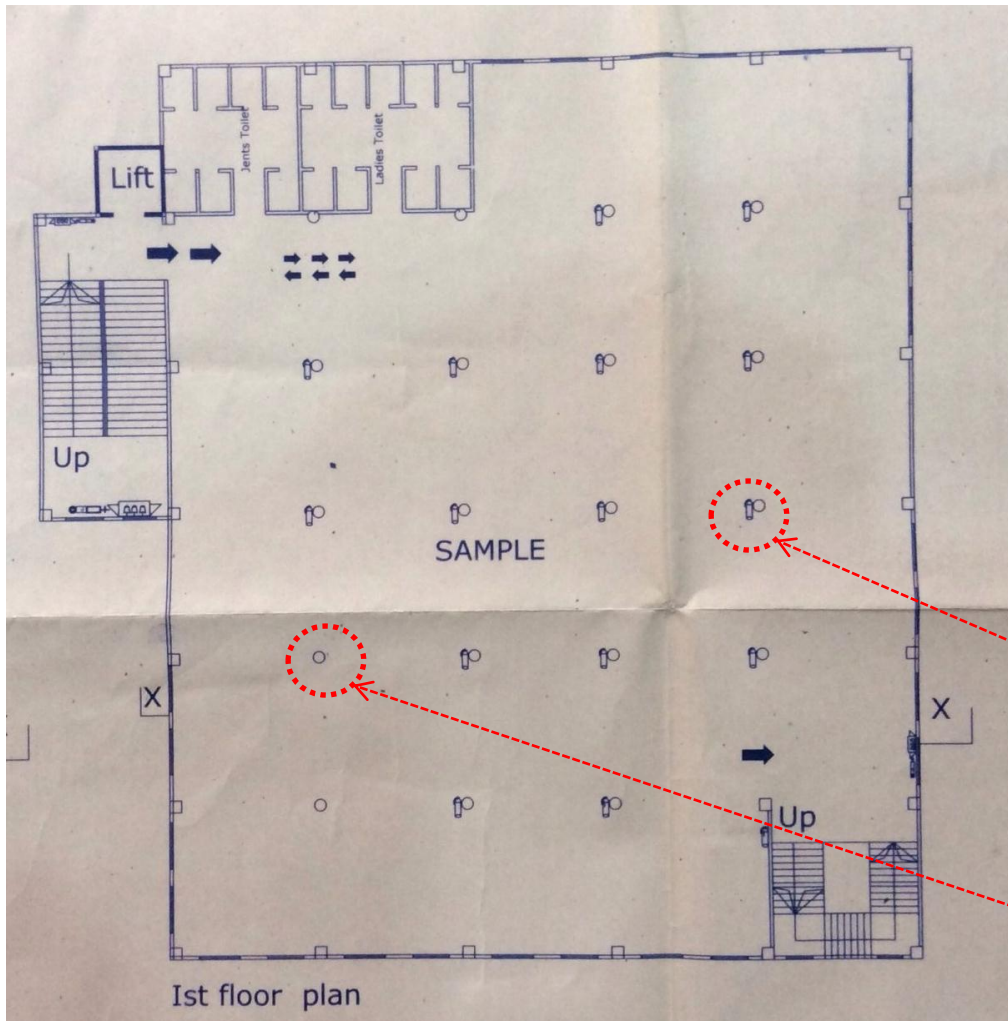
## 1st Priority 1 Concern

Based on the load rundown analysis following the agreed minimum design live load assignment, it has been found that typical columns in the building appear significantly insufficient in carrying the dead and live loads at the ground floor level, giving a firm RED warning. The building was constructed in 1993 with stone aggregate concrete and high yield strength reinforcement.

The column 1 is designed to support 12 concrete floors including mezzanine floor.

The column 2 is designed to support 11 concrete floors.

**Column stress check with scanned rebar shows insufficient loading capacity (RED)**

| Item No. | Observation | Recommended Action Plan | Recommended Timeline |
|---|---|---|---|
| 1 | 1st Priority 1 - Typical columns in the building have insufficient load carrying capacity under current building loading conditions. | Suspend all activities on the 6th, 7th, 8th, 9th, 10th levels | Immediate – Now |
| 2 | 1st Priority 1 - Typical columns in the building have insufficient load carrying capacity under current building loading conditions. | Carry out a full Detailed Engineering Assessment of the entire building including any intrusive testing required.<br>The Factory Engineer is to carry out thorough load checking of the entire structure, including slabs, beams and columns based on BNBC. | 6-weeks |
| 3 | 1st Priority 1 - Typical columns in the building have insufficient load carrying capacity under current building loading conditions. | As per the result of DEA, carry out the strengthening for members that are not able to support the applied loads. | 6-months |

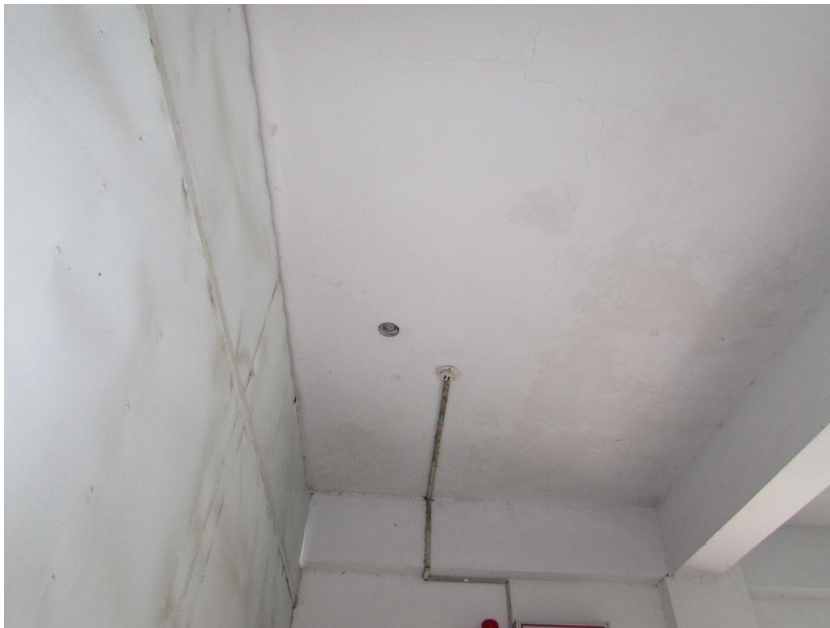
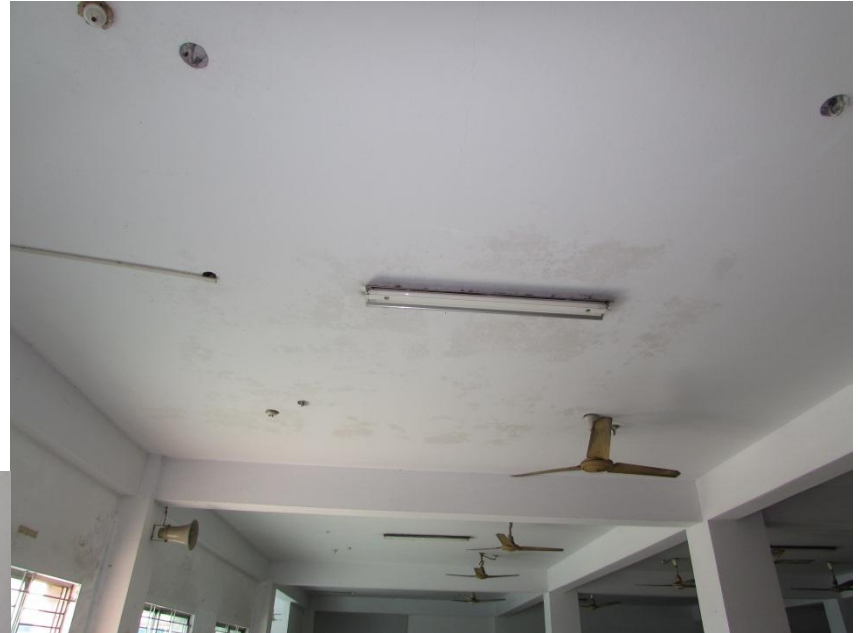
## 1<sup>st</sup> Priority 3 Concern

There are signs of water penetration at the underside of roof floor. The reinforcement in this area of the concrete floor could have already started to corrode. This could potentially lead to the failure of certain members

| Item No. | Observation | Recommended Action Plan | Recommended Timeline |
|---|---|---|---|
| 4 | 1st Priority 3 - Lack of proper waterproofing or poor construction on the roof level resulting in significant water damage on walls, ceilings and beams. | Provide propping to the damaged concrete areas (slab, beam and column). | 6-weeks |
| 5 | 1st Priority 3 - Lack of proper waterproofing or poor construction on the roof level resulting in significant water damage on walls, ceilings and beams. | Apply a proper waterproofing system to the roof floor level.<br>Hack away the damaged concrete and expose reinforcement to check for corrosion<br>Carry out replacement of reinforcement and proper repair of the structural elements. | 6-months |

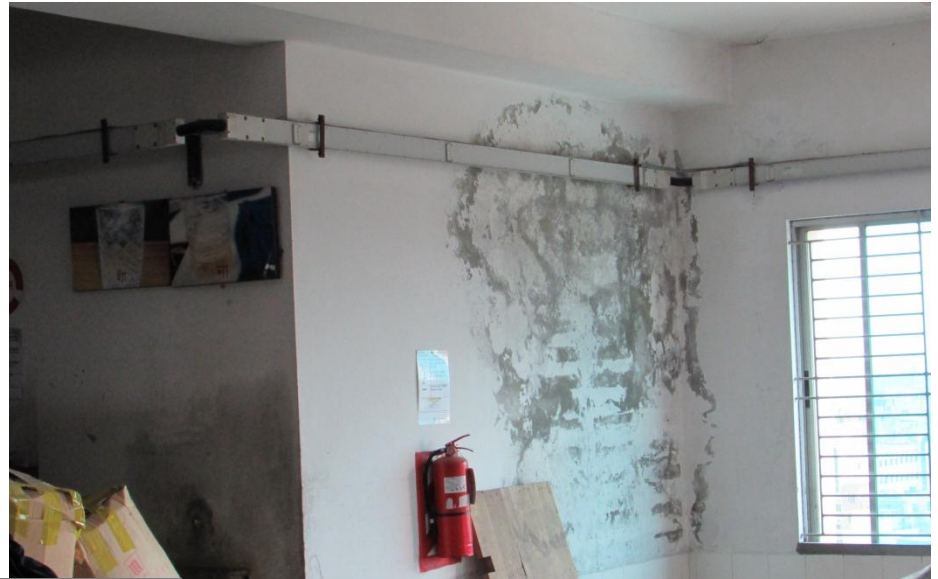
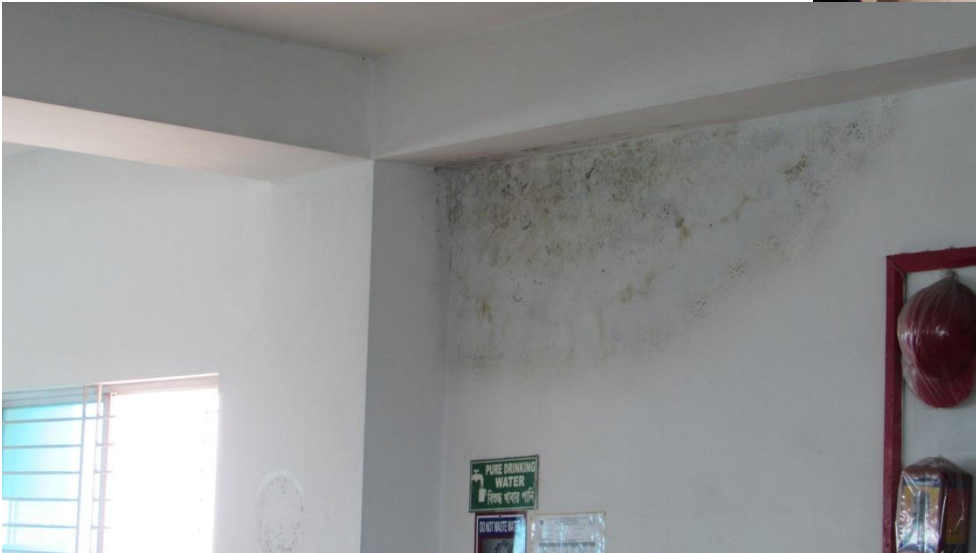
## 1<sup>st</sup> Priority 3 Concern (continue)

There are signs of water damage on the perimeter wall and on the wall at toilet areas. This could potentially lead to the failure of these walls.

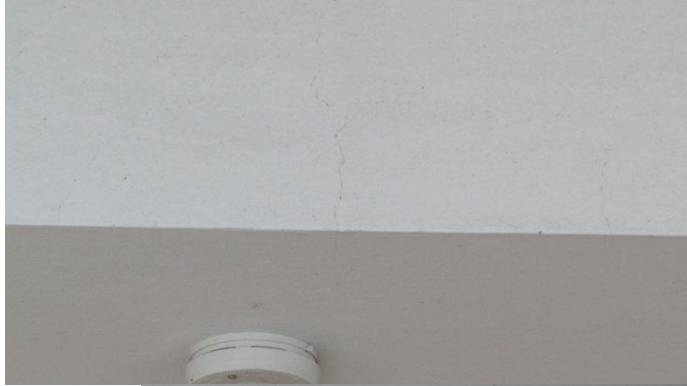
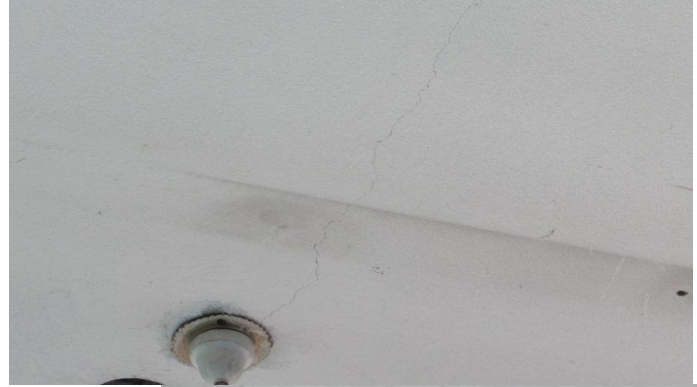
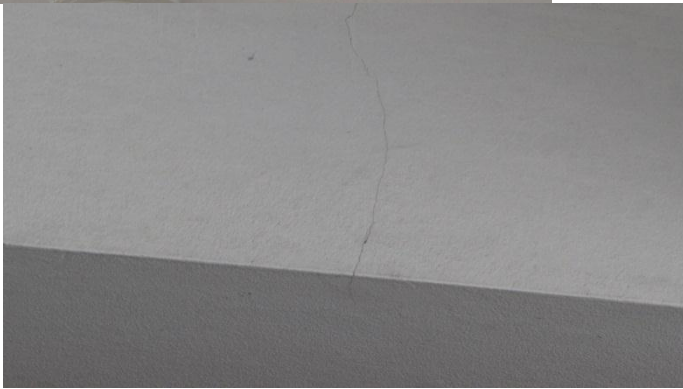
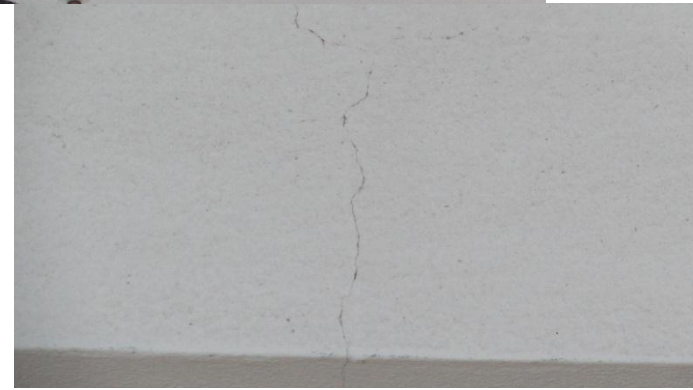
## 2<sup>nd</sup> Priority 3 Concern

There are many cracks on the slabs, beams on many storeys of the building.

| Item No. | Observation | Recommended Action Plan | Recommended Timeline |
|---|---|---|---|
| 6 | 2nd Priority 3 - There are many cracks on the ceiling, beams on all storeys of the building. | Carry out full survey of all structural elements and check for compliance with BNBC codes to figure out the reasons of crack formation ( due to under design or poor construction) | 6-weeks |
| 7 | 2nd Priority 3 - There are many cracks on the ceiling, beams on all storeys of the building. | Based on the result of the detailed structural survey, the Factory Engineer is to provide the solution and repairing program for the building. | 6-months |

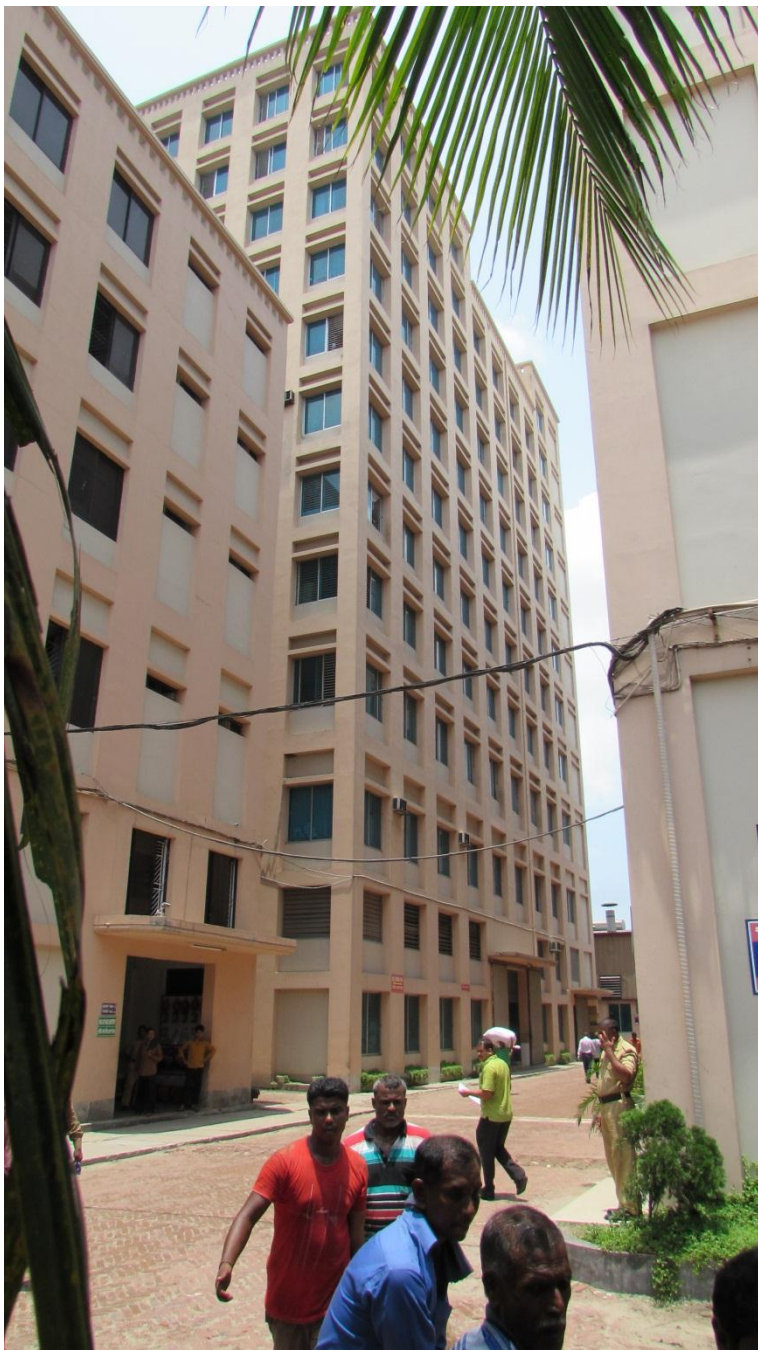
### 3<sup>rd</sup> Priority 3 Concern

The stability system appears to be provided by moment frame action and brick in-fill walls only. However, the structural record do not show any information on the design of lateral load resistance. A lateral load resisting analysis is required to be carried out as part of a DEA.

We suggest that these items be investigated as part of a Detailed Engineering Assessment.

| Item No. | Observation | Recommended Action Plan | Recommended Timeline |
|---|---|---|---|
| 8 | 3rd Priority 3 - The stability of the building has not been designed. | Carry out full survey of all structural elements and check for compliance with BNBC codes to figure out the reasons of crack formation ( due to under design or poor construction) | 6-weeks |
| 9 | 3rd Priority 3 - The stability of the building has not been designed. | Based on the result of the detailed structural survey, the Factory Engineer is to provide the solution and repairing program for the building. | 6-months |
