# Tripple Seven Apparels Ltd(10069)

2, Sujat Nagar, Sujat Plaza, Mirpur-12, Dhaka.

08.07.2014

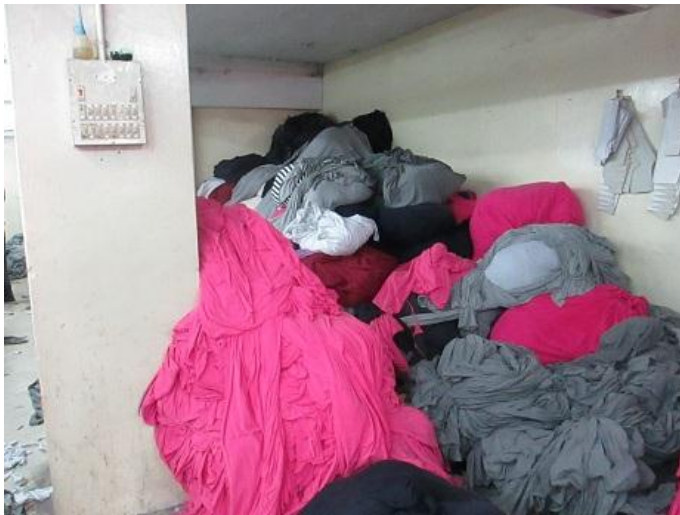
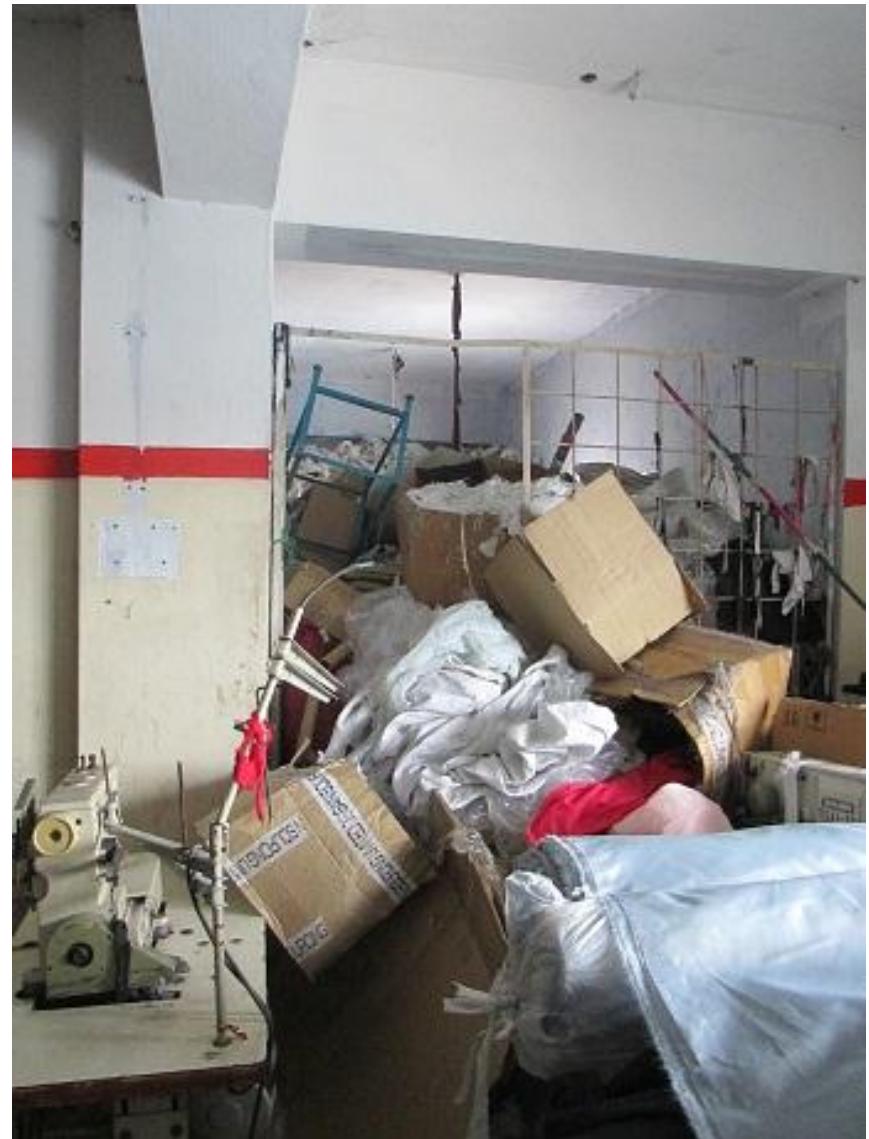
No loading plans were provided for either building.

High load in storage areas were observed during inspection .

Require an Engineering Assessment to verify maximum loading in storage areas.

| Item No. | Observation | Recommended Action Plan | Recommended Timeline |
|---|---|---|---|
| 1 | Priority 2 - No loading plan | Immediately reduce storage loading and ensure that loading at all floors is less than or equal to 2.0kPa. | Immediate – Now |
| 2 | Priority 2 - No loading plan | Perform an Engineering Assessment of the load bearing capacity of the floors.<br>Produce loading plans for each level. | 6-weeks |

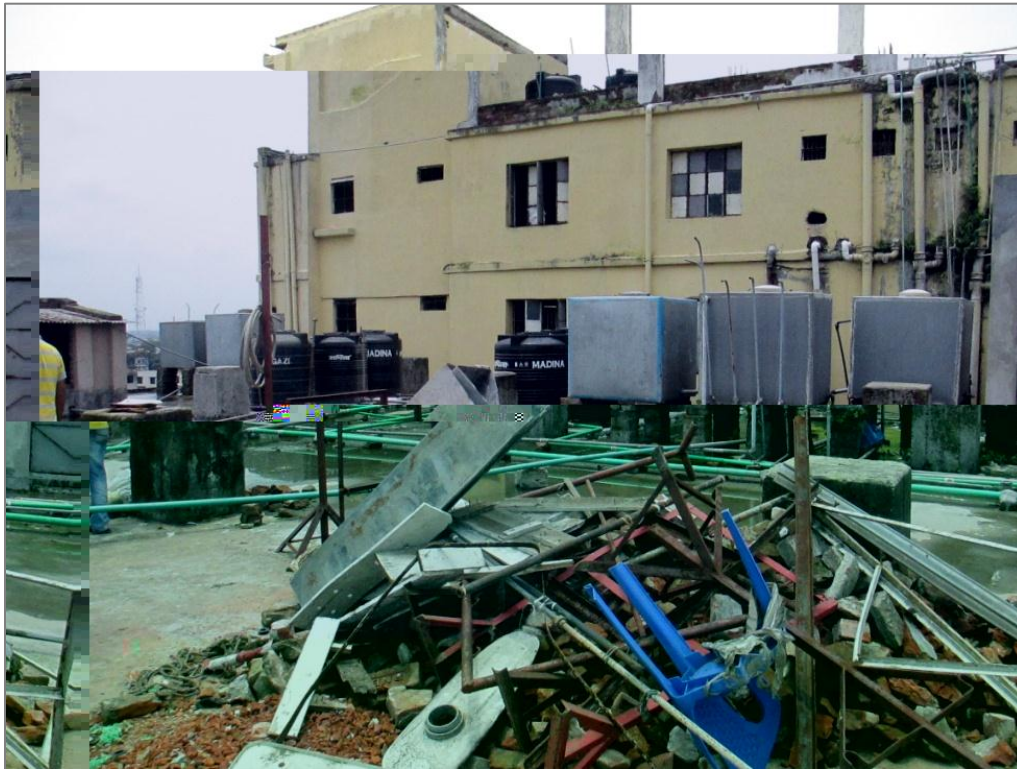
The Building 02 roof contains about 13 water tanks of different size and shape. Their capacity ranges from 1000 liters to 3000 liters.

Position of these water tanks is confusing and no actual engineering assessment was done to determine their position. Moreover a number of water tanks sits on the cantilever slab.

The total roof load must be reduced to the acceptable level of 2.0 kPa and spread out to not exceed this load in any area.

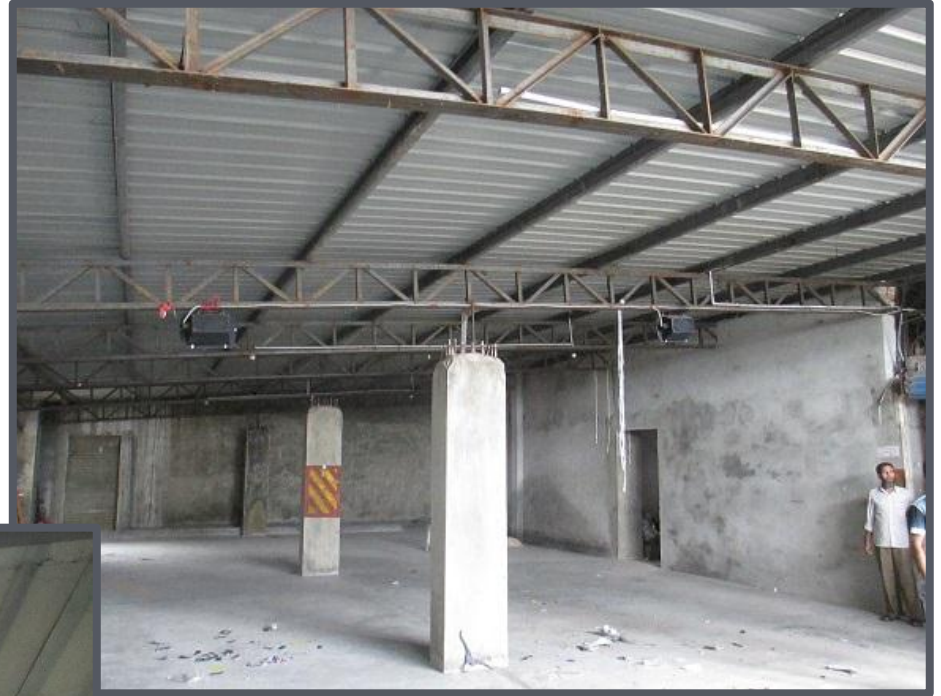
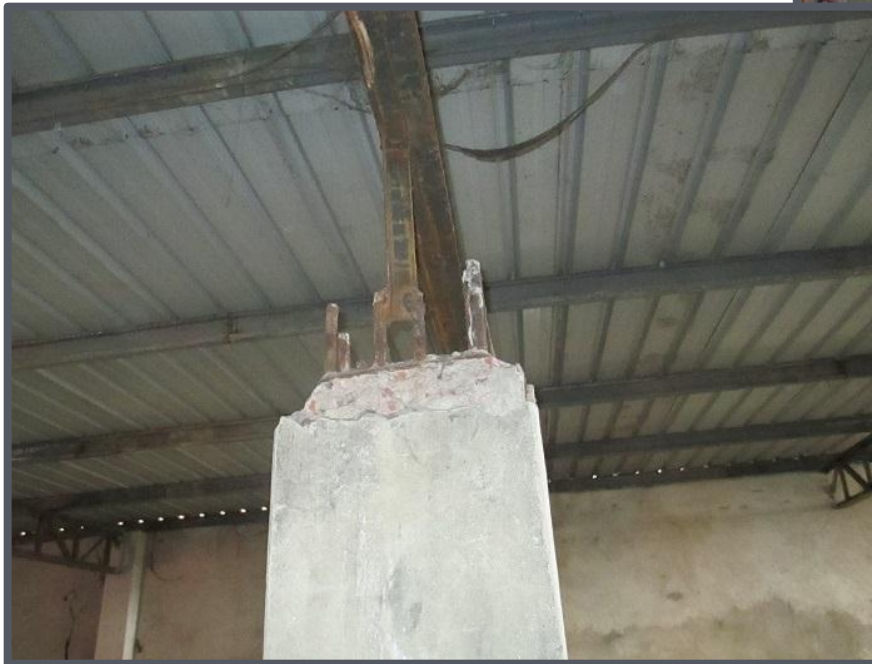
Steel roof connections to concrete column of building 1 seem poorly designed

Carry out an Engineering Assessment to verify that those connection are adequately designed.

| Item No. | Observation | Recommended Action Plan | Recommended Timeline |
|---|---|---|---|
| 7 | Priority 2 - Poor detailing to steelwork roof of the storage shed. | Carry out Engineering Assessment on steelwork roof to determine if it is adequate and securely fixed. | 6-weeks |

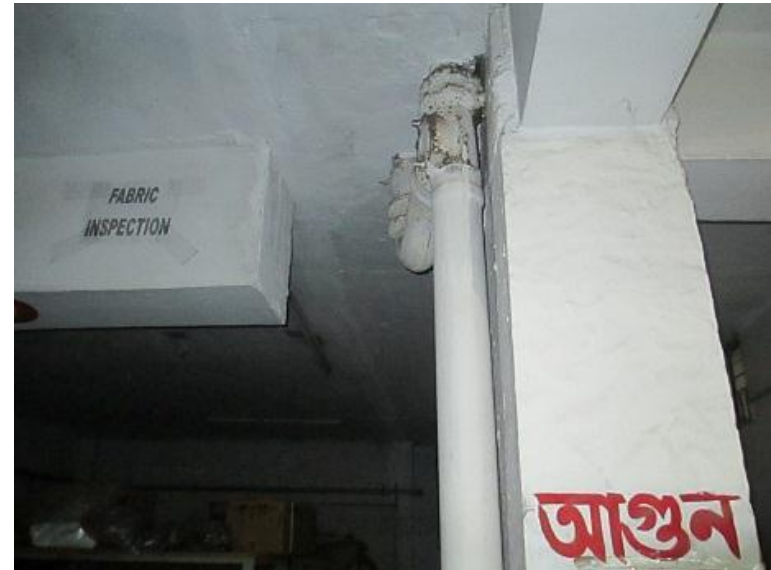
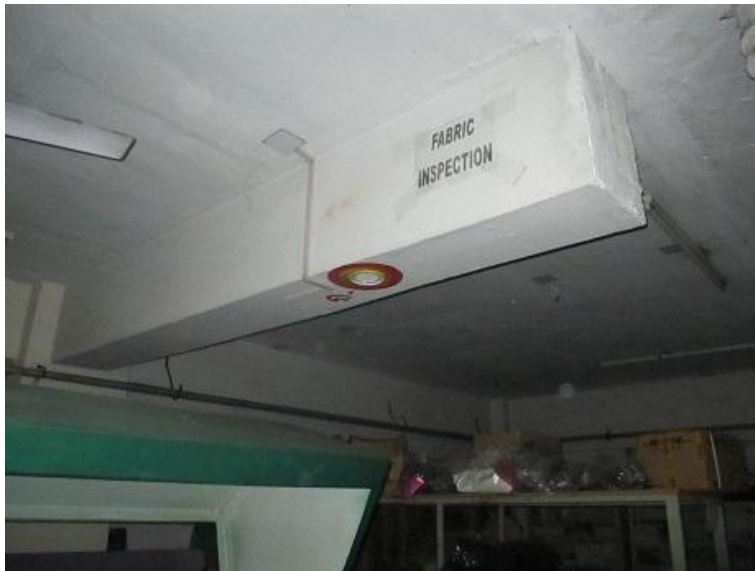
- Discontinued beam (photo from 5<sup>th</sup> floor, building 1)
- Ensure that loads in this area are not increased beyond current levels, and maintain constant surveillance until an Engineering Assessment is carried out to check if this condition meets BNBC requirements.

| Item No. | Observation | Recommended Action Plan | Recommended Timeline |
|---|---|---|---|
| 4 | Priority 2 - Discontinued beams in building 1 | Ensure that loading on the floor area supported by this beam is not increased beyond current levels.<br>Implement constant surveillance of this beam. | Immediate – Now |
| 5 | Priority 2 - Discontinued beams in building 1 | Carry out an Engineering Assessment to verify if the actual structure is adequately design. | 6-weeks |

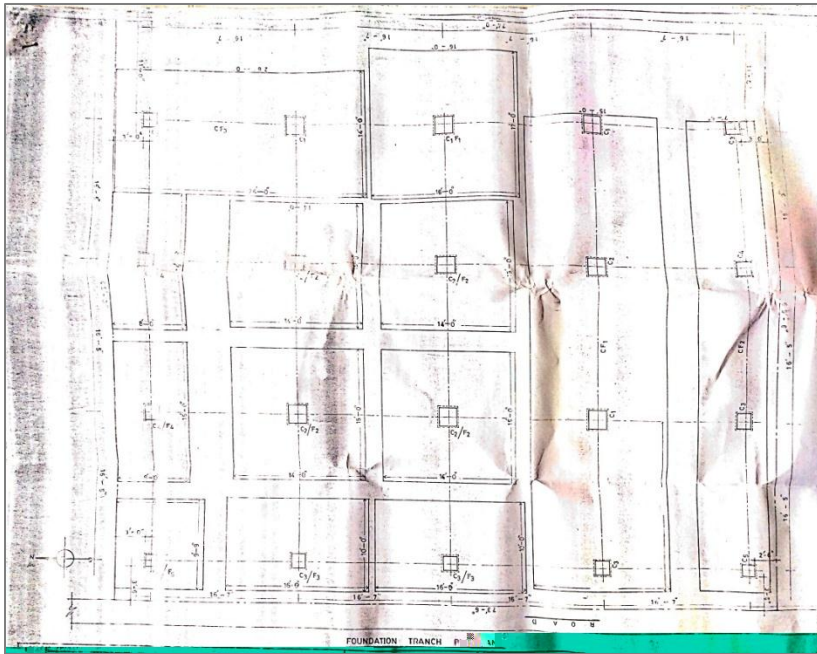
Footing layout plan for building 02

- The structural drawing for Building 02 does not matches with the actual site condition. The number of columns and the number of rows do not match.
- The drawing of Building 02 do not contain any directions. North direction should be mentioned in the drawings.
- There are no master plan for the entire premises.
- Building 01 has a couple of revised and as-build drawings. But none of them shows the connection between Building 01 an 02.

- We were not provided with complete structural documentation of building 2.
- Some structural element where not constructed as showed on the provided documents. We recommend to survey the actual condition and update the drawings.

| Item No. | Observation | Recommended Action Plan | Recommended Timeline |
|---|---|---|---|
| 11 | Priority 3 - Poor documentation | Survey all buildings and update existing drawings. | 6-months |

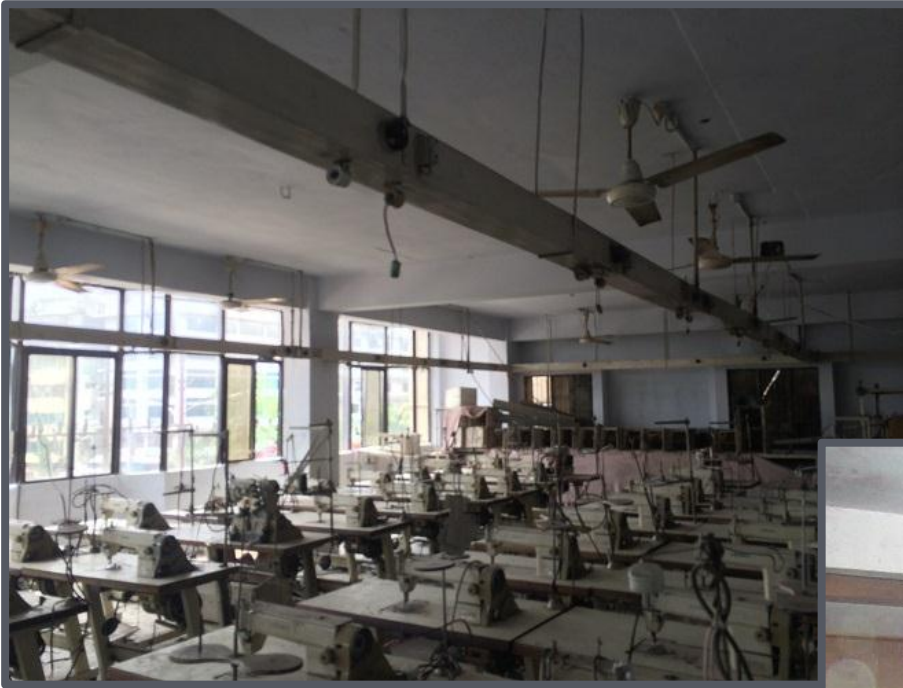
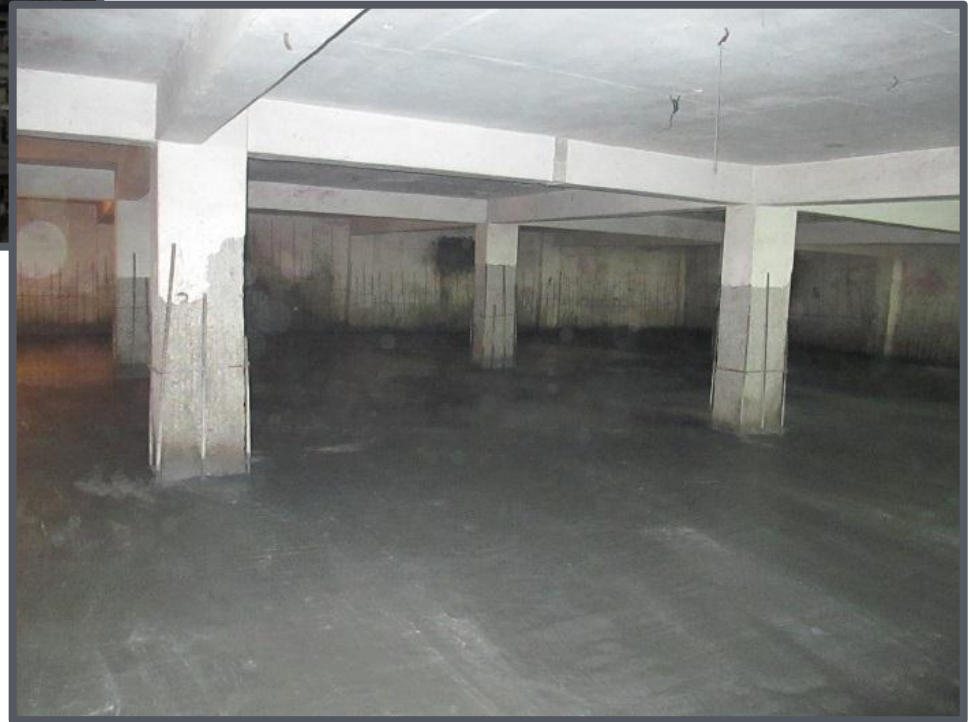
The buildings did not feature any core or shear walls. Stability was achieved through sway action between columns and beams and masonry infill walls.

We require that these items be investigated in a Detail Engineering Assessment

| Item No. | Observation | Recommended Action Plan | Recommended Timeline |
|---|---|---|---|
| 9 | Priority 2 - The buildings does not have any obvious stability system. | Carry out engineering assessment on the building to verify that it is stable under lateral loading as per BNBC. | 6-weeks |

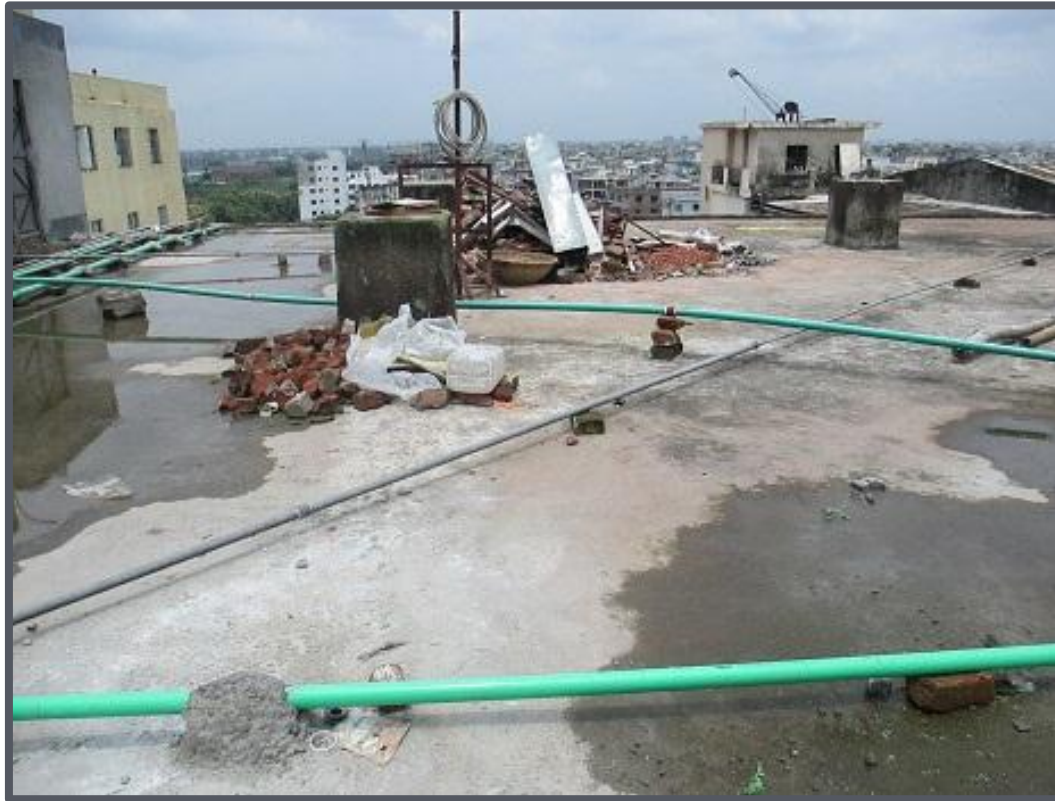
No waterproofing membrane was visible on the roof of the buildings. This means that any cracks in the surface finishes on the roof will allow water to seep into the concrete slab beneath the finishes, and cause long-term deterioration of the slab.
