# Far East Knitting & Dyeing Industries Ltd. (Building-3 & 4)

Chandona, Thana-Kaliakoir, Gazipur  
(24.042354N, 90.263318E)

17<sup>th</sup> September 2017

# Discrepancies between drawings and on site condition

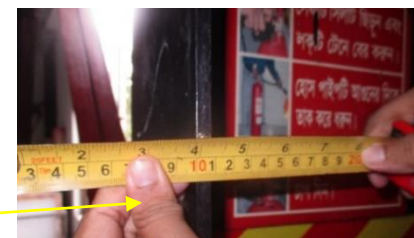
Measured 10 mm thickness of flange instead of 12 mm

Measured 230 mm width of flange instead of 255 mm

Column sizes and thickness not match with provided drawings at zone A for column AC2 & AC3. Building engineer is required to produce an “as constructed” drawings to reflect the actual site dimensions with complete structural information.

| Item No. | Observation | Recommended Action Plan | Recommended Timeline |
|---|---|---|---|
| 1 | Discrepancies between drawings and on site condition | Engage an Engineer to produce an “as constructed” drawings which reflect the actual site dimensions with complete structural information. | 6-weeks |

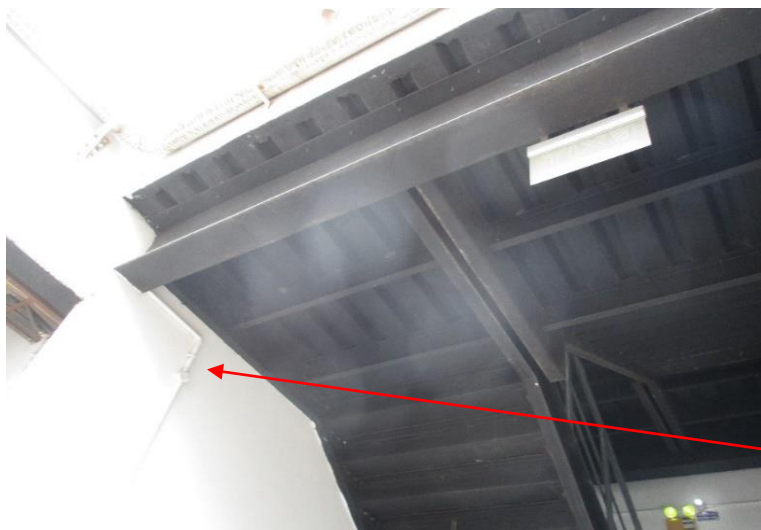
Sectional detail of bracing not found in provided drawings. Bracing is missing at south stair on ground floor.

Bracing missing at stair -1

| Item No. | Observation | Recommended Action Plan | Recommended Timeline |
|---|---|---|---|
| 2 | Lack of Bracings details | Building Engineer to review design and stability system of the structure for lateral loading. | 6-weeks |
| 3 | Lack of Bracings details | Carryout any remedial works arise from Engineering Assessment. | 6-months |

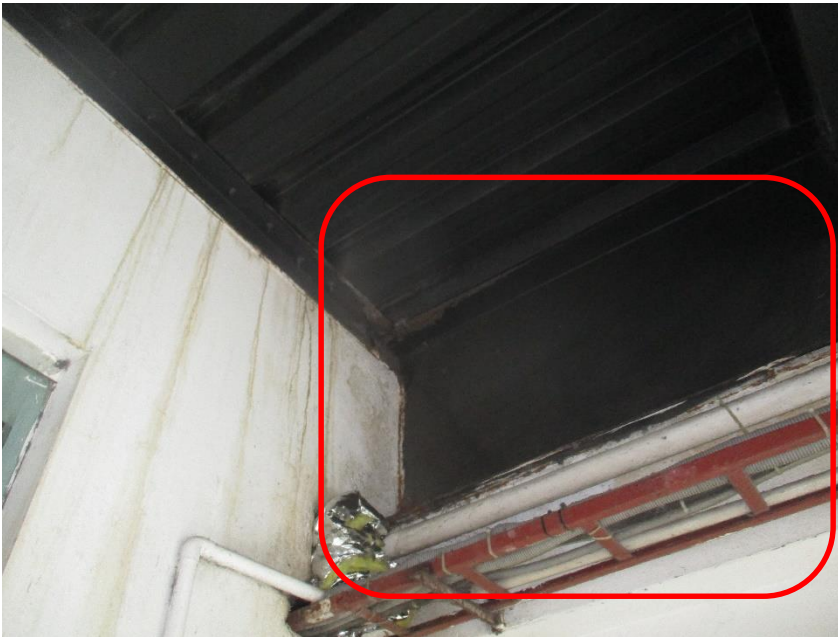
Corrosion found in 1<sup>st</sup> floor beam column connection at east. Corrosion also found in sub-beam at stair core (Stair-1).

Corrosion at beam-column joint

| Item No. | Observation | Recommended Action Plan | Recommended Timeline |
|---|---|---|---|
| 4 | Corrosion in Steel member | Apply suitable method to protect the steel members from corrosion. | 6-weeks |

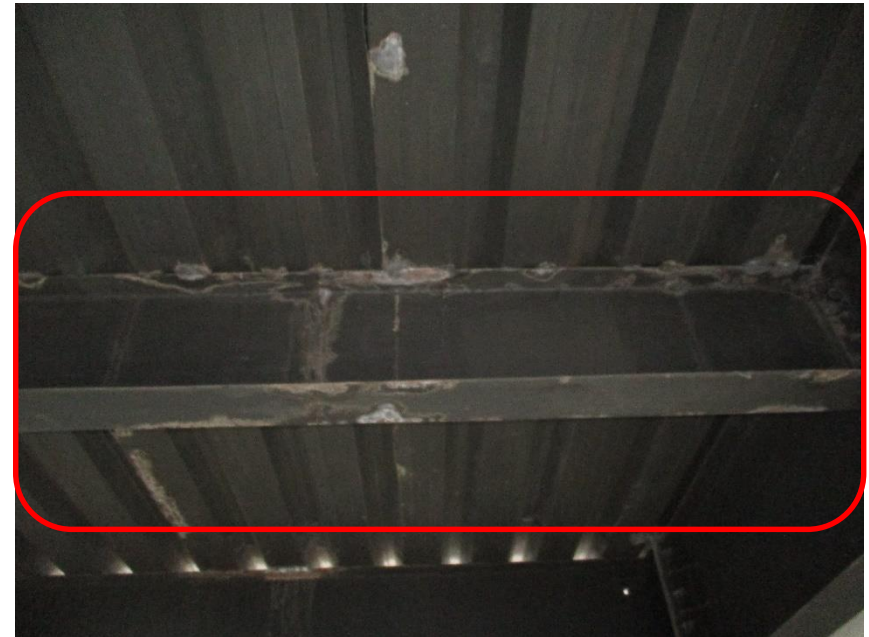
Corrosion at beam-column joint

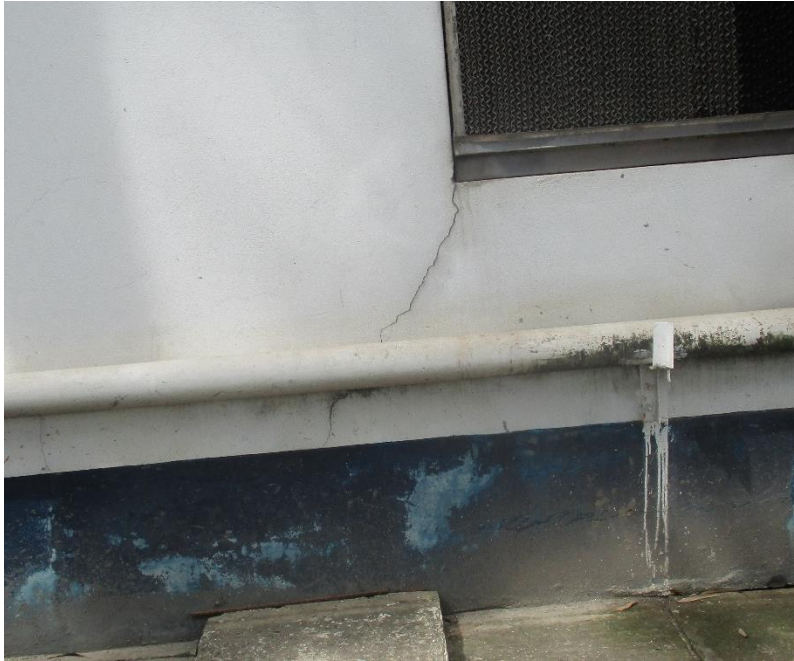
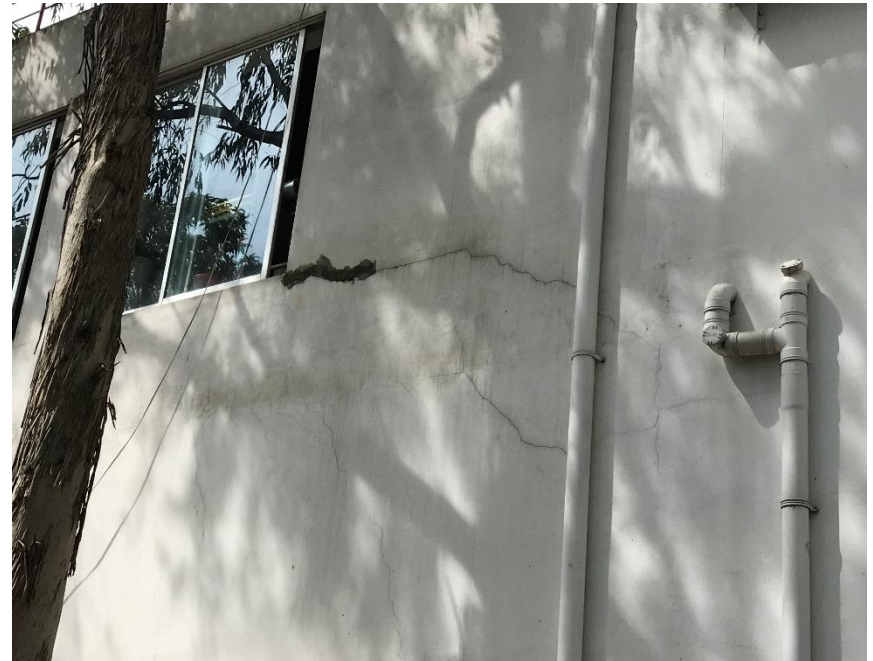
Diagonal cracks found on brick wall at south façade. Factory engineer is required to find the cause of cracking and suggest proper remediation procedure.

| Item No. | Observation | Recommended Action Plan | Recommended Timeline |
|---|---|---|---|
| 5 | Cracks on south façade wall | Have a qualified structural engineer provide further analysis of the identified cracks to determine the appropriate course of corrective actions. | 6-weeks |

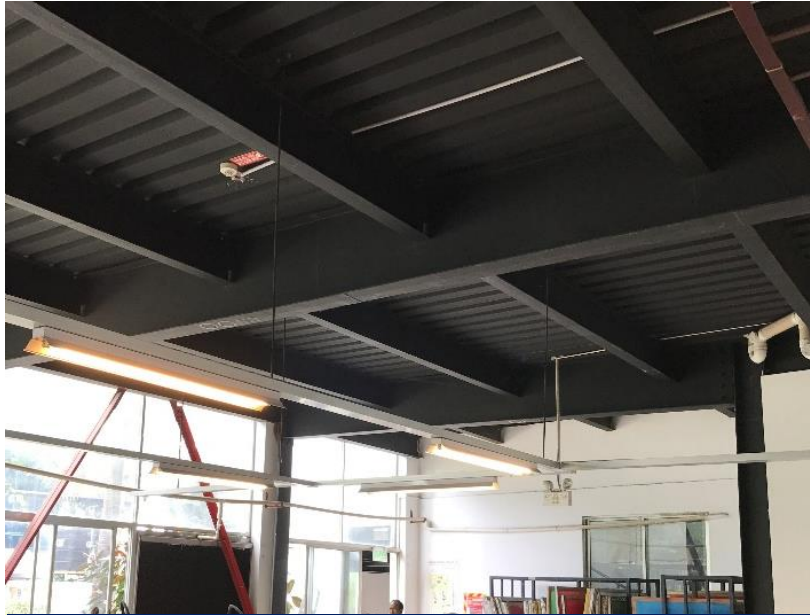
Building -3

Almost 8.2 m long steel beam in building-3 and 9.1 m long steel beam at building-4. There is no stiffener on main and sub beam in some floors which may causes local buckling of the structural members. Factory engineer to check the requirement of the stiffener and install it where required.

| Item No. | Observation | Recommended Action Plan | Recommended Timeline |
|---|---|---|---|
| 6 | Stiffener missing at Steel Beam. (Building 3 & 4) | Factory engineer to check the requirement of the stiffener and install it where required. | 6-weeks |

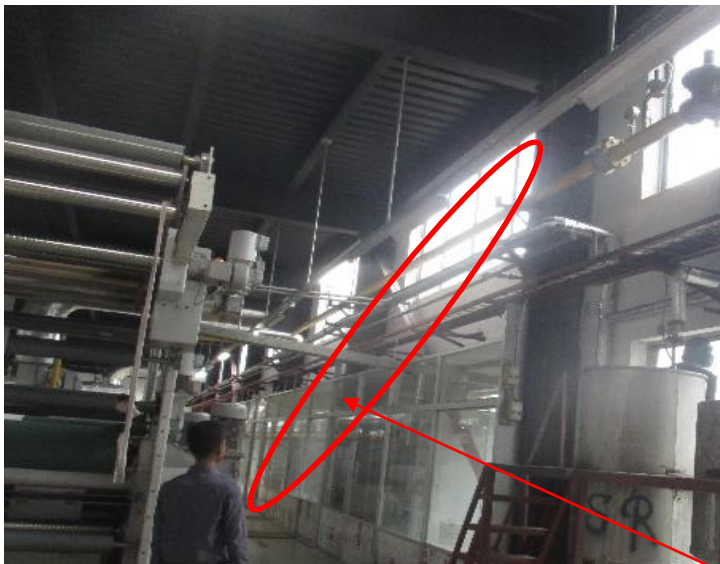
Bracing missing at one direction

Bracings were not installed properly. Bracing was missing at one direction and a bracing was not continued to the column at GF.

| Item No. | Observation | Recommended Action Plan | Recommended Timeline |
|---|---|---|---|
| 7 | Bracing were not properly installed at GF | Install missing bracing at mentioned location. | 6-weeks |

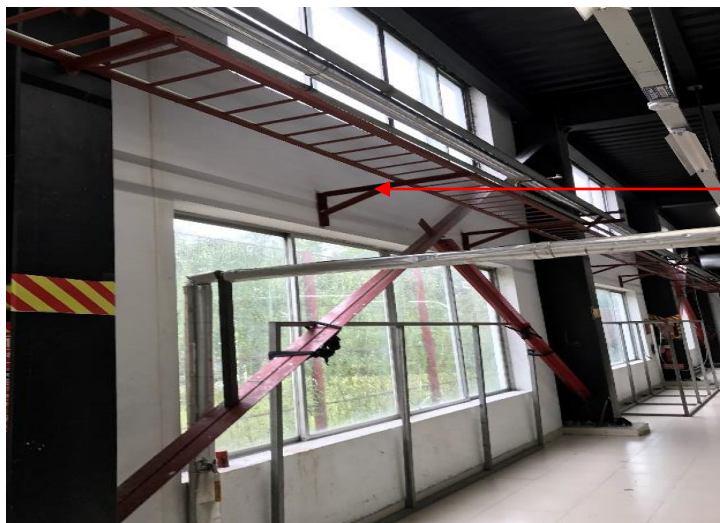
Bracing not continued to the column

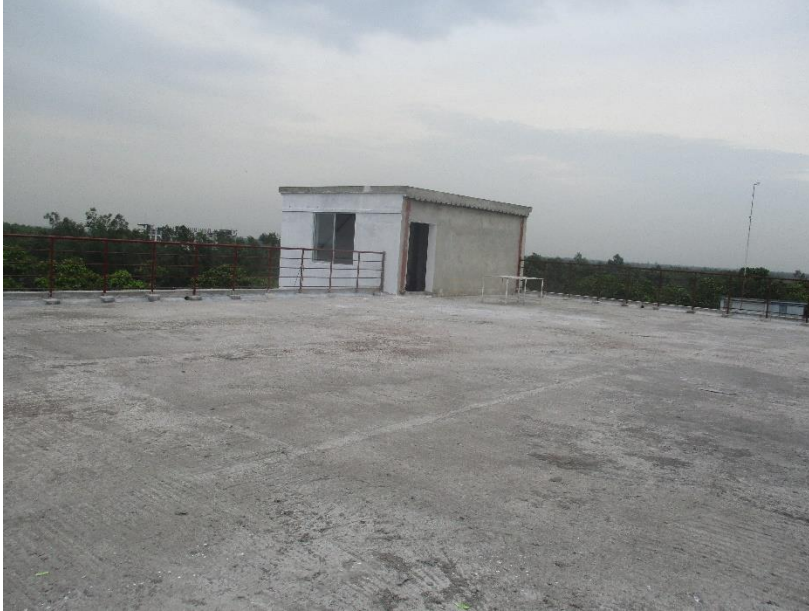
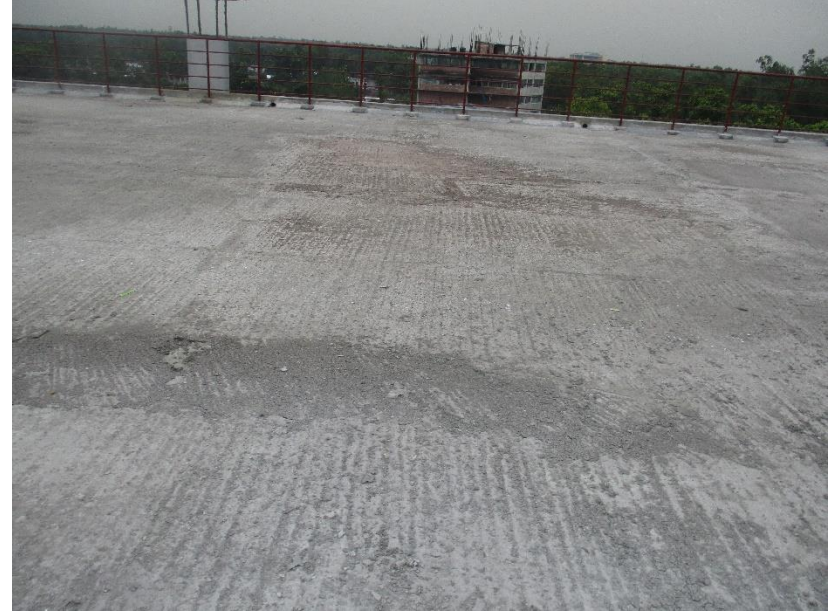
No waterproofing membrane was visible on these roofs. Proper drainage system and water proofing membrane need to apply on roof to resist water ingress into the slab.

| Item No. | Observation | Recommended Action Plan | Recommended Timeline |
|---|---|---|---|
| 8 | Lack of waterproofing system on roof | Waterproofing on the roof slab is to be applied. Moreover the roof slab drainage system should be investigated and improved. | 6-months |

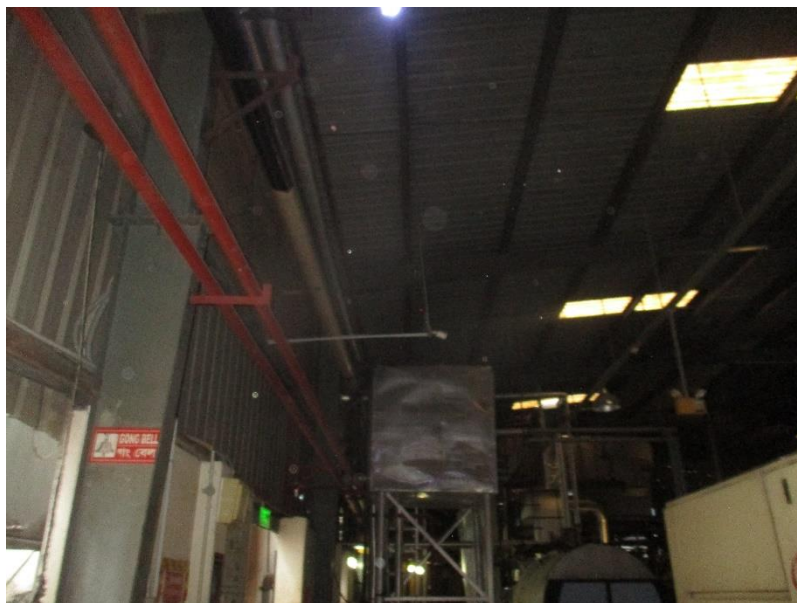
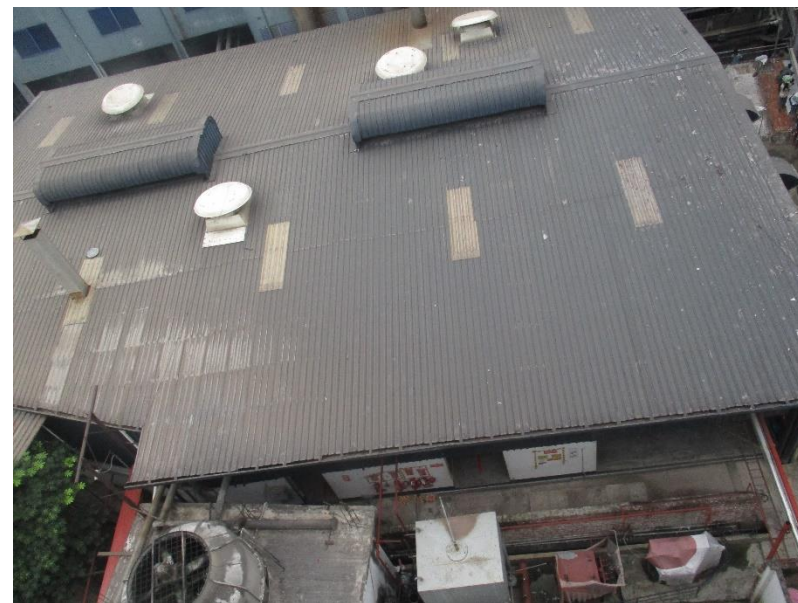
Generator Shed

As-built drawings were not available for Generator shed. Factory engineer to update the as-built drawings to the as-built condition.

| Item No. | Observation | Recommended Action Plan | Recommended Timeline |
|---|---|---|---|
| 9 | As-built documentation for Generator shed | Prepare update as-built documentation for all utility buildings. | 6-weeks |

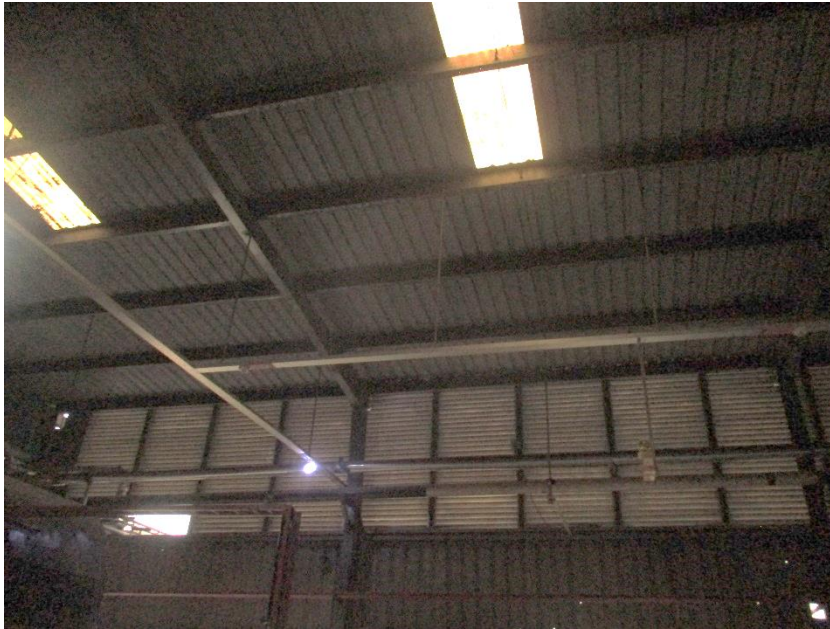
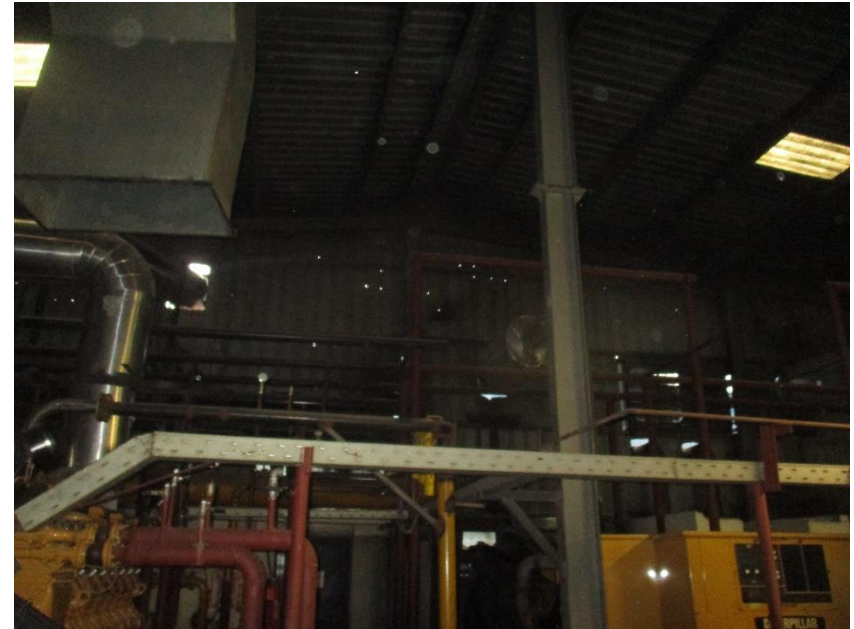
Lateral load transferring media/compression strut was not available in this structure. Also there is no proper bracing system in column and roof. Building engineer to check the stability of the structure under lateral and vertical loading.

No bracing and compression strut was observed.

| Item No. | Observation | Recommended Action Plan | Recommended Timeline |
|---|---|---|---|
| 10 | Lack of stability system (Generator Shed) | Building engineer to check the capacity of the structure under lateral and vertical loading. | 6-weeks |
| 11 | Lack of stability system (Generator Shed) | Carry out remedial works resulting from engineering assessment of building. | 6-months |
