KAC Fashion Wear Ltd. (9674)

12/13 Tetui Bari, Sarabo, Gazipur

09.July.2014

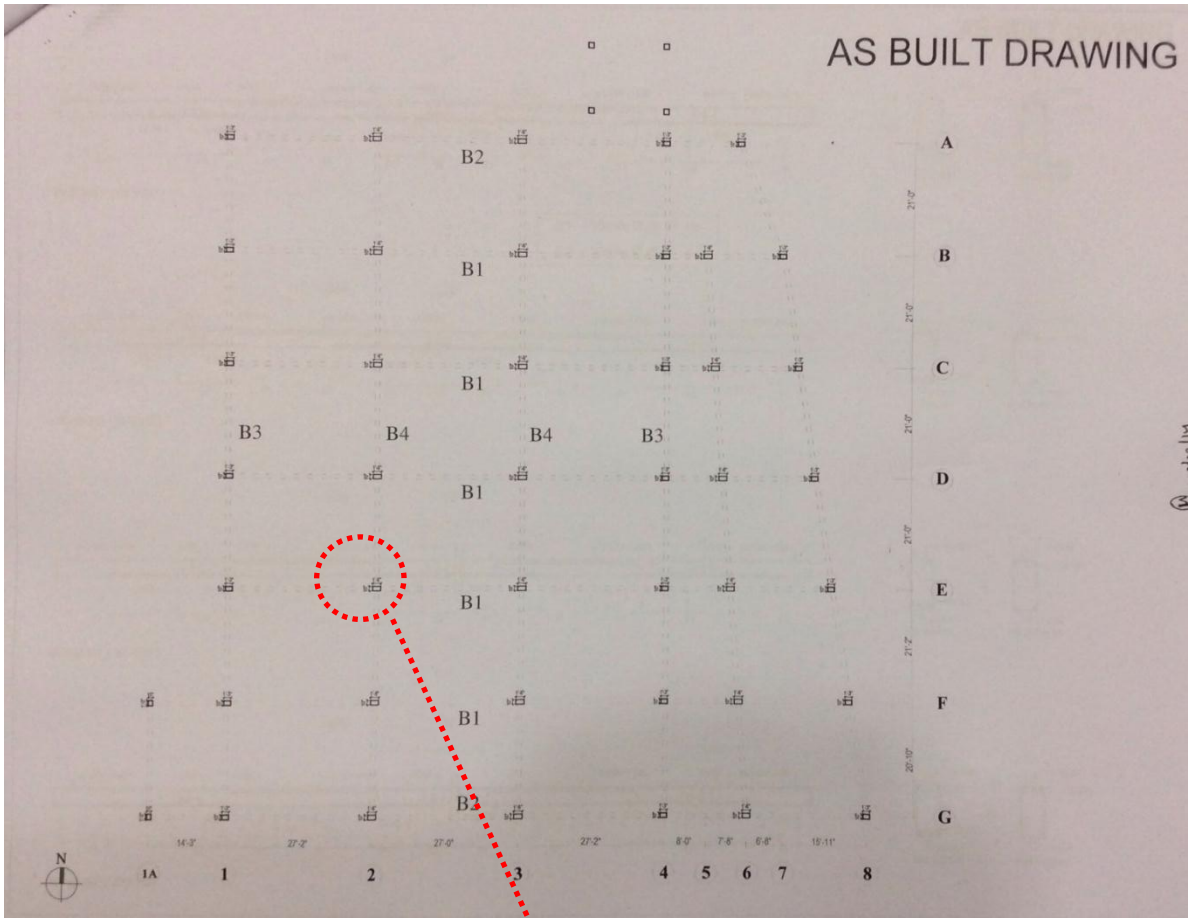
1st Priority 3 Concern

Based on the load rundown analysis with the agreed minimum design live load assignment, the typical column which is circled has been found to be possess a low factor of safety with respect to its load carrying capacity. The building was constructed with brick aggregate and high-yield strength re-bar.

Typical column to be checked

Item No.	Observation	Recommended Action Plan	Recommended Timeline
1	1st Priority-3 - The typical columns in building 1 have low factor of safety with respect to their load carrying capacity.	Carry out a full Detailed Engineering Assessment of the entire building including any intrusive testing required Building Engineer is to fully check the loading capacity of all components to determine whether or not the as-built components are able to sustain the applied loads.	6-weeks
2	1st Priority-3 - The typical columns in building 1 have low factor of safety with respect to their load carrying capacity.	Implement the steps as required from a DEA.	6-months
3	2nd Priority 3 - Inconsistency between drawing and real site condition in building 2	Factory Engineer to check full structural system to verify whether the slabs, columns are able to support the applied loads	6-weeks
4	2nd Priority 3 - Inconsistency between drawing and real site condition in building 2	Factory Engineer to revise the drawing record to reflect the real site condition	6-months

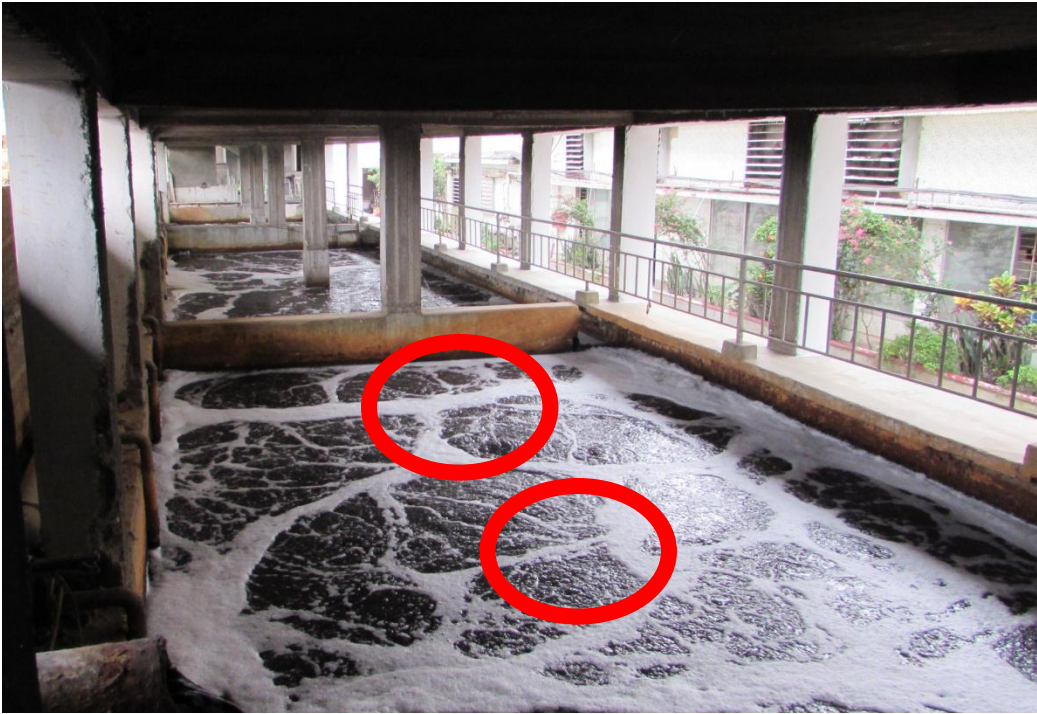
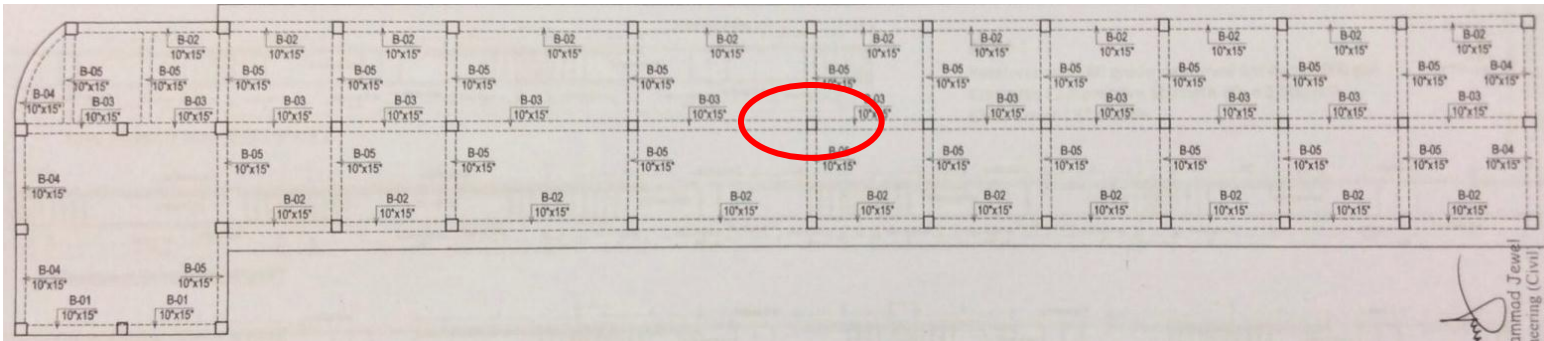
2nd Priority 3 Concern

In building 2 some columns are missing in middle grid. Columns in indicated area are missing for all three storeys.

Inconsistency between drawing and real site condition in building 2

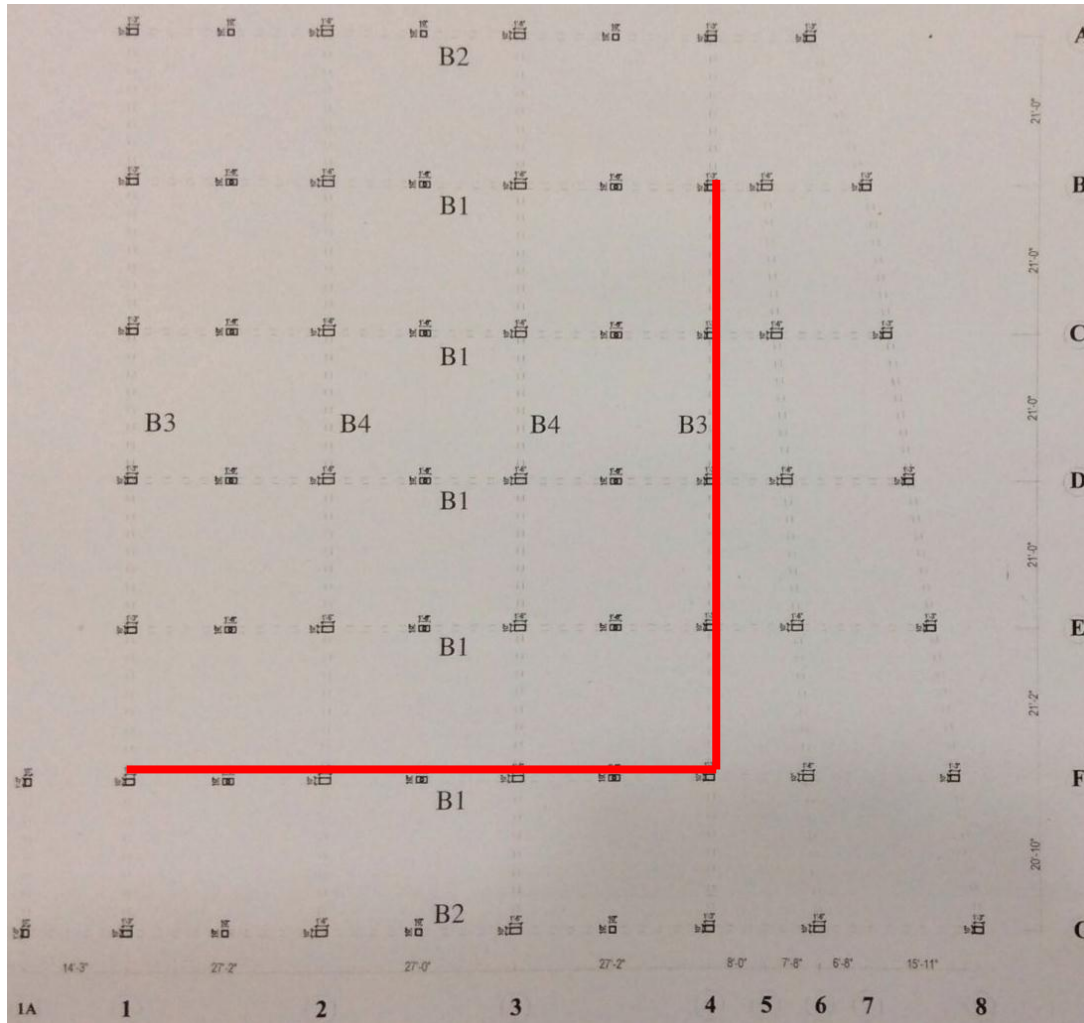
In building 1 grid spacing is 27'-2" x 21'-2" with slab thickness only 127mm. ($\text{Span/Depth ratio} = 326/5.5 = 59 > 40$). Beam depth is 15 inch ($326/15 = 21 > 16$). The span-depth ratios are greater than what were required in the building code. For long term deflection, slab thickness and beam depth does not satisfy.

Slab thickness and beam depth does not satisfy for long term deflection in building 1

5	3rd Priority 3 - Slab thickness and beam depth does not satisfy for long term deflection in building 1	Commence Detailed Engineering Assessment to verify slab thickness and beam depth is stable for long term deflection	6-weeks
6	3rd Priority 3 - Slab thickness and beam depth does not satisfy for long term deflection in building 1	Make strengthening work for slab or beam as recommended in Detailed Engineering Assessment	6-months
7	4th Priority 3 - Purlin depth does not satisfy for long term deflection even for strength	Replace flimsy existing purlins, or strengthen them to meet BNBC loads.	6-months

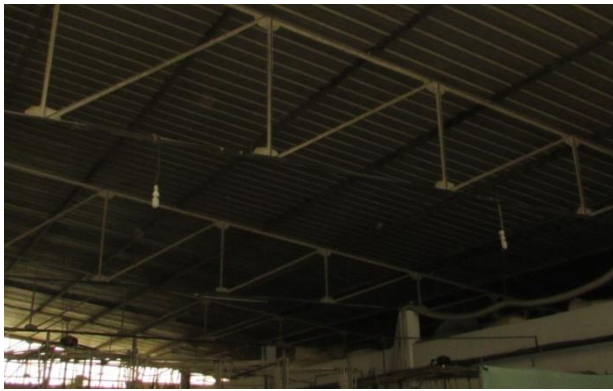
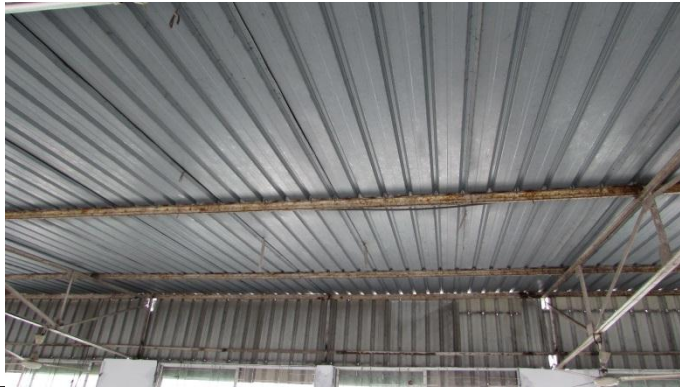
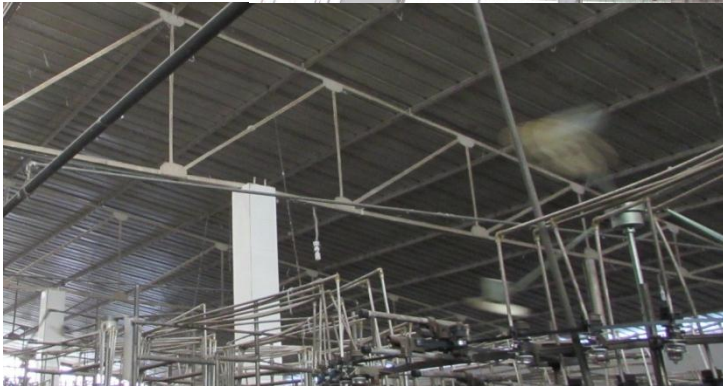
In shed 1 & 3 purlin seems very weak. Thickness of purlin used is 75mm which does not satisfy for long term deflection

Purlin depth does not satisfy for long term deflection even for strength

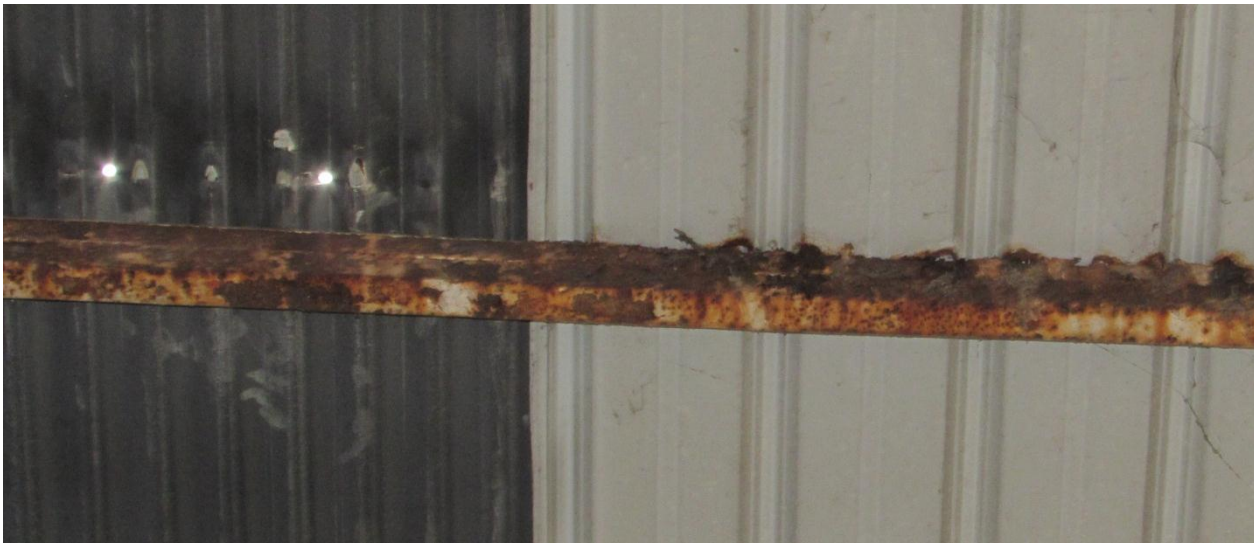
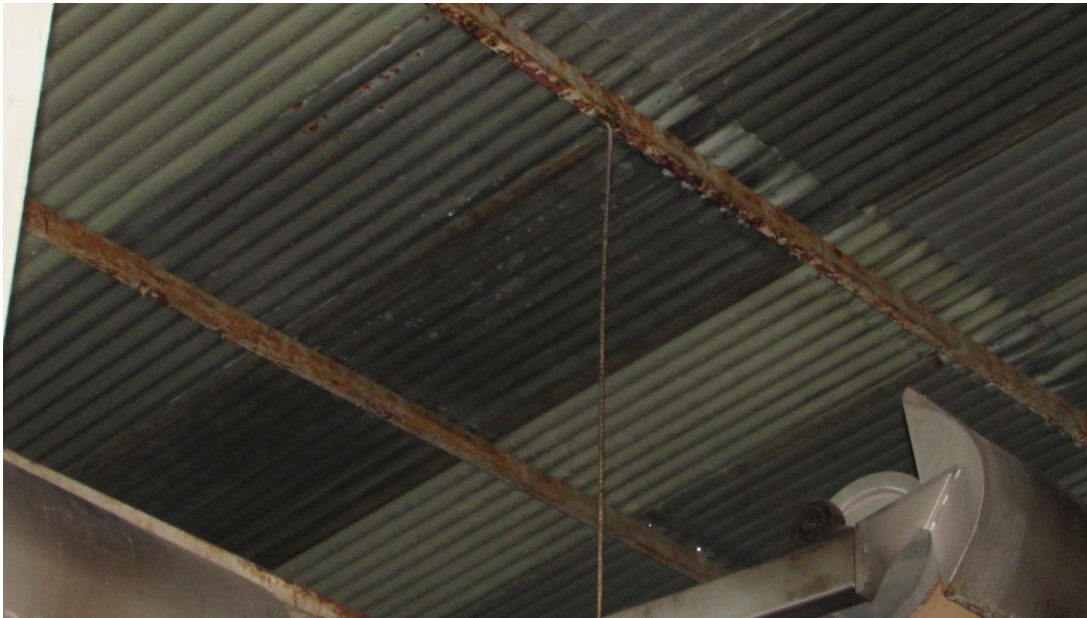
5th Priority 3 Concern

Rusting was observed on almost every member of the steel truss in shed 2. In shed 2 heavy steam and heat is produced due to operation of washing machineries. No heat proofing membrane or rust proof paint is used on members.

Rusting on steel shed member

Item No.	Observation	Recommended Action Plan	Recommended Timeline
8	5th Priority 3 - Rusting on steel shed member	Remove the members which are fully damaged and install new members Clean all steel members and apply rust proofing paint.	6-months
9	6th Priority 3 - No parapet wall and stair railing in building 2	Install parapet wall Install railing for stair case All work must comply to BNBC.	6-months
10	7th Priority 3 - Clear cover of columns in chemical water tank in building 2	Verify whether clear cover of the columns are appropriate	6-weeks
11	7th Priority 3 - Clear cover of columns in chemical water tank in building 2	Apply a protective membrane if clear cover of the columns is found to be insufficient.	6-months

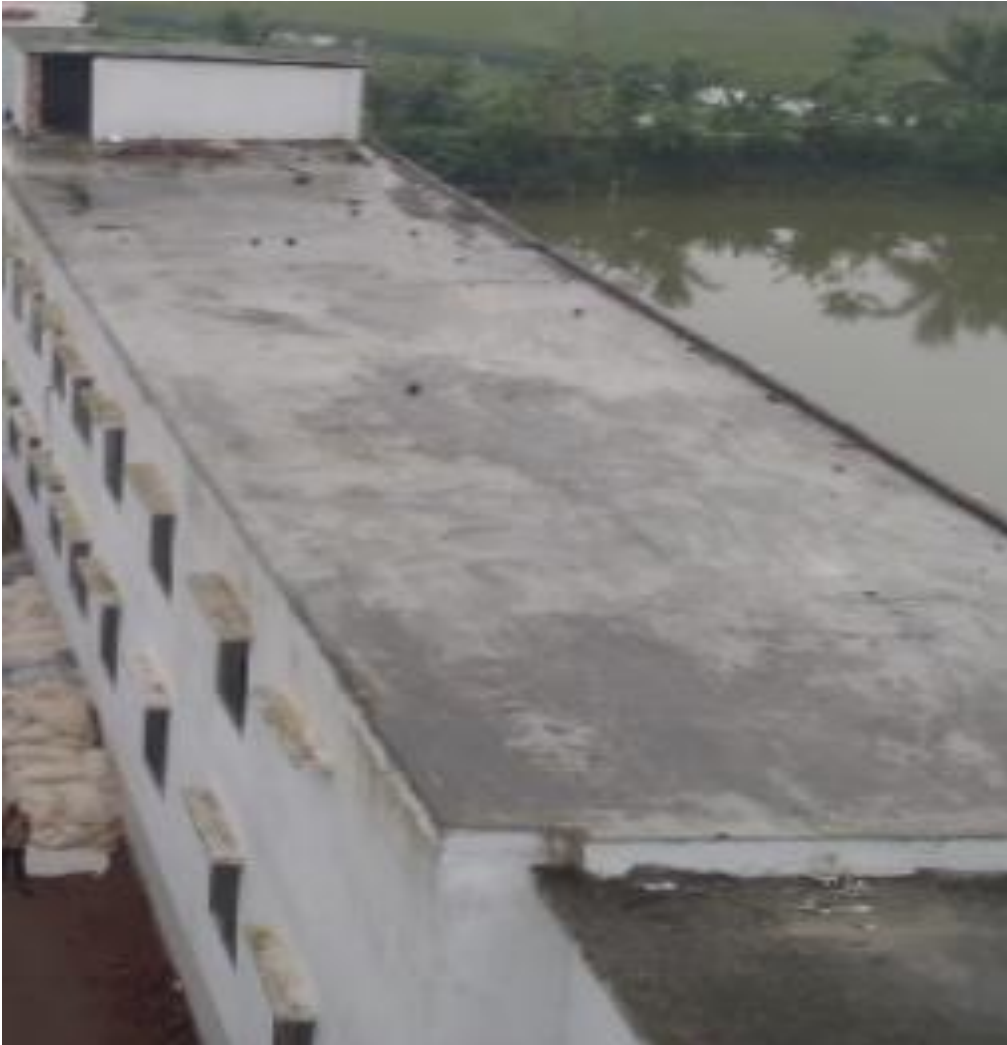
6th Priority 3 Concern

On roof of building 2 no parapet wall and no railing for stair is installed. In case of fire or any other emergency factory owner intended to use this roof for people gathering. For safety of people working in this building parapet wall and stair railing need to be installed.

No parapet wall and stair railing in building 2

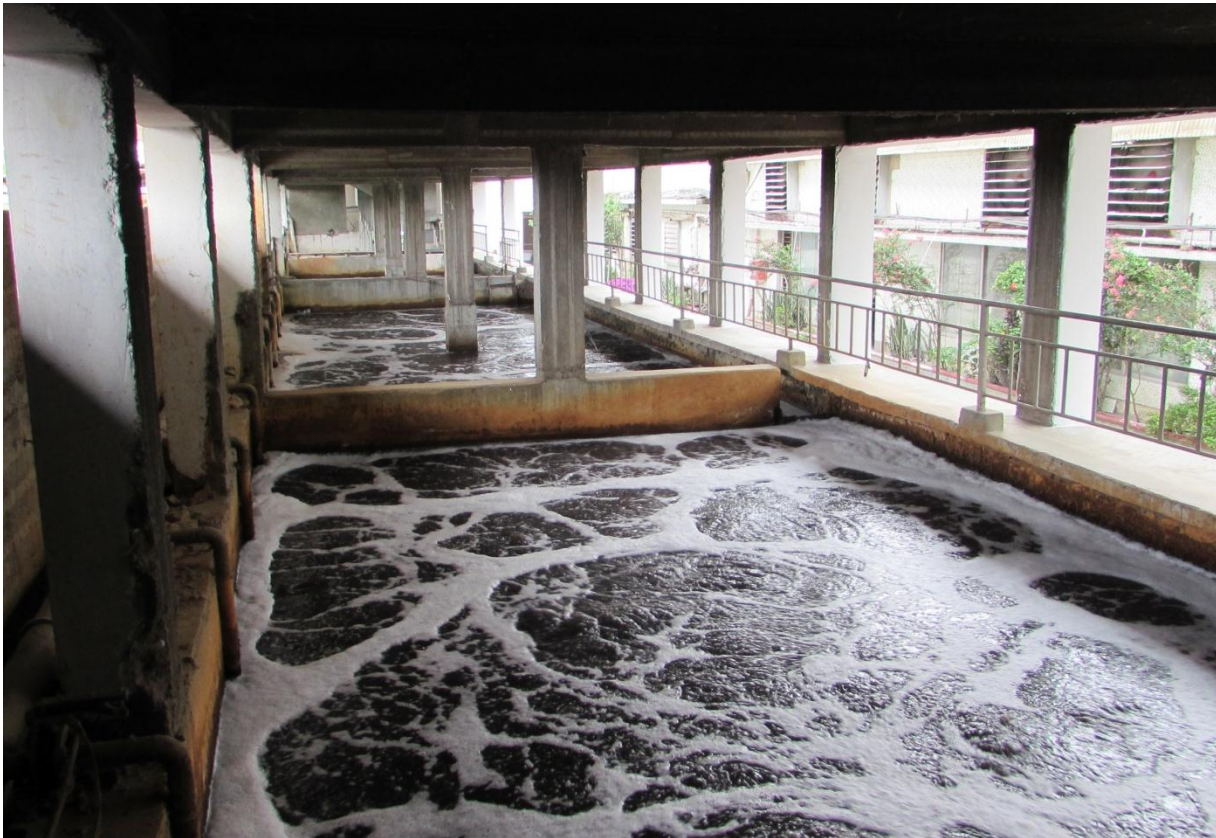
7th Priority 3 Concern

In building 2 columns are directly exposed to the chemical water tank. For chemical mixed water, clear cover of columns should strictly follow the code requirement . It was impossible for us to verify whether clear cover is appropriate or not.

Clear cover of column in chemical water tank in building 2

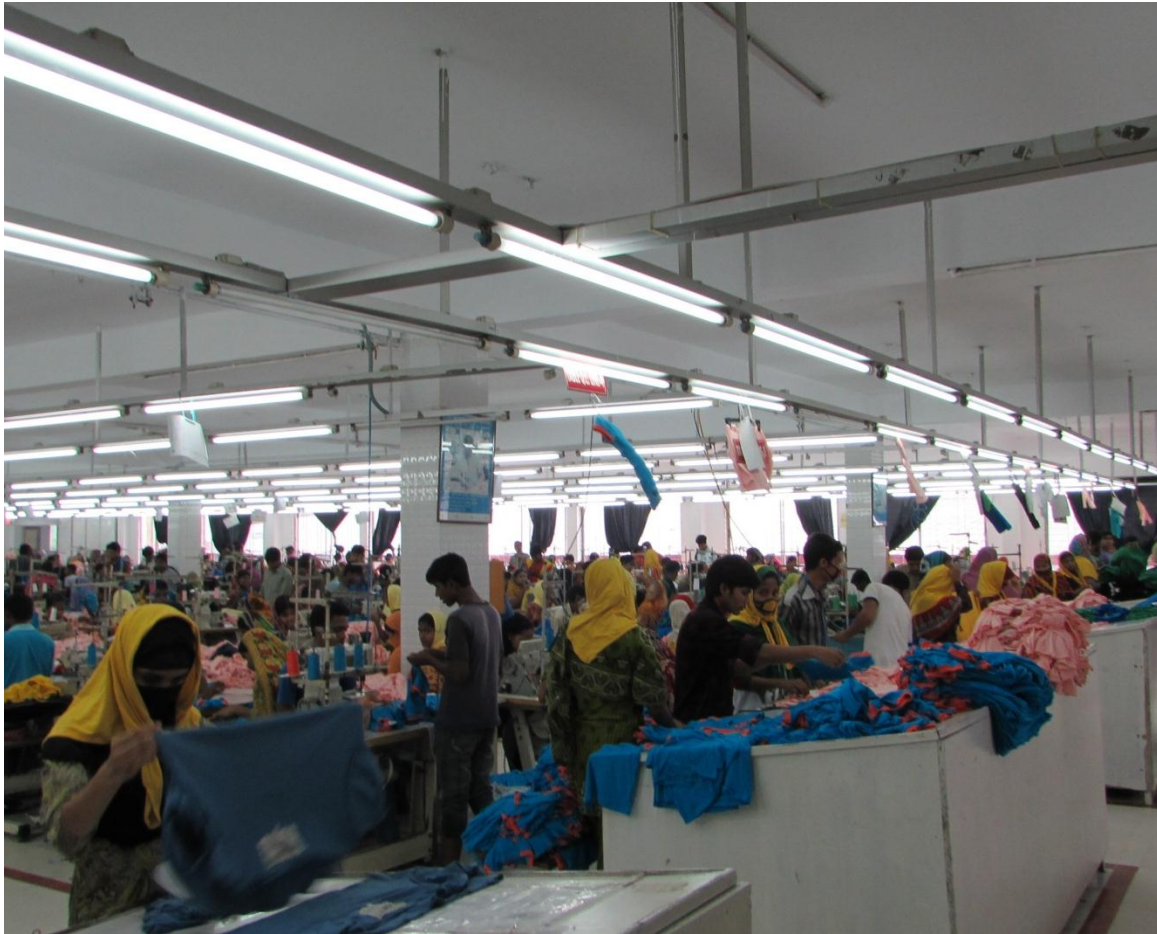
Overall Stability System

The building did not feature any core or shear walls. Stability was achieved through sway action between beams and columns and masonry infill walls.

We require that these items be investigated in a Detail Engineering Assessment

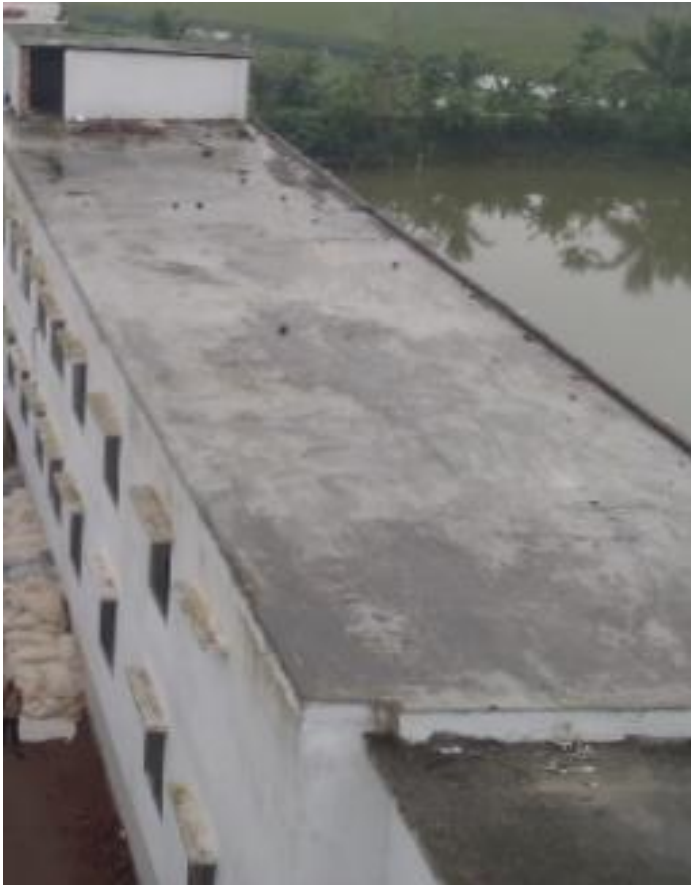
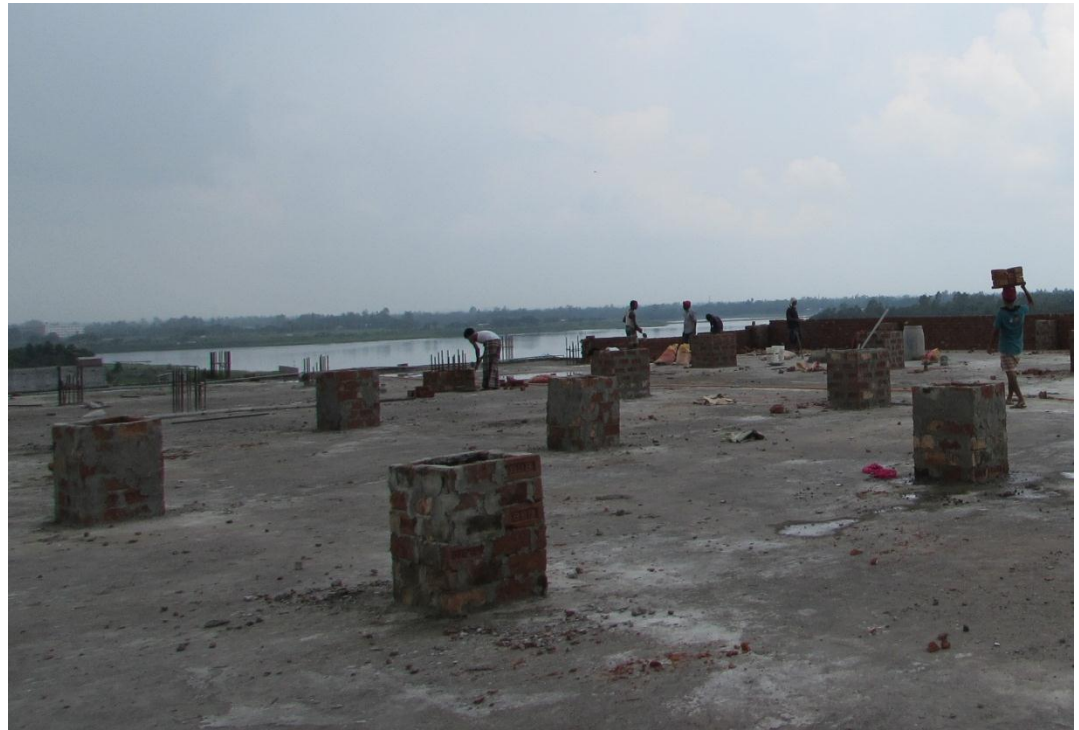
Water Ingress at Roof Level

No waterproofing membrane was visible on the roof of building 2 and 3. This means that any cracks in the surface finishes on the roof will allow water to seep into the concrete slab beneath the finishes, and cause corrosion of the reinforcing steel.
