GMS Composite Ltd.

Shardagonj, Kashimpur, Gazipur, Bangladesh
(23.968661, 90.296963)

22 March 2014

Observations

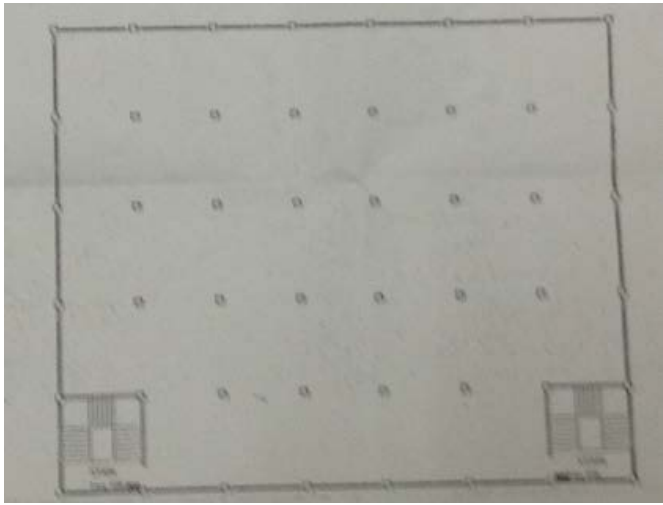
Typical Column Layout – Building 1

Highly stressed columns

Cursory calculations indicate that the working stresses of columns are at a high level.

Building Engineer to check that columns have been designed to accommodate applied loads.

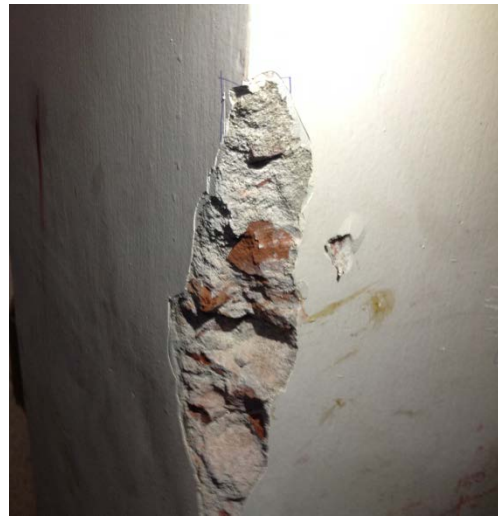
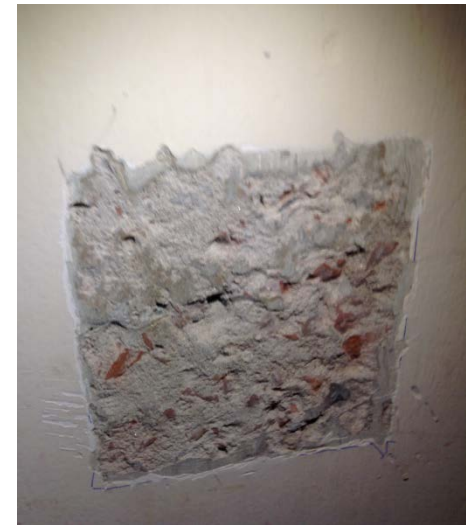
Brick aggregate observed.

Tested column at lower floors - Brick aggregate observed.

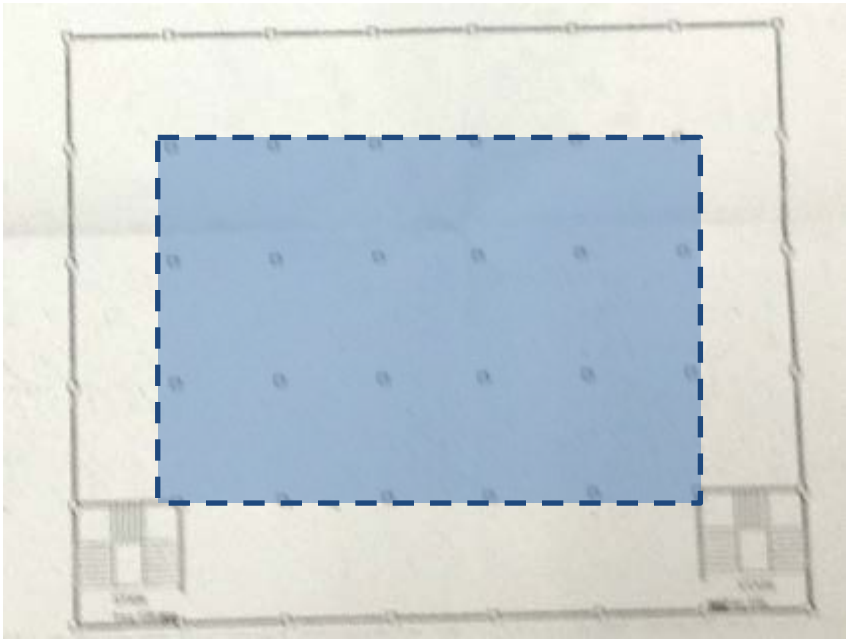
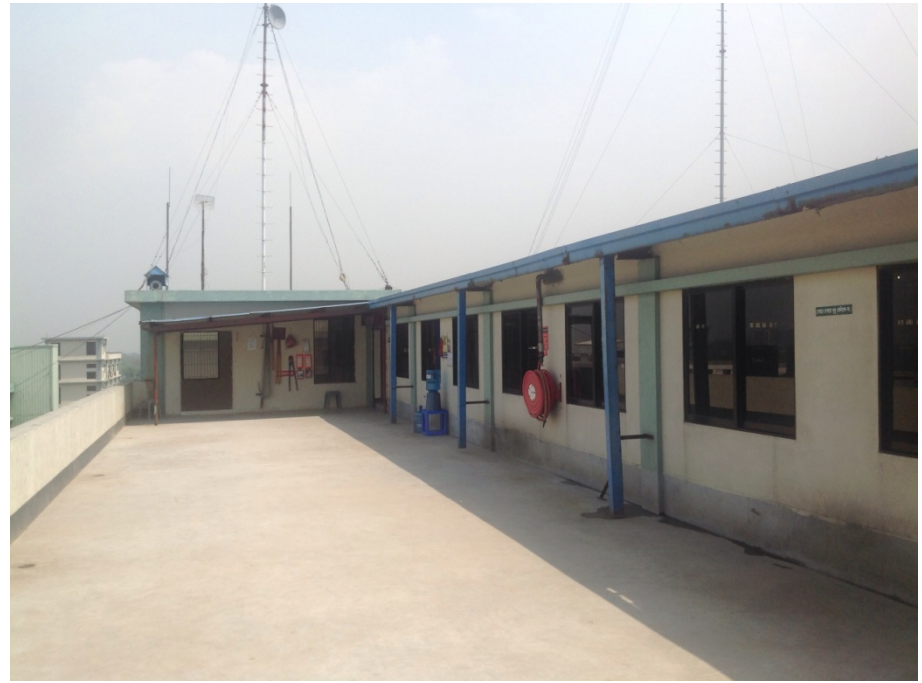
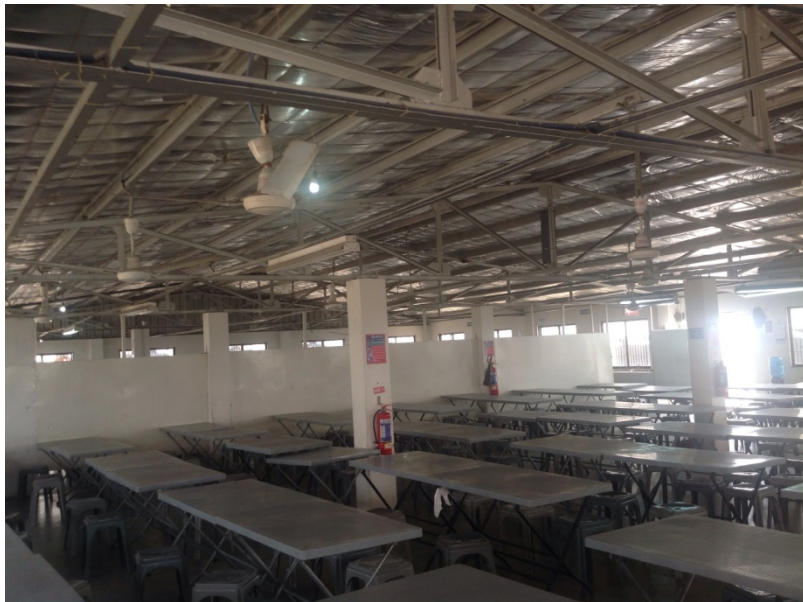
Vertical extension on roof comprising brick masonry walls with a lightweight steel trussed roof on Building 1. No evidence of horizontal bracing.

No structural or design documentation provided for extension. Subject to uplift forces .

Check on roof additions required

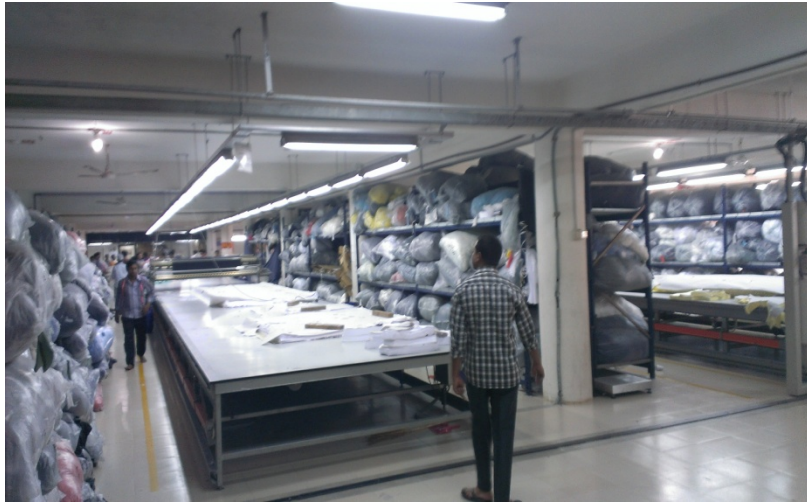
Localised storage loading in a number of other areas in all of the surveyed buildings.

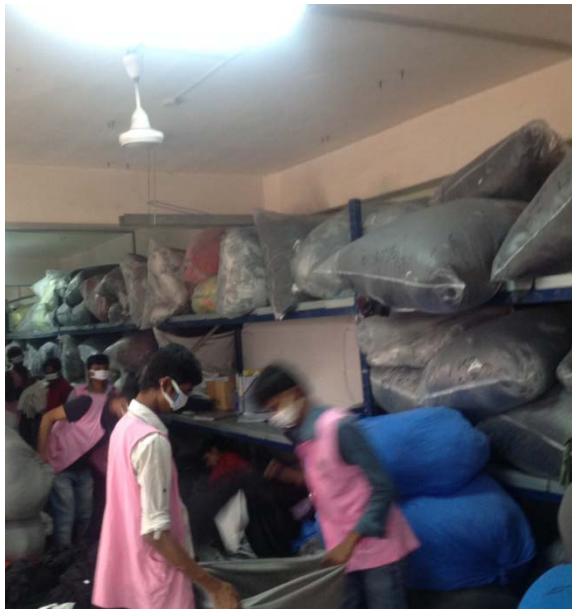
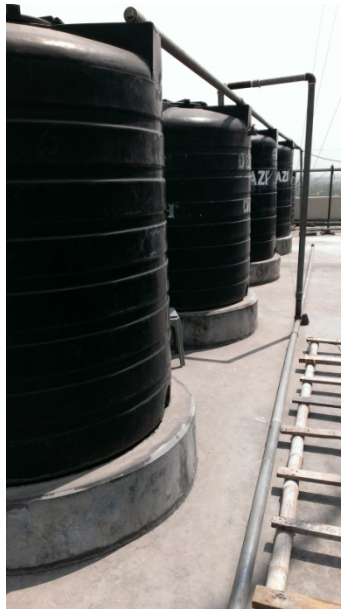
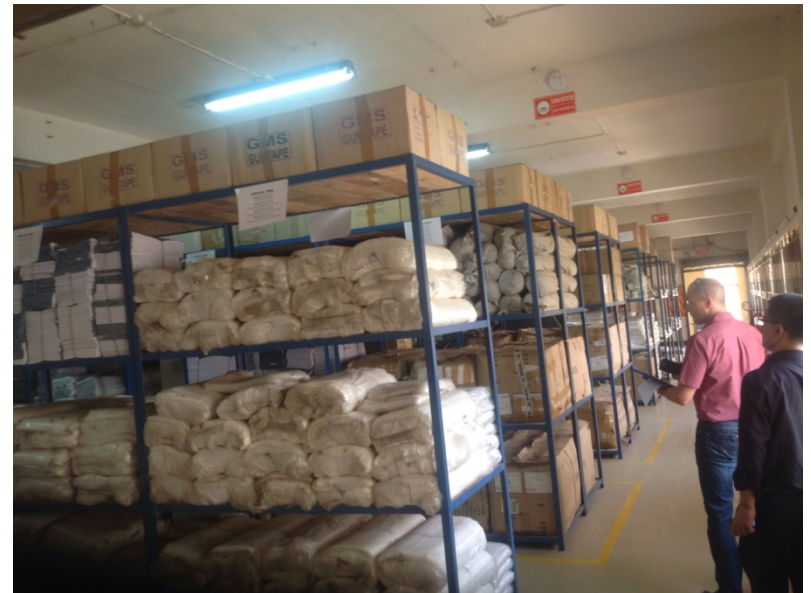
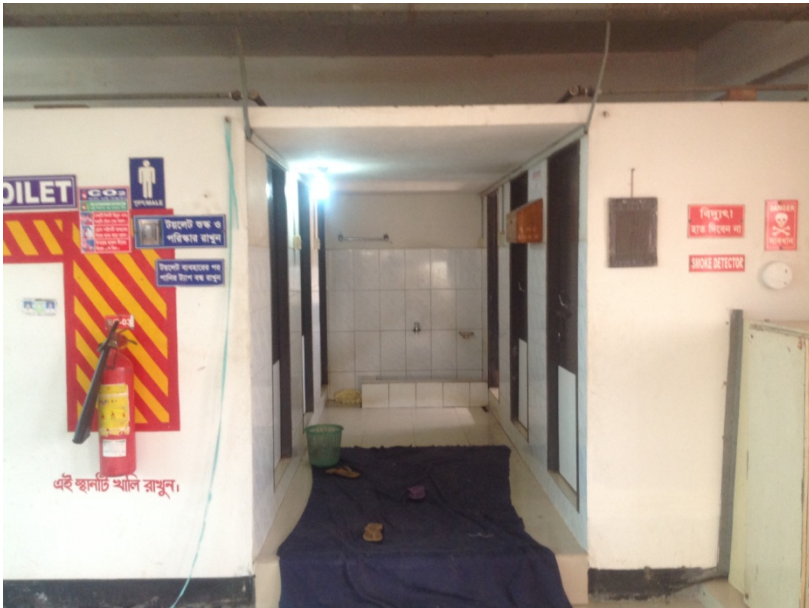
Typical toilet block building

Water tanks with concrete bases located at roof level (Building 1) supported on regular slab and beam structure spanning between columns.

Increased floor build-up in toilet block areas (~160 + 110mm in cubicles).

Partition walls around block and between additional cubicles

Additional approx. 100mm thick concrete ceiling above toilet blocks.

Storage added on top of ceiling slabs in a number of areas.

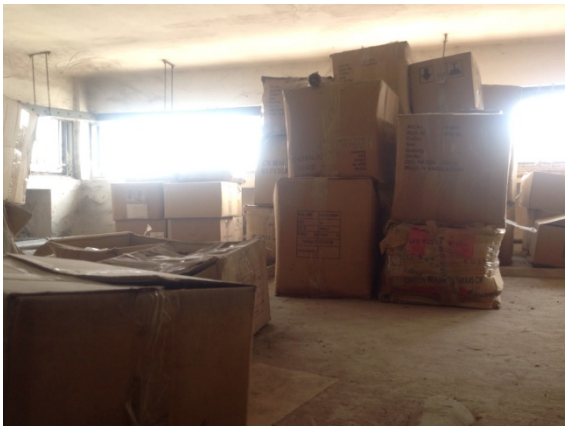
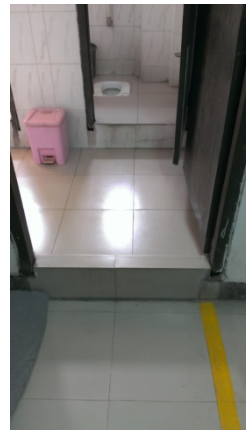
Storage on top of toilet block

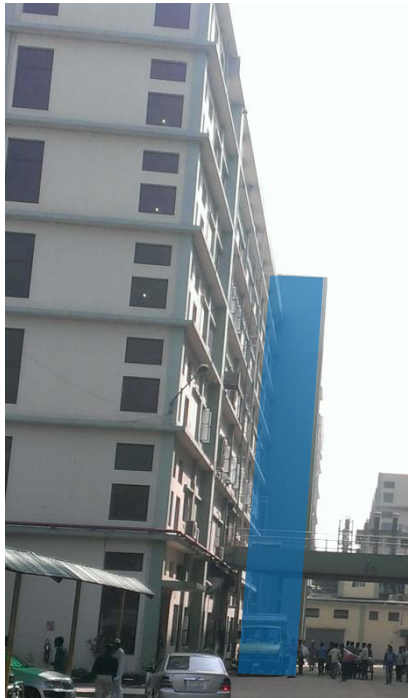
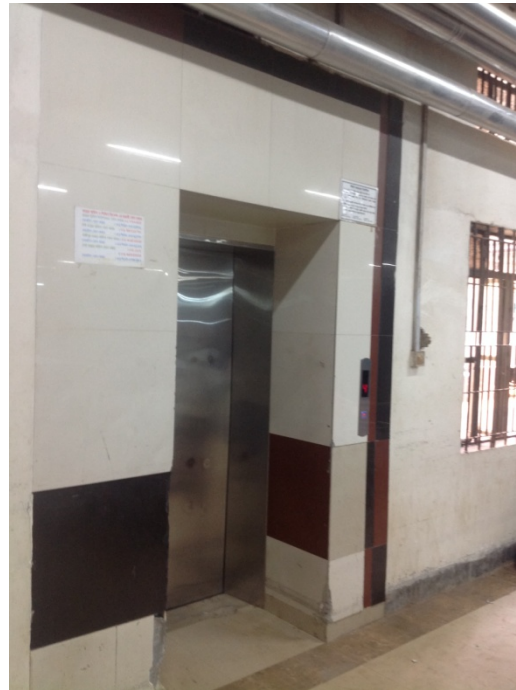
No structural or design documentation provided for horizontal extensions.

Lift shafts added to a number of buildings

Building engineer to carry out detailed engineering assessment of extensions and impact of additional loading on the primary building structures.

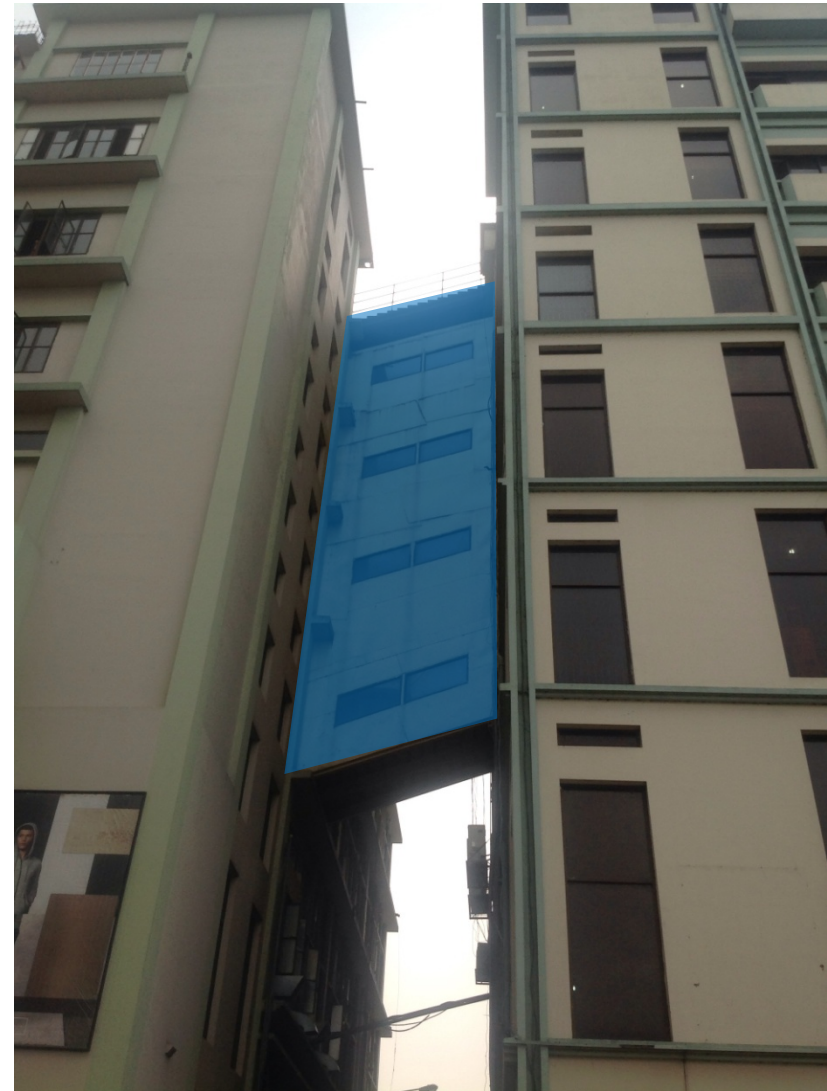
4 Storey Link Bridge between B1 and B2

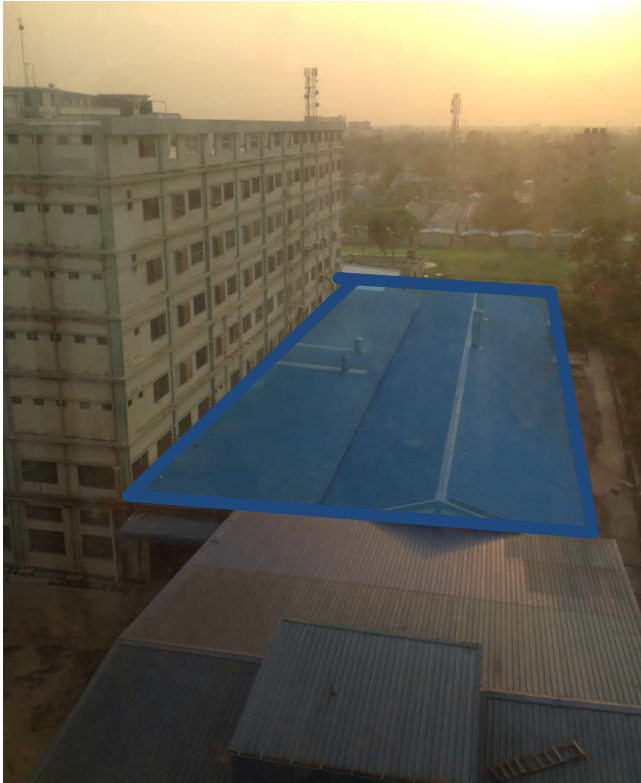
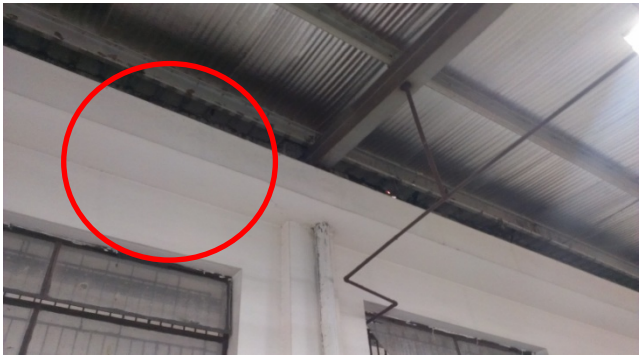
Shed extension (Building 3) supported off main building.

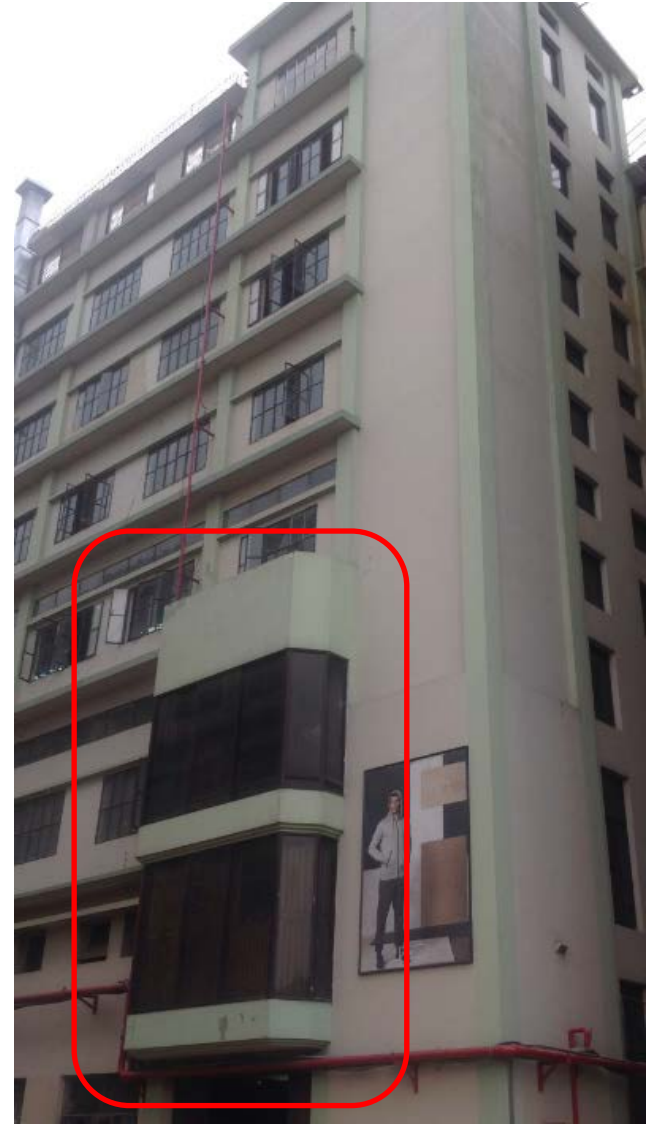
Undocumented cantilever structures from Building 2.

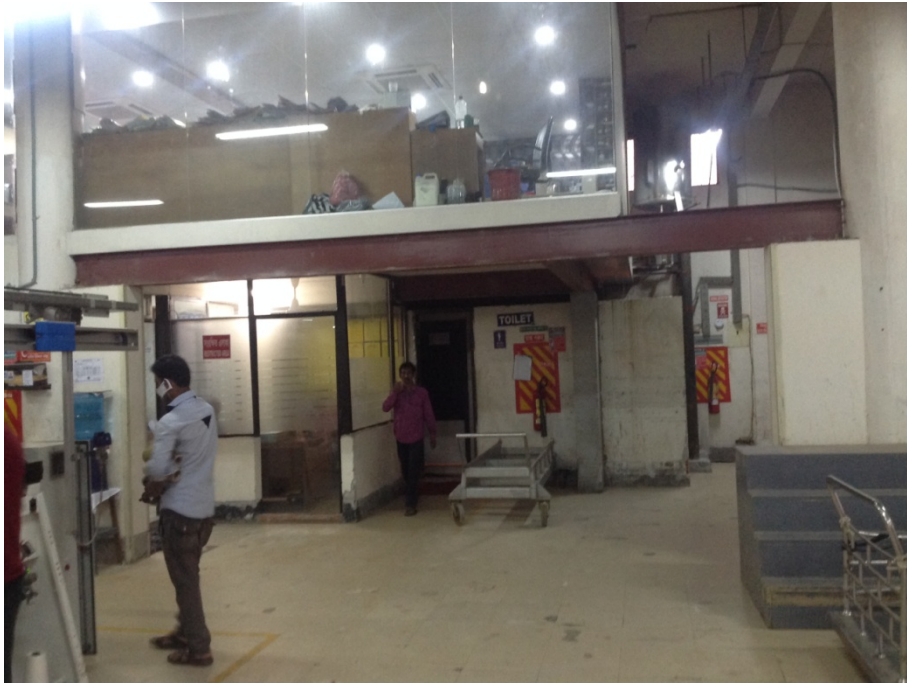
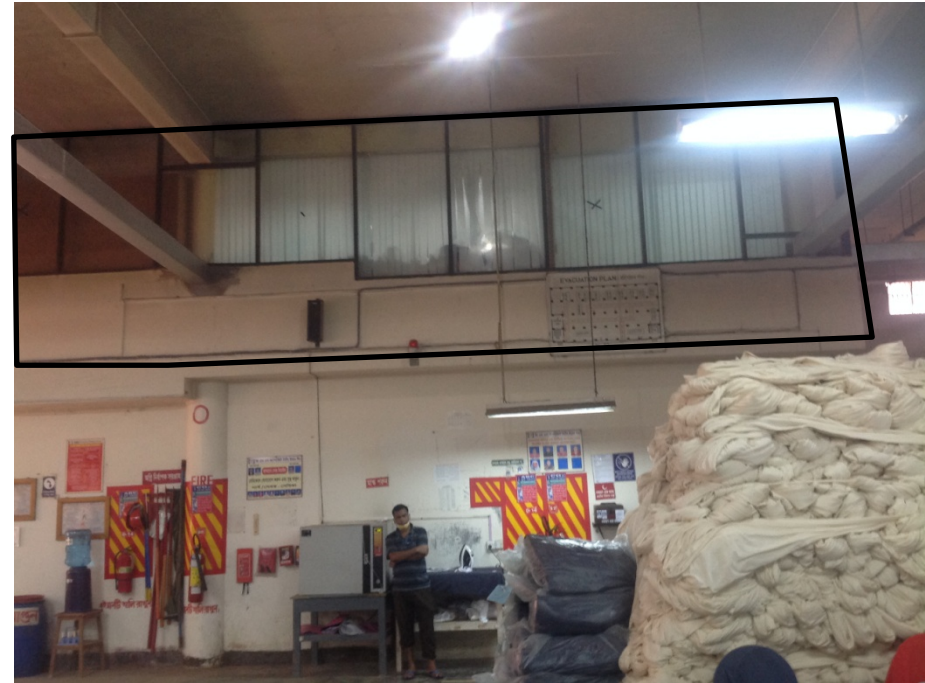
No structural or design documentation provided for alterations to structure.

Undocumented mezzanine levels have been added to Buildings 2 and 4.

Building engineer to carry out detailed engineering assessment of extensions and impact of additional loading on the primary building structures.

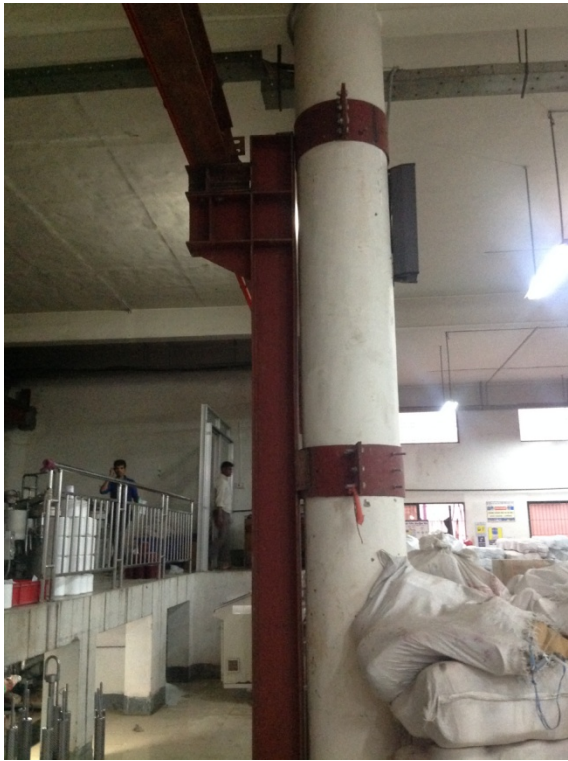
Crane beams attached to a number of columns in Building 4 applying additional loading.

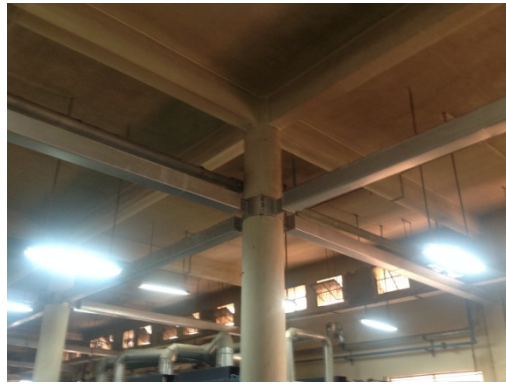
Additional steel frame for new ceiling/thermal barrier supported from structural column.

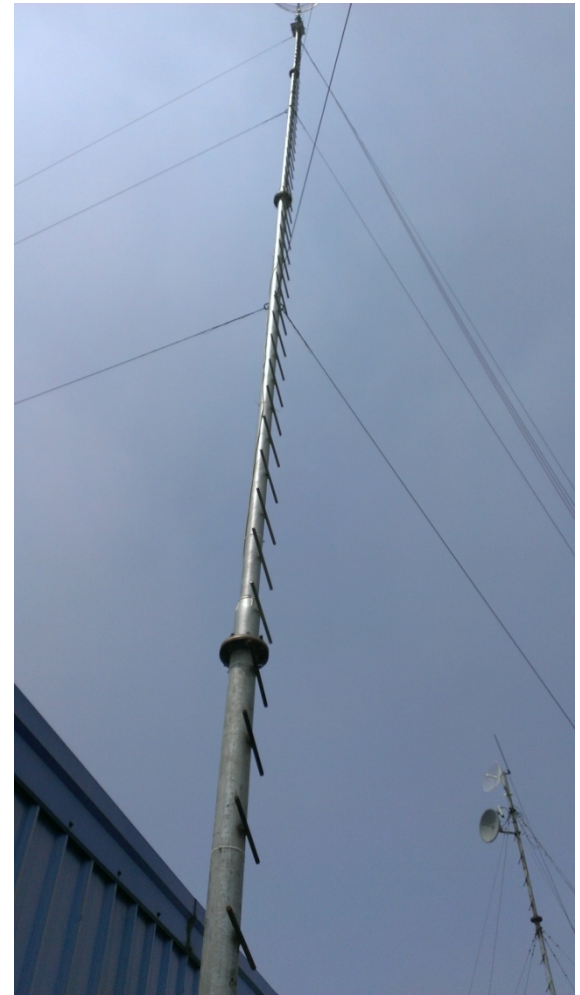
Communications mast supported on structure on roof of Building 1- Horizontal and vertical loads.

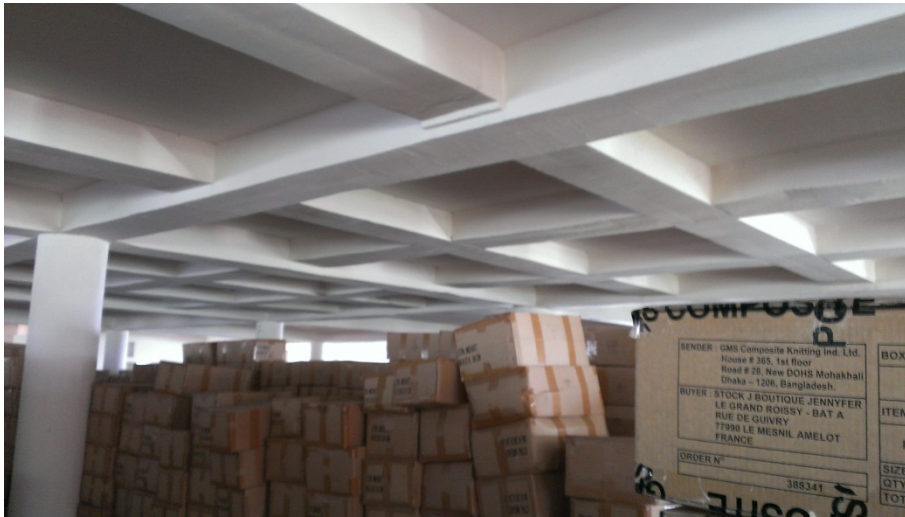
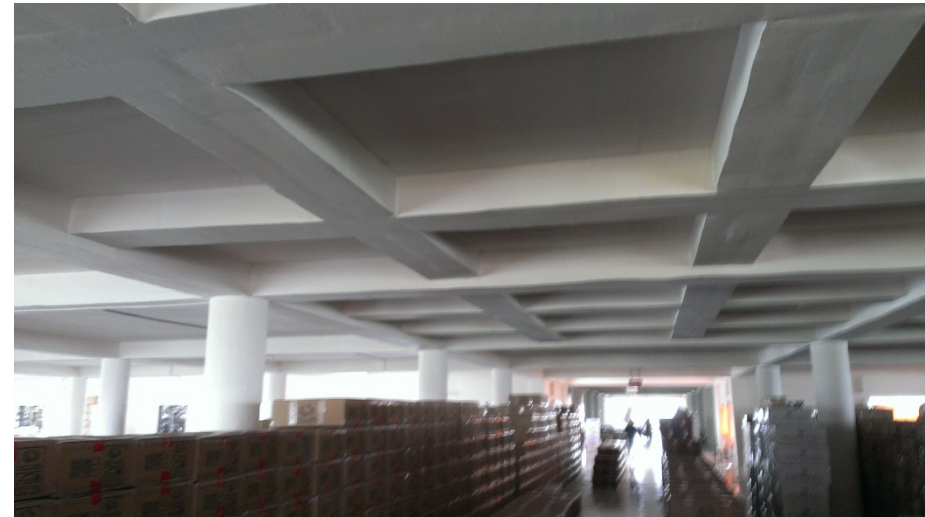
No structural or design documentation provided for alterations to structure (Buildings 5,6).

Undocumented roof level strengthening proposed for heli-pad.

Building engineer to confirm design of proposed area usage. Extent of works comprised of 4 bays with 2 additional shallow beams in each direction.

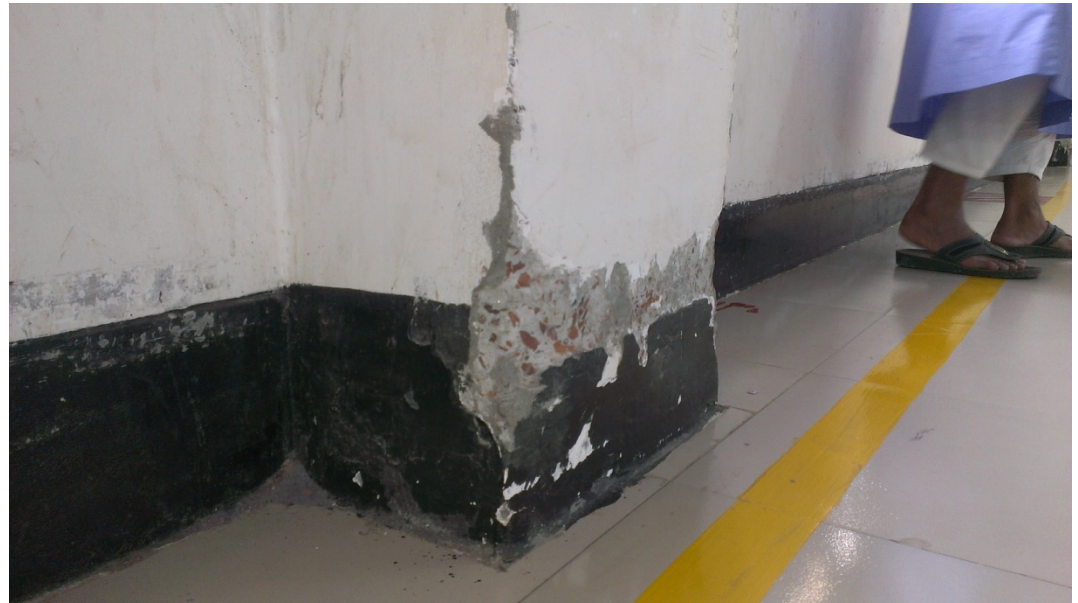
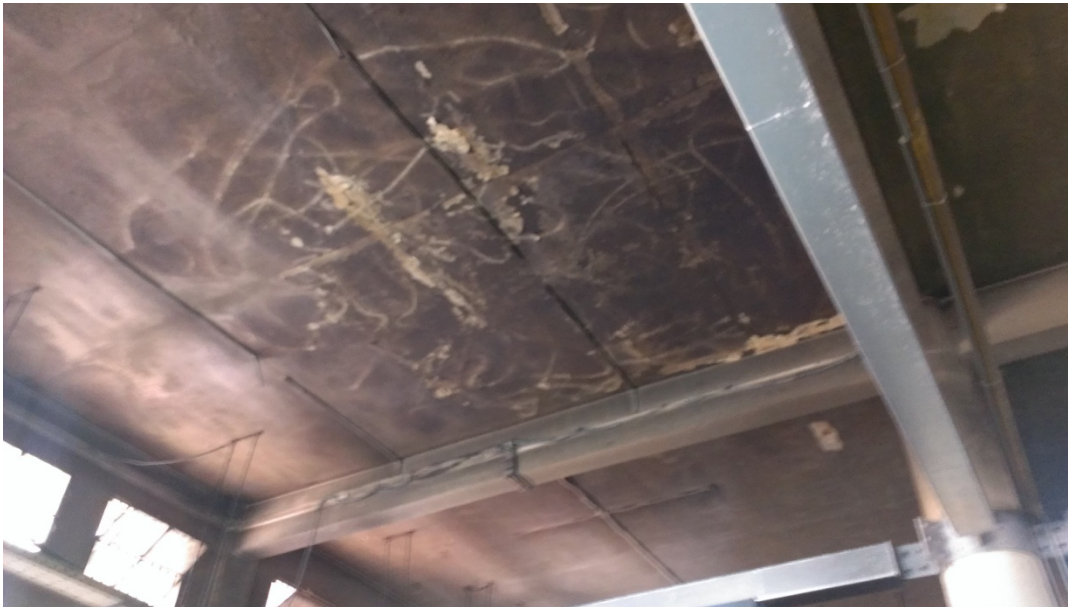
Damage to the base of a number of columns in the typical floors. No plaster finish observed. Repair of surface and protection of vulnerable columns required.

Damage to soffit of slab observed in Building 4. Extent of damage to be assessed by Building Engineer and repaired if necessary
