# **FIRE SAFETY INSPECTION REPORT**

**Purbani Fashion Limited**

**ACCORD ID: 22937**

**Date: 09 November, 2017**

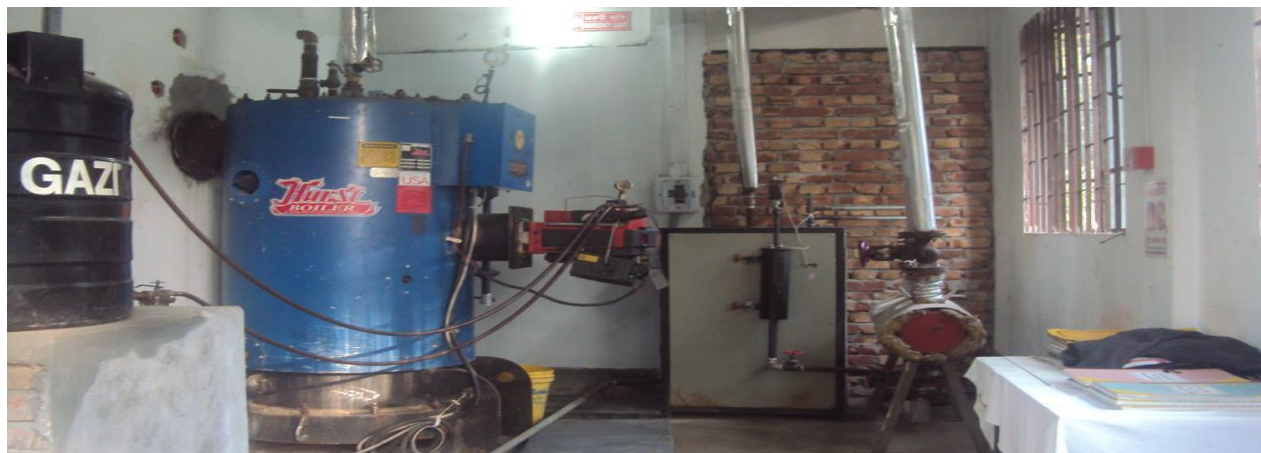
| Sl No. | Category | Findings | Required Action | Remediation Time Frame |
|---|---|---|---|---|
| 1 | Fire separation | The boiler room is not separated by fire rated construction (openings, penetrations) | Separate the boiler room by a minimum 1-hr fire rated construction (for low rise building). Seal and/or protected all openings to maintain fire separations. | #Within 3 months |

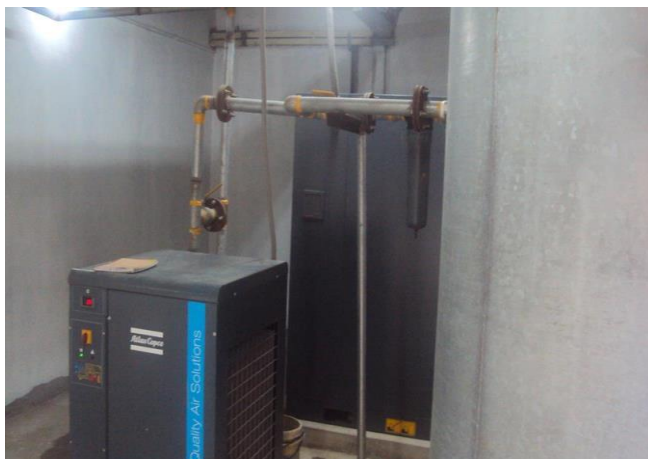
| SI No. | Category | Findings | Required Action | Remediation Time Frame |
|---|---|---|---|---|
| 2 | Fire separation | Compressor room is not separated by fire rated construction (openings, penetrations) | Separate the Compressor room by a minimum 1-hr fire rated construction (for low rise building). Seal and/or protected all openings to maintain fire separations. | Within 3 months |

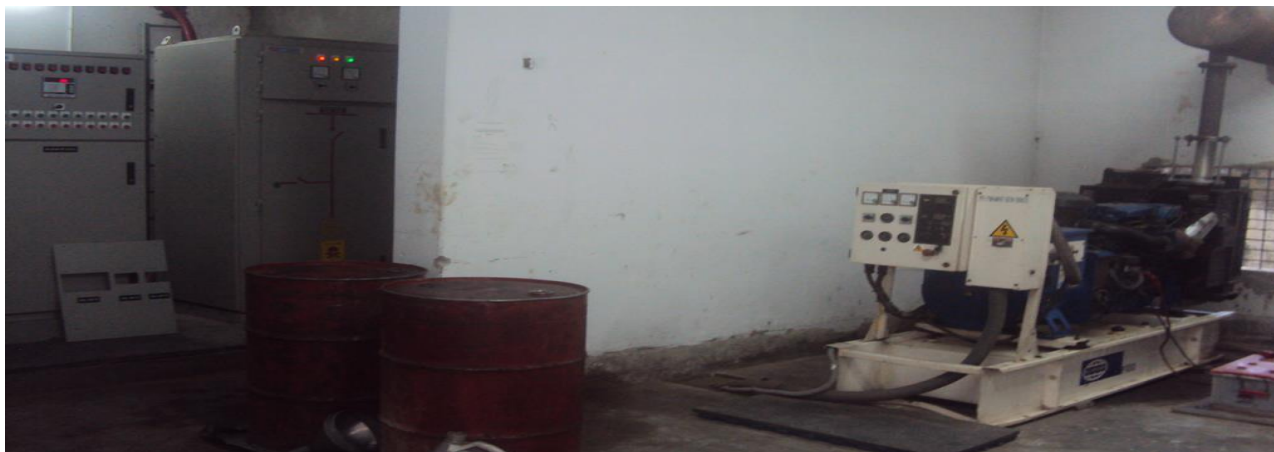
| SI No. | Category | Findings | Required Action | Remediation Time Frame |
|---|---|---|---|---|
| 3 | Fire separation | Generator room is not properly separated by fire rated construction with sub station | Separate the generator room by a minimum 1-hr fire rated construction (for low rise building). Seal and/or protected all openings to maintain fire separations. | Within 3 month |

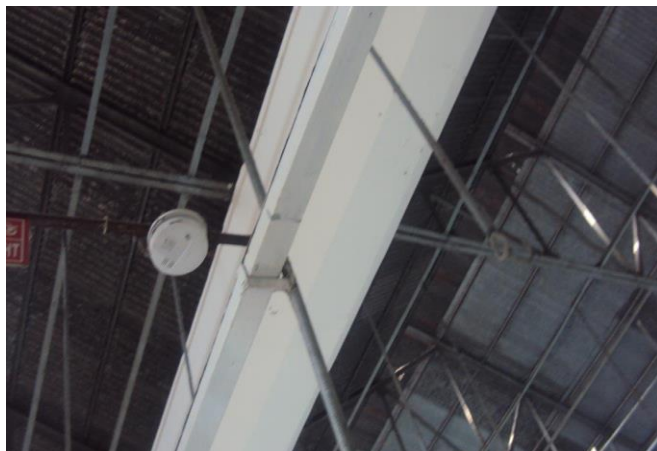
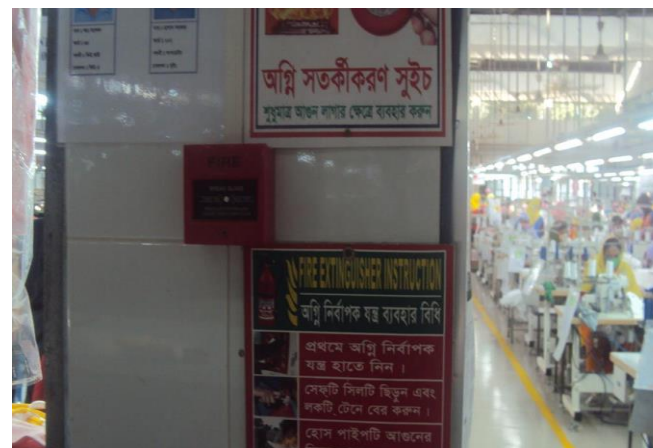
| SI No. | Category | Findings | Required Action | Remediation Time Frame |
|---|---|---|---|---|
| 4 | Fire Protection System | The fire alarm system is antiquated, not a listed system and does not provide alarm and notification features consistent with acceptable standard. | Modify the fire alarm system with a new, listed addressable/conventional fire alarm system in accordance with NFPA-72. | Design within 3 months and install within 6 months. |
