# Jeans 2000 Ltd

Plot #67, Sector #07, Export Processing Zone, Chittagong  
(+22.299113N, 91.777006E)

04 November 2013

# Building Observations

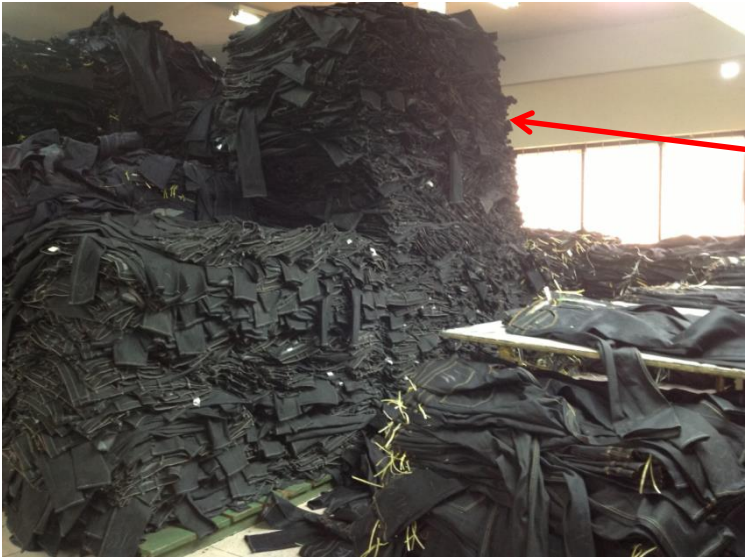
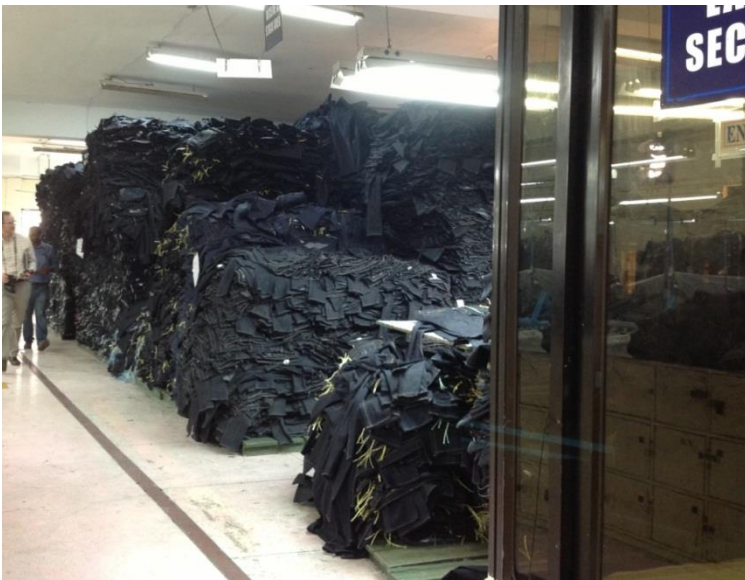
## 5<sup>th</sup> Floor

Material stacked to ceiling in a continuous 8 x 16m area

Engineering calculations indicate a design load of  $3\text{kN/m}^2$  for 4<sup>th</sup> to 6<sup>th</sup> floor. The encountered loading is over the design loading.

Plan and height restrictions to be introduced to prevent future overloading. Columns appear to be highly stressed, therefore loading to be limited to  $2\text{kN/m}^2$  on all levels.

Engineer to produce loading plans.  
Load management set in place.

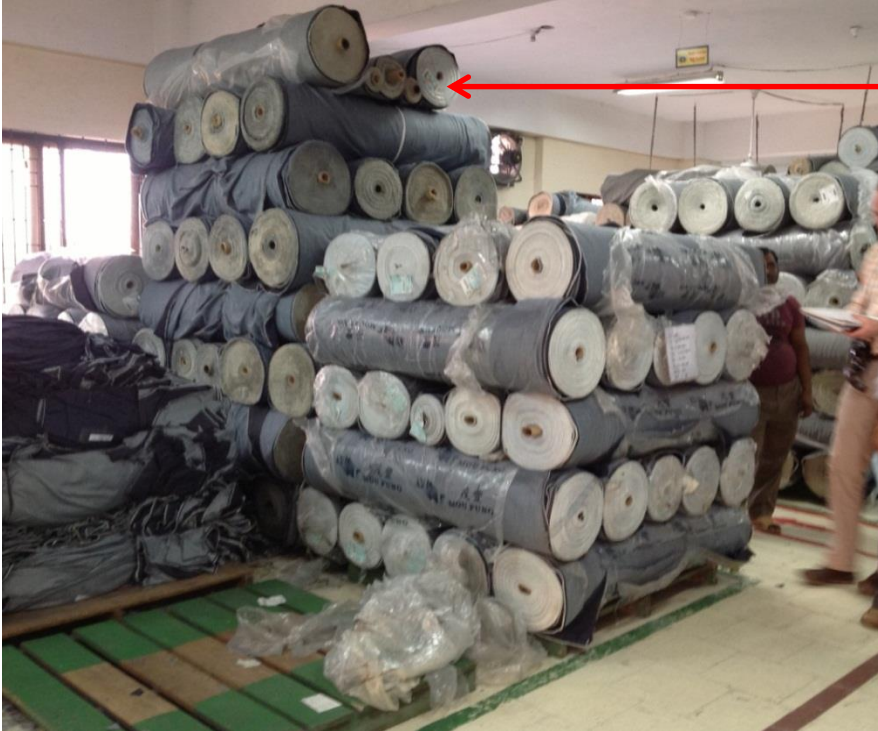
## 2<sup>nd</sup> Floor

**Material stacked to ceiling**

**Engineering calculations indicate a design load of 5kN/m<sup>2</sup> for 1<sup>st</sup> to 3<sup>rd</sup> floor.**

**The encountered loading appears over the design loading.**

**Plan and height restrictions to be introduced to prevent future overloading. Columns appear to be highly stressed, therefore loading to be limited to 2 kN/m<sup>2</sup> on all levels.**

**Engineer to produce loading plans.**

**Load management set in place.**

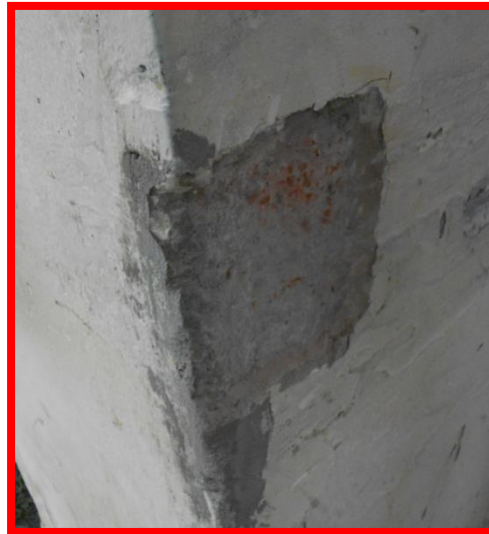
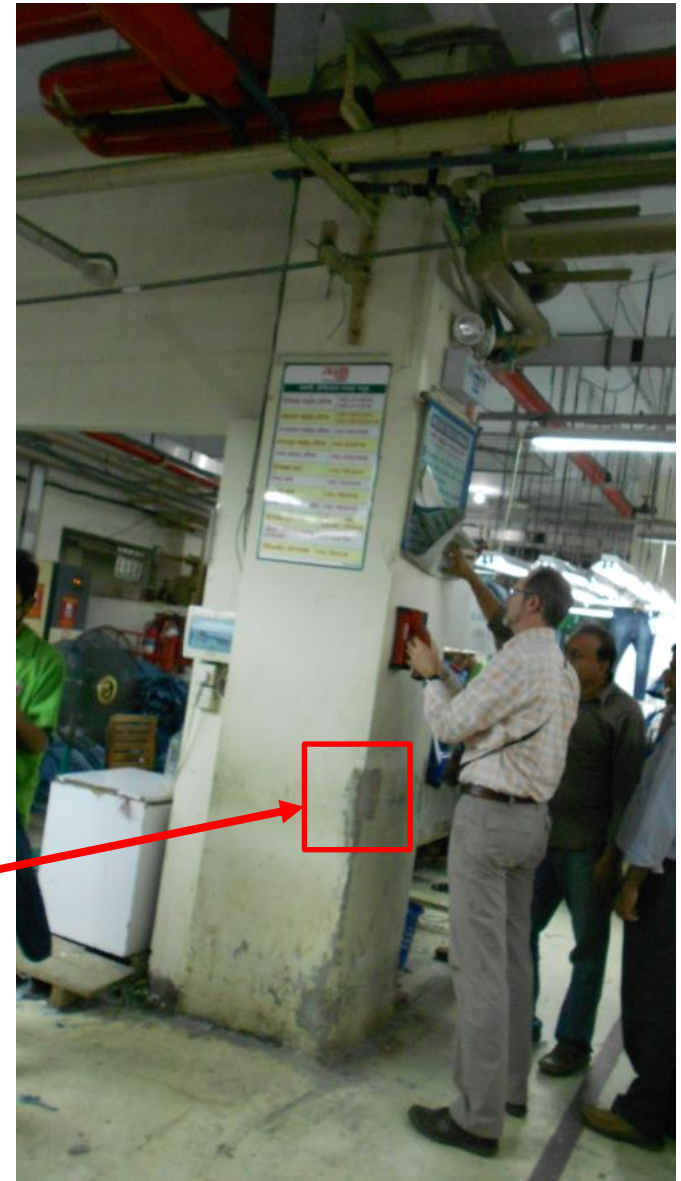
**Check column design required**

Cursory calculations indicate column working stress is at high level (valid for all columns)

Engineer is to perform detailed calculations and concrete tests to prove column size and confirm maximum floor loadings. Load management plans to be produced and implemented.

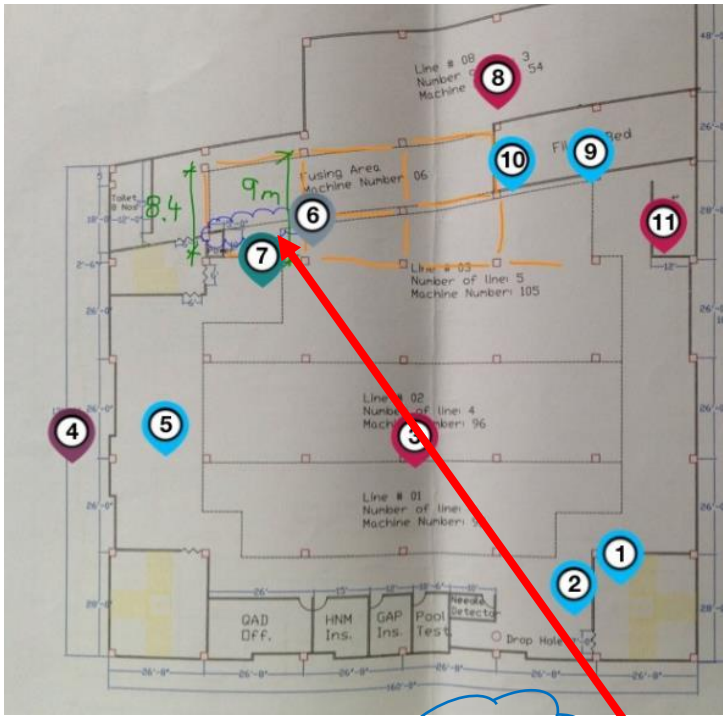
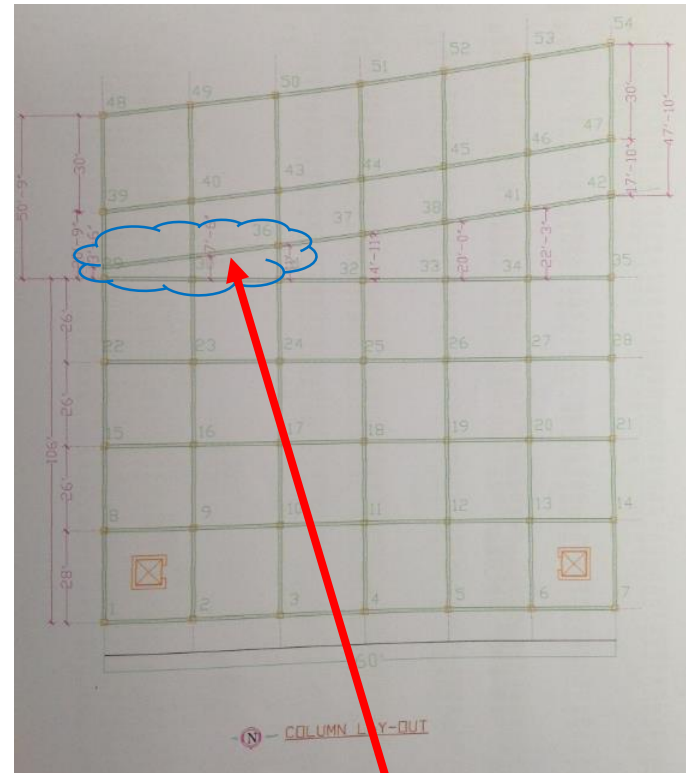
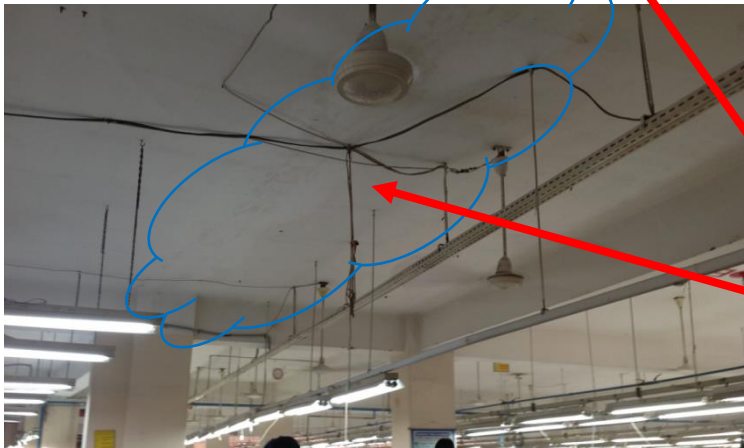
**Check slab design required**

Calculation assume beams at in all column bays.

As built condition shows no beam at this location (all floors)

Check on slab design required

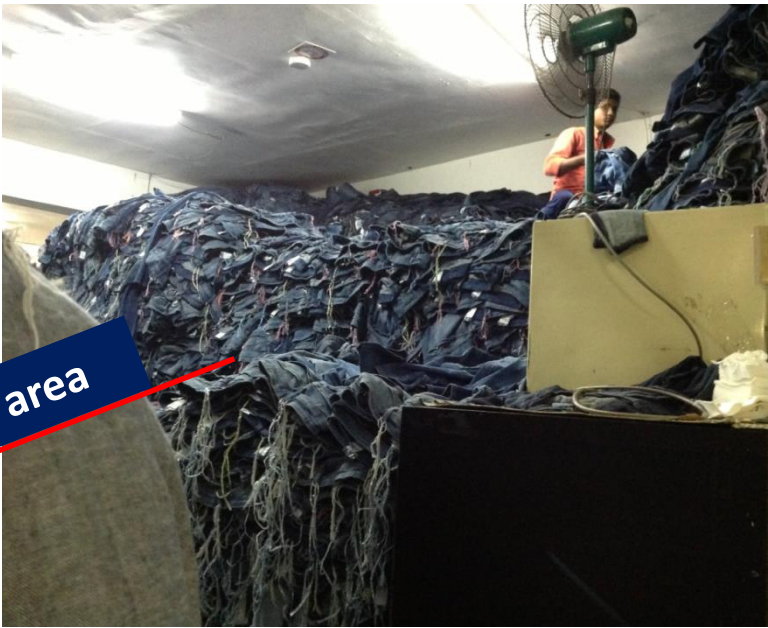
## 1<sup>st</sup> Floor

Very heavily loaded area

**Material stacked to ceiling within this room**

**9m span without intermediate beam in this area.**  
**Typical max span is 8.6m everywhere else.**

| Item No. | Observation | Recommended Action Plan | Recommended Timeline |
|---|---|---|---|
| 8 | Beam shown in on calculations is missing in the as built condition - Verify slab and column capacity in the 9m span location | Reduce load in the 9m span area to 2kN/m <sup>2</sup> | 6-weeks |
| 9 | Beam shown in on calculations is missing in the as built condition - Verify slab and column capacity in the 9m span location | Factory Engineer to review design and loads in slab with 9m span. | 6-weeks |

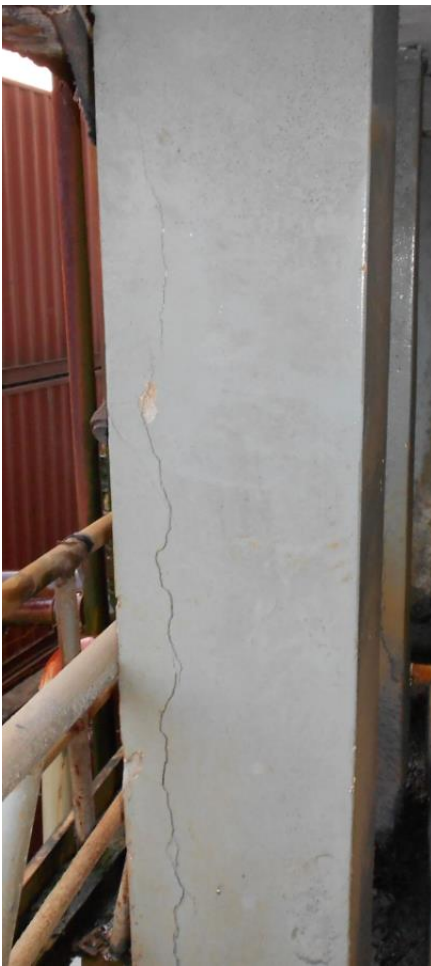
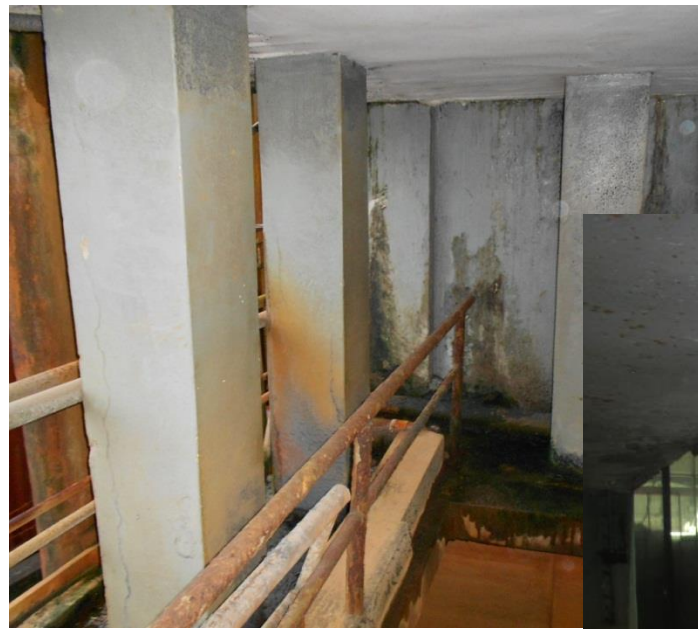
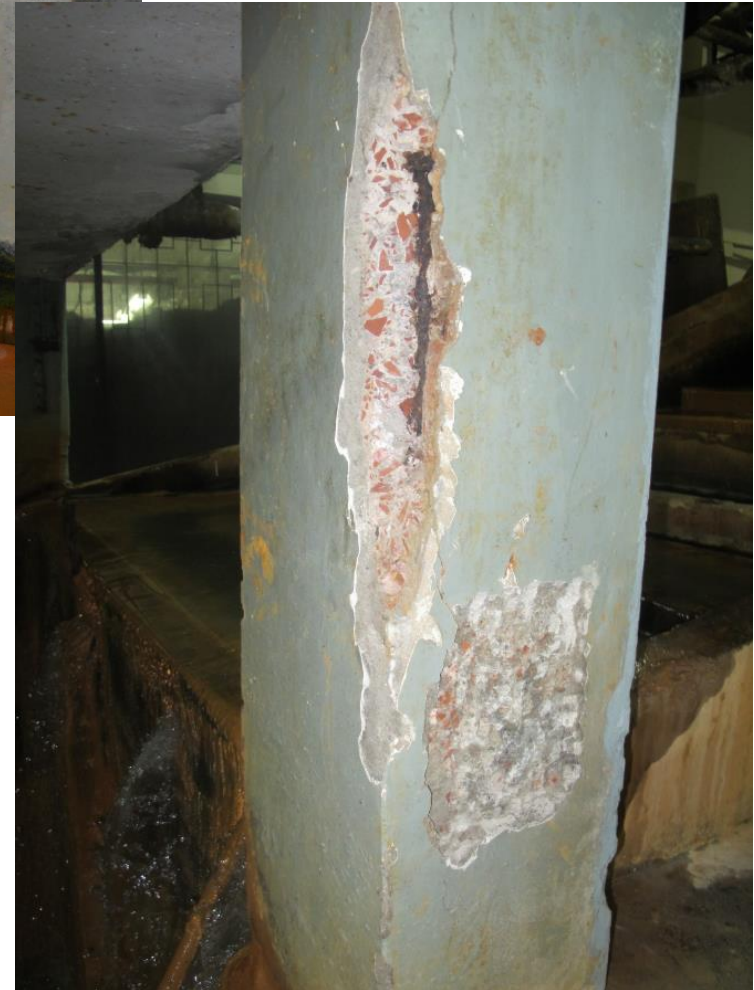
# **Cracking in column due to corroded reinforcement**

**Water damage in water treatment plant support structure has rusted steel reinforcement, causing spalling of concrete.**

**Cracking in column due to corroded reinforcement**

| Item No. | Observation | Recommended Action Plan | Recommended Timeline |
|---|---|---|---|
| 12 | Strengthen/repair water treatment plant support structure - Cracking in column due to corroded reinforcement | Building engineer to inspect all columns in the water treatment plant area for corrosion damage and spalling risk | 6-weeks |

| Item No. | Observation | Recommended Action Plan | Recommended Timeline |
|---|---|---|---|
| 13 | Strengthen/repair water treatment plant support structure - Cracking in column due to corroded reinforcement | If necessary, remove loading on the damaged columns | 6-weeks |
| 14 | Strengthen/repair water treatment plant support structure - Cracking in column due to corroded reinforcement | Strengthen spalled column | 6-months |
| 15 | Strengthen/repair water treatment plant support structure - Cracking in column due to corroded reinforcement | If required, specify a treatment system for corrosion | 6-months |

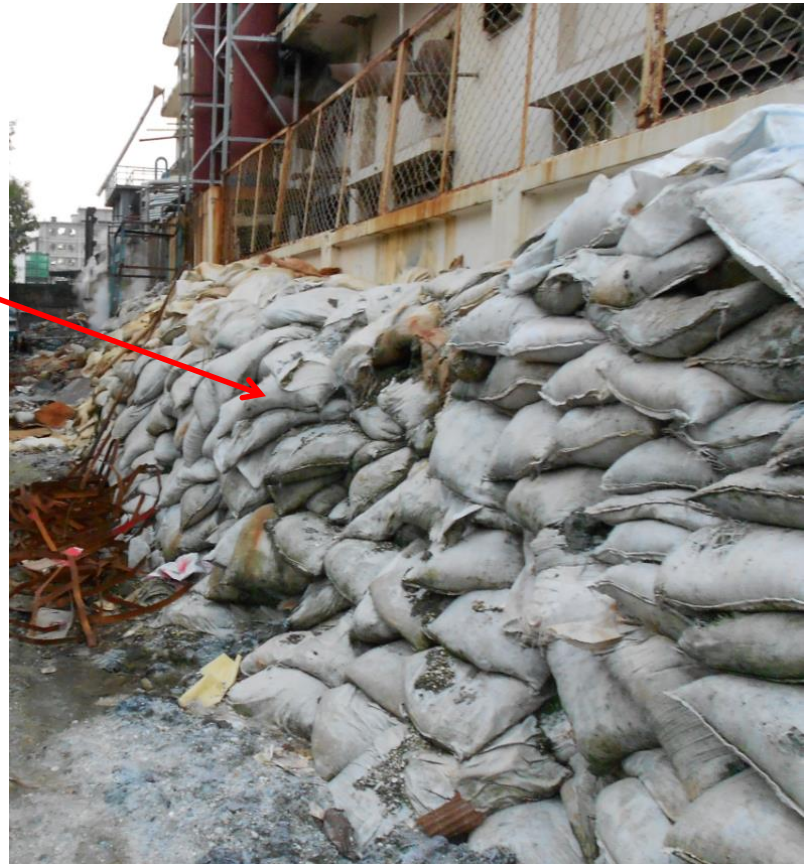
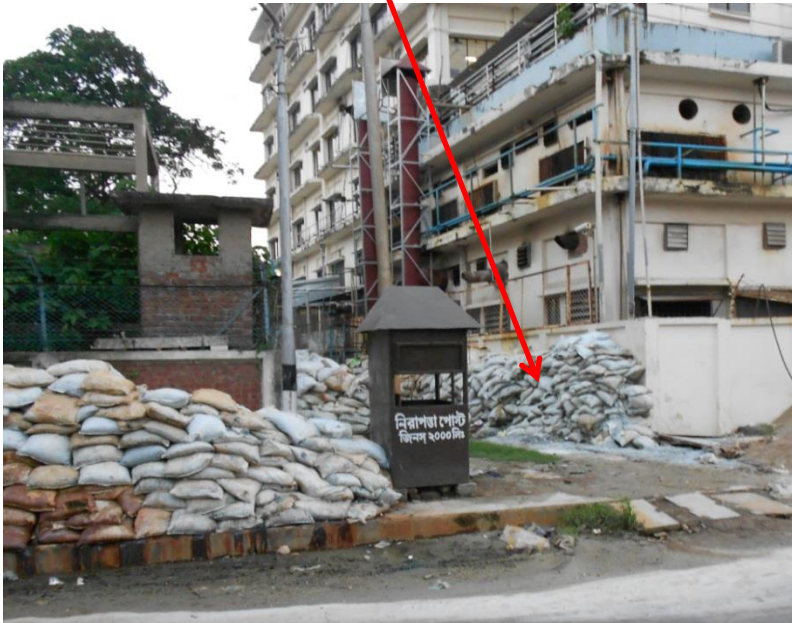
# Waste pile loading perimeter wall

**Waste pile is loading the  
perimeter wall.  
Risk of overloading due to  
lateral pressure on perimeter  
wall.**

| Item No. | Observation | Recommended Action Plan | Recommended Timeline |
|---|---|---|---|
| 16 | Waste bags at perimeter wall | Verify that perimeter wall has sufficient capacity to support lateral load. Limit height of stacked waste bags. | 6-months |

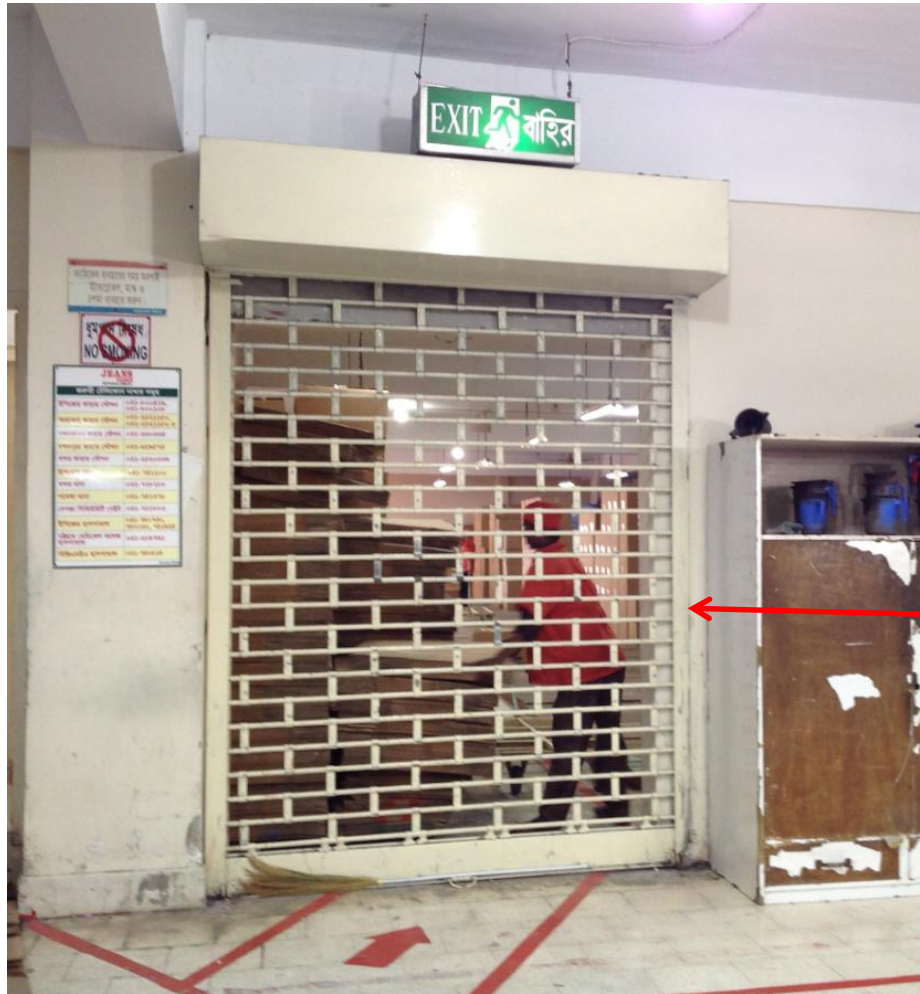
# **Emergency Exit (non structural observation)**

**Emergency Exit is locked**

Keep fire door unlocked
