Billah Resources Ltd (9284)

17/1, Khataldia, Squid Road, Nishad Nagar, Tongi, Gazipur

26.APRIL.2014

ACC RD
on Fire and Building Safety in Bangladesh

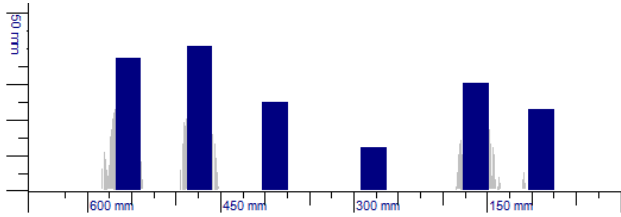
Potentially High Column Stresses and Questionable Reinforcing Quantities in Critical Columns.

Although Ferroskan results were not definitively conclusive, scans indicate a deficiency in the critical column reinforcing (scans show 20 bars, drawings show 24). In addition the column load run-downs indicate higher than desirable stress in the columns in question (G.L. C/7). However, we were provided with Compressive Strength Test results and Mill Test Certificates which indicate favourable material strengths.

ITEM 1: (Priority 1) Although not definitive, Ferro-scanning indicates reinforcement in the verified column is less than shown on the structural drawings. Additionally, column load run-downs indicate high levels of stress in the critical columns.

- A Detailed Engineering Assessment including verification of column reinforcing to be commenced.
- The Factory Engineer to verify design, loads and column stresses.

- The Detailed Engineering Assessment to be completed.

- Complete implementation of any works deemed necessary by the DEA.

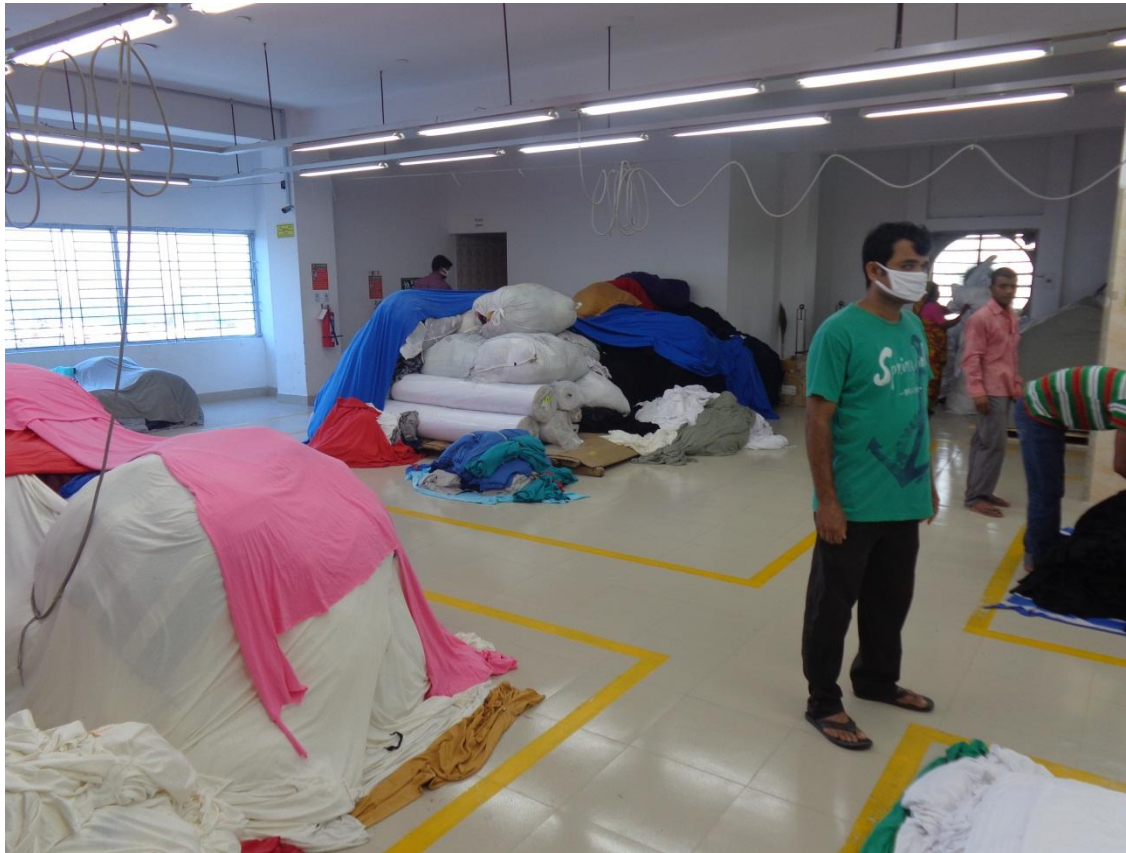
No Loading Plan or Storage Monitoring

No loading plan

Although slab loading was in general very light, there was some sporadic storage throughout the factory. There was no loading plan provided nor was there any evidence that load monitoring was taking place.

ITEM 2: (Priority 2) No loading plan was provided, nor did load monitoring measures appear to be in effect.

- Limit storage loads throughout the factory

- The Factory Engineer is to produce and actively manage a loading plan for all floor plates giving consideration to slab, beam and column capacities.

- Maintain and actively monitor loading plan.

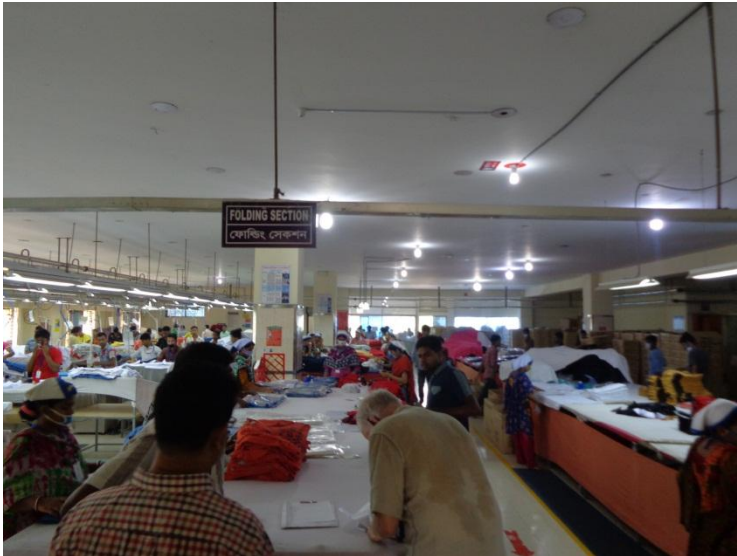
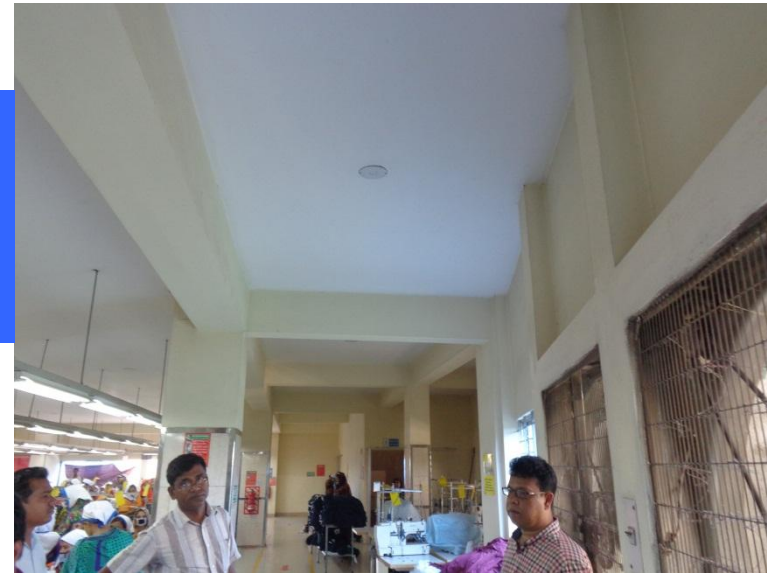
Lateral Restraint System

For all floor levels above the Ground Floor, the majority of the slab was constructed as a flat slab configuration. A proper lateral restraint system was not observed.

ITEM 3: (Priority 2) There was no significant lateral restraint system present and the majority of the floor area above the ground floor was constructed as flat slab.

We require that the lateral stability of the structure be further investigated through a Detailed Engineering Assessment.

- As part of the Detailed Engineering Assessment, evaluate the structure's lateral stability under wind and seismic loads.

- Detailed Engineering Assessment to be completed

- Complete implementation of any works deemed necessary by the DEA.

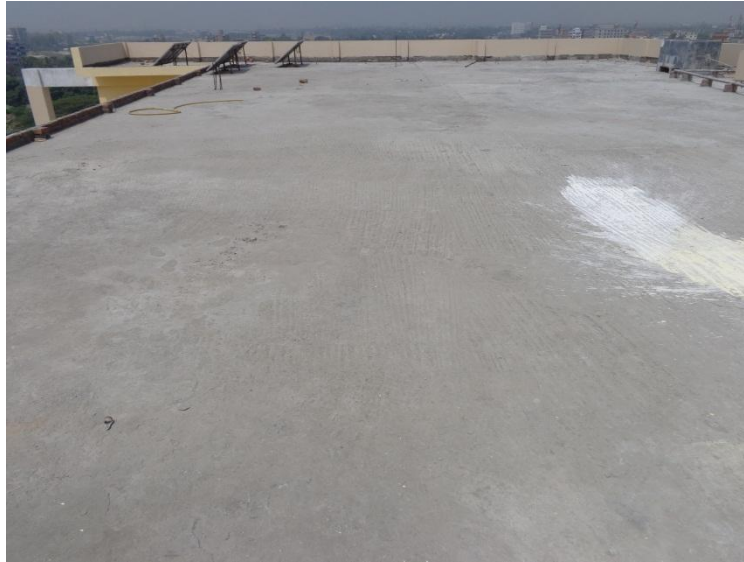
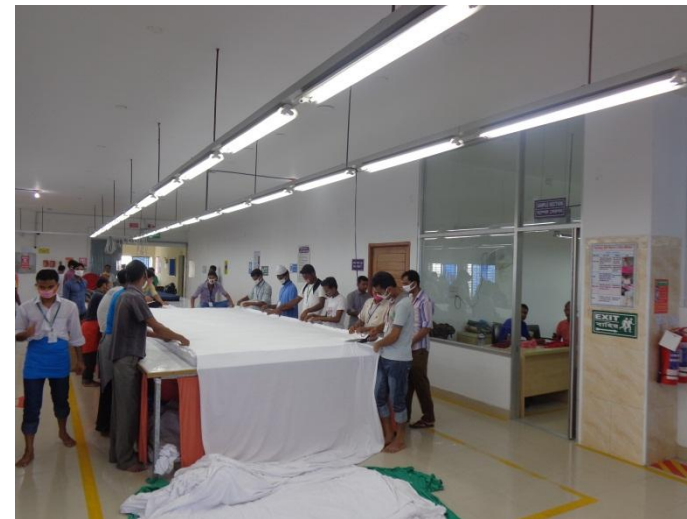
Roof Waterproofing System

Water Ingress at Roof Level

The exposed portion of roof slab contained no waterproofing. However, no evidence of water infiltration was observed at the underside of the roof slab.
