Liz Fashion Industry Limited (10228)

HMN Fashion Ltd (11250)

Holding 1, Block C, Shaheed Mosharaf Hossain Road, Purba Chandora, Sofipur, Kaliakoir,
Gazipur, Bangladesh

07.APRIL.2014

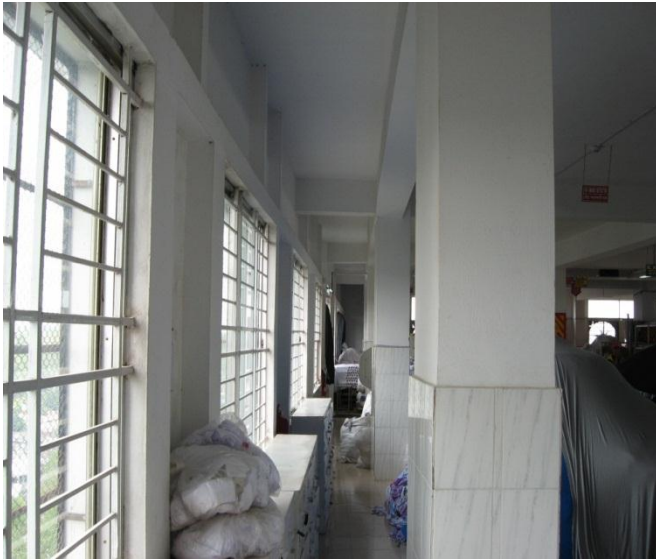
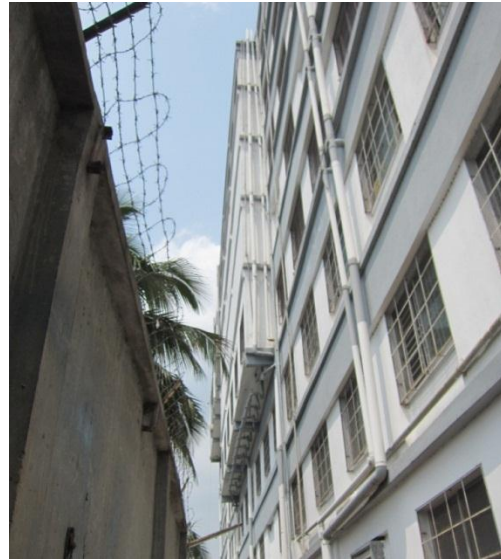
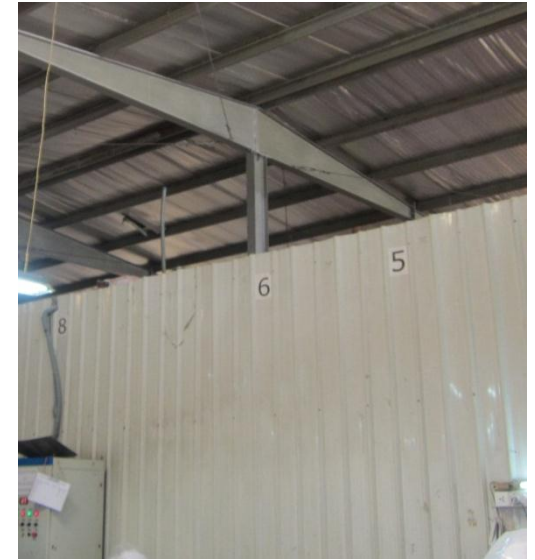
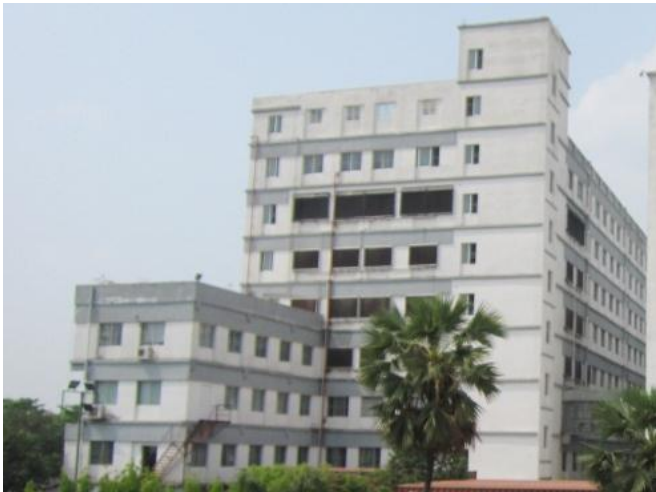
- Liz-1 building cantilever slabs of Liz-1
- The rear elevation of Liz-2 building – the structural arrangement does not match the as-built construction documentation.

There are cantilevered slabs that do not appear on the Liz-1 structural drawings, also the 3 storey side extension is not shown on the structural drawings. The steel column section sizes for Shed-1 and Shed-2 are not consistent with the produced drawings.

Item No.	Observation	Recommended Action Plan	Recommended Timeline
1	Construction documentation does not match the actual as built building conditions.	Remove all storage loading from the unrecorded areas. Factory Engineer to review design, loads, columns stresses to confirm suitability for the actual applied loads.	Immediate – Now
2	Construction documentation does not match the actual as built building conditions.	Verify in-situ concrete stresses either by cores or existing cylinder strength data for affected zone. Detail Engineering Assessment to be completed. Produce and actively manage a loading plan for all floor plates within the storage building giving consideration to floor capacity and column capacity.	6-weeks
3	Construction documentation does not match the actual as built building conditions.	Develop and continue to implement load plan.	6-months
4	Uncontrolled heavy storage loading.	Reduce stacking height to ensure total load does not exceed 2 kPa. Adopt some sort of signage/staff guidance to ensure that the maximum weight of storage is not exceeded. (A Loading Plan).	6-weeks

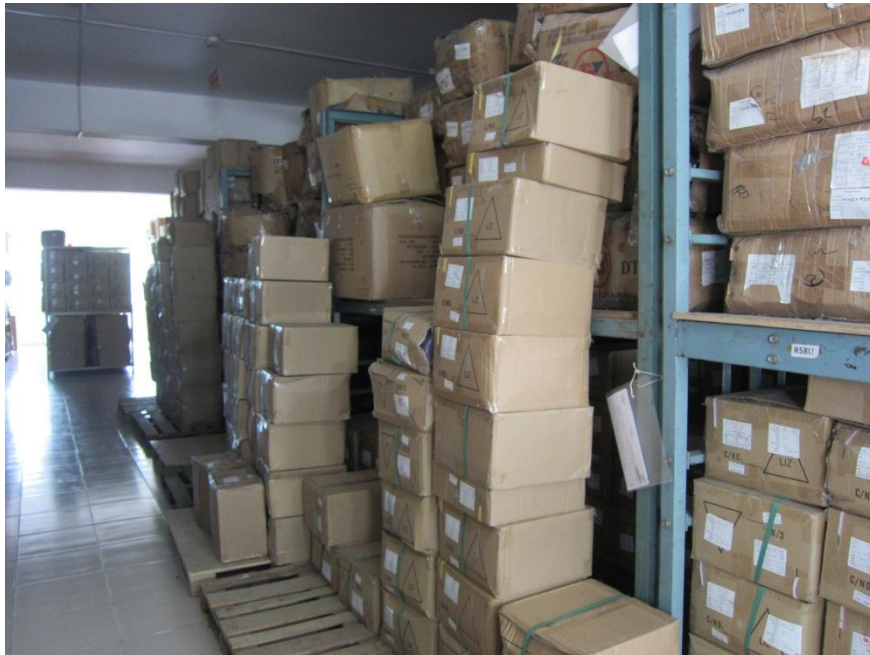
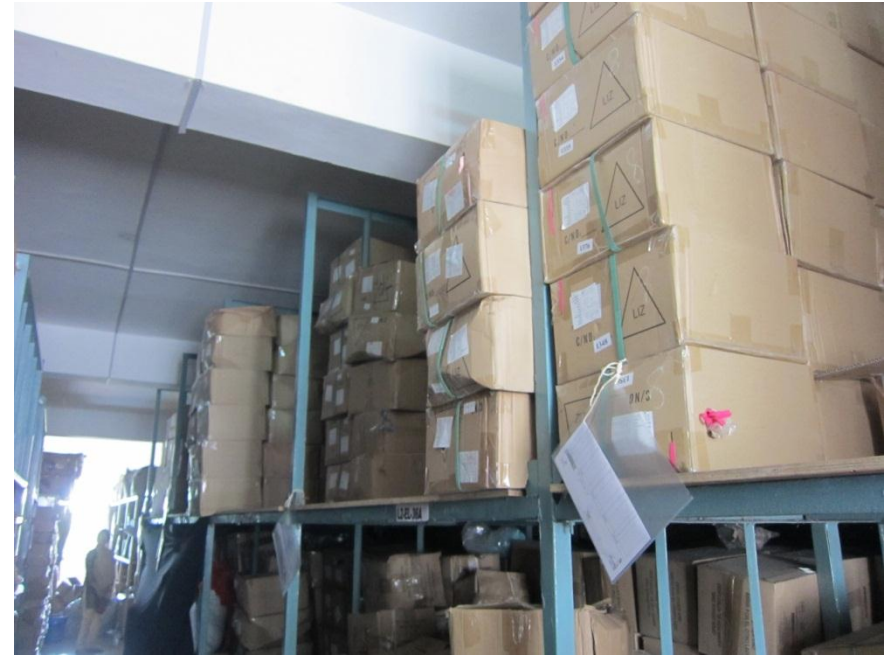
Uncontrolled heavy storage loading was found on the 2nd floor of Liz-2 Building.

5	Uncontrolled heavy storage loading.	Maintain standards of quality control to ensure that storage procedures are correctly followed so that overloading does not happen in the future. Develop and maintain a loading plan.	6-months
6	No fireproofing material for steel structures.	Fireproofing material for structural steel elements is recommended based on Bangladeshi regulations.	6-weeks
7	No fireproofing material for steel structures.	Maintain standard of quality control.	6-months

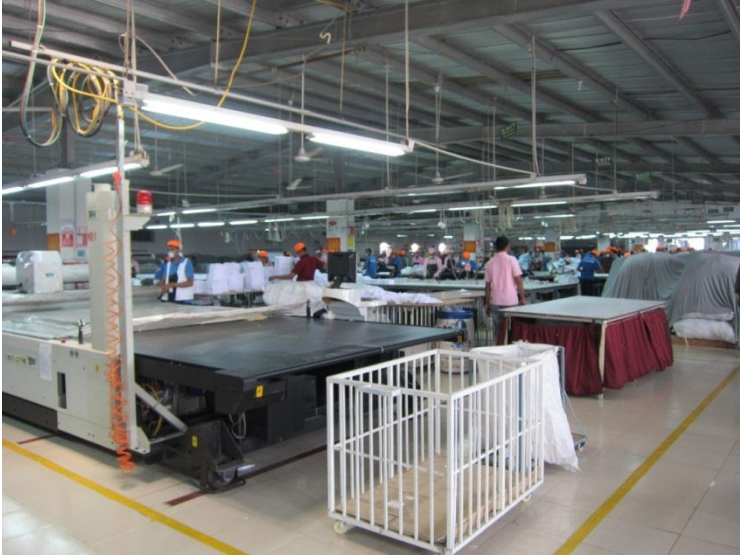
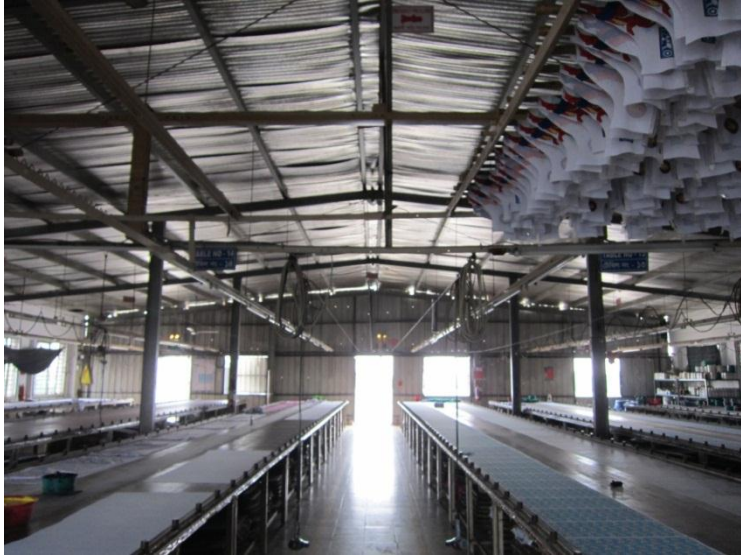
It appears that protective paint is applied to the steelwork elements, however, it is unclear if fire protective paint is also applied or required.

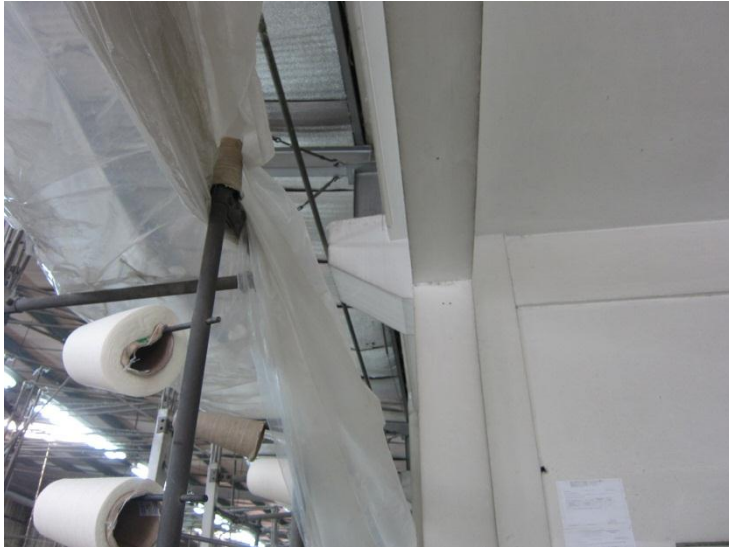
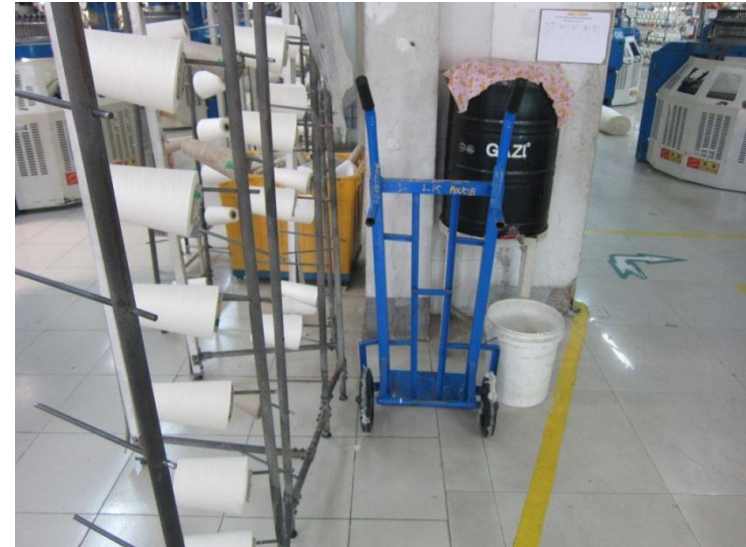
There is no movement joint on the connecting area between the Printing building and shed-1.

12	No movement joint properly established.	Do not construct any further buildings connected to the existing factory, without thorough structural design and full building approval.	6-months
13	No waterproofing material noted at any roof level.	For both durability and serviceability, waterproofing on the roof slab is recommended. Moreover the roof slab drainage system should be investigated.	6-months

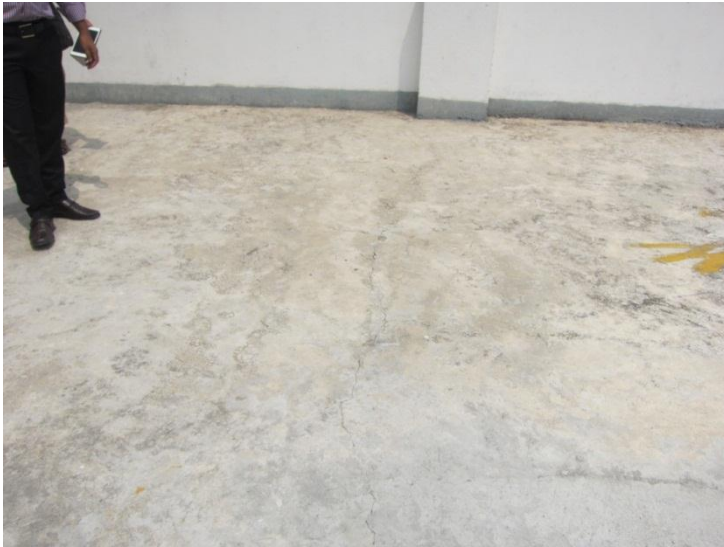
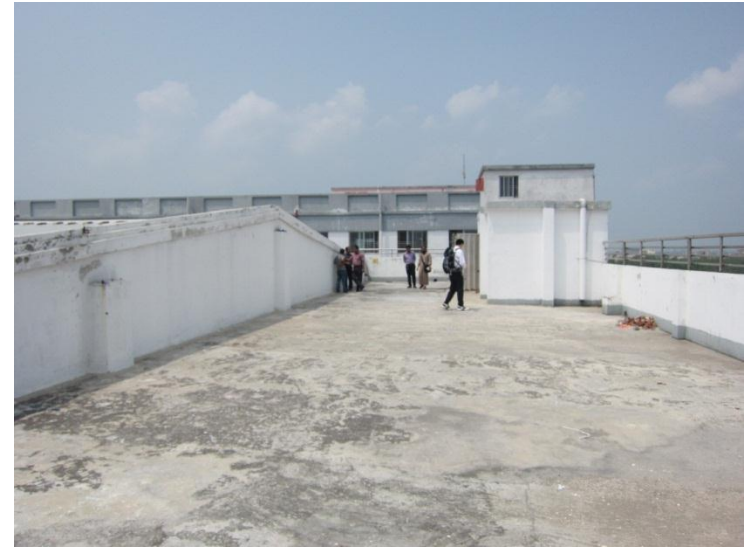
There are cracks on the roof slabs of Liz-1 building. There was no noted distresses due to water ingress but it is unclear if waterproofing material is present.

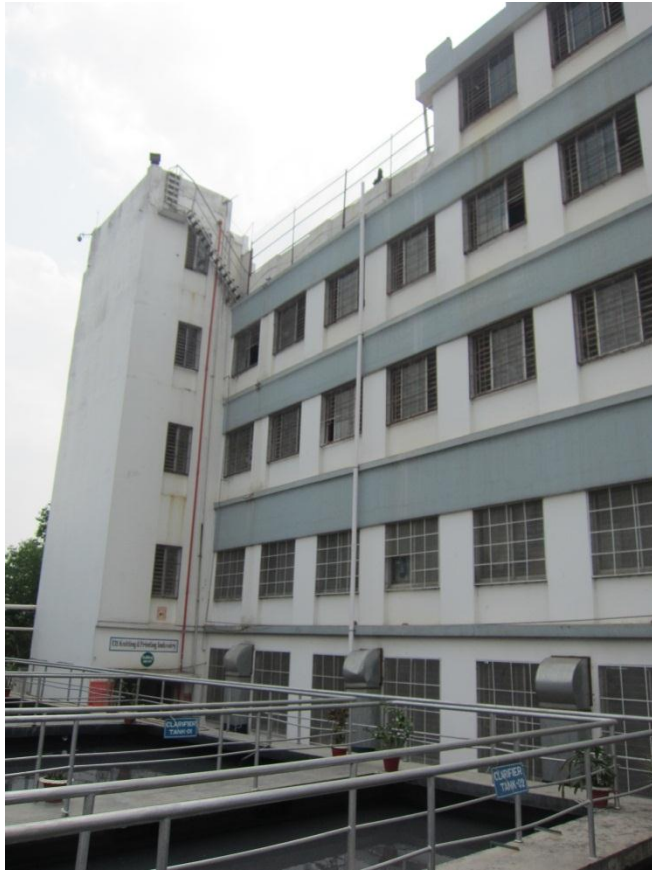
Concerns on the stability system for lateral loading and seismic loading. Façade brickwork walls lack moment capacity connection between columns and beams.

We require that these concerns be investigated as part of a Detailed Engineering Assessment

Item No.	Observation	Recommended Action Plan	Recommended Timeline
8	Overall stability system / moment frame capacity.	A Detailed Engineering Assessment of all of the buildings is to be carried out and in particular, stability and foundation aspects should be investigated in detail.	6-weeks
9	Adequacy of columns to support loading.	Factory Engineer to review design, loads and columns stresses Verify in-situ concrete stresses either by cores or existing cylinder strength data for [the identified columns / cores from 4 columns].	6-weeks
10	Adequacy of columns to support loading.	Produce and actively manage a loading plan for all floor plates within the factory giving consideration to floor capacity and column capacity.	6-months
11	No movement joint properly established.	The Factory Building's Structural Engineer should carry out a Detailed Engineering Assessment to prove the capacity of the building in its existing state, a further building approval should be gained for the building as it exists, as altered since the original approval. Alternatively, the extension building should be separated by a non-structural joint and allowed to act as a fully structurally independent structure.	6-weeks

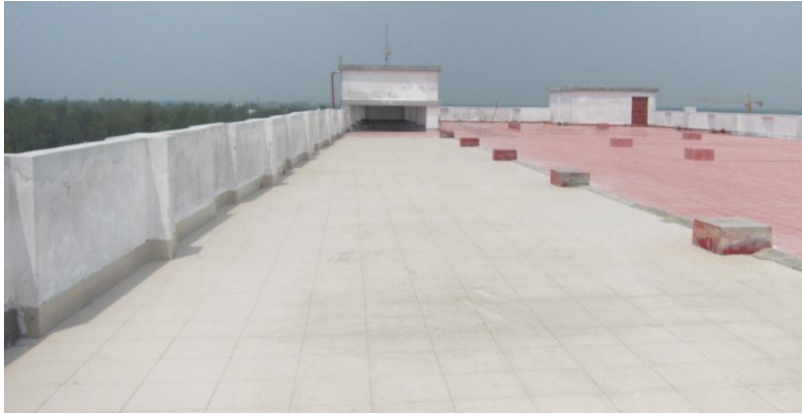
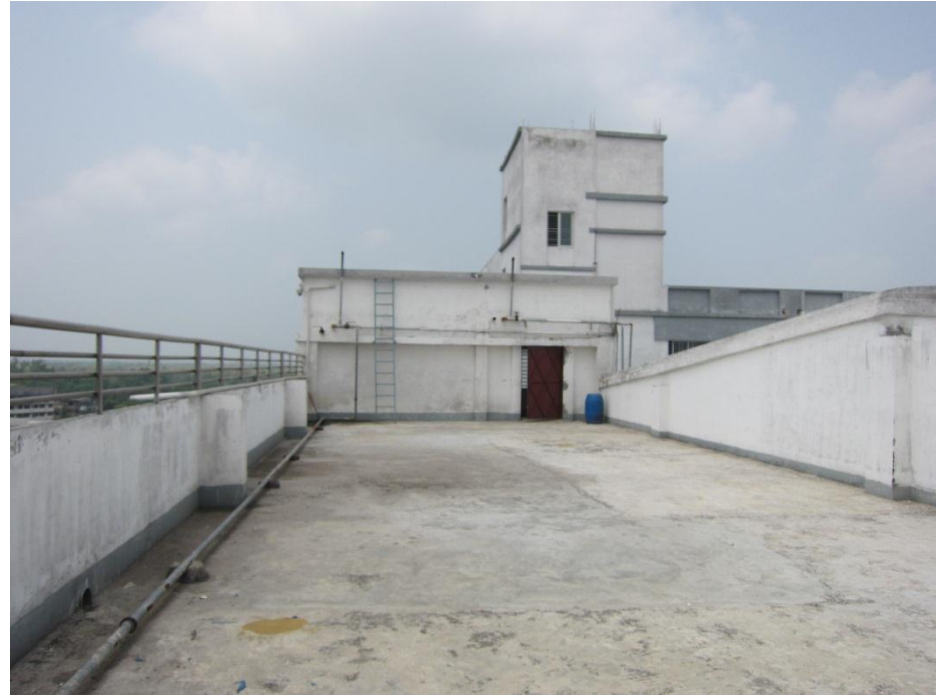
Water Ingress at Roof Level

No distresses due to water ingress was found on any roof level. On Liz-2 building, tiles are applied on the roof surface.
