# BG Collection Ltd. (10959)

Baniarchala, Bhabanipur, Gazipur

01.SEPTEMBER.2014

## Client Summary Report

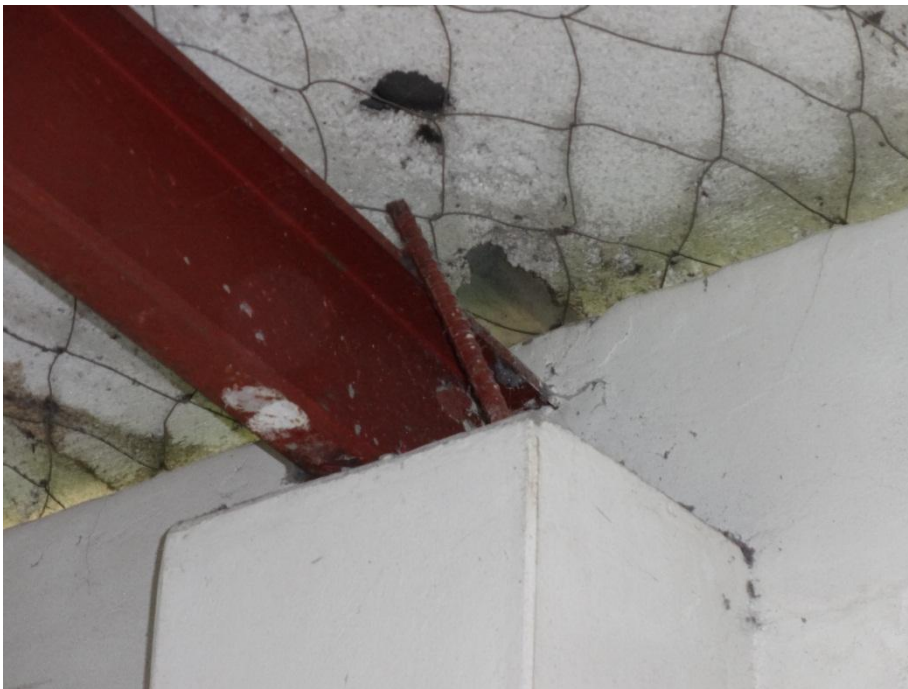
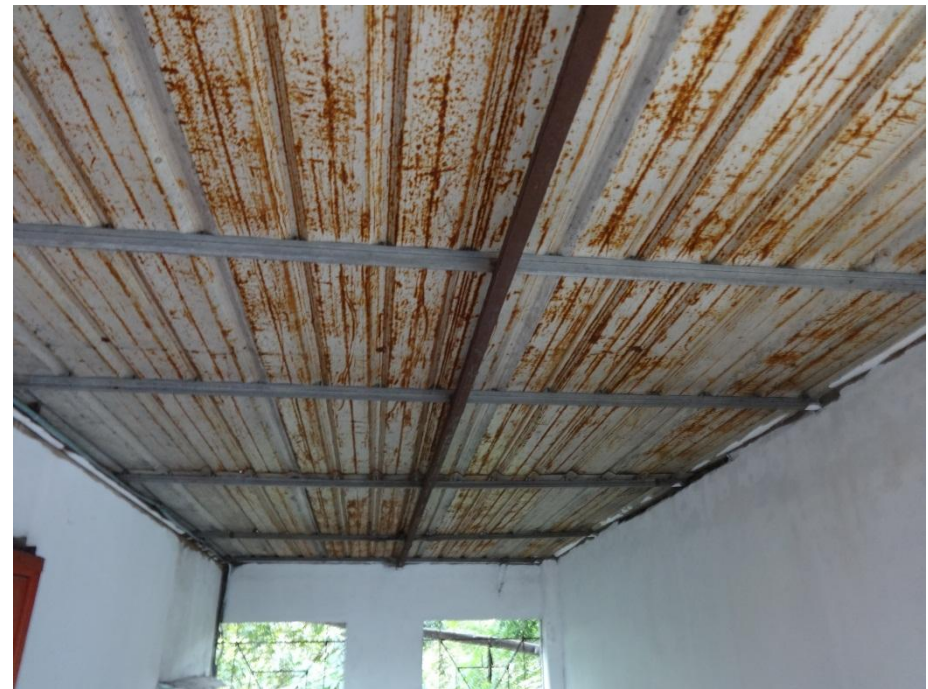
## 1<sup>st</sup> Priority 2 Concern

Inadequate steel detailing on the, rafter connections to concrete columns, steel roofs over staircases & the dining shed.

### Priority 2 (within 6 – weeks)

- Carry out Engineering Assessment on steel roof to determine if any strengthening works are required.

### Priority 3 (within 6 – months)

- Carry out recommendations highlighted in Engineering Assessment.

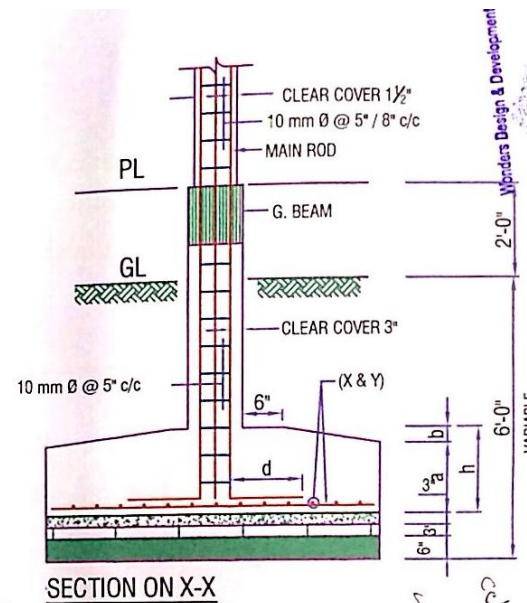
1<sup>st</sup> Priority 3 Concern

Structural “as built” drawings show information based on back calculations, the plan drawings are not dimensioned and some drawings are incorrectly titled.

### Priority 2 (within 6 – weeks)

- Building Engineer to survey the as built condition and update the structural drawings, paying close attention to the column and beam size.

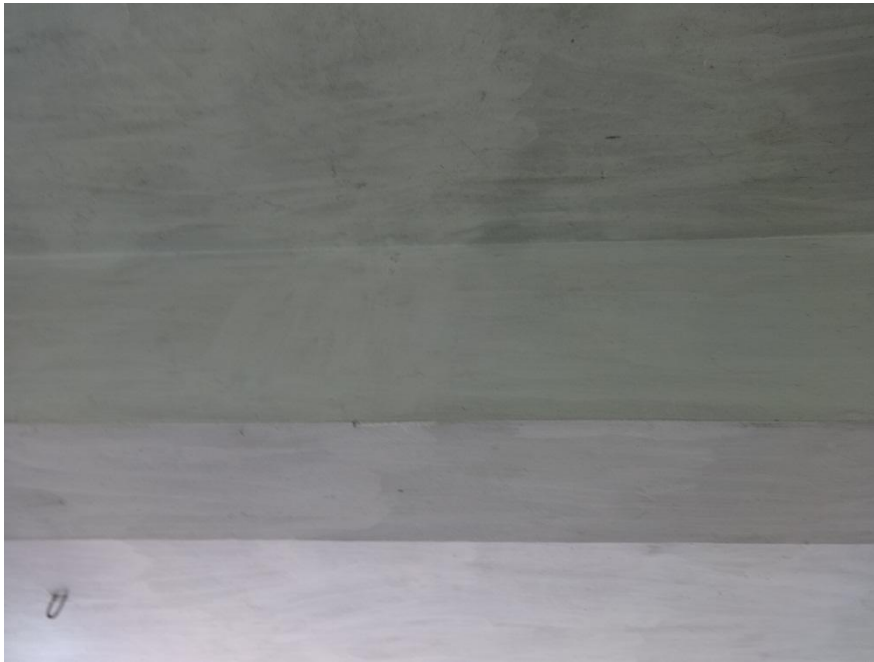
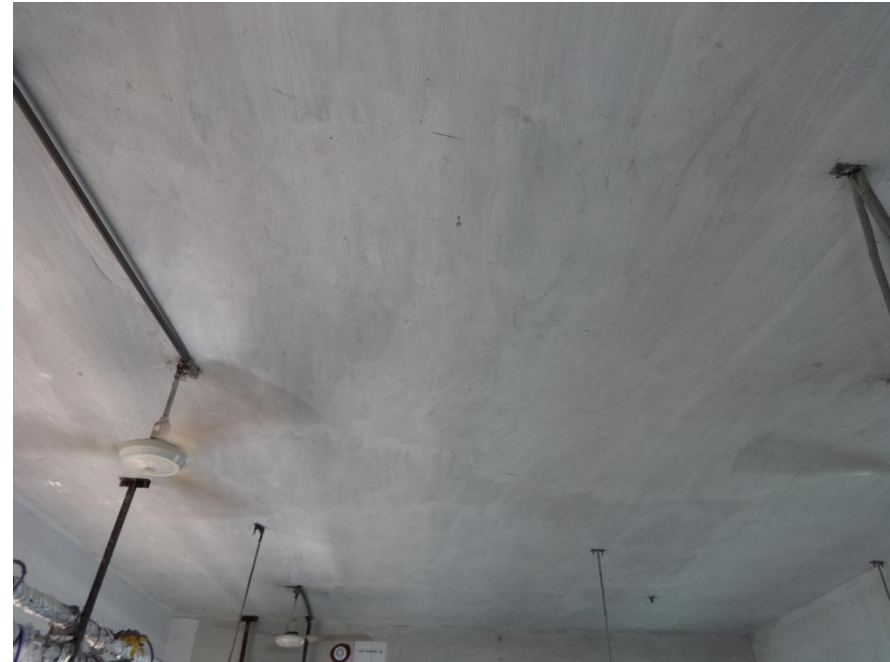
### 3<sup>rd</sup> Priority 3 Concern

Cracks observed in one beam and slab.

### Priority 2 (within 6 – weeks)

- Building Engineer to survey the beams, removing plaster, to establish the extent of the cracks in the beams.

### Priority 3 (within 6 – months)

- Monitor the cracks over a period no less than 6 months to establish if there is further movement.

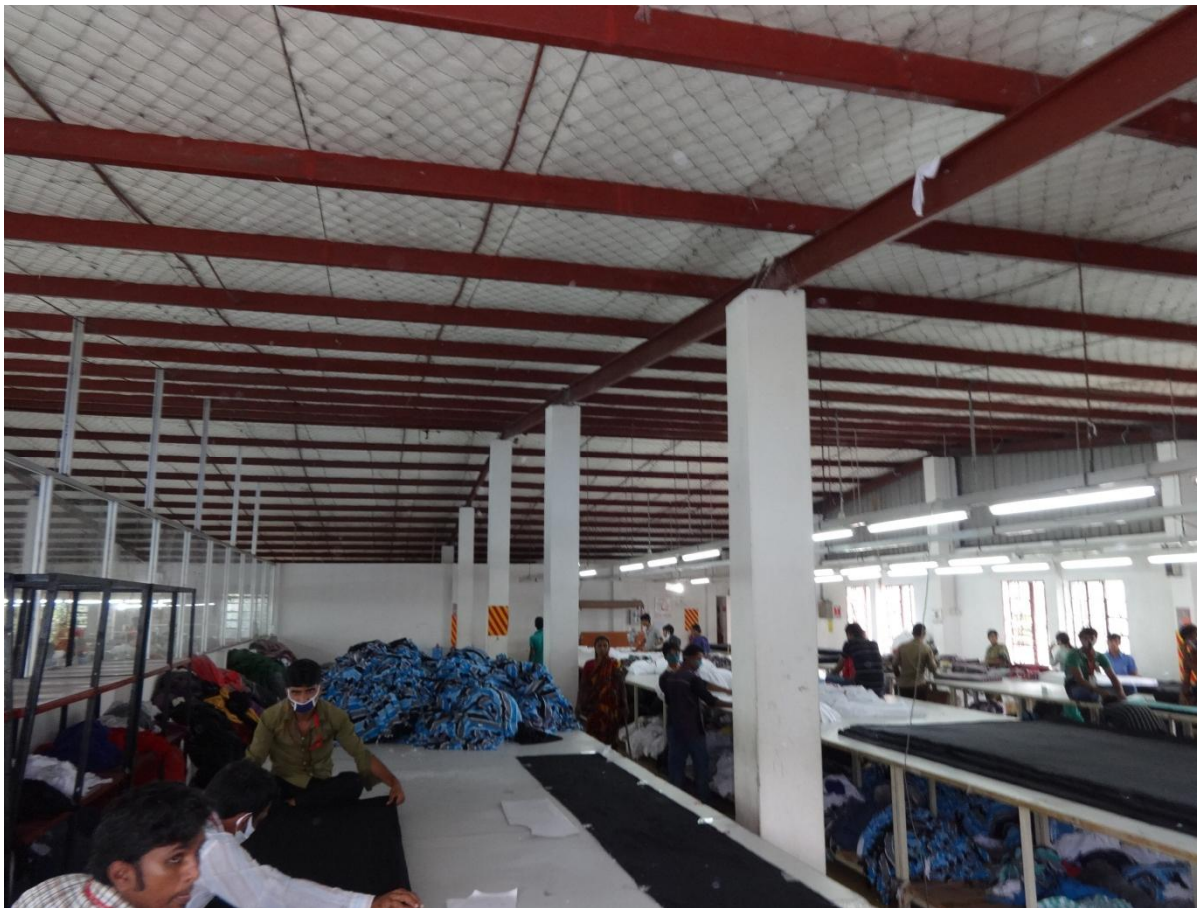
#### 4<sup>th</sup> Priority 3 Concern

No fireproofing material was noted on any structural steel elements.

- Fireproofing material for structural steel element is recommended as suggested in BNBC Codes.
- Maintain standard of quality control and protection of the fire protection.

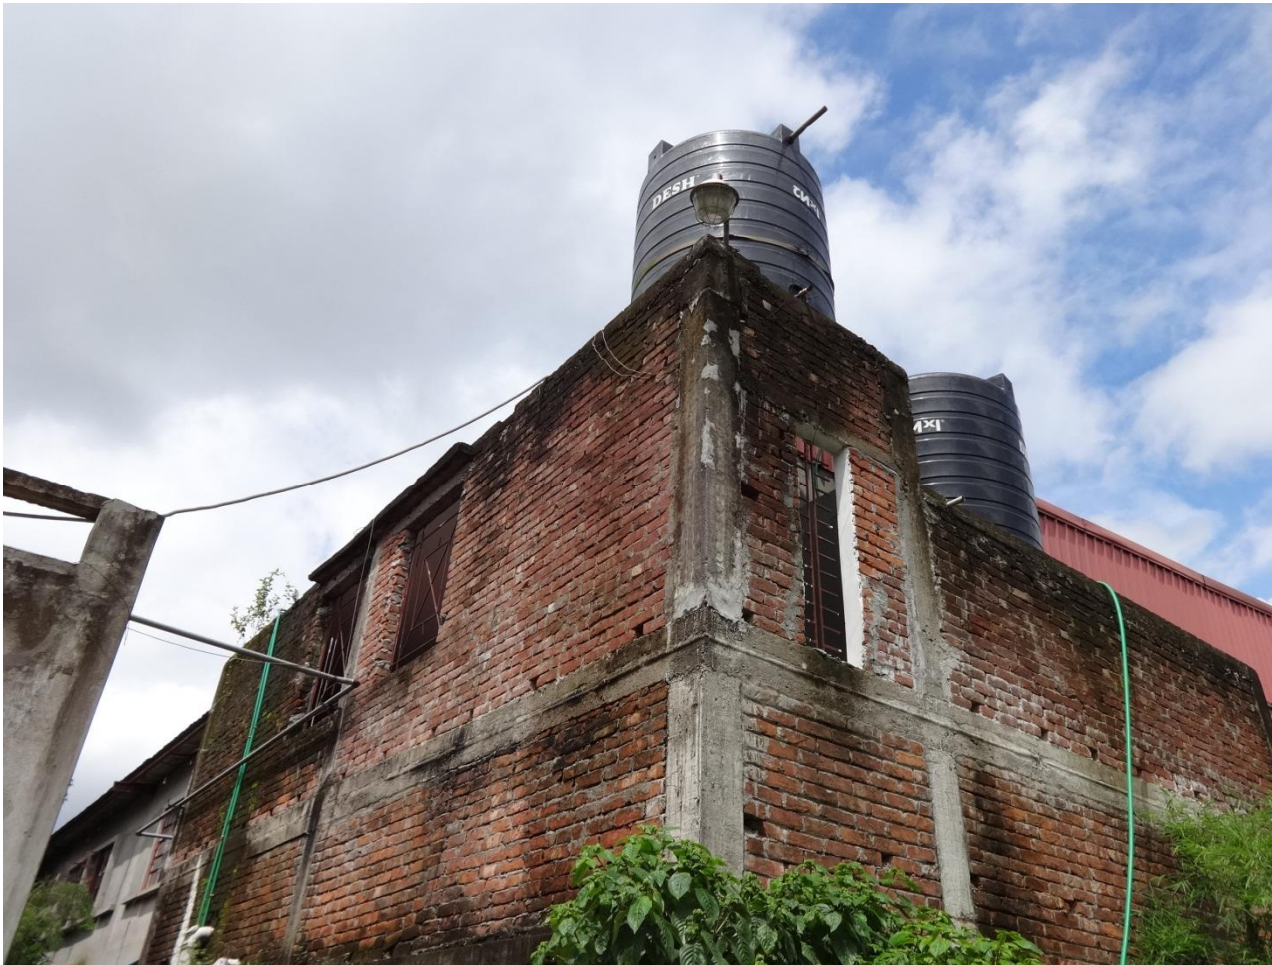
### 5<sup>th</sup> Priority 3 Concern

The plastic water tanks on the roof appear to be leaking.

- Building Engineer to investigate the exact cause of the leak and repair the tanks / pipes accordingly.

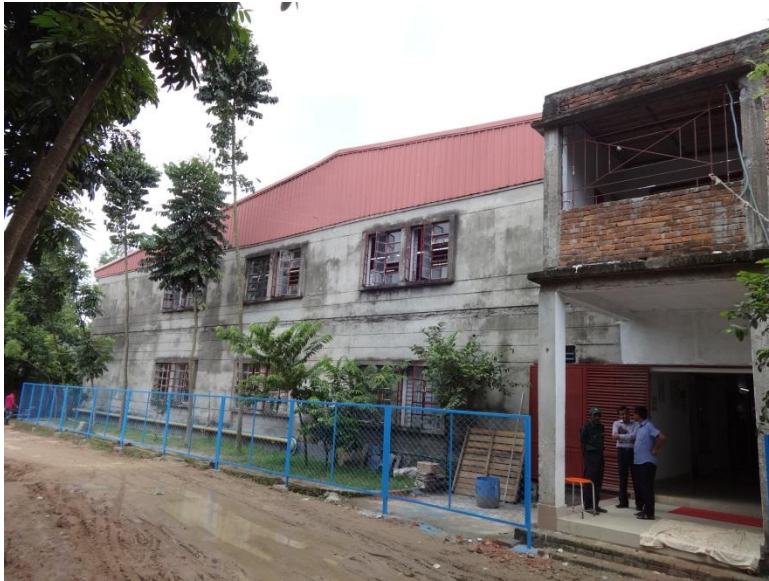
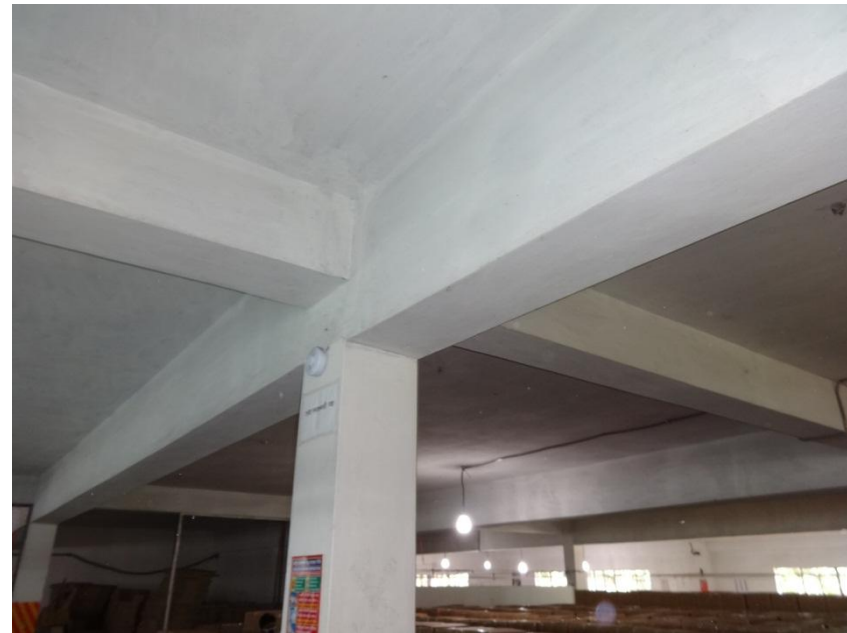
# Overall Stability System

The lateral loading resistance for this 2-storey building is provided by moment frame action without any shear walls and the façade brickwork walls lack moment capacity due to their poor connections with the surrounding columns and beams.

We require that the stability of this building is investigated as part of an Engineering Assessment.

- Carry out an Engineering Assessment on the building to verify that it is stable under lateral loading.

- Carry out all recommendations of the Engineering Assessment.
