# Shovon Knitwear Ltd. (10922)

West Masdair, Fatullah, Narayanganj

27.APRIL.2014

## Identified Priority 2 Concerns

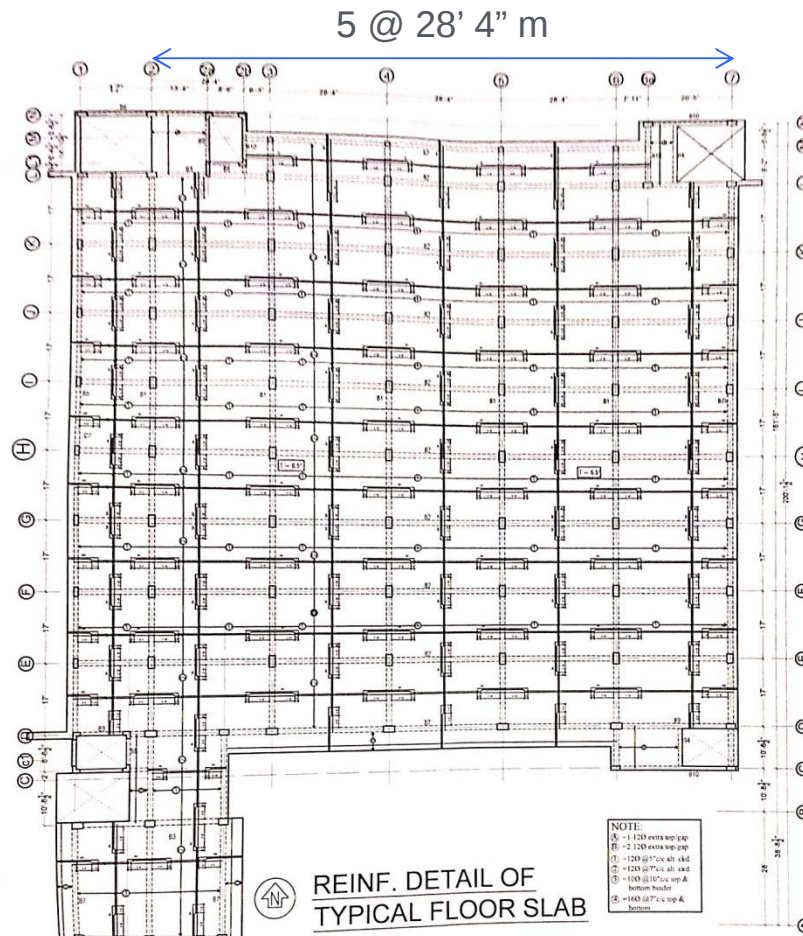
## 1<sup>st</sup> Priority 2 Concern

Cracks on 4<sup>th</sup> floor beam.

Several cracks found on 4<sup>th</sup> floor beams spanning approx. 8.50m. We were informed that structural elements in this building were covered with plasterwork. It is not clear if these cracks are structural. They should be investigated further.

- The Factory Engineer to investigate the cause of cracks by appropriate methods.
- The distress found is to be suitably rectified and then repaired.

- Create loading plans for each floor level.
- Maintain standards of quality control to ensure that loading plan is correctly followed so that problems do not arise in the future.
- Maintain and enforce the loading plans.

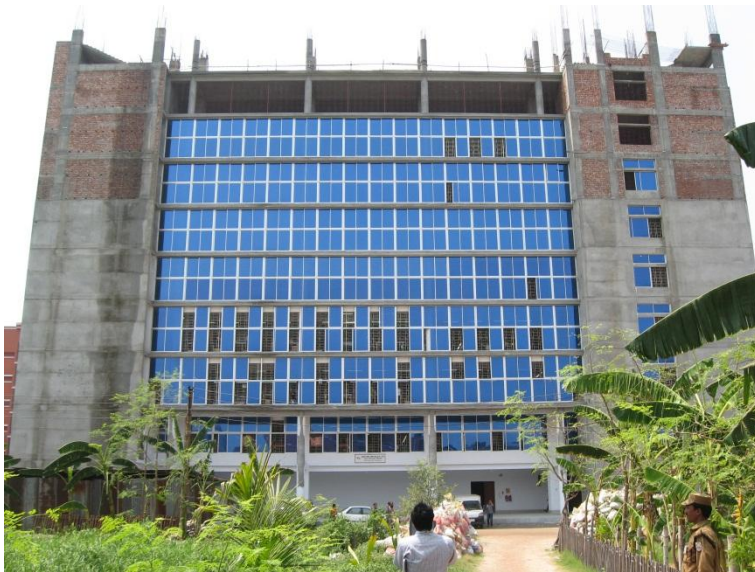
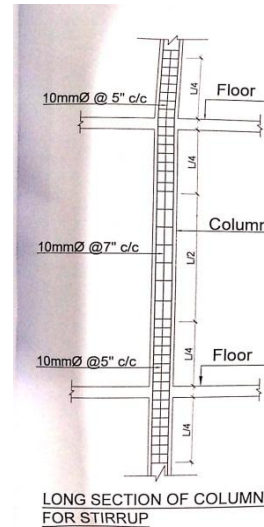
Overall stability system / moment frame capacity

It is appeared that the original Engineer was aware of lateral loads. However, there is no evidence that a lateral stability system had been used. Therefore, we require that these items are investigated as part of a Detailed Engineering Assessment .

- Request that the Detailed Engineering Assessment of overall building to be carried out again with the actual built conditions.
