Spring Trade Ltd. (9522)

Plot # 42, Konapara Tenguri, Zirani Bazar, B.K.S.P, Savar, Dhaka, Bangladesh.

28.APRIL.2014

ACCORD
on Fire and Building Safety in Bangladesh

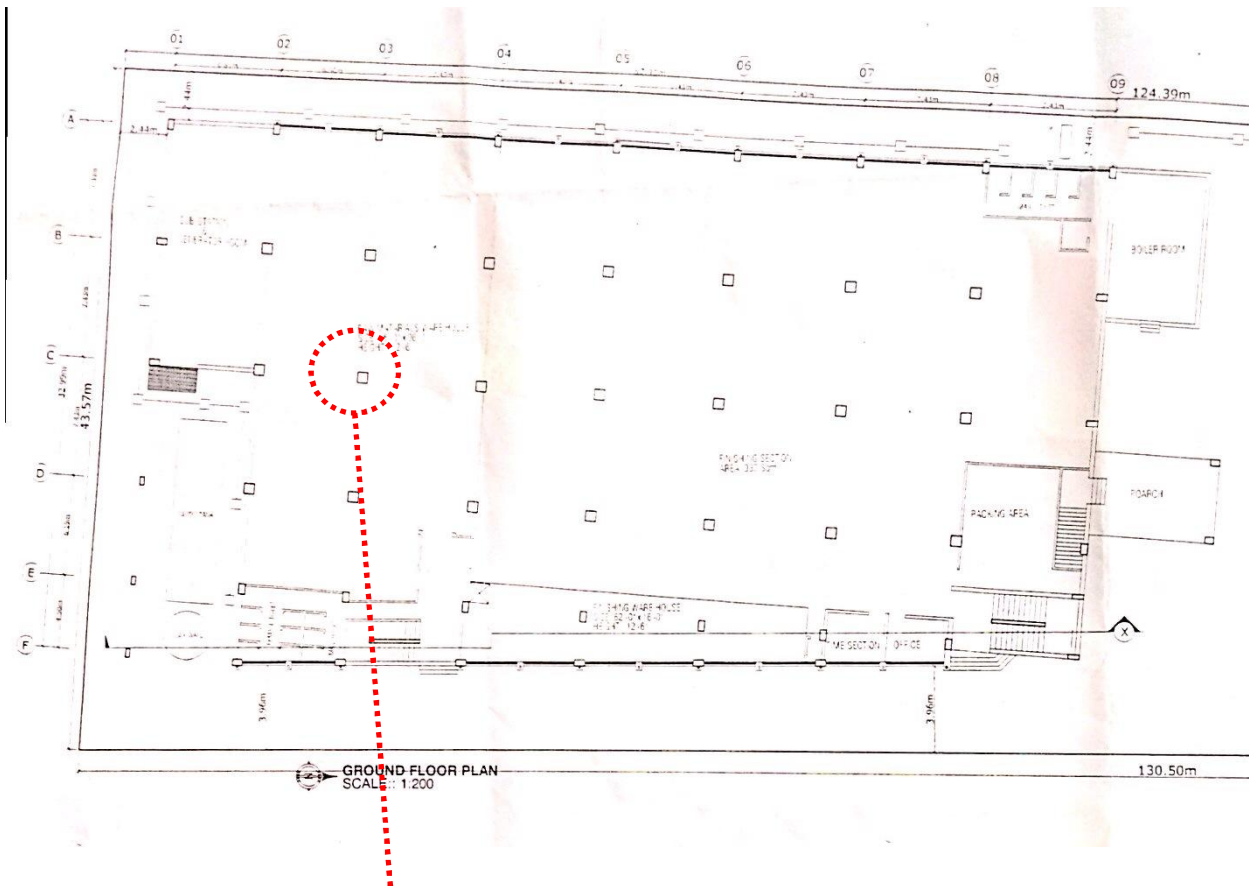
1st Priority 1 Concern

Typical column to be checked

Based on the load rundown analysis with the agreed minimum design live load assignment, the column at the circled area has been found to be significantly insufficient in carrying the dead and live loads. The working stress is just a fraction above being rated with a 'red' warning, giving a firm 'AMBER' warning instead. The building was constructed with brick aggregate and high-yield re-bar.

ITEM 1: (1st Priority 1) Columns in Building 1 exhibit insufficient capacity under current building floor loads.

Preliminary load take-down calculations suggest that the typical columns in two buildings are very close to having a 'red' warning. The typical columns possess very little spare capacity.

- Carry out a full Detailed Engineering Assessment of the entire building including any intrusive testing required.
- Carry out full survey of all structural elements to check the loading capacity of the overall structural system.
- The Factory Engineer to review design, loads and columns stresses in entire building in accordance with BNBC regulations.

- Provided loading plan must be strictly maintained.

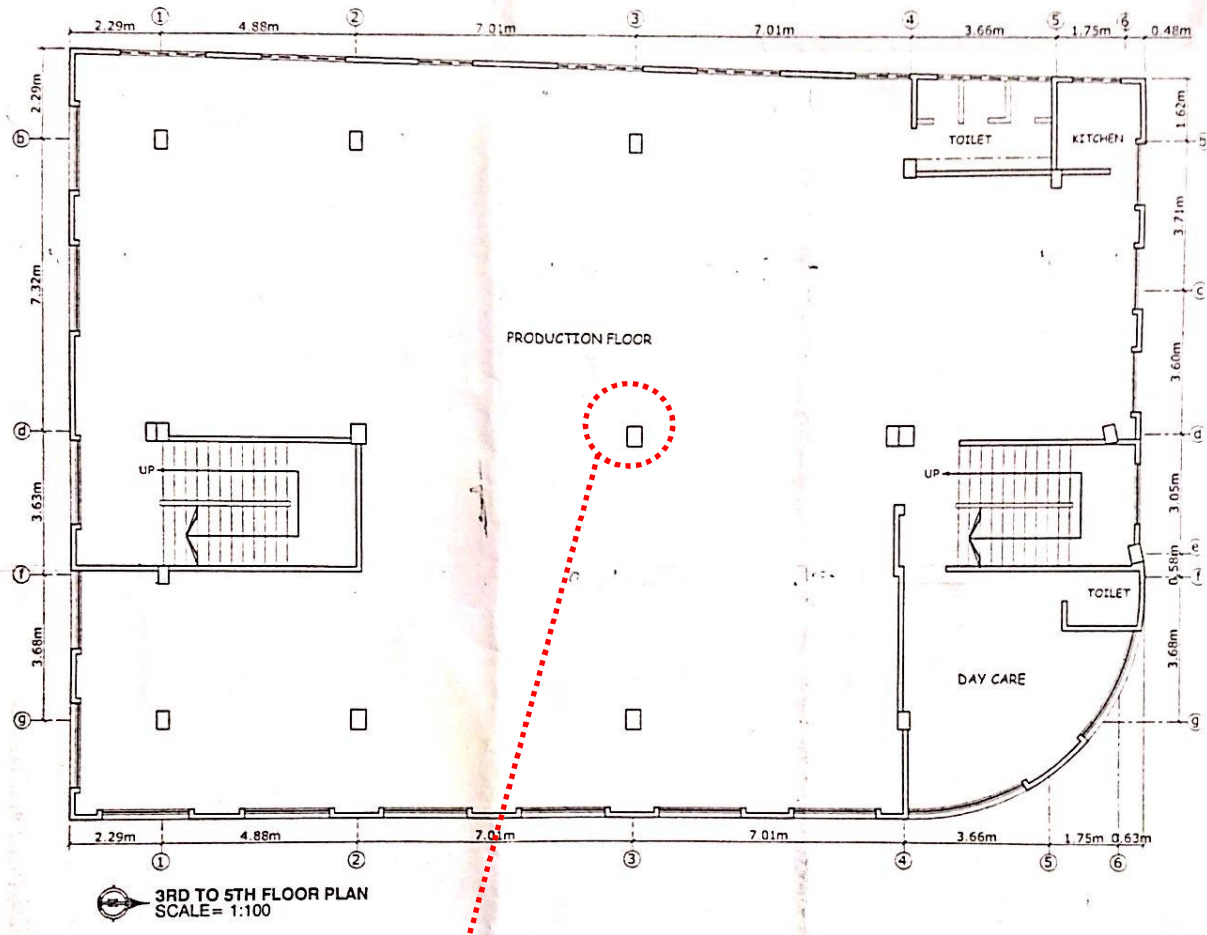
2nd Priority 1 Concern

Typical column to be checked. Two buildings has been designed in the same way. Thus, the results are very similar for all typical columns

The same procedure is applied for the typical columns in building 2 for checking the working stress. The column at the circled area has been found to be significantly insufficient in carrying the dead and live loads. The working stress is just a fraction above being rated with 'red' warning, giving a firm 'AMBER' warning. The building was constructed with brick aggregate and high-yield re-bar.

ITEM 2: (2nd Priority 1) Columns in Building 2 exhibit insufficient capacity under current building floor loads

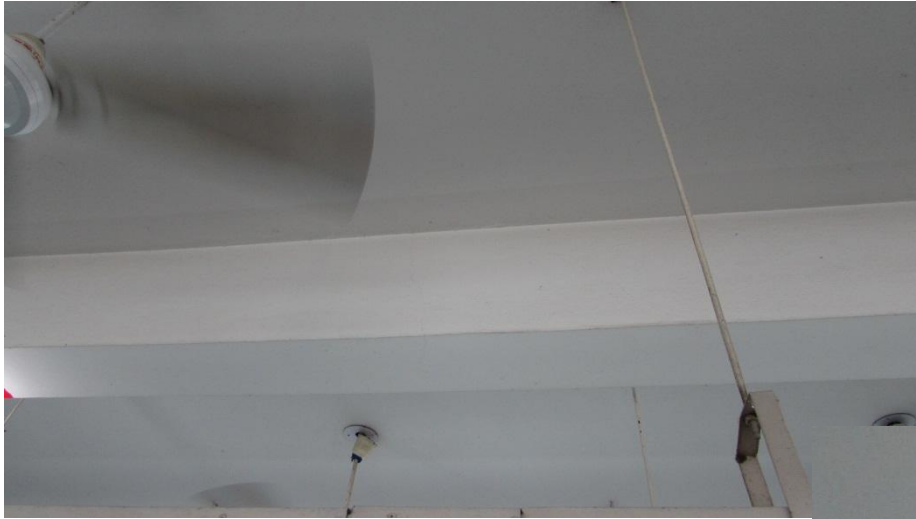
1st Priority 3 Concern

Crack on the beams in building 1

ITEM 3: (1st Priority 3) There are many hairline cracks at the middle of the beams on the soffit of the 5th floor in Building 1.

There are many visible cracks at the middle of the beams on the soffit of the 5th floor in Building 1. It could be due to poor construction or under-design of these beams.

- Carry out the steps noted in Item 1
- The Factory Engineer to review design, loads to figure out the reasons of the crack formation

- As per result of design check, building engineer to propose the strengthening or repairing works for those beam with cracks accordingly.
- Consider to remove the old plaster and reapply the new plastering layer.

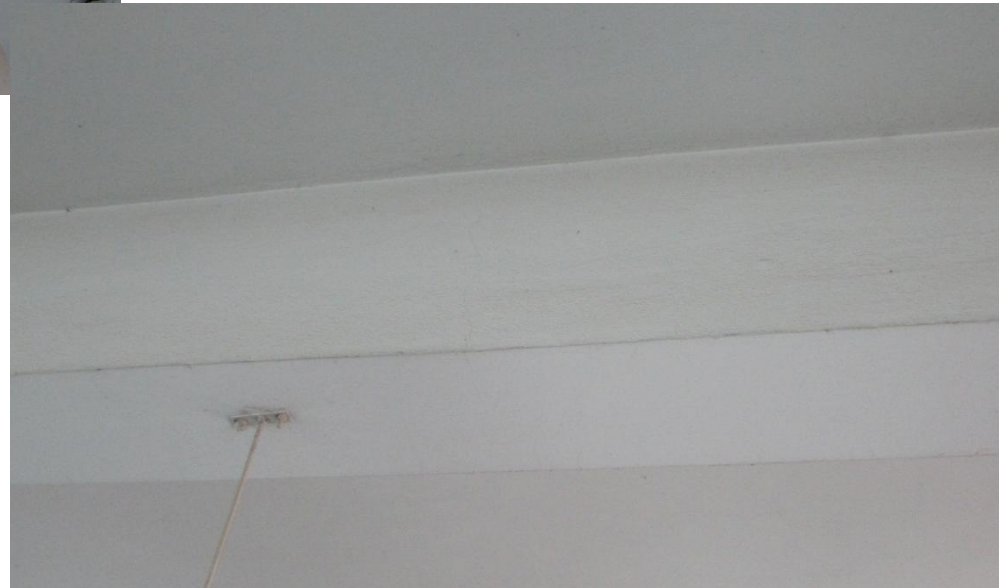
hairline cracks have been seen at the middle of the beams on the 5th floor in Building 1

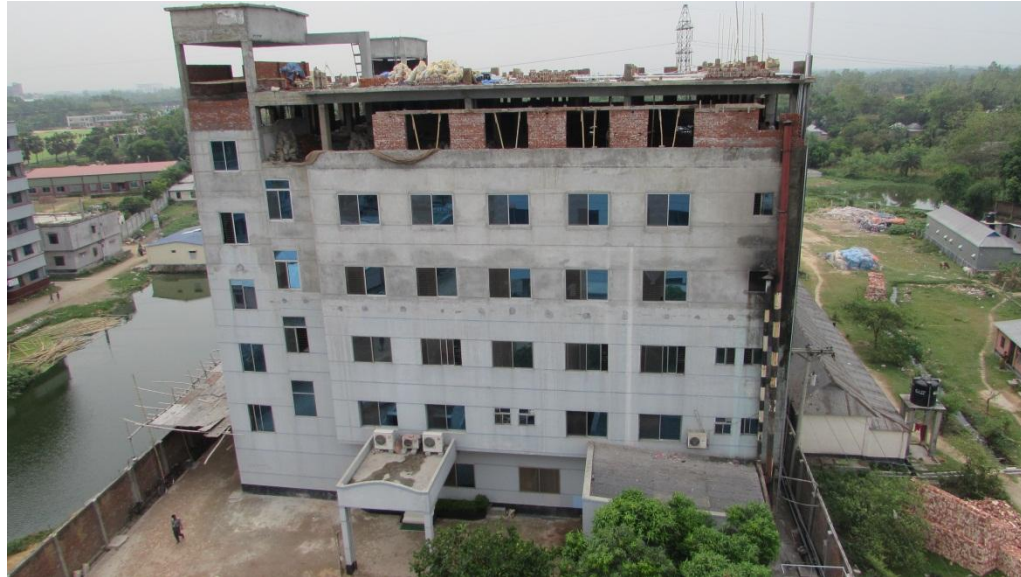
We suggest that these items be investigated as part of a Detailed Engineering Assessment.

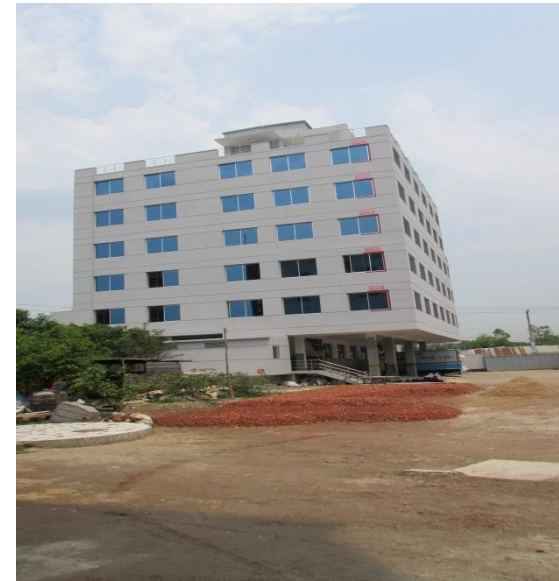
The two buildings do not appear to have any rational form of lateral stability system to resist the wind or earthquake loads. It is essential to design for lateral loads.

ITEM 4: (2nd Priority 3) It appears that two buildings are not designed with any lateral resisting systems.

There is a lack of any lateral support design for two buildings. It could lead to serious damage in a wind or earthquake event.

- As per the results of structural analysis, the building needs to be revised to accord with BNBC building codes with regard to lateral stability.
