# FIRE SAFETY INSPECTION REPORT

**FACTORY: Bando Eco Apparels Ltd.**

**ACCORD ID: 22952**

**Date: 21/11/2017**

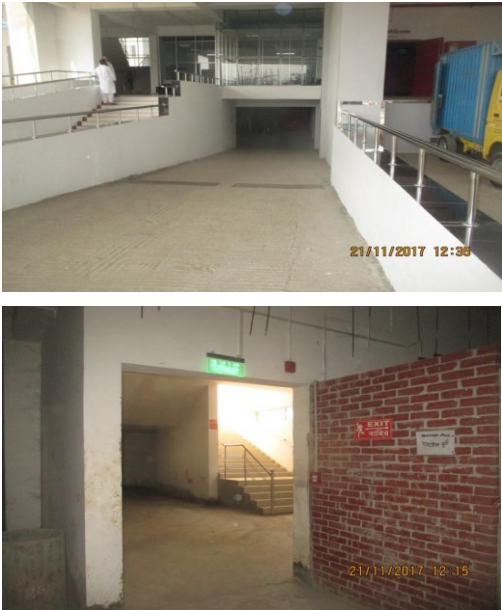
| Sl No. | Category | Findings | Required Action | Remediation Time Frame | Pictorial Evidence |
|---|---|---|---|---|---|
| 1 | Fire Rated Construction | The exit stairs enclosures are not separated from work areas and other spaces on each floor by fire-rated construction(Non rated doors, unsealed penetrations and openings etc.). | <p>Provide minimum 1.5-hr fire rated doors and seal all unprotected openings to separate the exit stairs from work areas and other building spaces on all floor levels.</p> <p>Ensure that the fire doors are self-closing and positive latching and that they are provided with fire exit (panic) hardware where serving production floors.</p> <p>If fire doors are required to be held open for functional reasons, provide automatic closing devices tied to the fire alarm system.</p> | Within 3 months | |

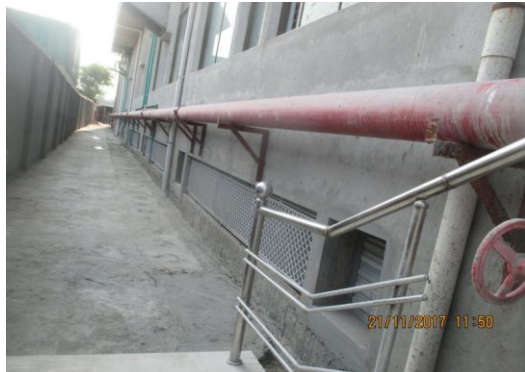
| Sl No. | Category | Findings | Required Action | Remediation Time Frame | Pictorial Evidence |
|---|---|---|---|---|---|
| 2 | Fire Rated Construction | The exit discharge path serving east exit is less than 10 ft wide and is not separated from the building interior. | <p>Seal all penetrations and openings to the interior of the building along the discharge path, up to a height of 10 ft., to provide a minimum 1-hr fire separation.</p> <p>Alternatively, provide a second remote discharge path to the public way (only include this if feasible).</p> | Within 3 months | |

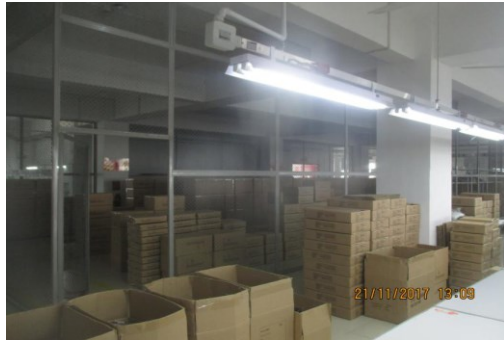
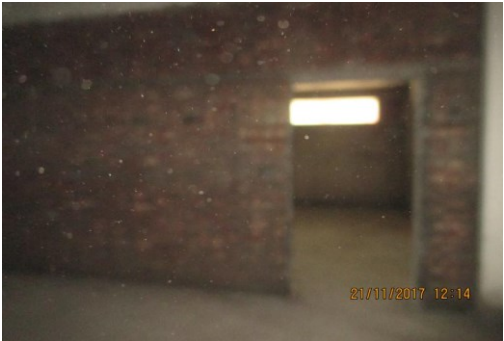
| Sl No. | Category | Findings | Required Action | Remediation Time Frame | Pictorial Evidence |
|---|---|---|---|---|---|
| 3 | Fire Rated Construction | <p>Areas used for combustible storage are not separated by fire-rated.</p> <p>Locations: Various floors.</p> | <p>Provide dedicated storage rooms separated by minimum 1-hr fire-rated construction.</p> <p>Where separate storage rooms are not feasible, provide defined storage areas and limit the storage arrangement as follows:</p> <ul style="list-style-type: none"> <li>- Maximum height of 2.4m and maximum area of 23m<sup>2</sup></li> <li>- If sprinkler protected: maximum height of 3.66m and maximum area of 93m<sup>2</sup></li> </ul> <p>Separate areas of unenclosed combustible storage by a minimum clear distance of 3m</p> | Within 3 Months | |

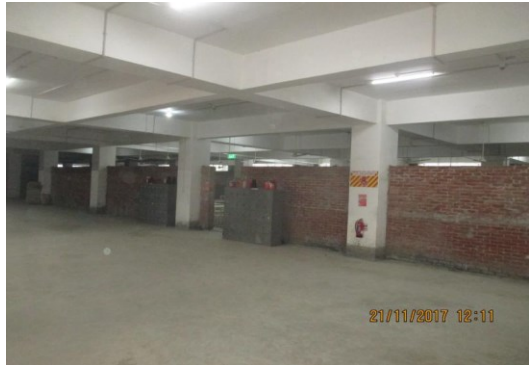
| Sl No. | Category | Findings | Required Action | Remediation Time Frame | Pictorial Evidence |
|---|---|---|---|---|---|
| 4 | Fire Rated Construction | The dining room is not separated from [work areas, other spaces] on basement floor by fire-rated construction. | Separate the dining room (ceiling, floor, wall etc.) by 1/2- hr fireresistance rated construction and shall terminate at an exit discharge. | Within 3 Months | |

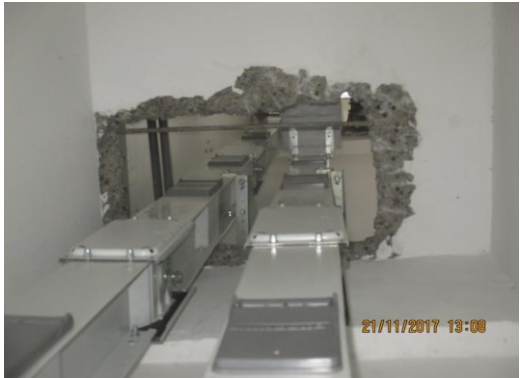
| Sl No. | Category | Findings | Required Action | Remediation Time Frame | Pictorial Evidence |
|---|---|---|---|---|---|
| 5 | Fire Rated Construction | Penetrations through floor/ceiling assemblies are found unsealed. | Seal all penetrations and openings in floor/ceiling (full thickness of the floor/ceiling) assemblies by fire rated materials to maintain the fire resistance rating.<br>Or<br>Provide a minimum 2-hr fire rated shaft to separate the utility risers from each floor if required. | Within 3 Months | |

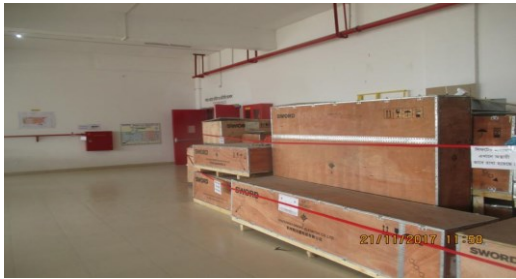
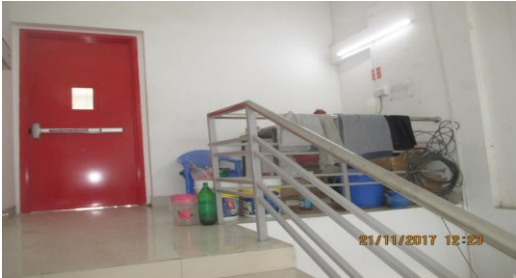
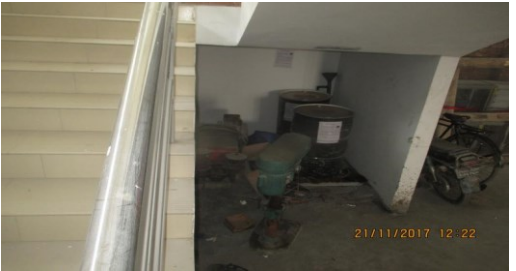
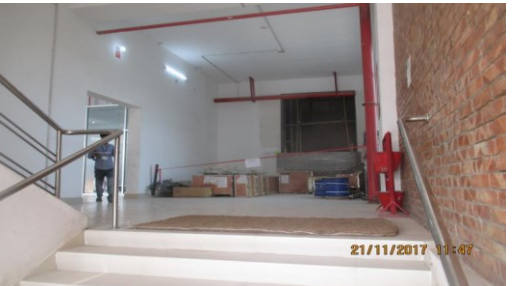
| Sl No. | Category | Findings | Required Action | Remediation Time Frame | Pictorial Evidence |
|---|---|---|---|---|---|
| 6 | Storage in Egress Path | Storage was located in the egress paths. | Keep egress path and stair clear of storage. | Immediate | |

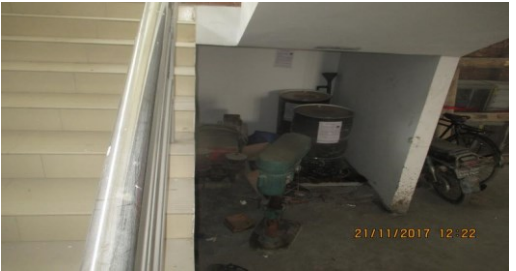
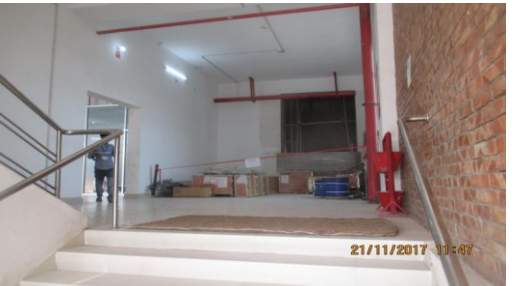
| Sl No. | Category | Findings | Required Action | Remediation Time Frame | Pictorial Evidence |
|---|---|---|---|---|---|
| 7 | Storage in Exit Stair | Storage was located in exit stairs. | Remove storage from the exit stairs and egress path | Immediate | |

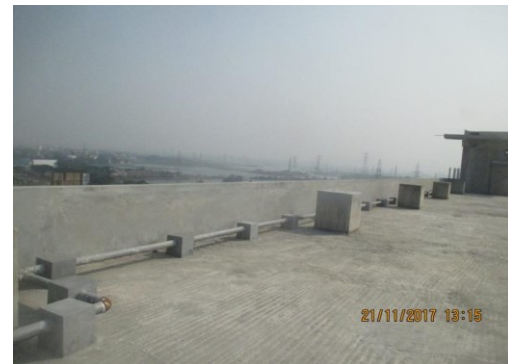
| Sl No. | Category | Findings | Required Action | Remediation Time Frame | Pictorial Evidence |
|---|---|---|---|---|---|
| 8 | No Parapets or Guards | Parapets or guards are provided in occupied roof which is less than 1067mm (42 inch.). | Provide parapets or guards with a minimum height of 1067mm (42 inch.). | Within 1 Month | |

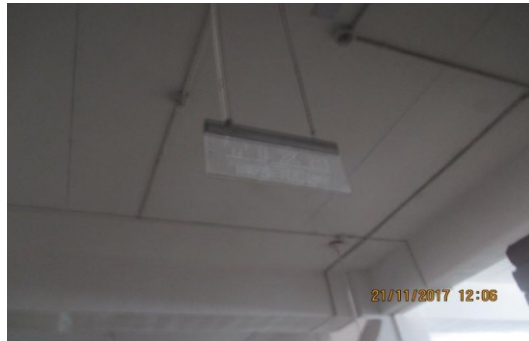
| Sl No. | Category | Findings | Required Action | Remediation Time Frame | Pictorial Evidence |
|---|---|---|---|---|---|
| 12 | Non-Working Exit Signs | Exit signage not illuminated (burned out, broken, etc.). | Regularly inspect all exit signage and replace/install lights as needed to illuminate signs | Within 1 month | |

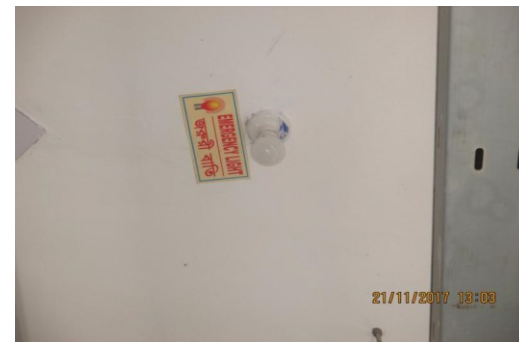
| Sl No. | Category | Findings | Required Action | Remediation Time Frame | Pictorial Evidence |
|---|---|---|---|---|---|
| 13 | Non-Working Lighting | Emergency lighting did not function in test mode (burned out, broken, etc.). | Regularly test the emergency lighting system on each floor and replace/repair lights as needed | Within 1 month | |

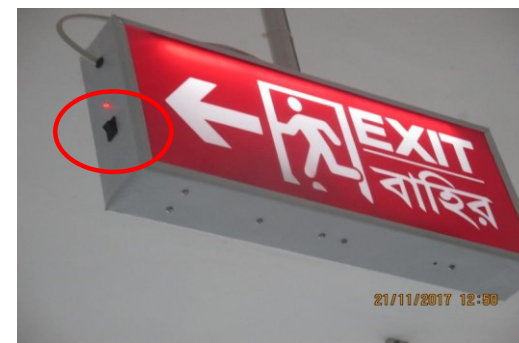
| Sl No. | Category | Findings | Required Action | Remediation Time Frame | Pictorial Evidence |
|---|---|---|---|---|---|
| 14 | On/Off Switch | Manual on-off switch is provided for [emergency lighting / exit signage] units. | Remove manual on/off switches from [emergency lighting / exit signage] units to prevent them from being switched off | Within 1 month | |

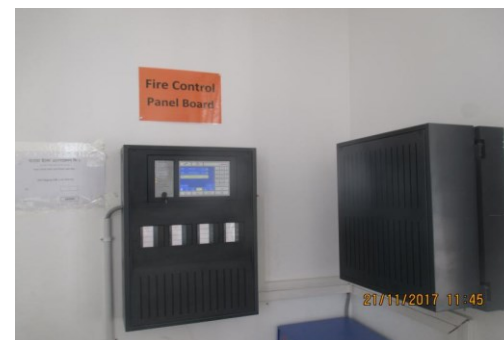
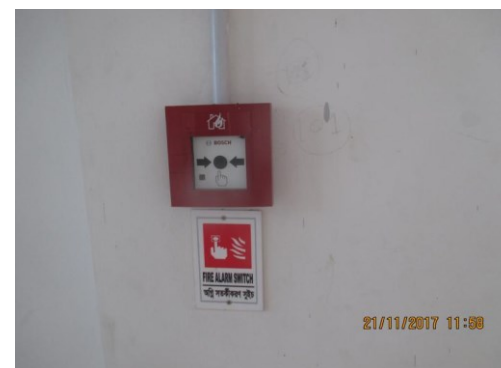
16

The addressable fire alarm system installation is going on without approval from AHJ.

Submit As-Built drawing to AHJ for approval and replace or modify the fire alarm system in accordance with NFPA 72.

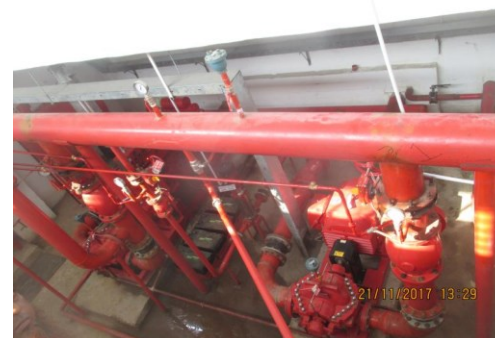
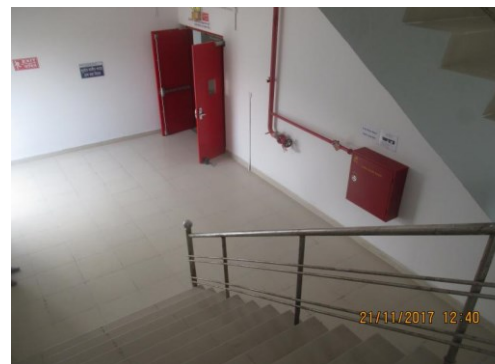
18

The standpipe system installation is going on without approval from AHJ.

Submit As-Built drawing to AHJ for approval and replace or modify the standpipe system in accordance with NFPA 14.
