# Sinha Knit Industries Ltd. (10184)

Chamurkhan, P.O - Uttarkhan, P.S – Uttara, Dhaka, Bangladesh.

29.APRIL.2014

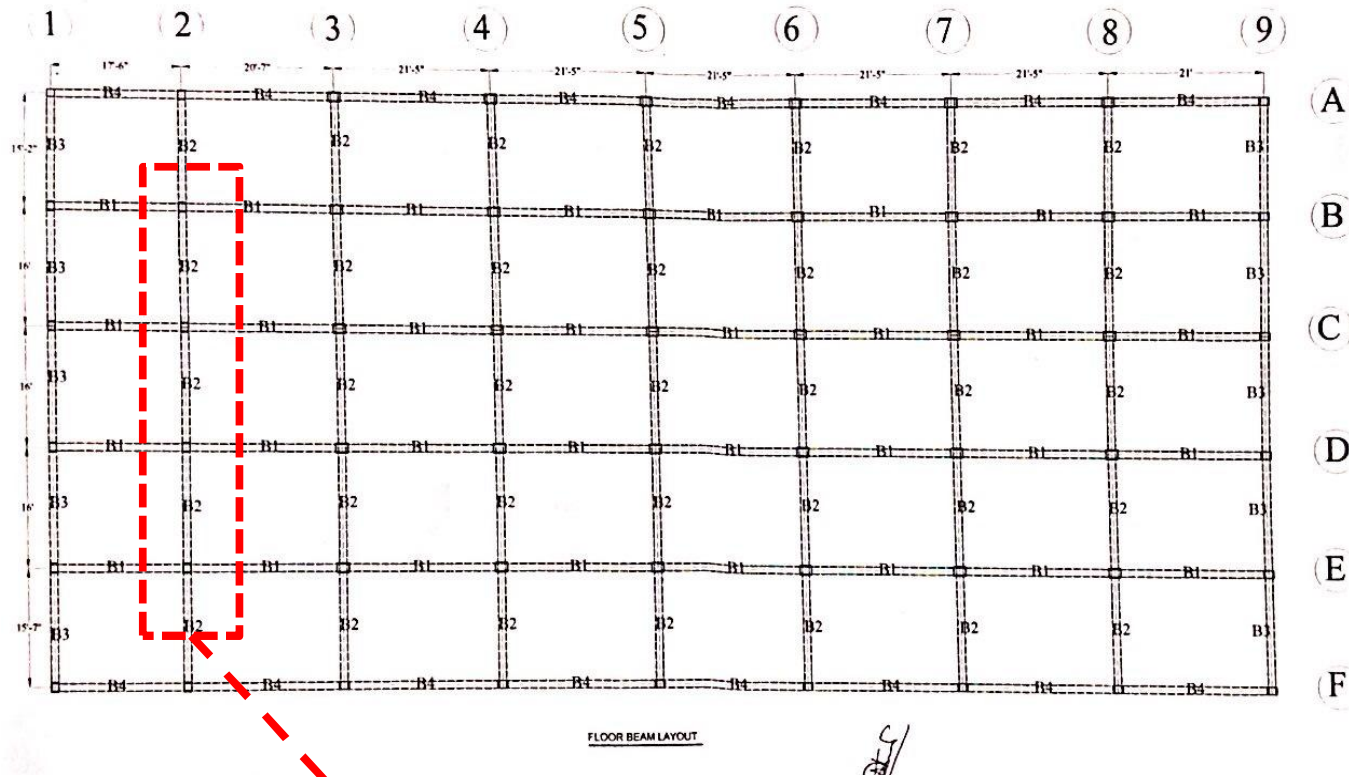
These columns (300x380 mm ) on the 2<sup>nd</sup> grid line have been checked for their loading capacity.

Based on the structural design and the Ferro-scan results, the column reinforcement in some columns appears to be inconsistent with the rebar arrangement at the ground level. According to the load rundown calculation, typical columns have been found to possess marginal loading capacity, thus attaining an 'AMBER' warning.

Column possesses low factor of safety

**ITEM 1: (1<sup>st</sup> Priority 1) Column load rundown indicates that the columns on 2<sup>nd</sup> grid line appear to have very low factors of safety with respect to their loading capacity.**

- Carry out a full Detailed Engineering Assessment of the entire building including any intrusive testing required.
- Carry out full survey of all structural elements to check the loading capacity of the overall structural system.
- The Factory Engineer to review design, loads and columns stresses in entire building in accordance with BNBC regulations

- Develop and maintain a set of floor loading plans.

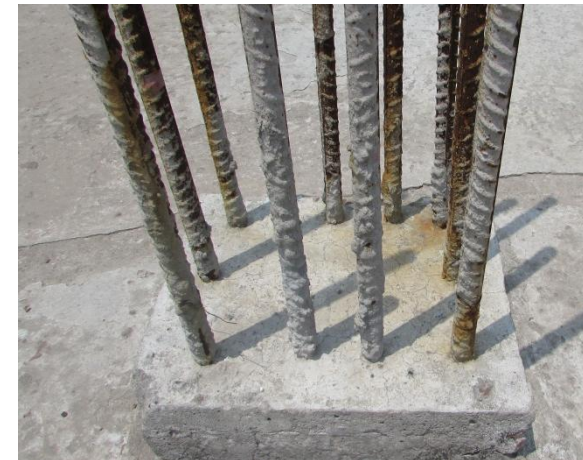
Other than the undersized C2 columns on the 2<sup>nd</sup> grid line. All other C2 columns have the correct size of 380x460 on all floors.

The columns C2 have been designed with 12 bars of 20mm diameter for all floor levels. However, the Ferro-scan image and picture of those columns on the top floor suggests 10 bars only. Lack of 2 bars leads to a lower factor of safety for those columns.

The structural record is not reliable

**ITEM 2: (1<sup>st</sup> Priority 3) The structural drawings are not reliable to be considered as structural record drawings.**

- Carry out the steps as noted in Item 1 for structural survey

- Based on the building survey, building engineer to develop full structural records and check for compliance with BNBC codes.

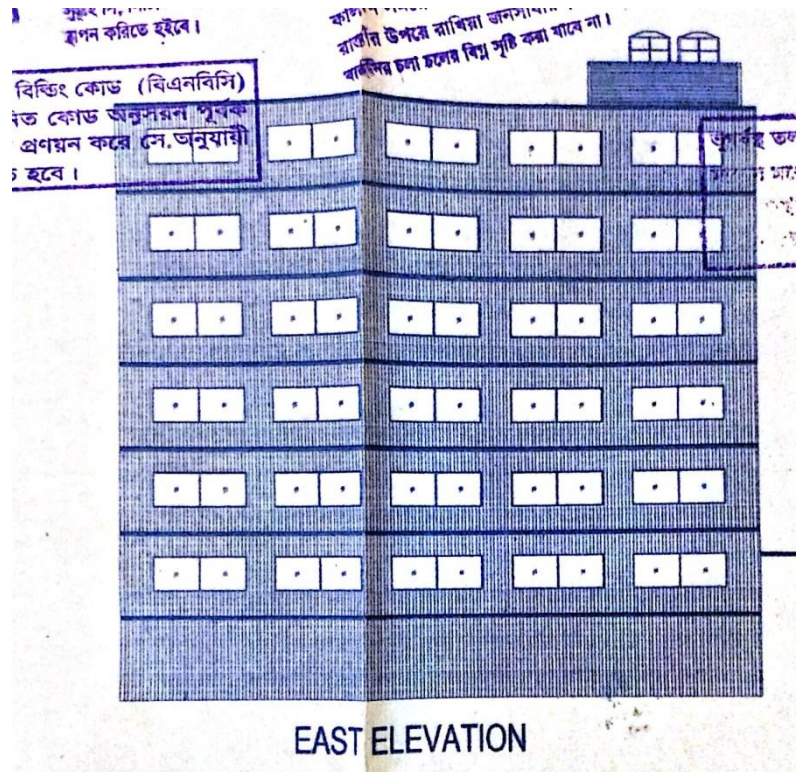
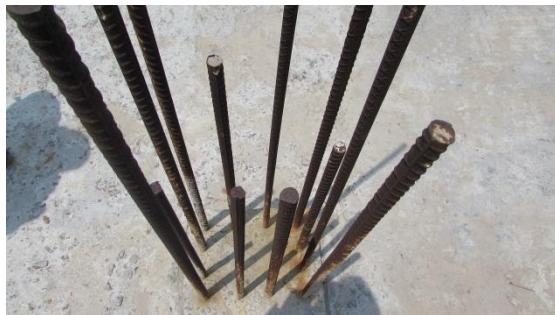
The building was approved for 6 storeys and one basement. The existing building has been finished up to 5 storeys high. The addition of one more floor has been planned. Reinforcement is left exposed at the upper levels intentionally for the vertical extension. This future extension may cause a significant increase in column loads which would need to be fully checked. All columns C2 on the 2<sup>nd</sup> grid line have very low factors of safety with regard to their loading capacity. This is mainly due to a lower level of reinforcement than specified. Thus, adding one more floor could result in even greater overstressing. With our preliminary calculation, the smaller columns C2 on 2<sup>nd</sup> grid line can not be able to sustain the additional load from future extension without any strengthening work for those columns.

**ITEM 3: (2<sup>nd</sup> Priority 3) Possible future vertical extension has been planned. This could leads to overstressed for those smaller column C2 on 2<sup>nd</sup> grid line.**

The possibility of a future vertical extension will only lead to further overstressing of the structural system.

- Any further extensions or structural modifications of the existing building needs to be investigated fully by a Structural Engineer and it should be in full compliance with the BNBC codes.
