# Consumer Knitex Limited. (Unit-2)- New Buildings

Baghan Trishal, Mymensingh 2222  
(24.552171N, 90.400753E)

19<sup>th</sup> November 2017

# Observation

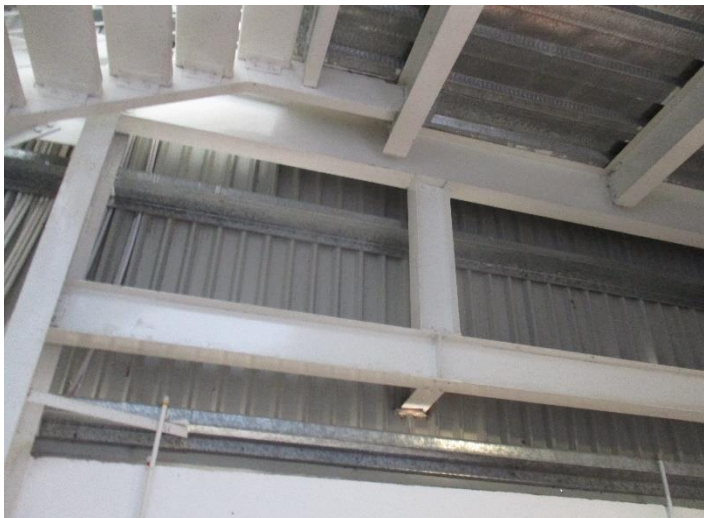
Additional short column in gable frame was not shown in drawing

| Item No. | Observation | Recommended Action Plan | Recommended Timeline |
|---|---|---|---|
| 1 | All buildings -<br>Paucity of details in As-Built drawings | Building Engineer to survey as-built structure and prepare accurate as-built survey information with connection details for the building. | 6-weeks |

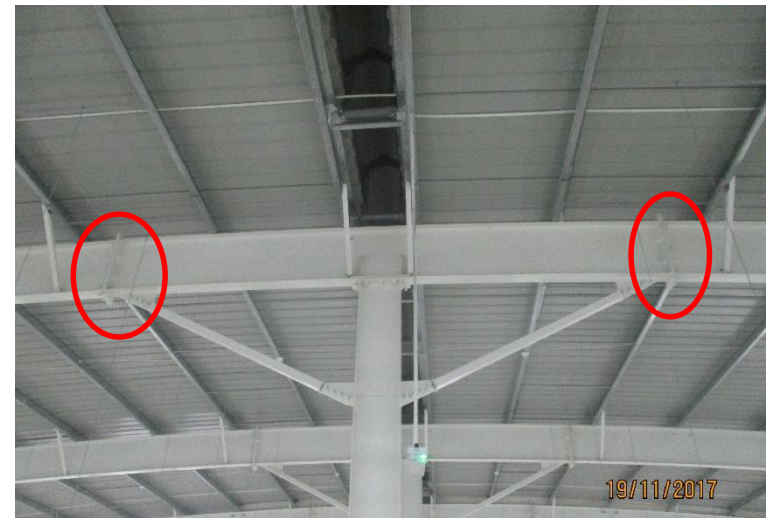
Additional joints in rafter were not shown in drawing

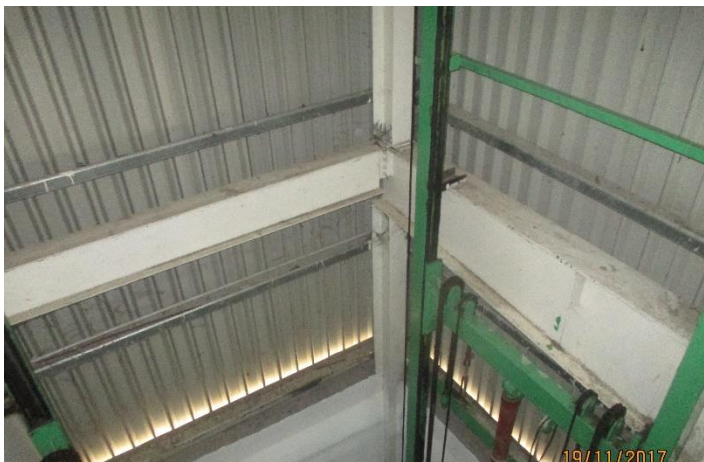
Additional columns for cargo lift and toilet zone were not shown in column layout. Also thickness of flange was measured 6mm but in column section it shows 8mm.

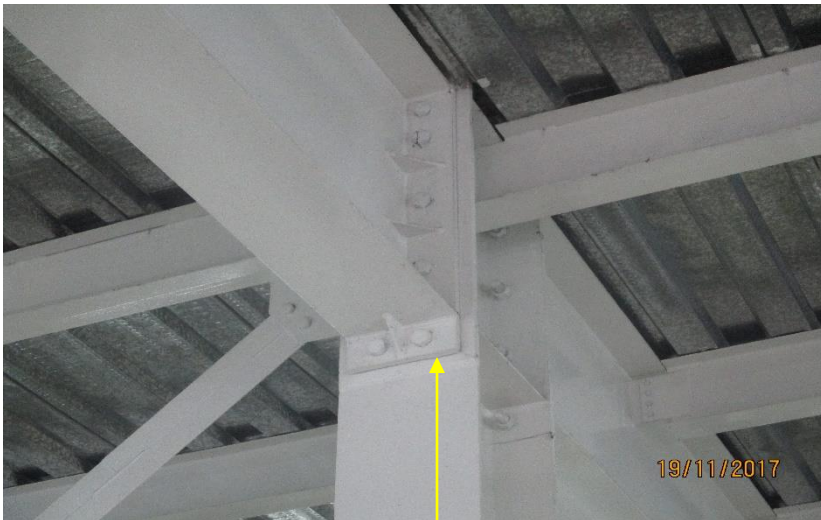
Connection details were not matched with provided drawings

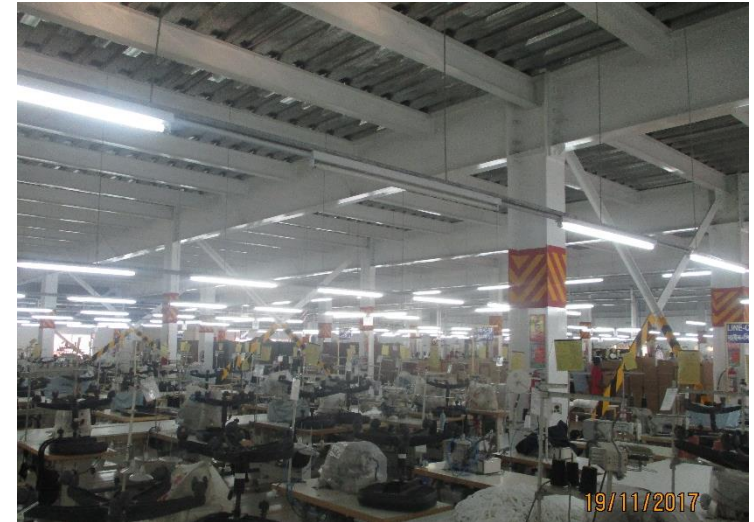
Cross bracing was observed instead of portal frame bracing

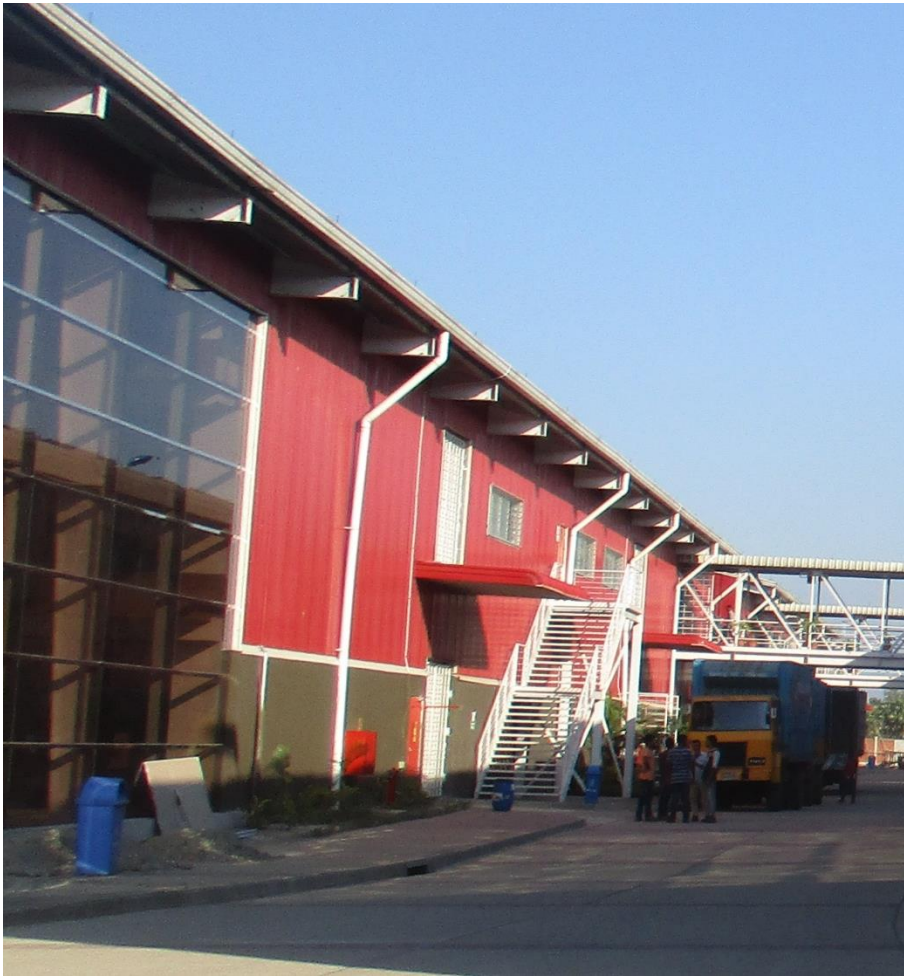
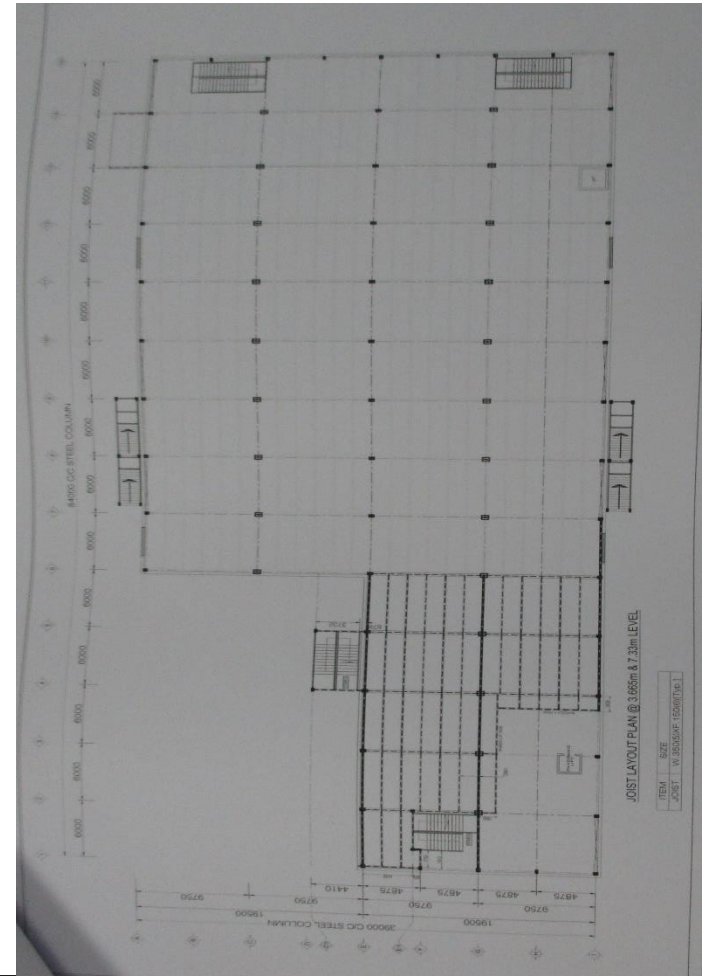
Number of bays were not matched with provided drawing. In provided drawings 14 number of bays were shown but during inspection 13 number of bays are found.

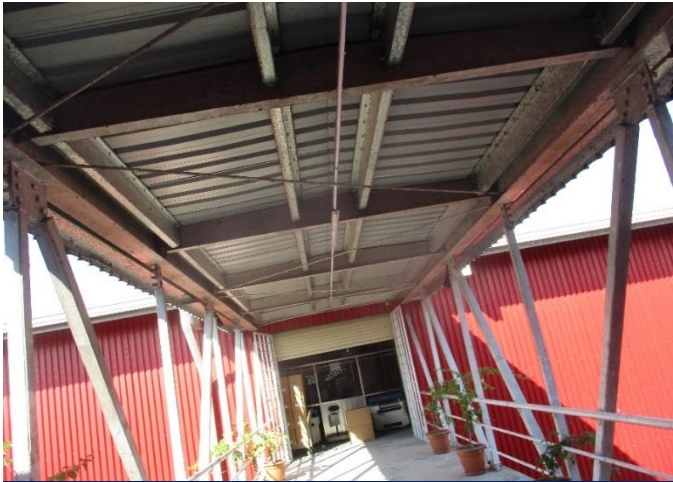
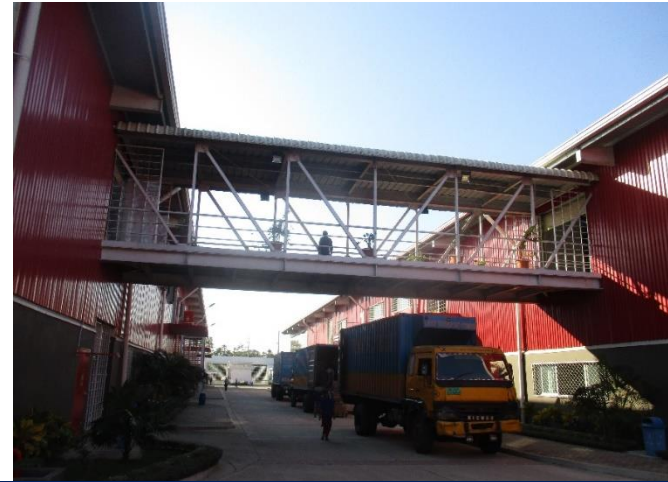
Connection Bridge

During inspection no drawings details were available for the connection bridge & Pump house.

| Item No. | Observation | Recommended Action Plan | Recommended Timeline |
|---|---|---|---|
| 2 | All buildings -<br>Lack of documents for connection bridge & pump house | Prepare up-to-date as-built documentation for all connection bridge & pump house. | 6-weeks |

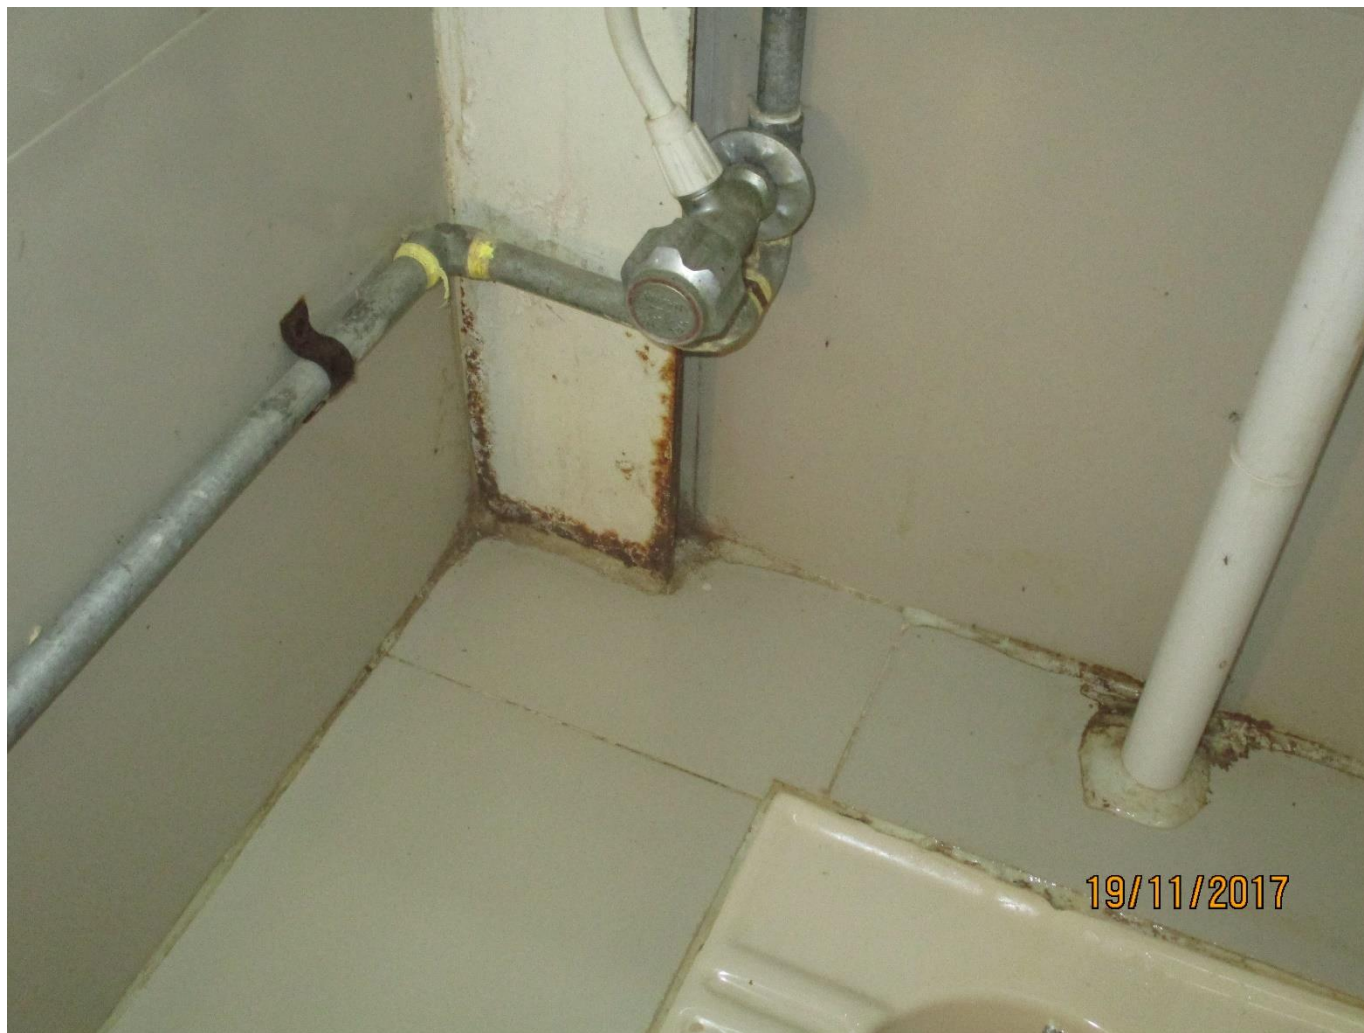
Corrosion found at toilet zone column of building 1.

| Item No. | Observation | Recommended Action Plan | Recommended Timeline |
|---|---|---|---|
| 3 | Building-1 -<br>Corrosion in steel column | Apply suitable method to protect the steel members from corrosion. | 6-weeks |

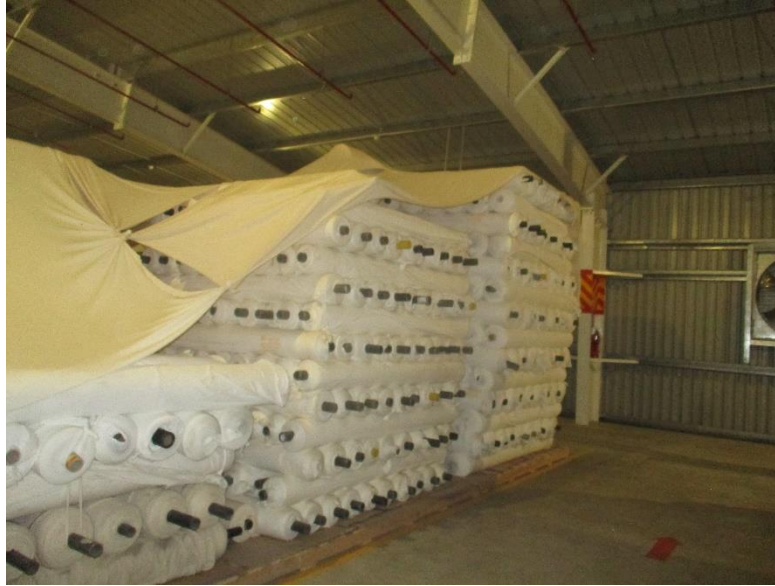
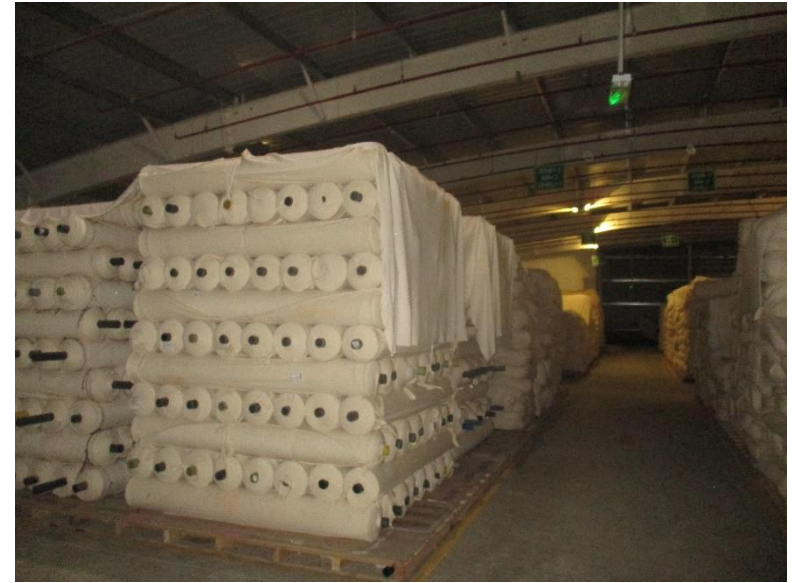
1  
1 **Observation : Building 5, 9, 10 & 12**

Building 5, 9, 10 & 12 is used for store and ware house at 1<sup>st</sup> floor. No standard load plan wasn't produced for those building. During inspection, 84 psf live load was found in some areas. Factory engineer is required to prepared load plan considering column and slab capacity. And also mentioned the maximum allowable limit on the load plan.

| Item No. | Observation | Recommended Action Plan | Recommended Timeline |
|---|---|---|---|
| 4 | Building-5, 9, 10 & 12 -<br>Produce load plan in standard format | Produce and actively manage a loading plan for all floor plates within the factory, giving consideration to floor capacity and column capacity. | 6-weeks |

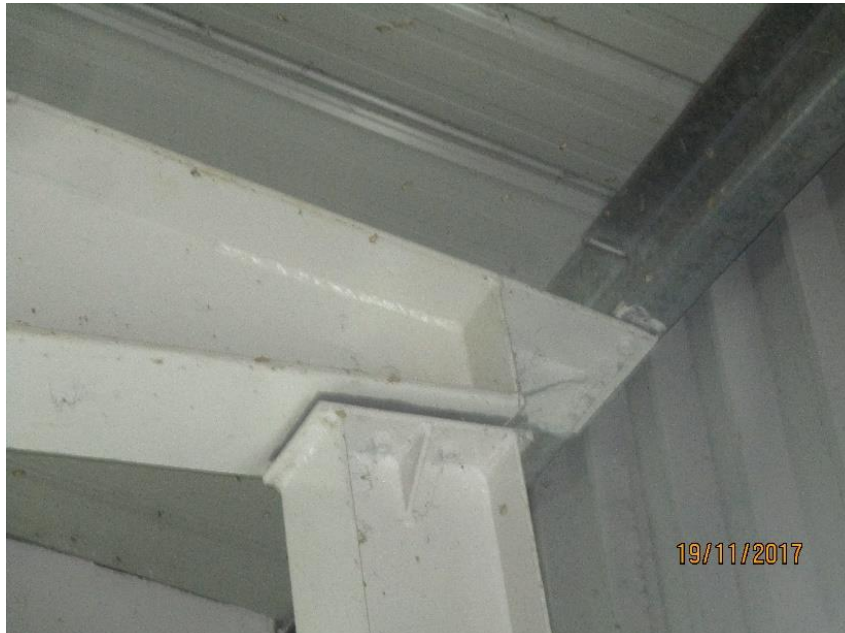
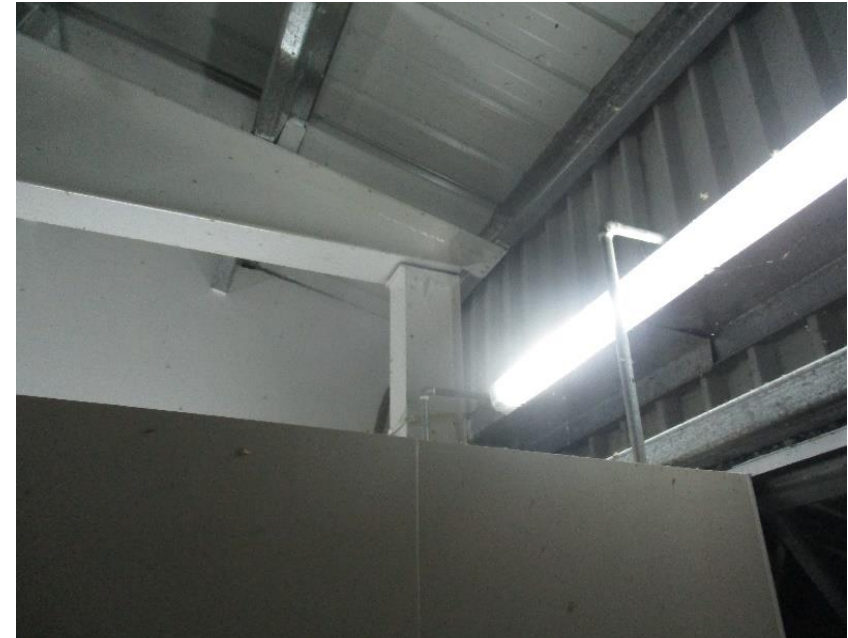
Gap found in between column and rafter at toilet zone

| Item No. | Observation | Recommended Action Plan | Recommended Timeline |
|---|---|---|---|
| 5 | Building- 9 & 10 -<br>Gap between column & rafter connection | Factory Engineer to check the connections and provide shim plate where required. | 6-weeks |
