# Euro Arte Apparels Ltd.

Plot - 346, Kabirpur, Ashulia, Savar  
(24.009166N, 90.247896E)

28<sup>th</sup> November 2017

# Observations

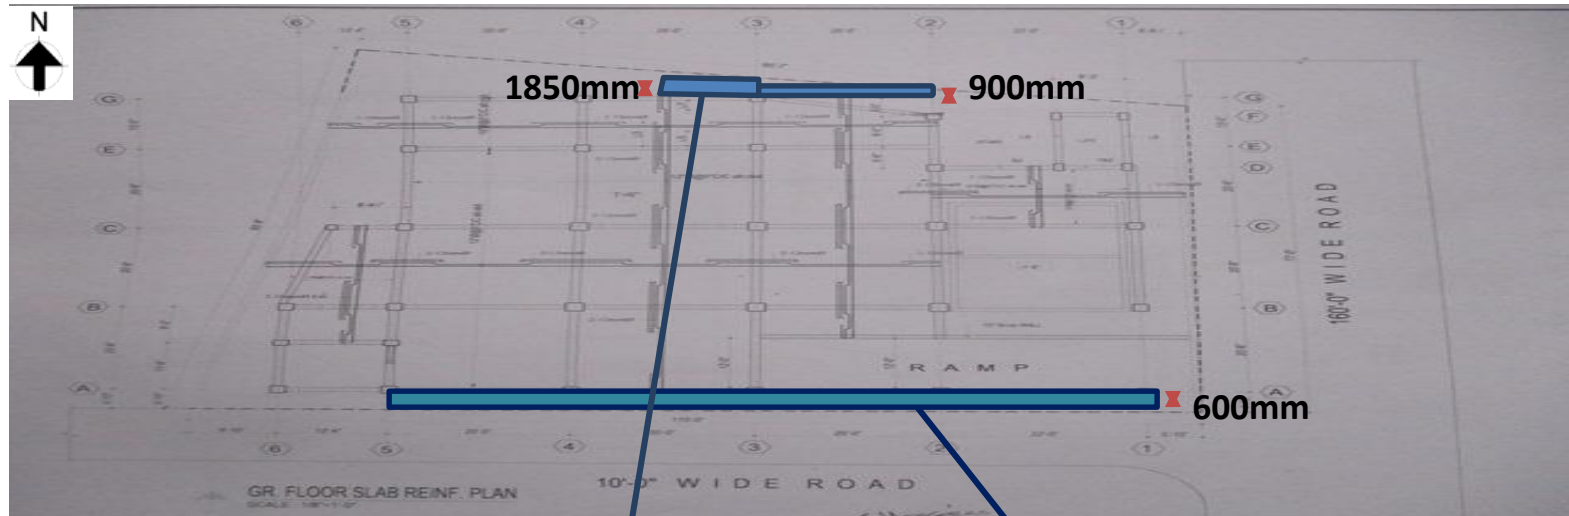
Ground Floor Slab Layout

# Discrepancies between provided drawing and on site condition

| Item No. | Observation | Recommended Action Plan | Recommended Timeline |
|---|---|---|---|
| 1 | Discrepancies between provided drawing and on site condition | Building Engineer is required to prepare as –built drawings reflecting the actual site condition. | 6-weeks |

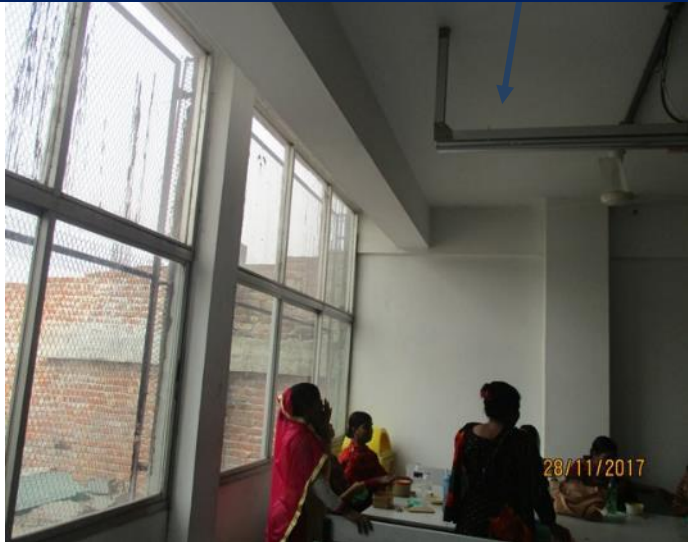
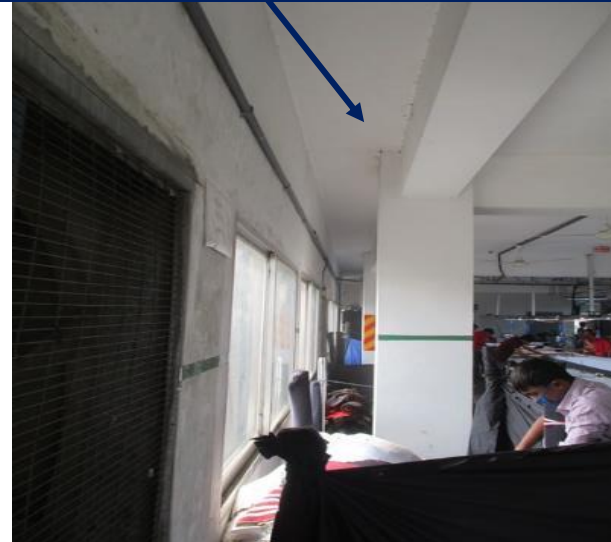
1850mm and 900mm wide cantilever on north side and 600mm wide cantilever on south side found which was not mentioned in drawing

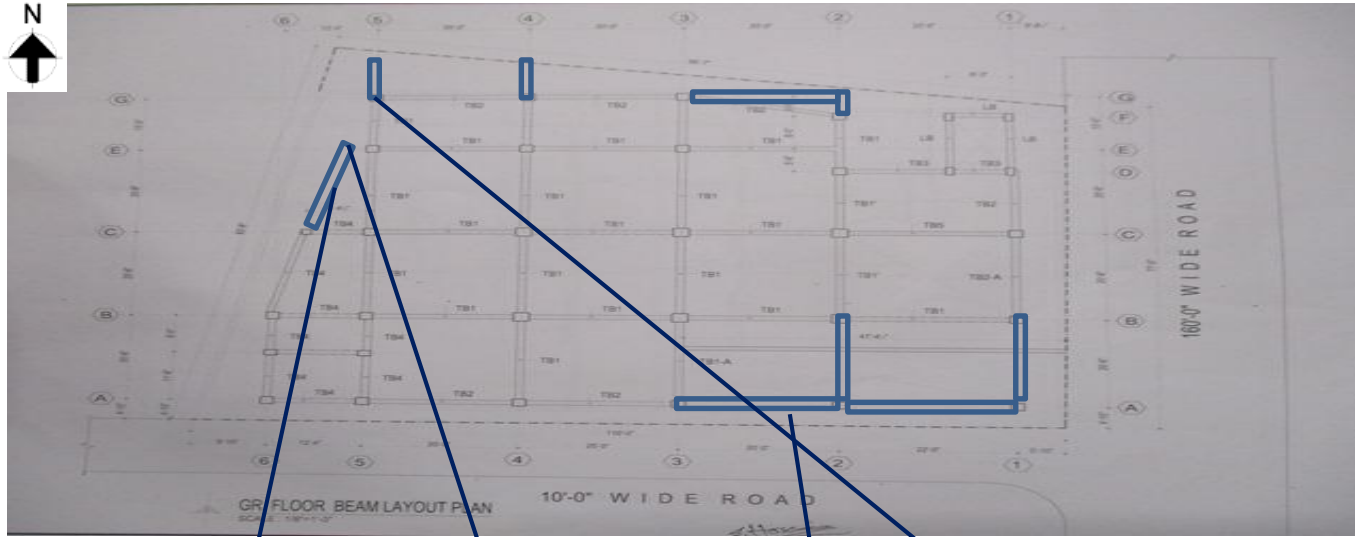
Provided Beam Layout

Marked beams were found in every floor which were not mentioned in as built drawing. Factory is required to revise As – Built drawings reflecting the on site condition.

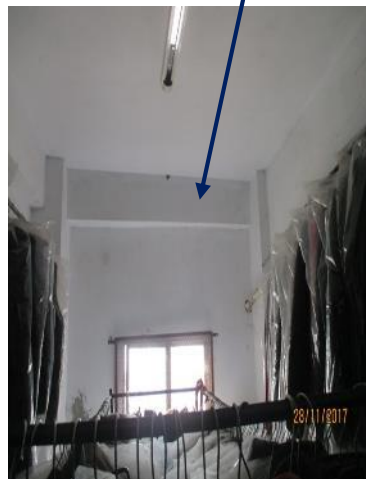
Beam Size measured 300mm (w) x 350mm (d/s)

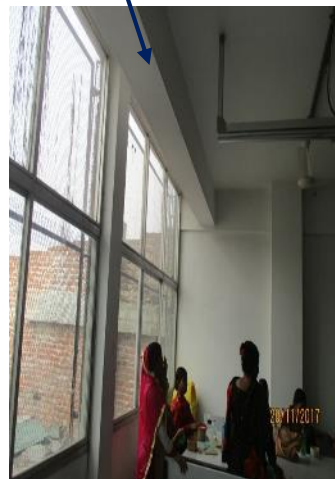
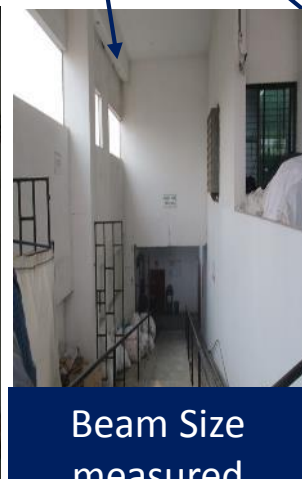
Beam Size measured 300mm (w) x 400mm (d/s)

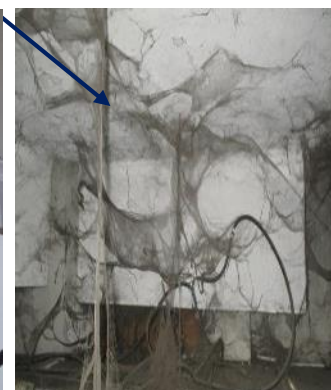
Beam Size measured 250mm (w) x 400mm (d/s)

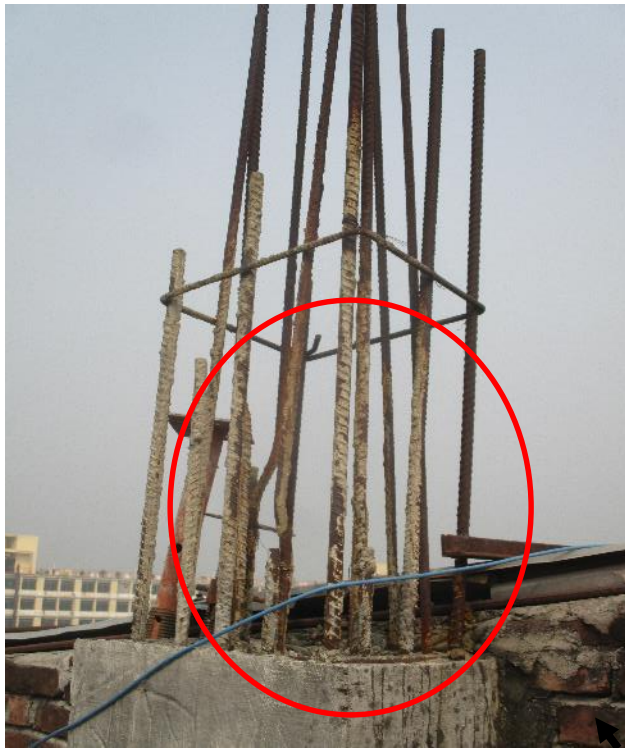
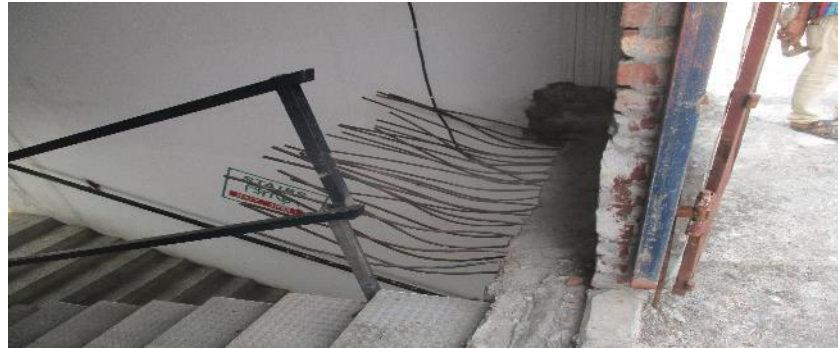
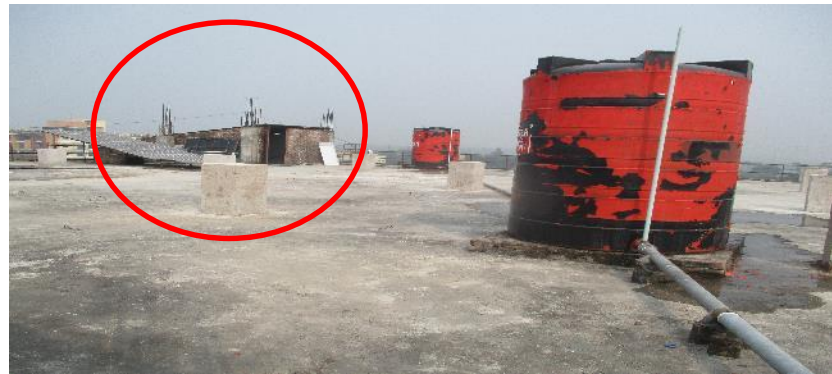
Exposed Rebar on roof top tends to corrosion

Exposed rebar was observed on roof top which tends to corrosion. Some corroded rebar was observed. Factory is required to take necessary steps to avoid corrosion.

| Item No. | Observation | Recommended Action Plan | Recommended Timeline |
|---|---|---|---|
| 2 | Corrosion on roof top exposed reinforcement | Building engineer to check the reinforcement for corrosion and take proper remedial action. | 6-weeks |

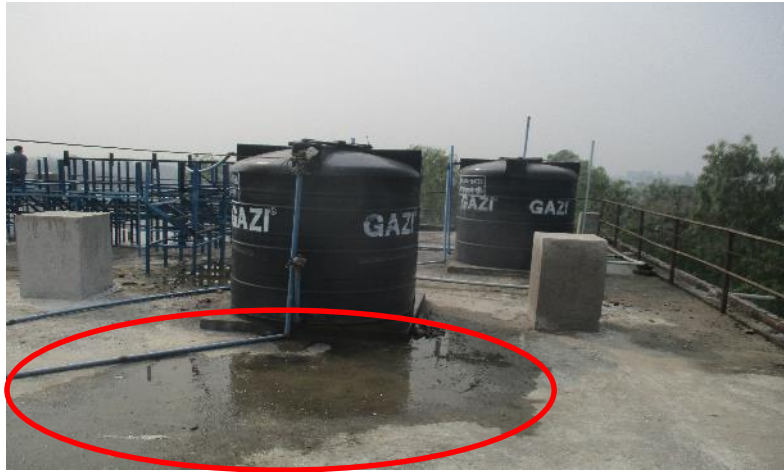
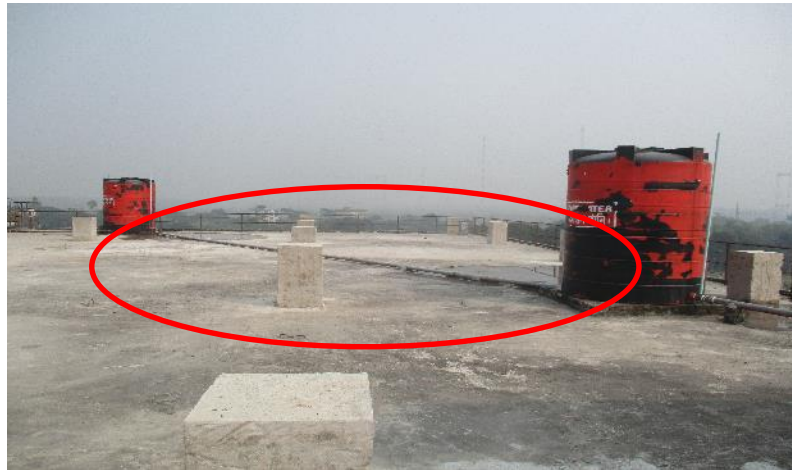
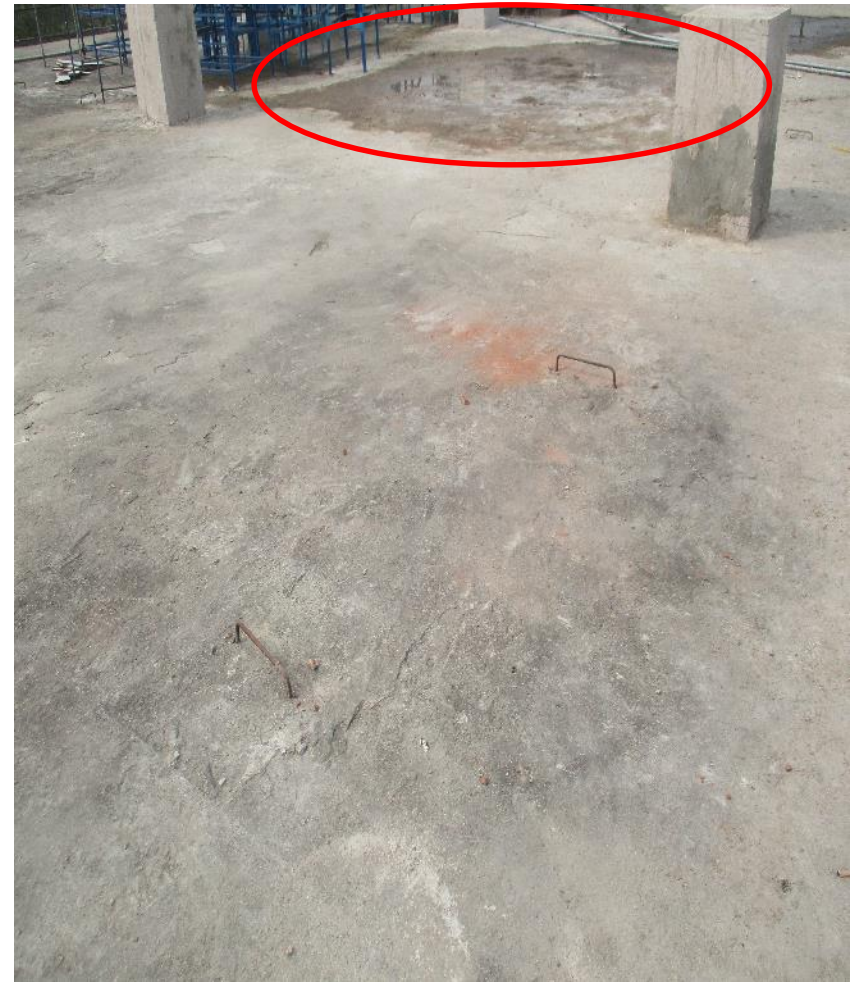
No proper water proofing or drainage system was observed. Besides, Water clogging was observed on some portion on roof. Factory is required to provide water proofing membrane and improve the drainage system on roof.

| Item No. | Observation | Recommended Action Plan | Recommended Timeline |
|---|---|---|---|
| 3 | Water clogging on roof | Factory is required to provide the water proofing membrane or install the adequate drainage system to prevent water clogging. | 6-weeks |

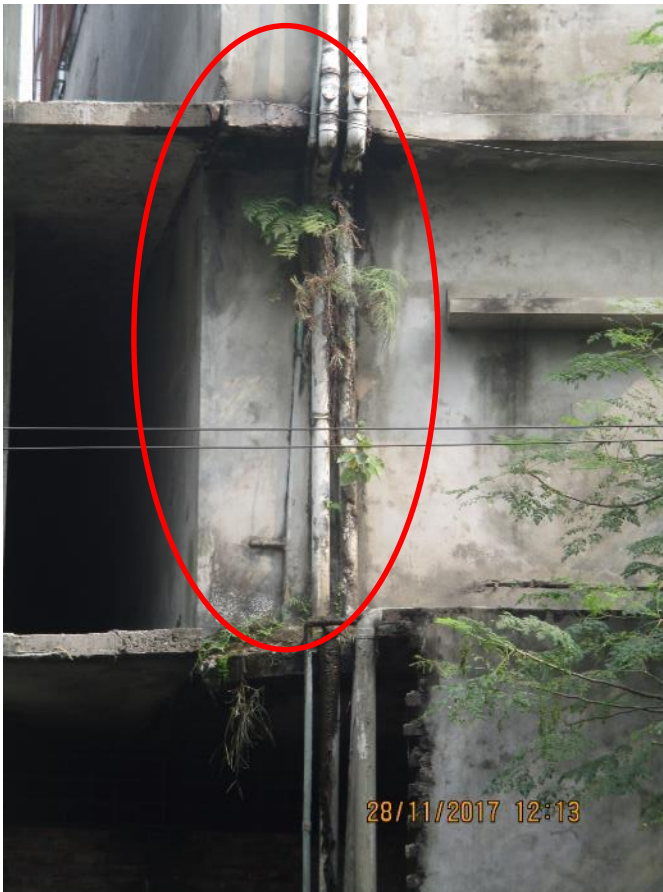
Vegetation was observed on west side facade wall

Dampness was found on several area on brick wall. Factory is required to identified the reason and repair with appropriate method

| Item No. | Observation | Recommended Action Plan | Recommended Timeline |
|---|---|---|---|
| 5 | Dampness and Vegetation on several areas of building | Take necessary steps for removing the vegetation. | 6-weeks |

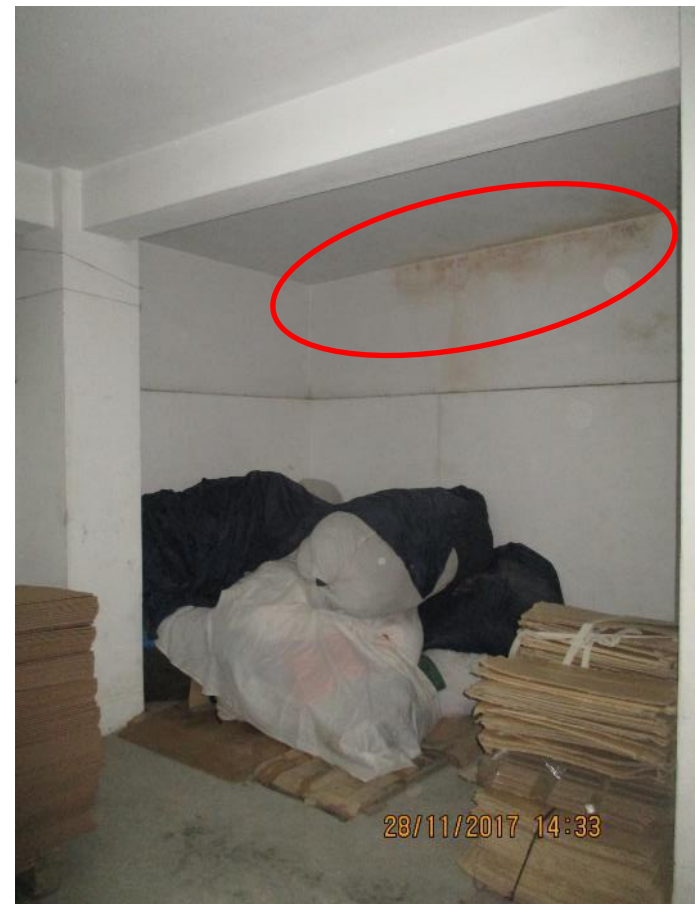
Dampness was observed on South West corner of basement wall

| Item No. | Observation | Recommended Action Plan | Recommended Timeline |
|---|---|---|---|
| 4 | Dampness and Vegetation on several areas of building | Building engineer to investigate the reasons and provide necessary repair method. | 6-weeks |
| 6 | Dampness and Vegetation on several areas of building | Implement the repair works suggested by the building engineer. | 6-months |

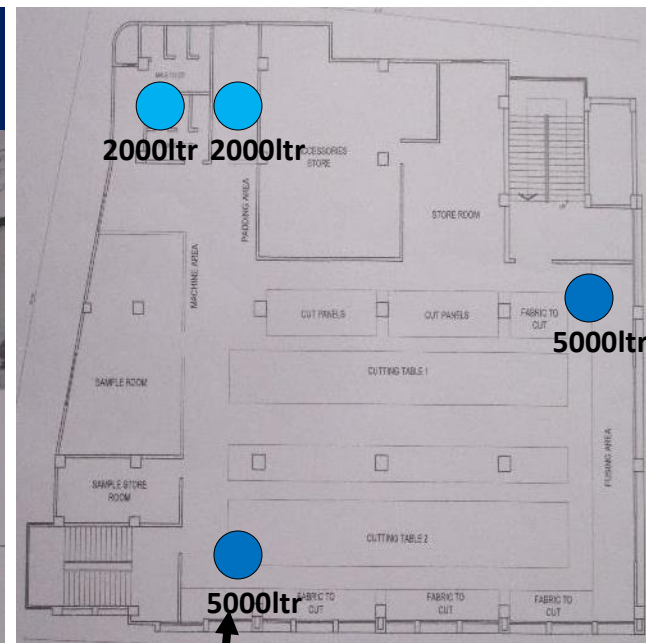
Water tank location on roof top

According to the preliminary assessment report, supporting structure for the roof top water tank needs to be reviewed. Moreover, Any kind of vertical or horizontal extension is restricted without performing Detail Engineering Assessment. Factory is required to submit the assessment report for the supporting structure of the water tank.

| Item No. | Observation | Recommended Action Plan | Recommended Timeline |
|---|---|---|---|
| 7 | Issue highlighted in ILO report | Complete review of Engineering Assessment for the water tank supporting structure with Accord. | 6-weeks |
| 8 | Issue highlighted in ILO report | Complete remedial works arise from engineering assessment after review by Accord(If any). | 6-months |

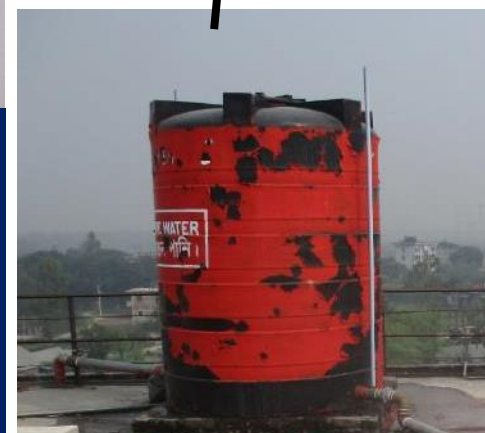
5000 litre water tank

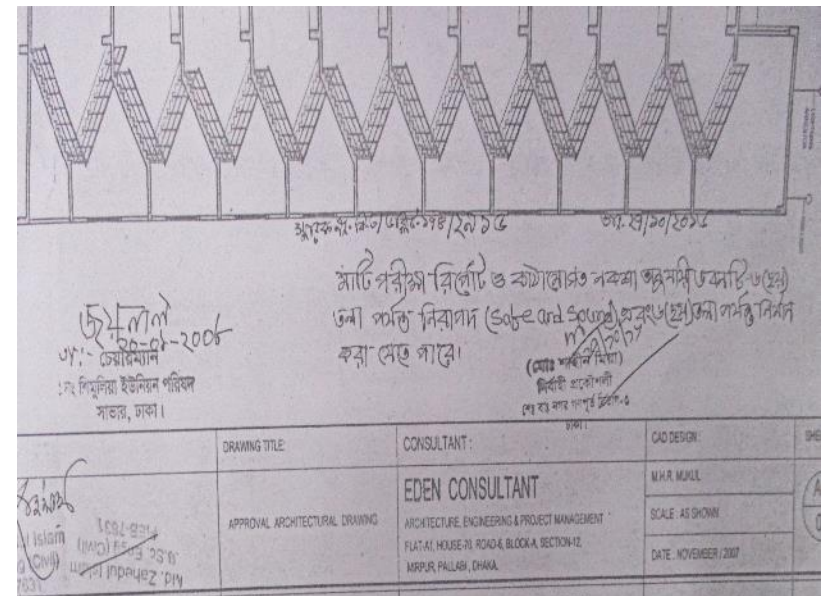
The existing 6-stories building is declared safe by 'Public Works Department" (PWD) based on the soil test report

If any future extension may take place a significant increase of stresses in column and foundation . Details Engineering Assessment is required to be completed before construction of any additional floors above 6-storey.

As per soil test report, after improving the foundation base factory can extent up to 9-storied.

| Item No. | Observation | Recommended Action Plan | Recommended Timeline |
|---|---|---|---|
| 9 | Issue highlighted in ILO report | In case of any extensions or modifications of the existing building, carryout Detail Engineering Assessment in compliance with the BNBC provision. | 6-months |
