# FIRE SAFETY INSPECTION REPORT

**Factory Name: Natural Woolwear Ltd.**

**Date: 27th August, 2017**

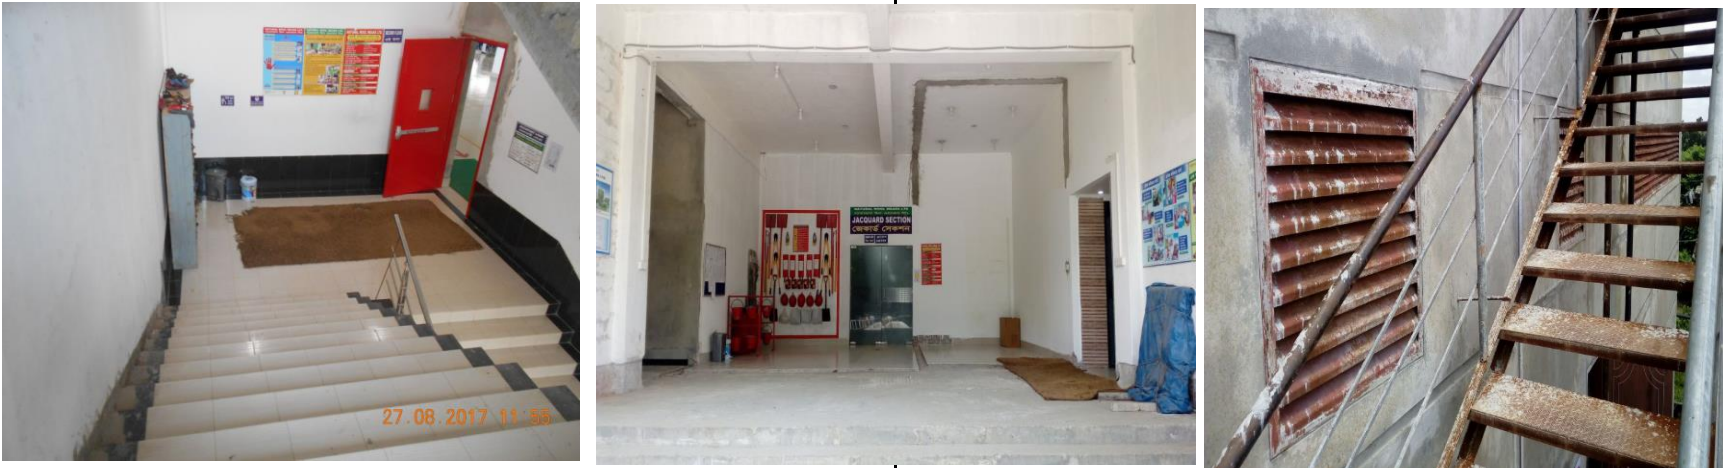
SI No.	Category	Findings	Required Action	Remediation Time Frame
1	<b>Fire Rated Construction</b>	Exit stairs are not completely separated from other occupancy by fire rated assemblies. Fire door has not been installed in few locations. Installed fire doors were open by non-mechanical means <b>(without automatic-closing devices tied to the fire alarm system)</b> . <b>Location: Buiding-1,2 &amp; 3.</b>	Provide minimum 1-hr rated doors for buildings with 3 or fewer stories and 1.5-hr fire rated doors for buildings that are 4 or more stories. Seal all unprotected openings to separate the exit stairs from work areas and other building spaces on all floor levels. Ensure that the fire doors are self-closing and positive latching and that they are provided with fire exit (panic) hardware where serving production floors. If fire doors are required to be held open for functional reasons, provide automatic closing devices tied to the fire alarm system. Once fire doors are installed, every door in a stair enclosure serving more than 5 stories shall be provided with re-entry unless it meets. The rating of the exterior wall shall extend 3.05 m (10 ft.) beyond the ends of the stair structure.	<b>Within 3 months</b>

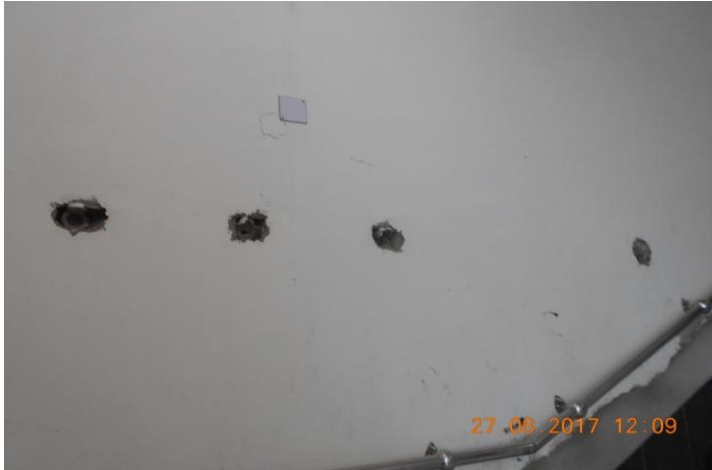
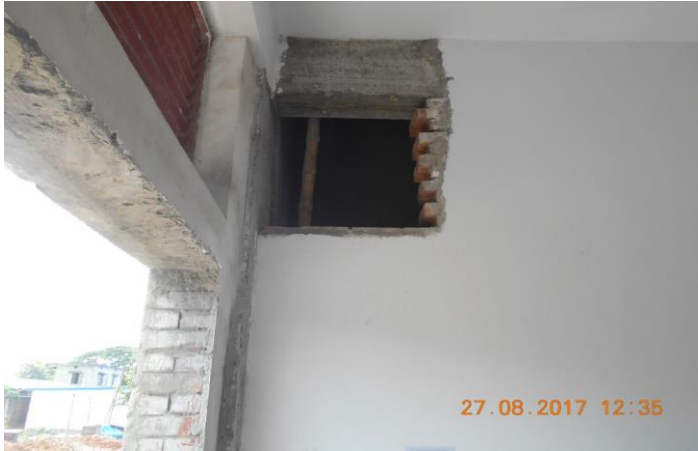
2	<b>Fire Rated Construction</b>	Unsealed penetrations and openings are located in exit stair enclosures.	Seal all penetrations and openings in the wall of exit enclosure walls (full thickness of the wall) by fire rated materials to maintain the fire resistance rating.	<b>Within 3 months</b>

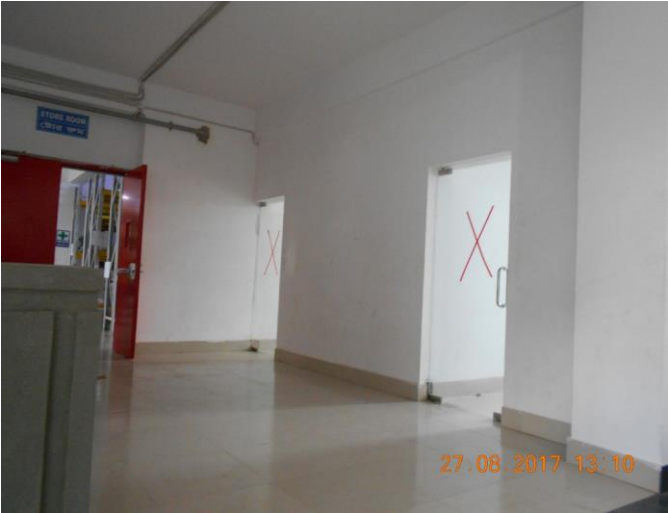
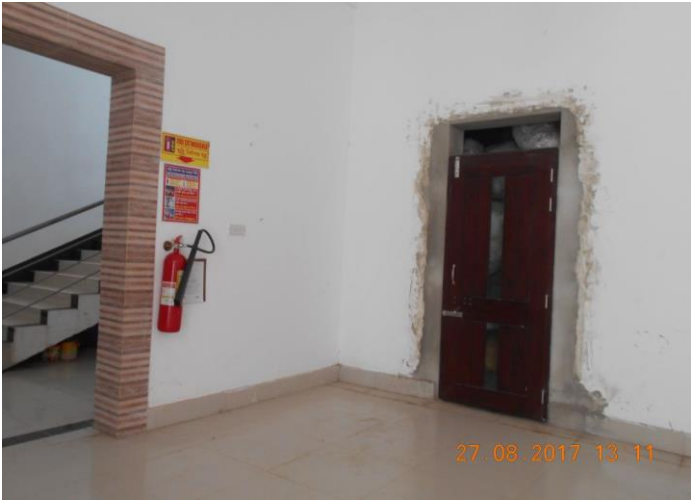
3	<b>Fire Rated Construction</b>	Rooms used for storage of combustible materials are not separated from the surrounding occupancy/areas. <b>Location: Building-2.</b>	Rooms used for storage of combustible materials shall be separated from the surrounding occupancy with a minimum 1 hour construction.	<b>Within 3 months</b>

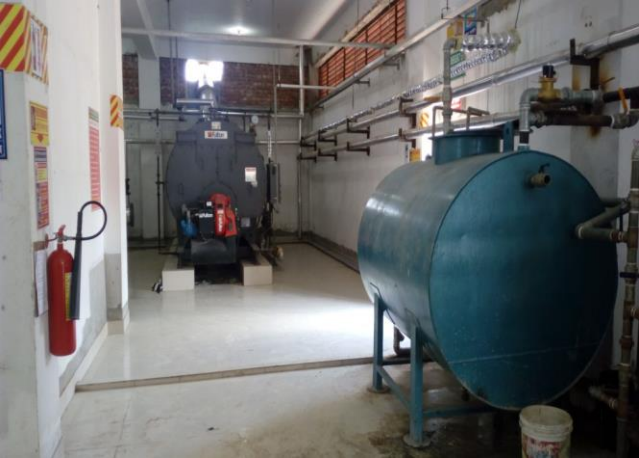
4	<b>Fire Rated Construction</b>	<p>Boiler, Generator, Compressor and Transformer room in the utility building are not separated by fire rated construction (openings, non-rated doors, penetrations) and from each other by fire rated construction.</p> <p><b>Location: Utility building (1st floor &amp; Ground floor).</b></p>	<p>All the utility room shall be separated from other occupancy and each other by a minimum 2-hr fire rated construction (wall, floor, slab etc.). Seal all penetrations and openings (door, window etc.) should be protected by 1.5-hr fire rated materials to maintain the fire separation if required. All exhaust systems shall discharge to the exterior of the building in a safe location.</p>	<b>Within 3 months</b>

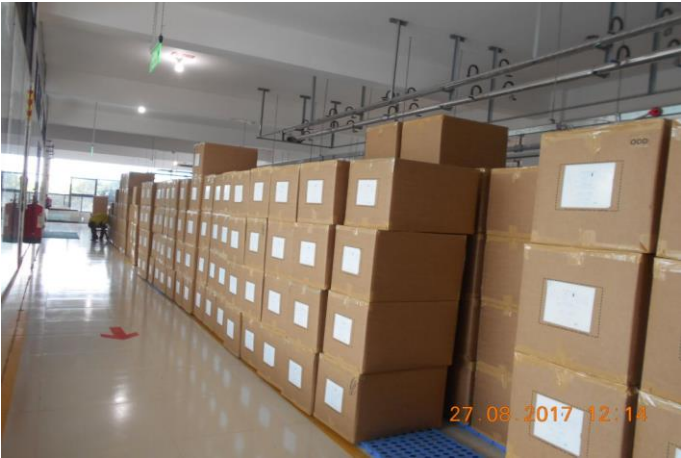
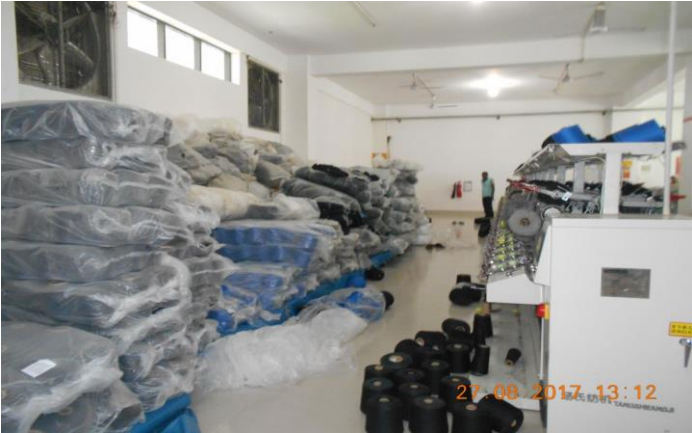
SI No.	Category	Findings	Required Action	Remediation Time Frame
7	<b>Fire Rated Construction</b>	Areas used for in-process storage of combustible materials are open to the surrounding occupancy.	<p>Provide dedicated storage rooms separated by minimum 1-hr fire-rated construction.</p> <p>Where separate storage rooms are not feasible, provide defined storage areas and limit the storage arrangement as follows:</p> <ul style="list-style-type: none"> <li>- Maximum height of 2.4m and maximum area of 23m<sup>2</sup></li> <li>- If sprinkler protected: maximum height of 3.66m and maximum area of 93m<sup>2</sup></li> </ul> <p>Separate areas of unenclosed combustible storage by a minimum clear distance of 3m.</p>	<b>Within 3 months</b>

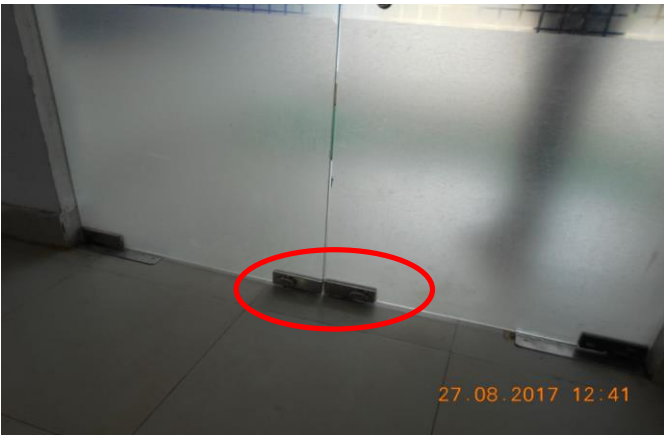
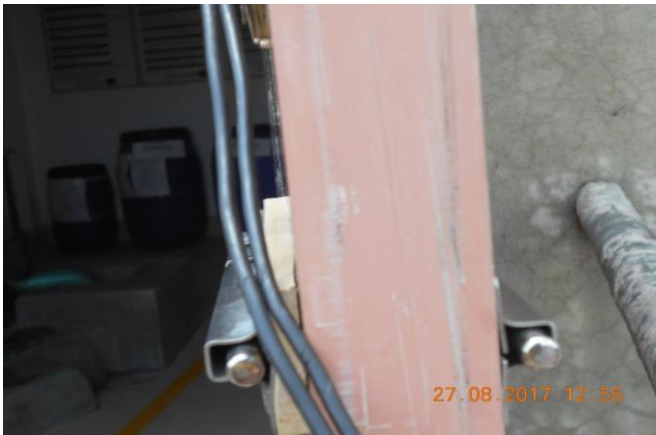
SI No.	Category	Findings	Required Action	Remediation Time Frame
9	Egress	Doors along means of egress are provided with non compliant locking system.	<ol style="list-style-type: none"> <li>1. Remove all non compliant locking features from egress doors.</li> <li>2. If locks are required for security reasons, utilize special door locking features complying with NFPA 101.</li> <li>3. Doors may be locked where the latch and lock are disengaged with one motion where the occupant load does not exceed 49 persons.</li> <li>4. Doors may be provided with locking hardware from the ingress side provided that a panic bar is installed on any door with an occupant load exceeding 49 persons.</li> </ol>	Immediate

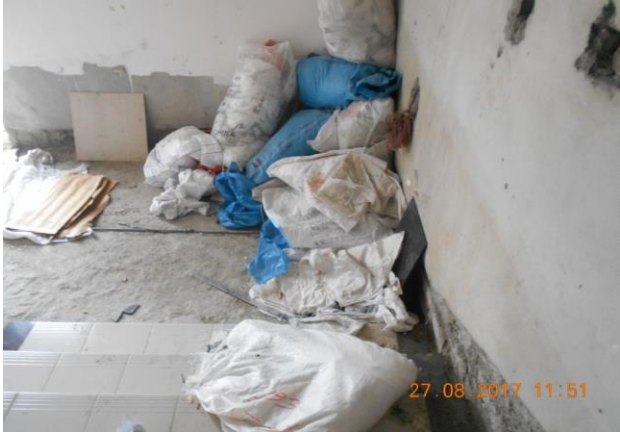
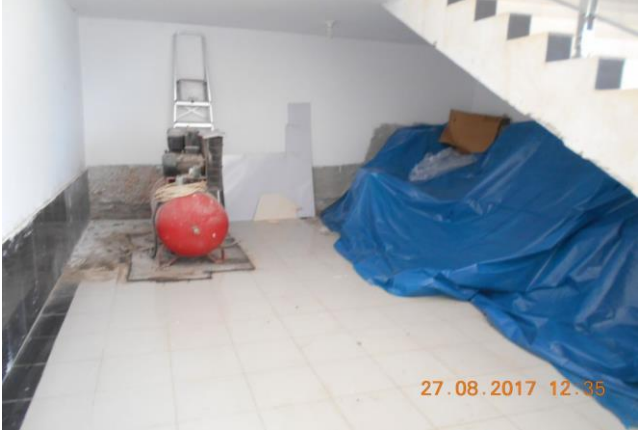
SI No.	Category	Findings	Required Action	Remediation Time Frame
10	Egress	Storage was located in the exit stair.	Remove all storage from exit stairs.	Immediate

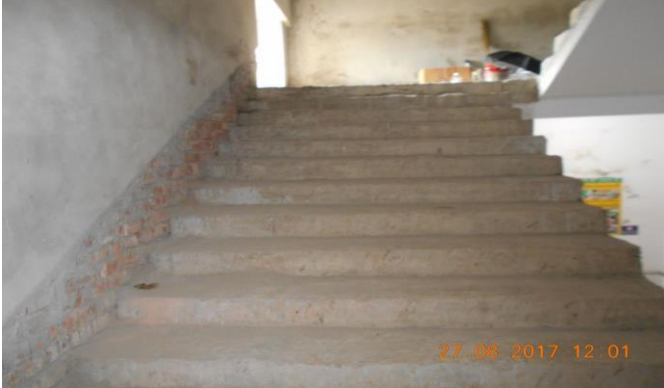
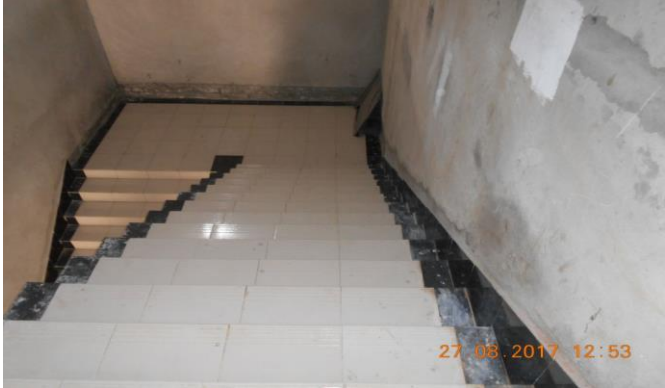
SI No.	Category	Findings	Required Action	Remediation Time Frame
11	Egress	Handrails are not provided in the exit stair. <b>Location: All the buildings.</b>	Provide handrails on both sides of the exit stair. New handrails shall have a minimum height of 865 mm (34 in.) and a maximum height of 965 mm (38 in.) as measured from the leading edge of the tread. Intermediate handrails shall be provided when the stair width exceeds 2.2 m (87 in.).	<b>Within 3 months</b>

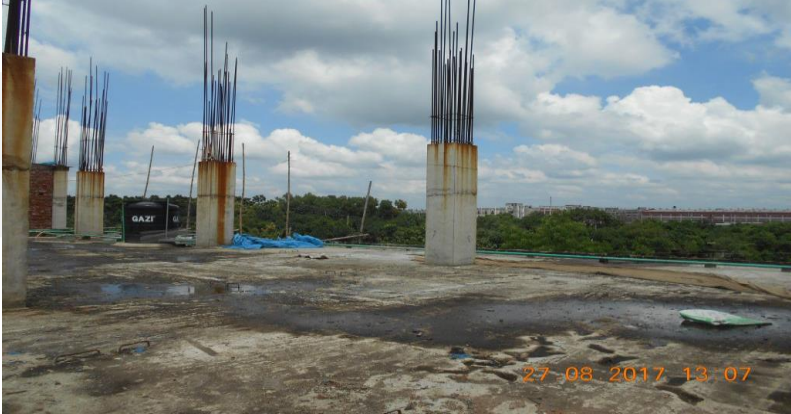
SI No.	Category	Findings	Required Action	Remediation Time Frame
12	Egress	Parapets or guards are not provide in Occupiable roof.	Provide parapets or guards with a minimum height of 1067mm (42 in.).	Within 3 months

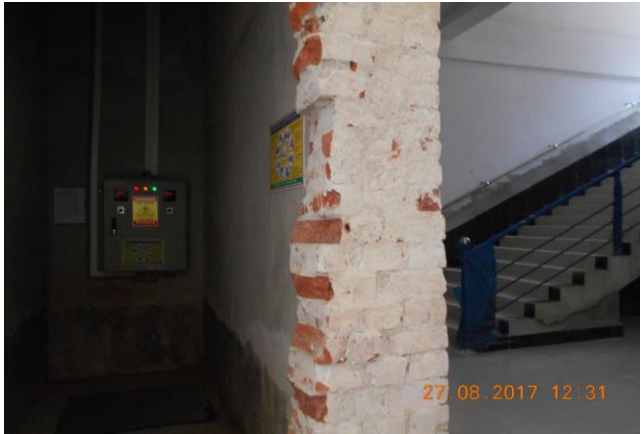
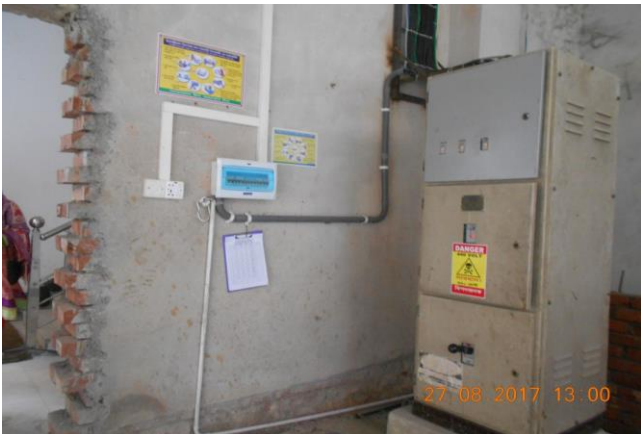
SI No.	Category	Findings	Required Action	Remediation Time Frame
13	Egress	Electrical panel (DB) was located in exit stair.	Remove all electrical panel or board from exit s	Within 1 month

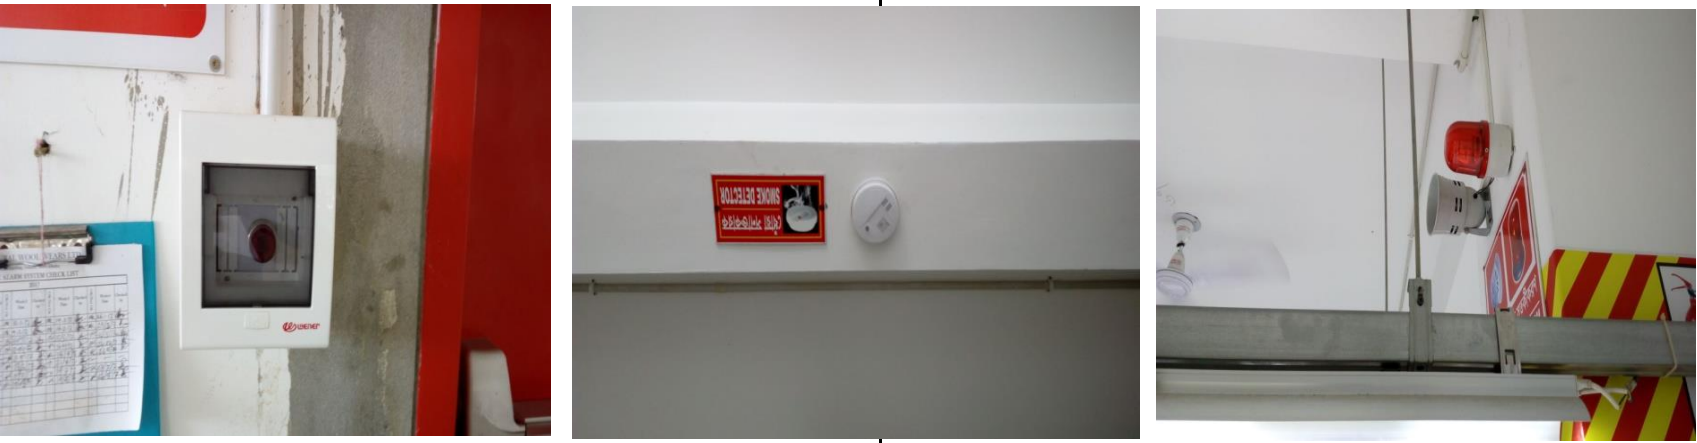
SI No.	Category	Findings	Required Action	Remediation Time Frame
14	<b>Fire Detection and Alarm System</b>	The fire detection system is antiquated, not a listed system, and does not provide alarm and notification features consistent with acceptable standards.	Replace the fire detection system with a new, listed addressable fire detection system in accordance with NFPA 72.	<b>Design within 4 months, Install within 9 months</b>

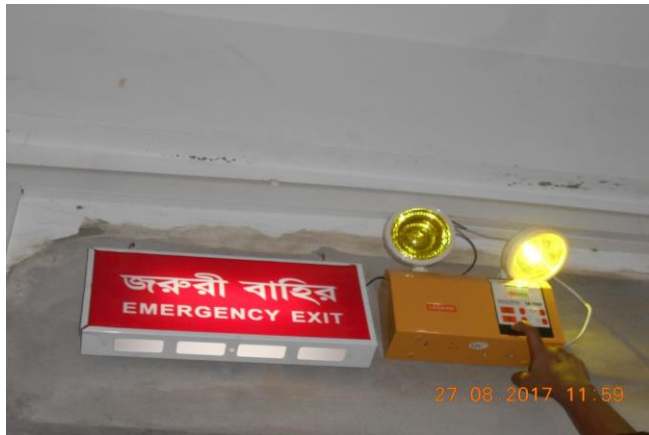
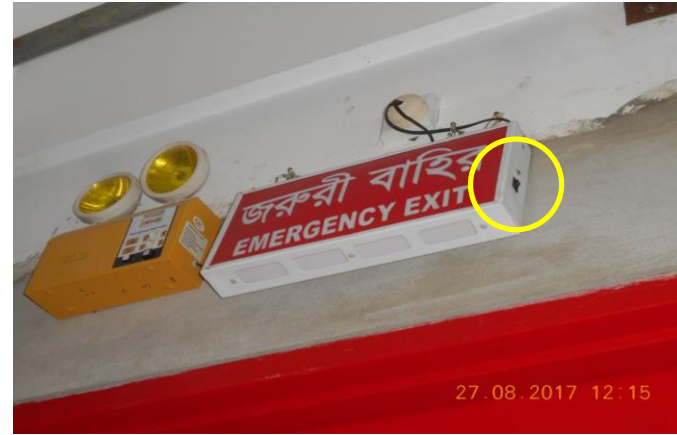
SI No.	Category	Findings	Required Action	Remediation Time Frame
17	Egress Lighting	Manual on-off switch is provided for [emergency lighting / exit signage] units.	Remove manual on/off switches from emergency lighting / exit signage units to prevent them from being switched off.	Within 3 months
