# Softex Sweaters (9329)

DEPZ (Extension area), Ganakbari, Savar.

04.06.2014

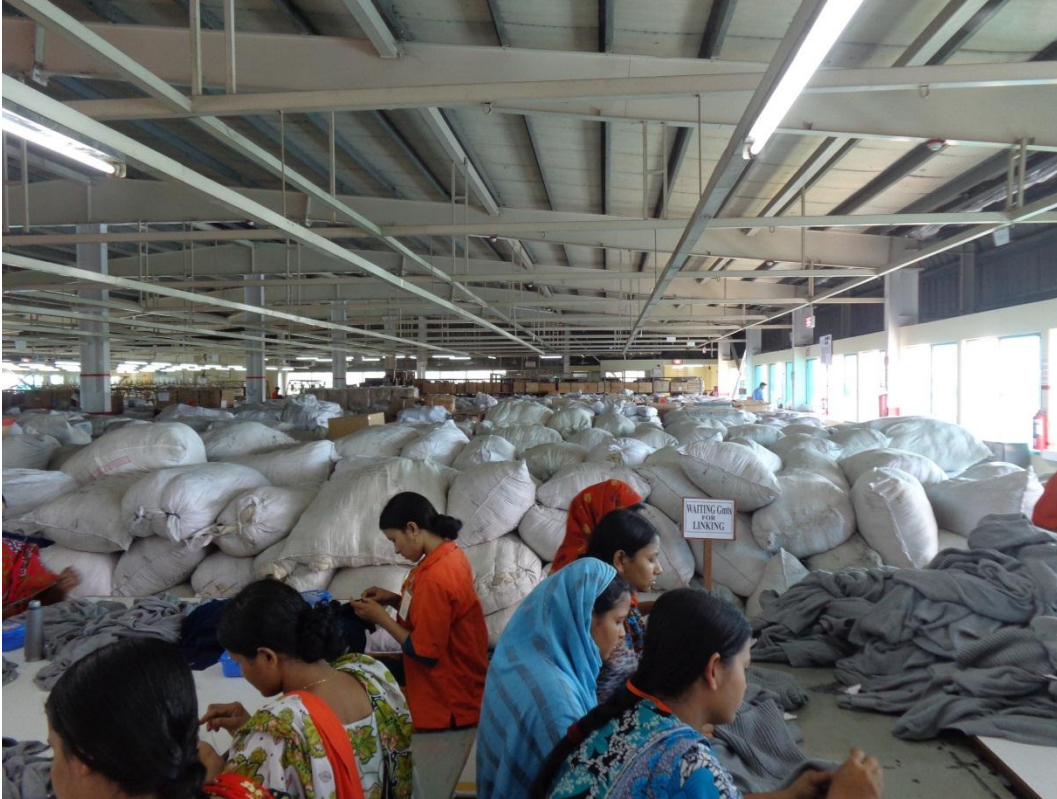
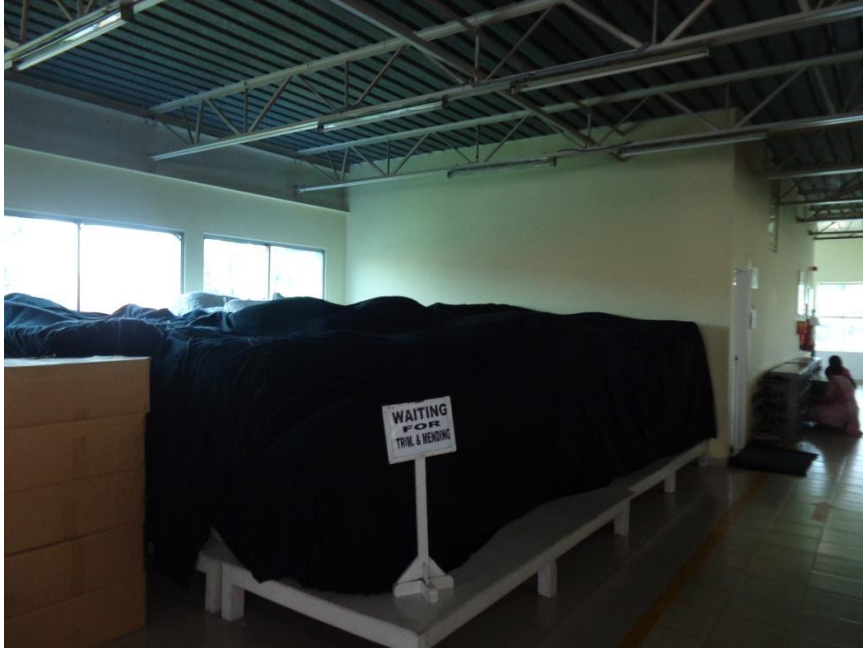
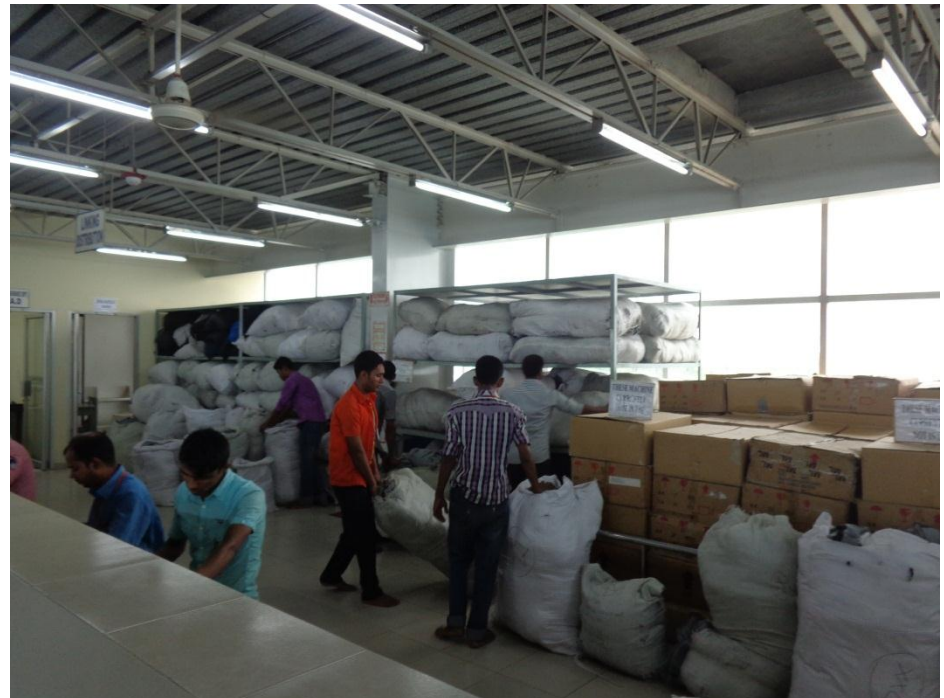
In 2<sup>nd</sup> floor of main building we observed uncontrolled loading. Sacks of fabrics and finished cartons were piled up on this floor. We also saw fabrics waiting for further processing kept in some localised area and also on storage rack. We calculated loading for this floor as 3kpa. No loading plan was made available for us.

Under minimum allowable live loading, steel column load run-downs yield lower than desirable safety factors.

| Item No. | Observation | Recommended Action Plan | Recommended Timeline |
|---|---|---|---|
| 1 | Priority 1 - Heavy loading on the building. Based upon minimum allowable live loads the column load run-down indicates low safety factors (1.25 to 1.5) | Remove excess loading above 3 kpa from all floor<br>Factory engineer to review design, loads and column stresses | Immediate – Now |
| 2 | Priority 1 - Heavy loading on the building. Based upon minimum allowable live loads the column load run-down indicates low safety factors (1.25 to 1.5) | Conduct a detailed engineering assessment | 6-weeks |
| 3 | Priority 1 - Heavy loading on the building. Based upon minimum allowable live loads the column load run-down indicates low safety factors (1.25 to 1.5) | Carry out any recommendations put forth by the detailed engineering assessment | 6-months |

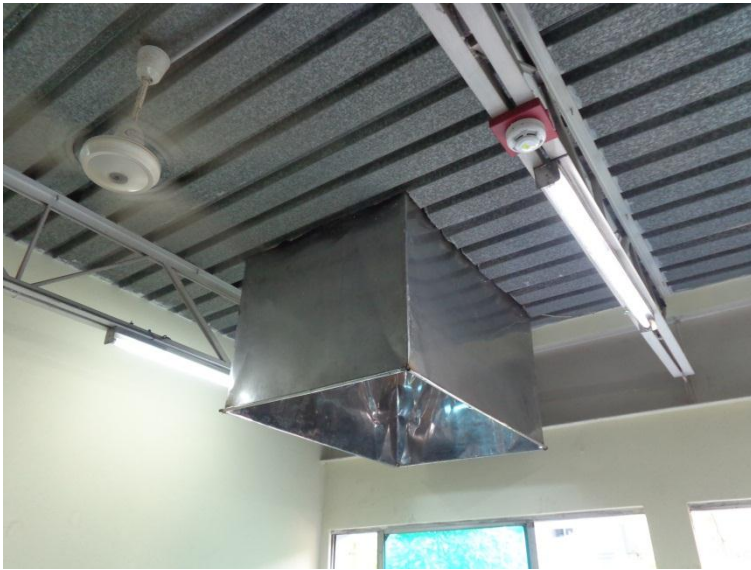
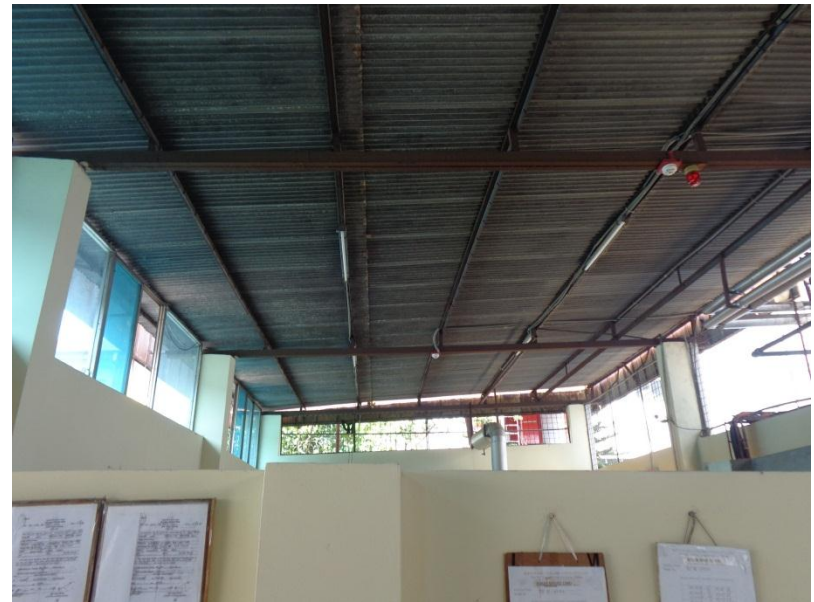
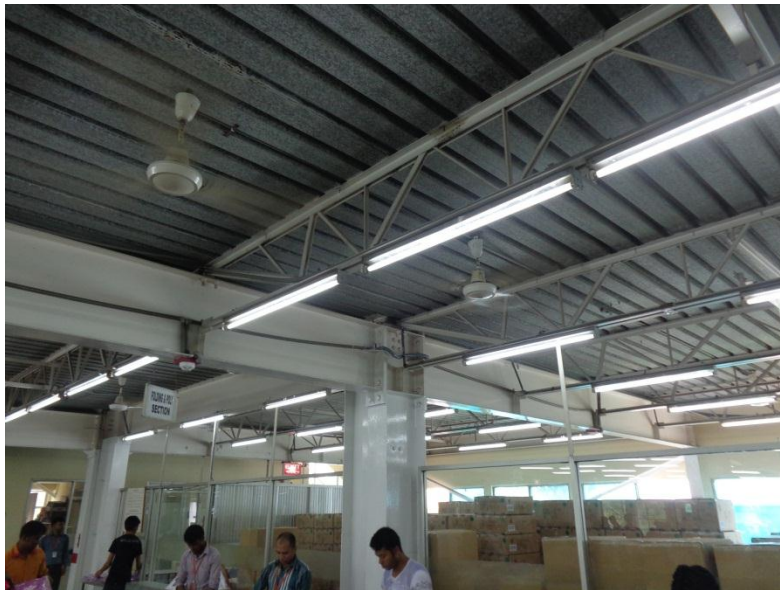
No fireproofing material was noted on structural steel elements of main building and utility building as suggested by BNBC 2006.

| Item No. | Observation | Recommended Action Plan | Recommended Timeline |
|---|---|---|---|
| 4 | Priority 2 - No fireproofing material used on steel member | Fireproofing material for structural steel element is recommended as suggested in BNBC Codes. | 6-weeks |
| 5 | Priority 2 - No fireproofing material used on steel member | Maintain standard of quality control and protection of the fire protection. | 6-months |

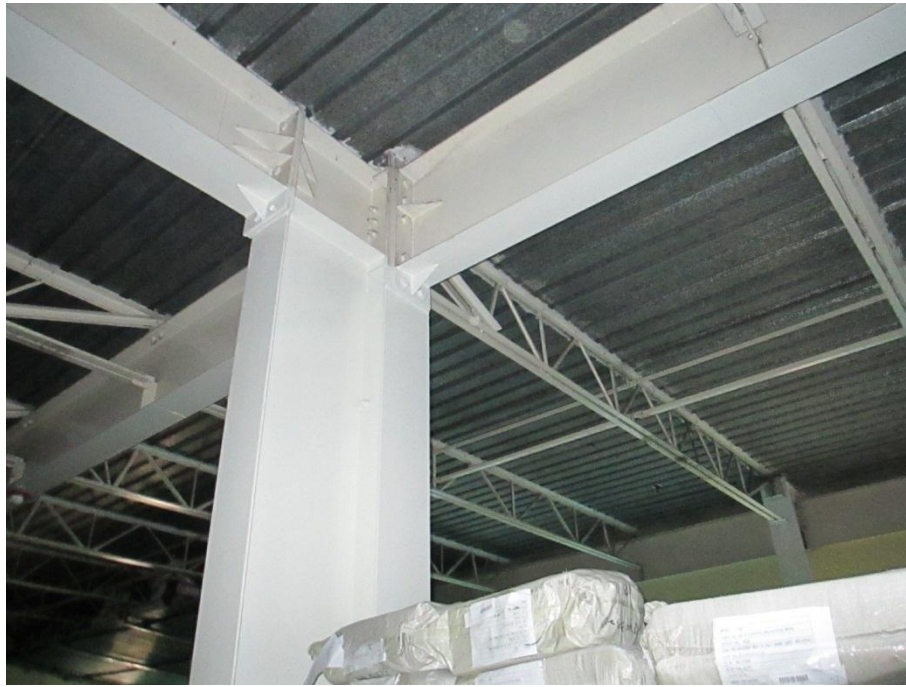
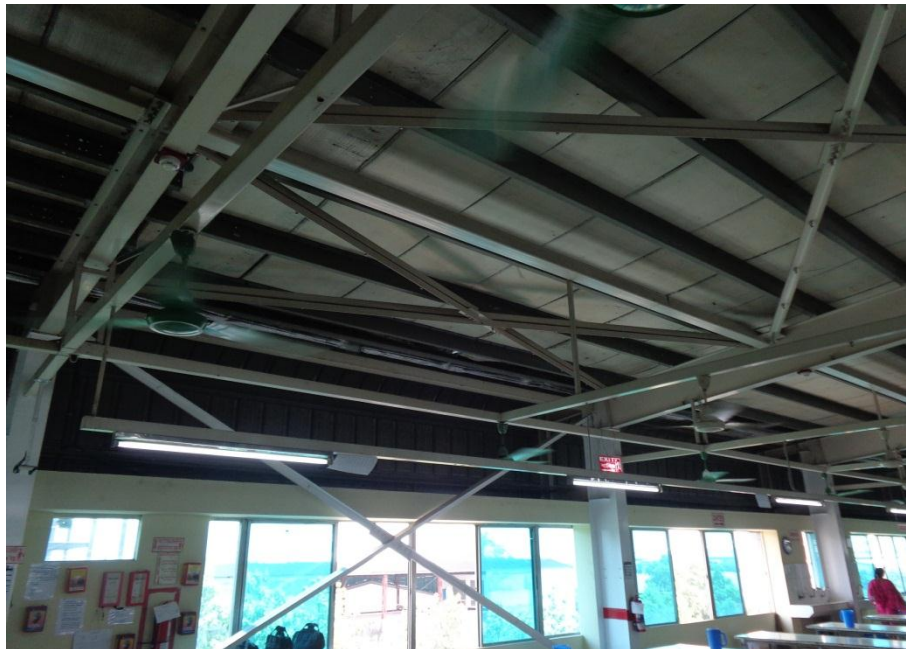
The factory is made of steel frame with lateral bracing. We were provided details calculation of steel structure which shows stability is well achieved by the lateral and vertical bracing.
