# Basic Shirt Ltd. (9909)

Basic Tower, Harvaid, Mazu Khan, Pashim para, mosjid, Gazipur sadar, Gazipur.

24.06.2014

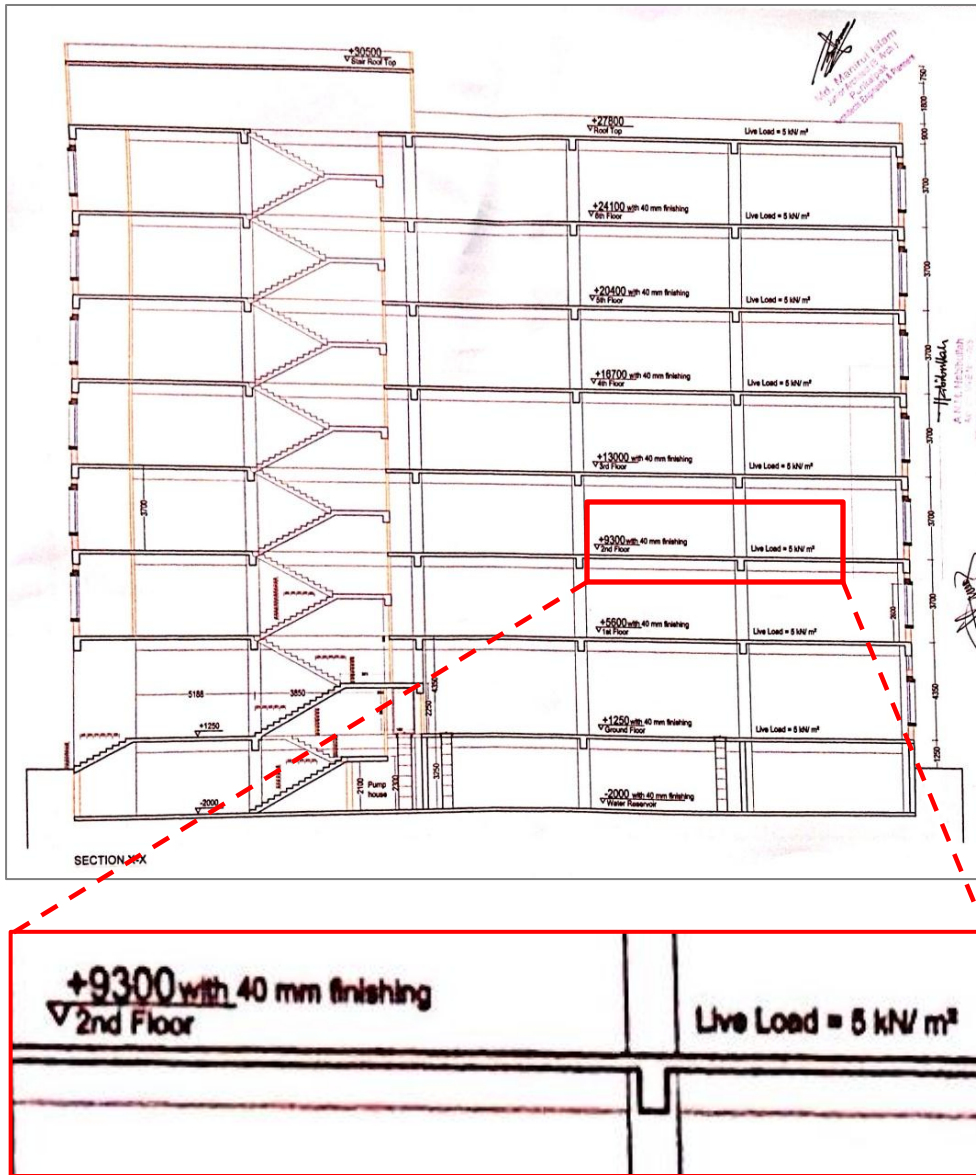
The loading document for the factory building shows that all the floors can withstand a live load of 5KN/m<sup>2</sup>, but our analysis shows that the columns gets overstressed to AMBER if 5.00kN/m<sup>2</sup> load is applied on all the floors. On the other hand the columns retain a YELLOW rating if a live load of 2.00kN/m<sup>2</sup> is applied.

We haven't seen any signs of distress in the columns because most of the floors are not occupied yet.

| Item No. | Observation | Recommended Action Plan | Recommended Timeline |
|---|---|---|---|
| 1 | Priority 2 - Factory Buildings Loading plan has to be revised. | Carry out an Engineering Assessment to verify all the actual load bearing capacity for the slabs, beams and the columns. | 6-weeks |
| 2 | Priority 2 - Factory Buildings Loading plan has to be revised. | Develop and maintain a proper loading plan. | 6-months |

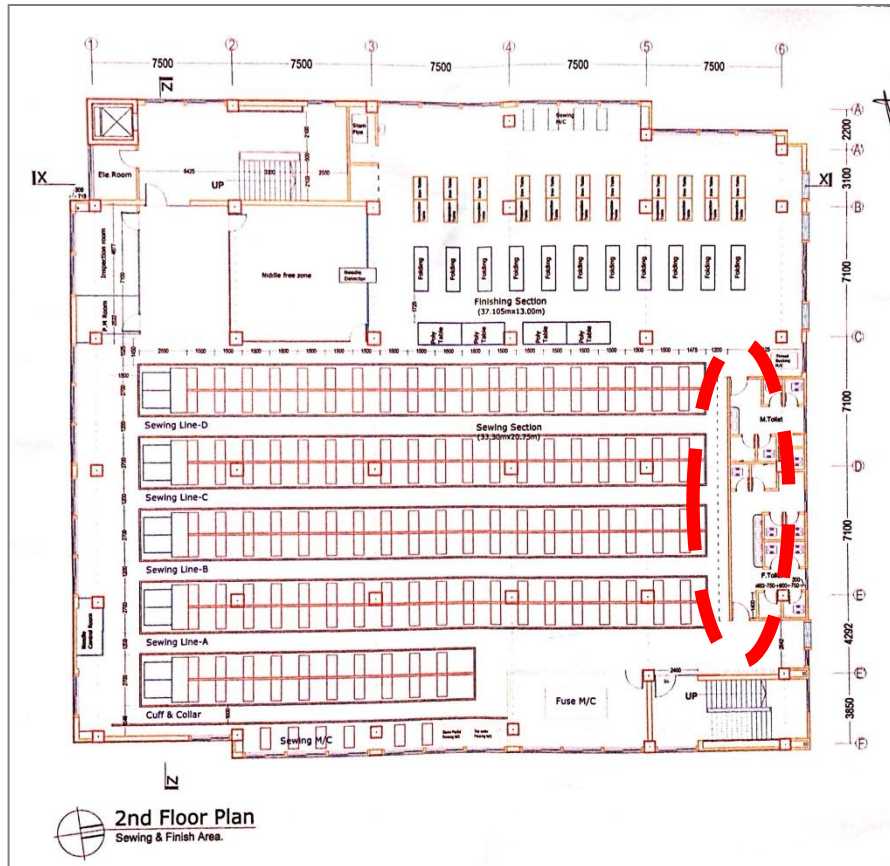
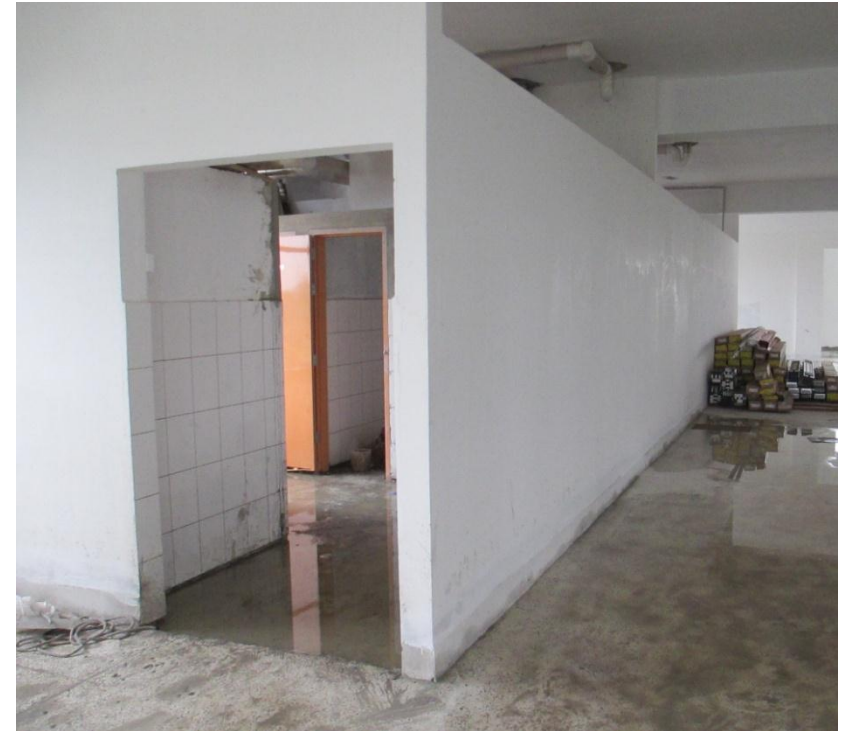
The Toilet block of the Factory building is has 5" thick brick partition walls that are not over the beams.

| Item No. | Observation | Recommended Action Plan | Recommended Timeline |
|---|---|---|---|
| 3 | Priority 2 - Factory Building toilet block contains brick partition walls that are not over the beams and the toilets have increased floor finish. | Carry out a Detailed Engineering Assessment to verify all the structural system of the partition walls and the increased floor finishes.<br>No loads such as fabric or equipment should be placed in the area 3 meters around the toilets until the DEA is completed. | 6-weeks |
| 4 | Priority 2 - Factory Building toilet block contains brick partition walls that are not over the beams and the toilets have increased floor finish. | Carry out any strengthening works recommended in the DEA. | 6-months |

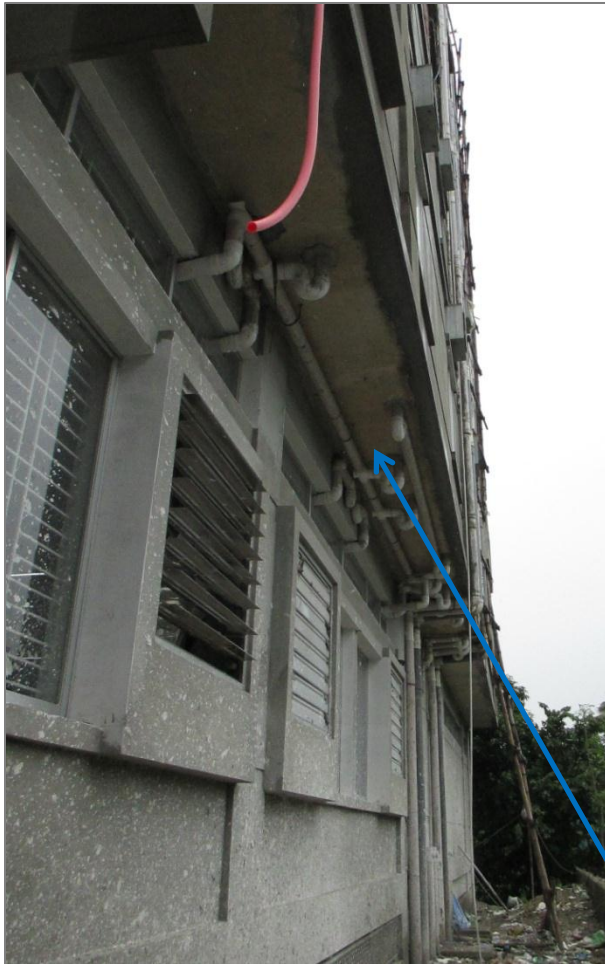
400mm floor finish

The toilet has a floor finish of about 16" which could apply a local dead load of approximately 10 kN/m<sup>2</sup>. Moreover the toilets partially sit on a cantilever slab. These loads in addition to live load of 2kN/m<sup>2</sup> could overstress the structure.

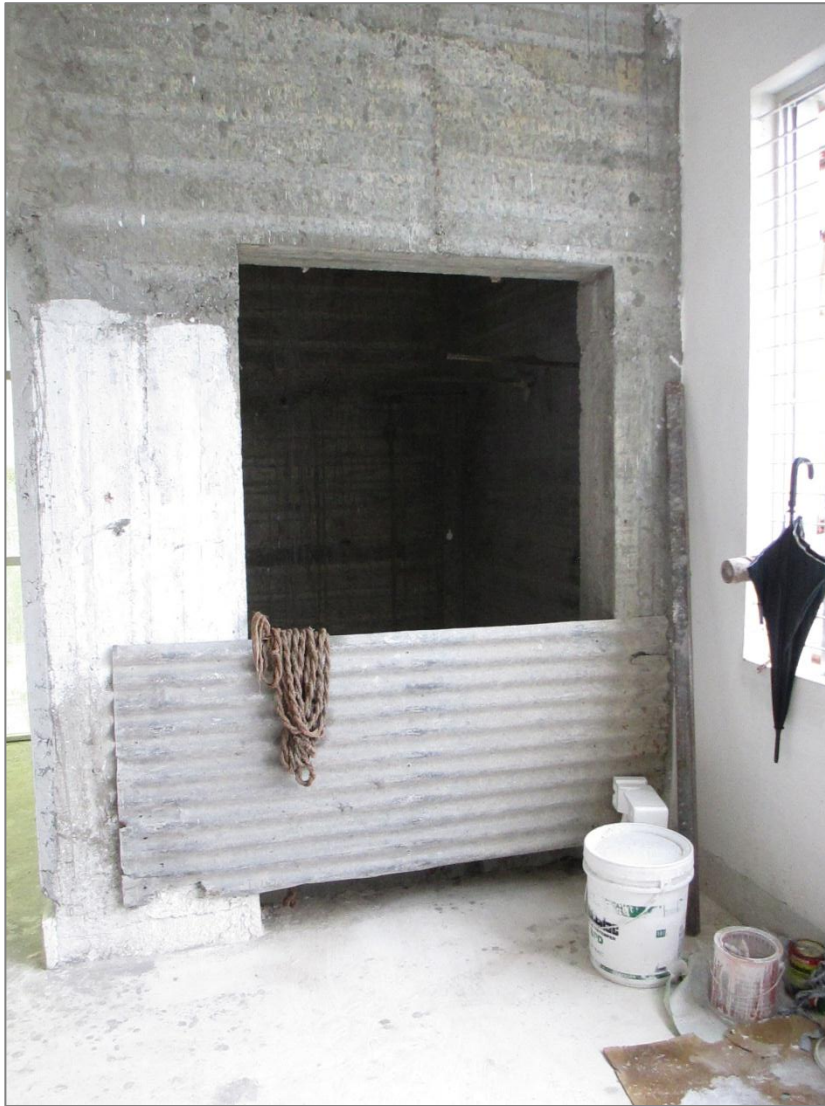
The opening of the lift core is not properly secured in all the floors. Any unsuspecting worker could tip over the unsecured closures and fall down.

| Item No. | Observation | Recommended Action Plan | Recommended Timeline |
|---|---|---|---|
| 5 | Priority 3 - Factory Building - Guard rail at the elevator shaft is not secure. | Secure the openings with a guard rail or wall meeting BNBC requirements. Close them down properly until the lift is installed.<br>Put caution signs in front of the openings. | 6-weeks |

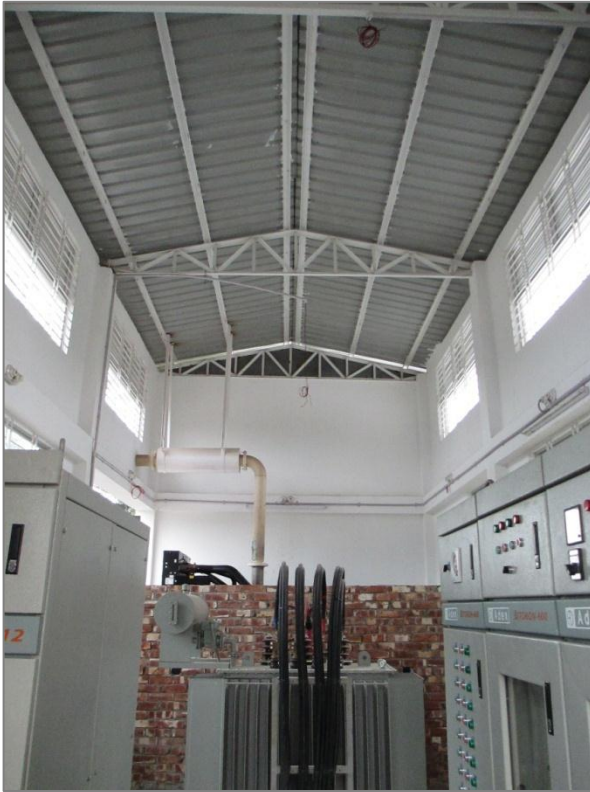
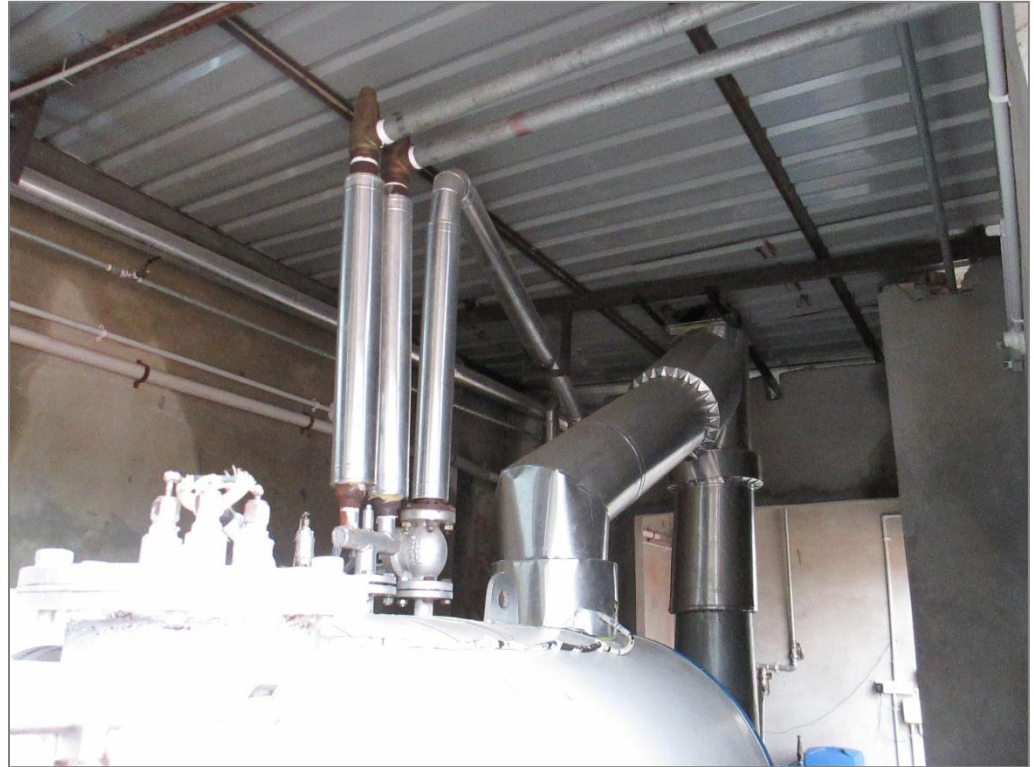
The structural steel roof of the generator and Boiler shed may not be properly tied down to resist uplift wind force and lateral loads. In case of the Boiler shed the connection between the steel roof and the RCC columns looks improvised and needs to be checked.

| Item No. | Observation | Recommended Action Plan | Recommended Timeline |
|---|---|---|---|
| 6 | Priority 3 - Generator, Sub-station, Compressor and Boiler Sheds Structural steel roof has to be checked. | Carry out an Engineering Assessment to verify all the structural system of these sheds.<br>Develop proper structural steel documents. The factory engineer must check the steel roofs against uplift wind pressure. | 6-weeks |
| 7 | Priority 3 - Generator, Sub-station, Compressor and Boiler Sheds Structural steel roof has to be checked. | Carry out any repair works if necessary suggested by the factory engineer. | 6-months |

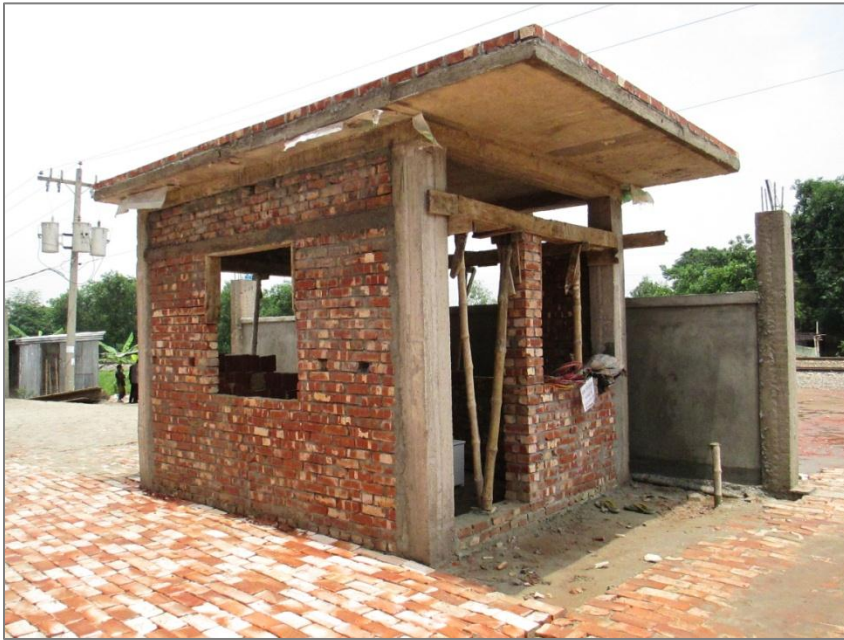
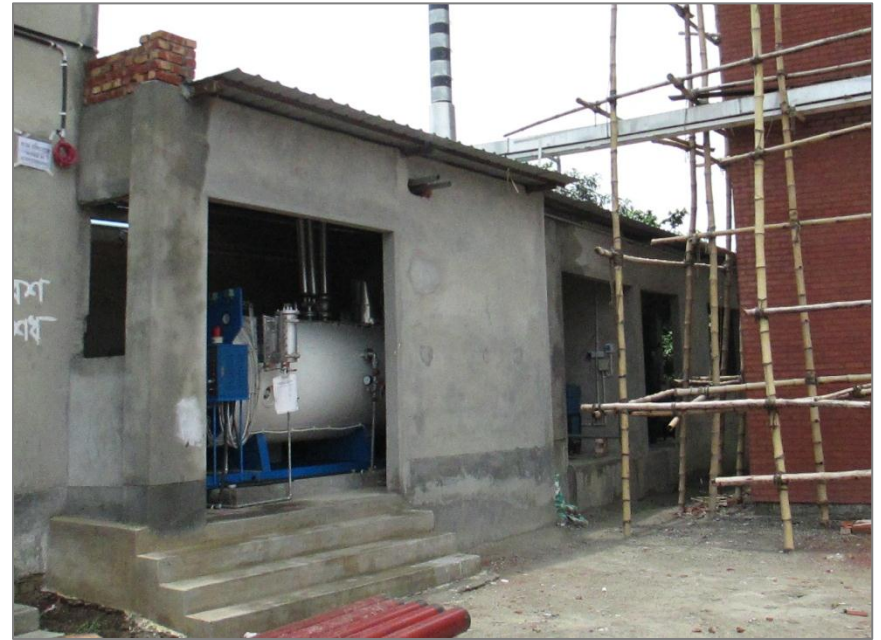
As previously mentioned, no structural documents were provided for the security and the Compressor, Boiler shed.

| Item No. | Observation | Recommended Action Plan | Recommended Timeline |
|---|---|---|---|
| 8 | Priority 3 - Compressor, Boiler and Security Sheds - No documentations were provided. | Develop proper structural documents for the Compressor, Boiler shed and the Security shed. These documents have to be validated by an engineering assessment. | 6-weeks |
| 9 | Priority 3 - Compressor, Boiler and Security Sheds - No documentations were provided. | Carry out any repair works if necessary suggested by the factory engineer.<br>Edit the master plan of the whole premises and put Compressor, Boiler shed and the Security sheds location on it. | 6-months |

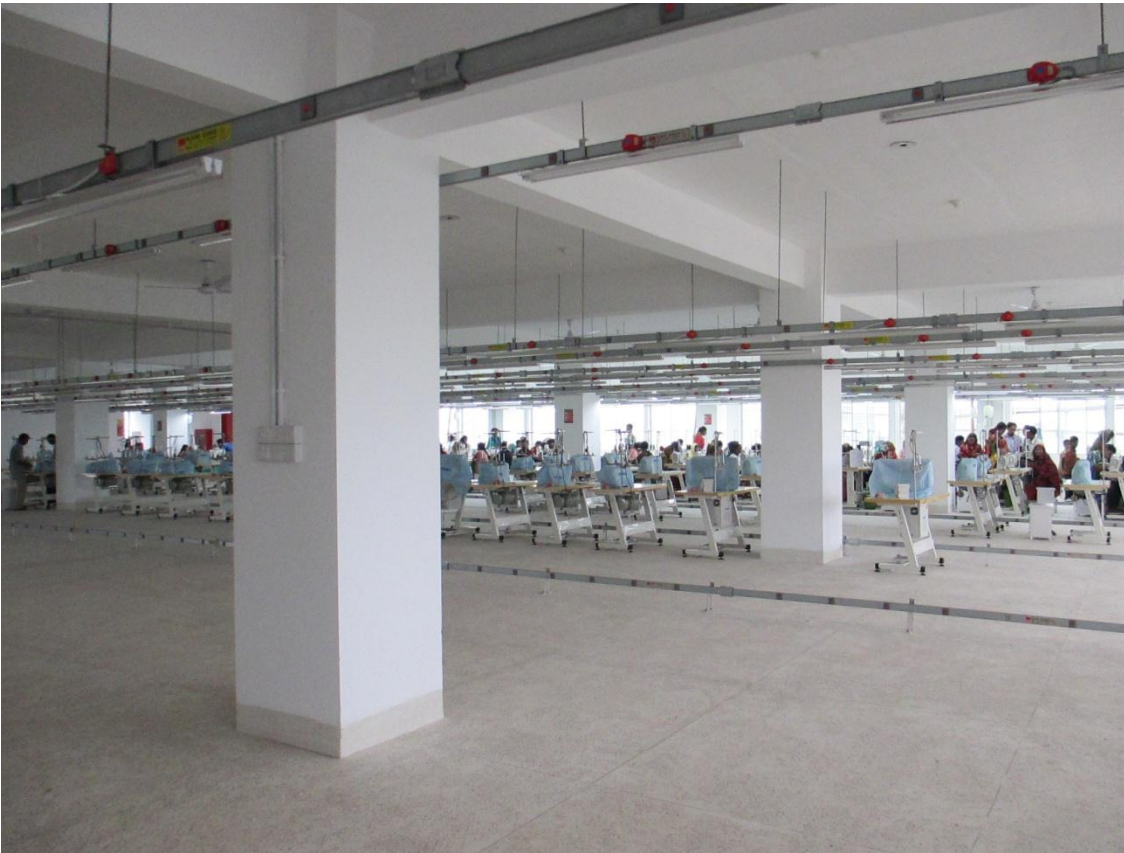
**Building Extents – Overall Lateral Stability System**

Sway stability of the Factory Building could be expected from rigid frame system (beam and column participation) although no ductile detailing is provided in structural plans. Brick infill is unrestrained and should not be considered.

We require that the lateral support system is investigated as part of a Engineering Assessment.

| Item No. | Observation | Recommended Action Plan | Recommended Timeline |
|---|---|---|---|
| 10 | Priority 3 - Overall stability system | Carry out a Detailed Engineering Assessment of the building to verify that it is stable under lateral loading as per BNBC. | 6-weeks |
| 11 | Priority 3 - Overall stability system | Carry out recommendations of engineering assessment. | 6-months |

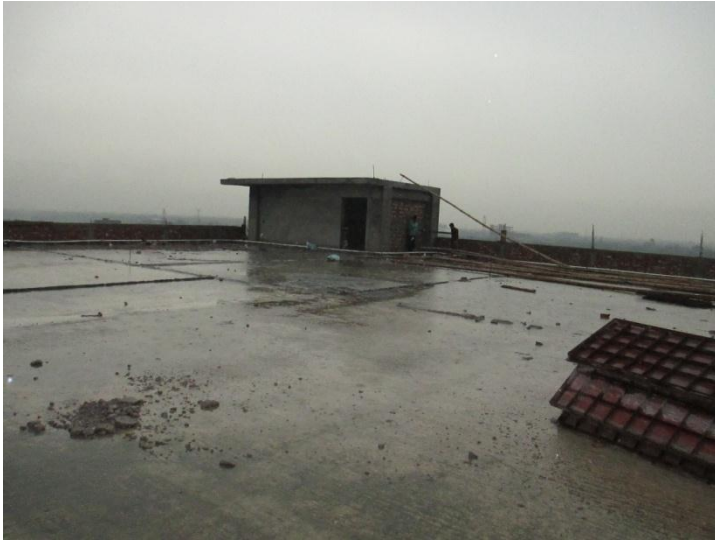
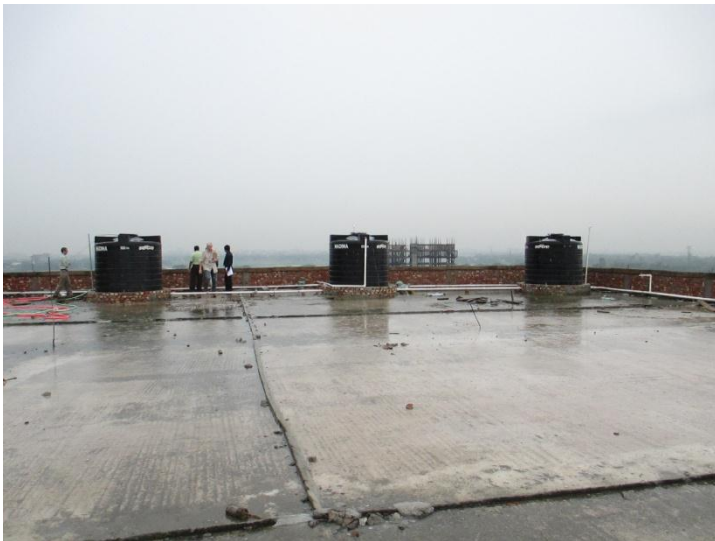
## Roof Waterproofing System at Factory Building

No waterproofing membrane was visible on the roof of the building. The construction works of the roof is not finished yet.

It is our recommendation that they put waterproofing membrane otherwise any cracks in the surface finishes on the roof will allow water to seep into the concrete slab beneath the finishes, and cause long-term deterioration of the slab.
