Denim Attires Ltd. (11366)

Nimtoly, Shilmon, Tongi, Gazipur.

28.06.2014

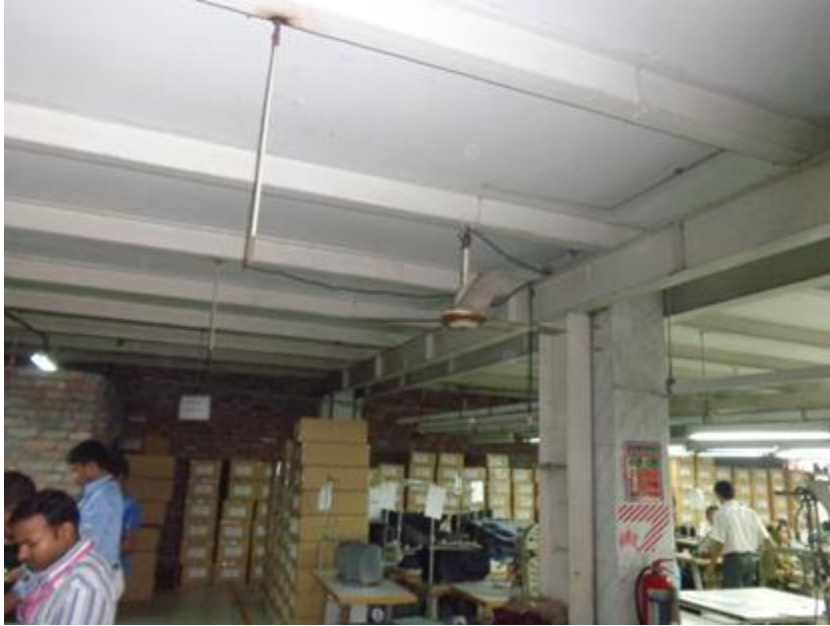
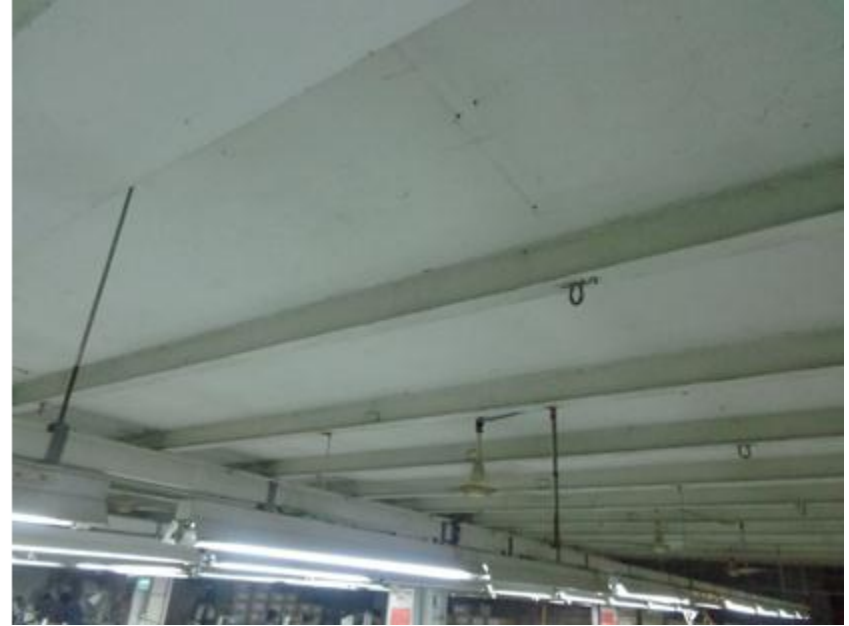
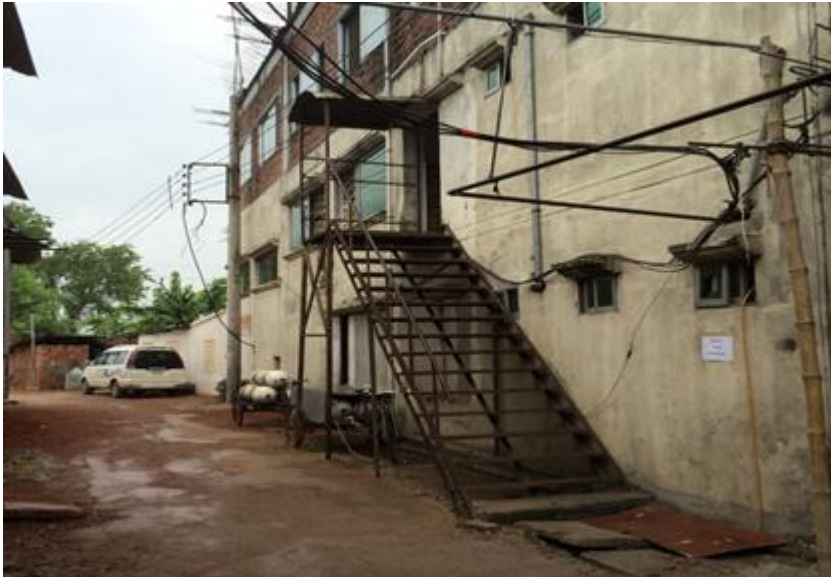
1st Priority 2 Concern

Structural details of steel structures (mezzanine, stairs, shed roofs) were not provided on any documents.

ITEM 1: (1st Priority 2) No structural documentation for any steel structure.

Item No.	Observation	Recommended Action Plan	Recommended Timeline
1	1st Priority 2 - No structural documentation for any steel structure.	Factory Engineer to update or produce as-built drawings for all the buildings in the factory.	6-weeks
2	2nd Priority 2 - Exterior steel staircase is poorly designed.	Carry out an Engineering Assessment on the steel staircase to verify that it is adequately design for its purposes.	6-weeks
3	2nd Priority 2 - Exterior steel staircase is poorly designed.	Carry out recommendations of the Engineering Assessment.	6-months
4	3rd Priority 2 - No fireproofing on mezzanine floor steel structure.	Fireproofing material for structural steel element is recommended as suggested in BNBC Codes.	6-weeks
5	3rd Priority 2 - No fireproofing on mezzanine floor steel structure.	Maintain standard of quality control and protection of the fire protection.	6-months
6	Priority 3 - Highly stressed columns for the proposed 6-storey construction.	Carry out Engineering Assessment on the building to verify if the columns are adequately designed for a 6-storey building. In-situ concrete testing may be required.	6-months

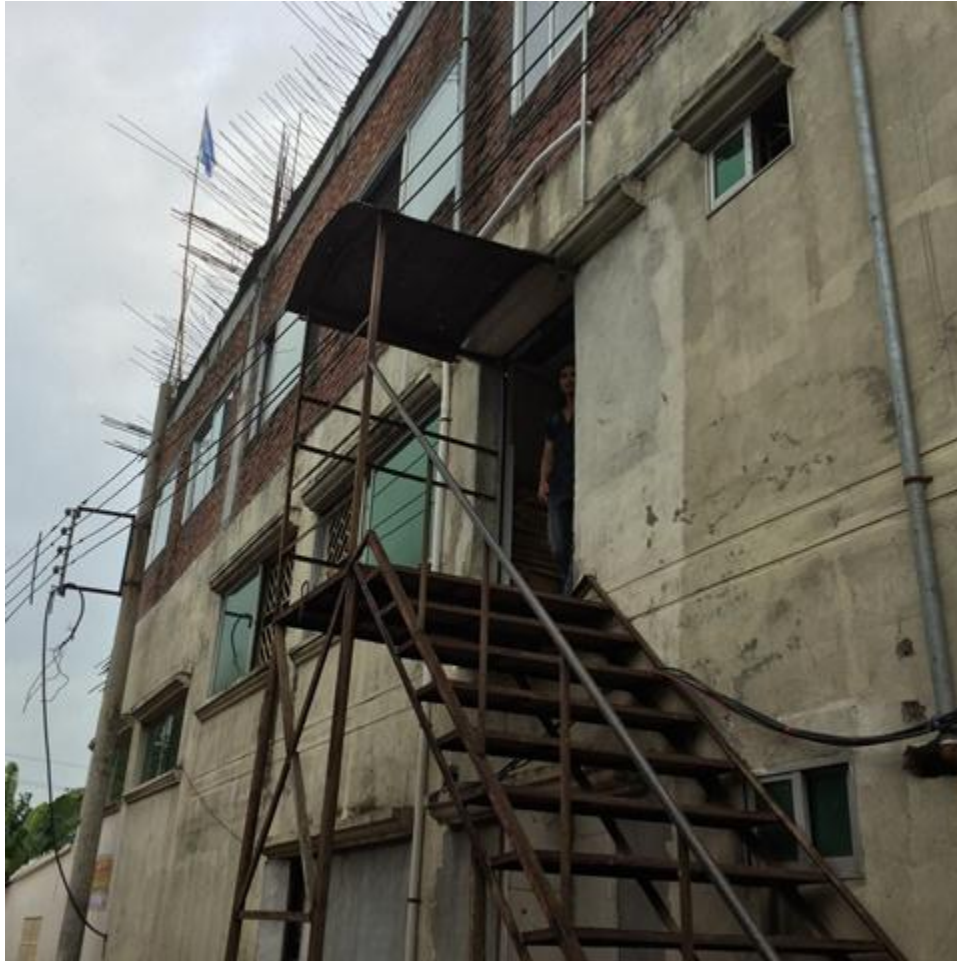
2nd Priority 2 Concern

Exterior steel staircase of the main building is poorly designed.

ITEM 2: (2nd Priority 2) Exterior steel staircase is poorly designed.

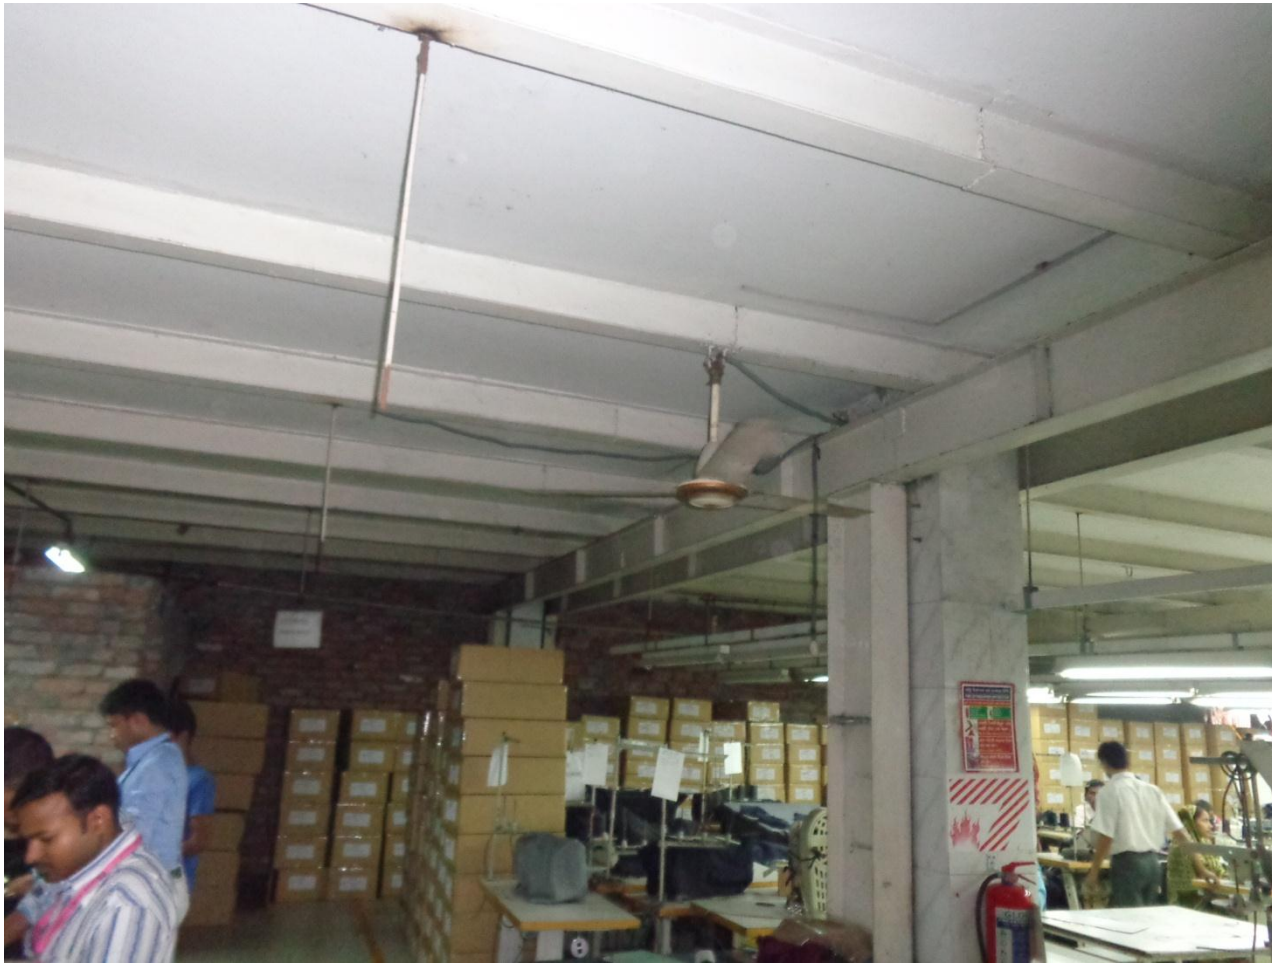
3rd Priority 2 Concern

No fireproofing material was noted on any structural steel elements supporting the mezzanine floor as suggested by BNBC 2006.

ITEM 3: (3rd Priority 2) No fireproofing on mezzanine floor steel structure.

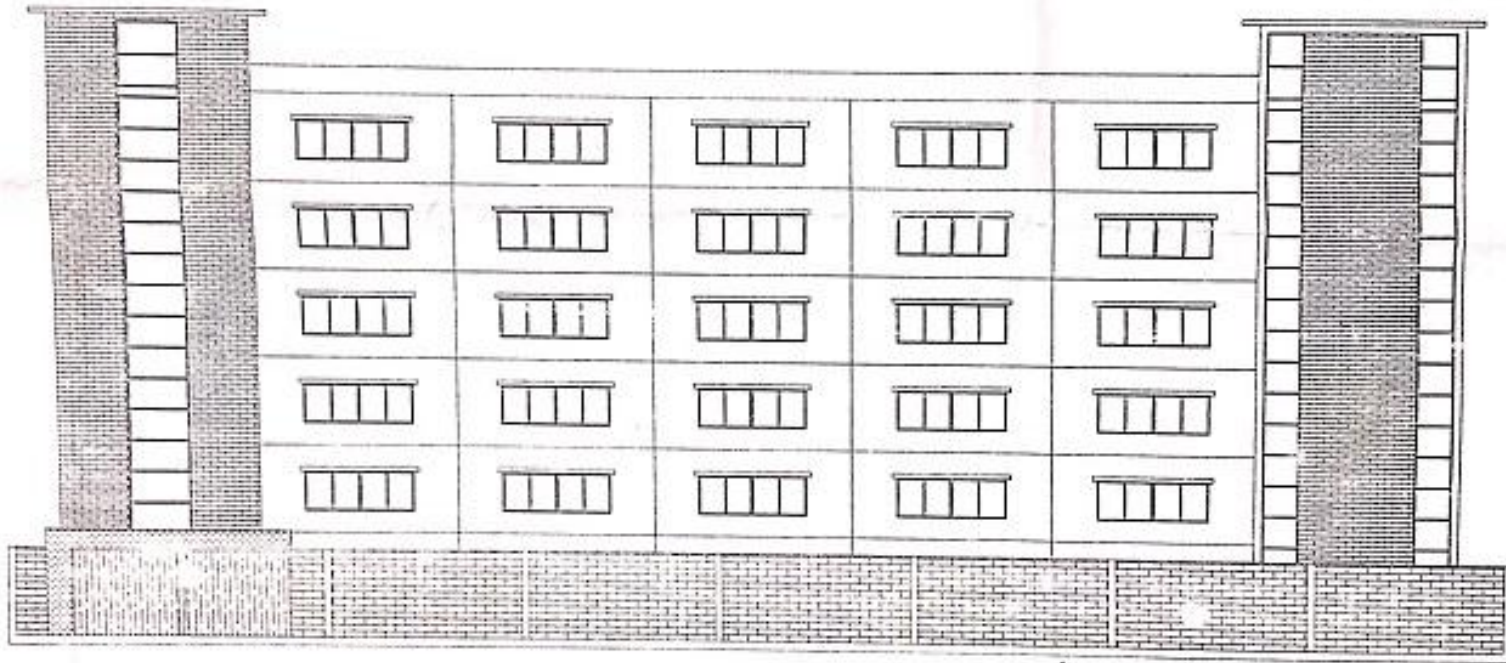
SOUTH SIDE ELEVATION
SCALE: 1:150

Highly stressed columns for the proposed 6-storey.

If construction is extended to 6 storeys as permitted, the columns will be somewhat overstressed to a YELLOW rating.

ITEM 4: (Priority 3) Highly stressed columns for the proposed 6-storey construction.

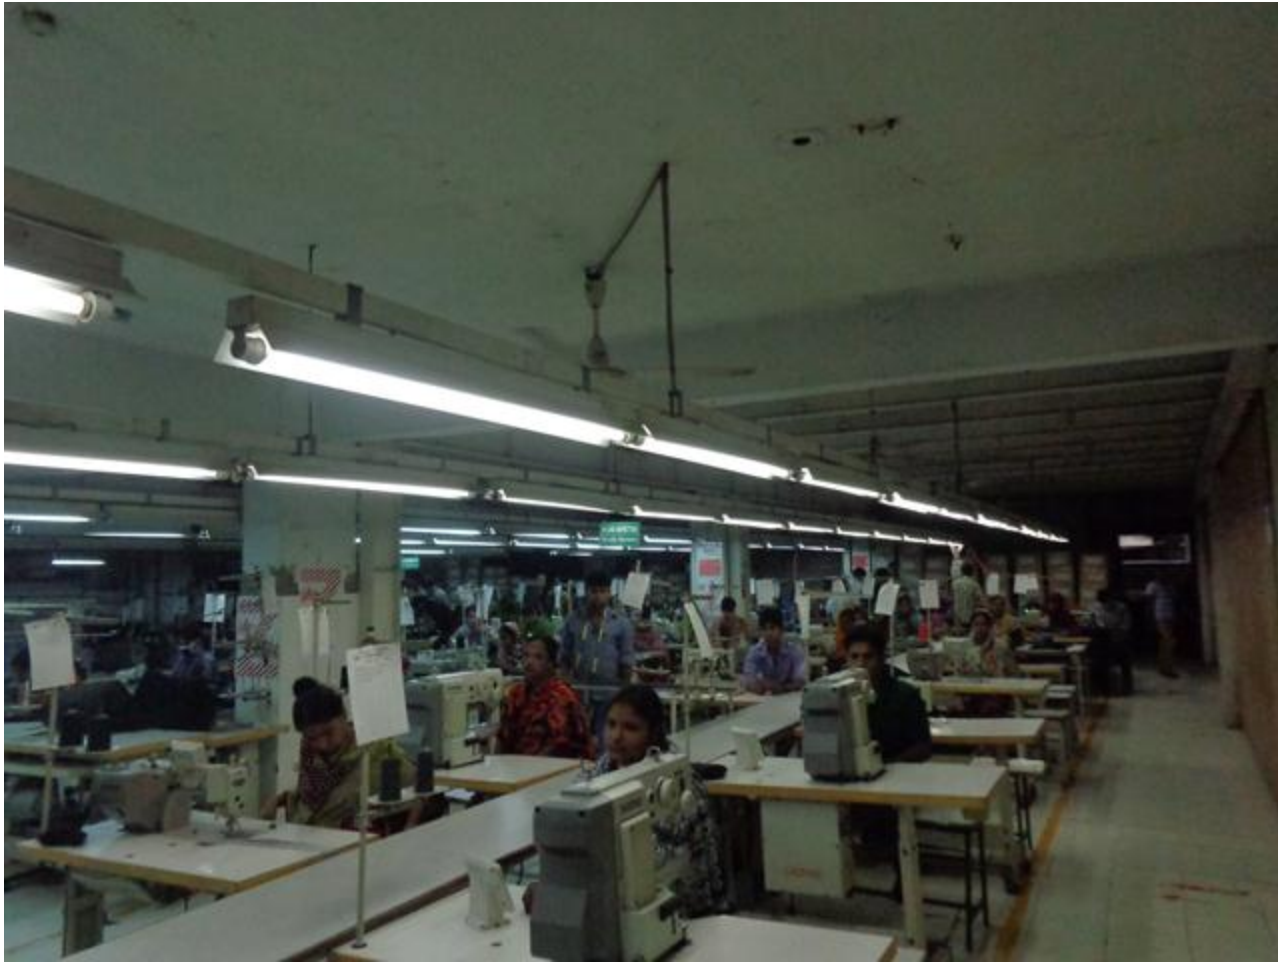
Overall Stability System

The building did not feature any core or shear walls. Stability was achieved through sway action between beams and columns and masonry infill walls.

ITEM 5: No obvious lateral stability system observed.

We recommend that these items be investigated in an Engineering Assessment

7	No obvious lateral stability system observed.	Carry out Engineering Assessment on the building to verify that it is stable under lateral loading as per BNBC both in the current and proposed configurations.	6-weeks
8	No obvious lateral stability system observed.	Carry out recommendations from Engineering Assessment.	6-months

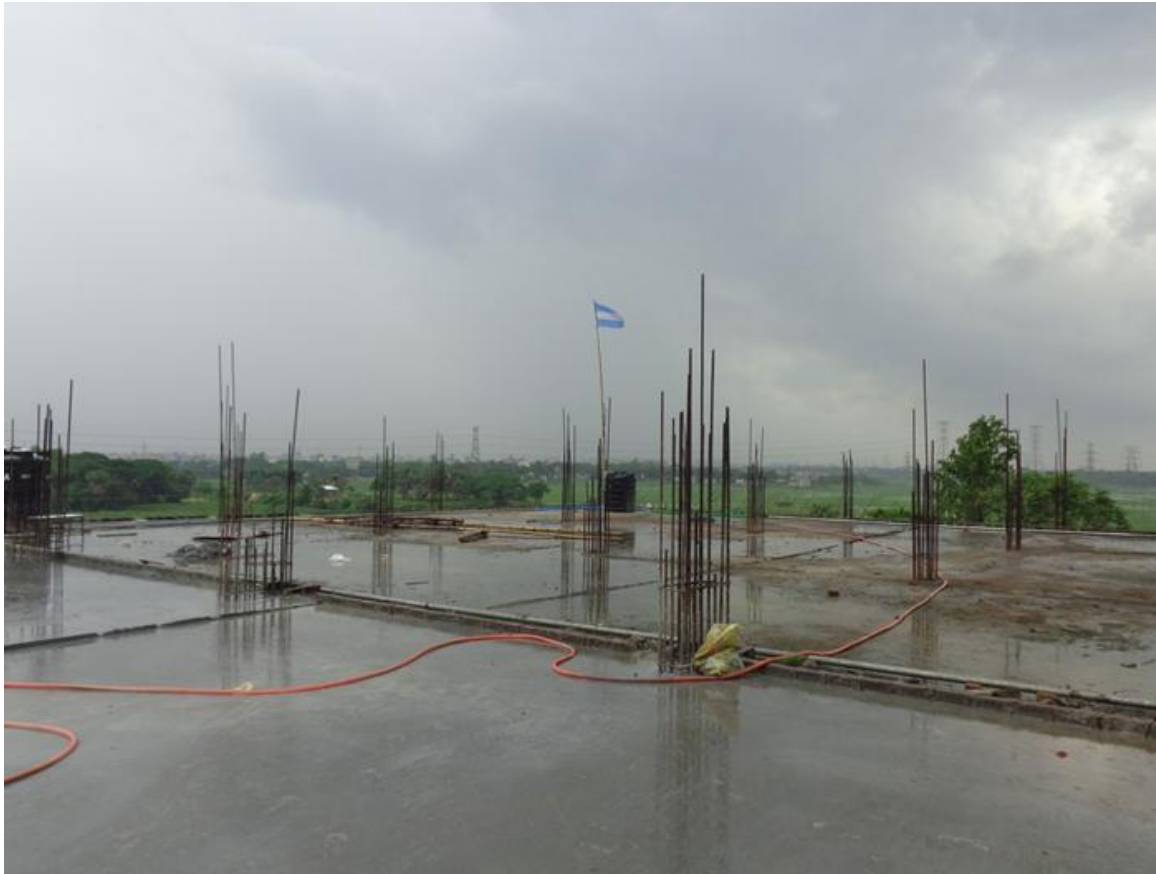
Water Ingress at Roof Level

No waterproofing membrane was visible on the roof of the building. This means that any cracks in the surface finishes on the roof will allow water to seep into the concrete slab beneath the finishes, and cause corrosion of the reinforcing steel.
