# Shanta Expressions Ltd.(9459)

Mudafa(Vadam Rood), Kakil Shataish, Tongi, Gazipur

30.APRIL.2014

**ACCORD**  
on Fire and Building Safety in Bangladesh

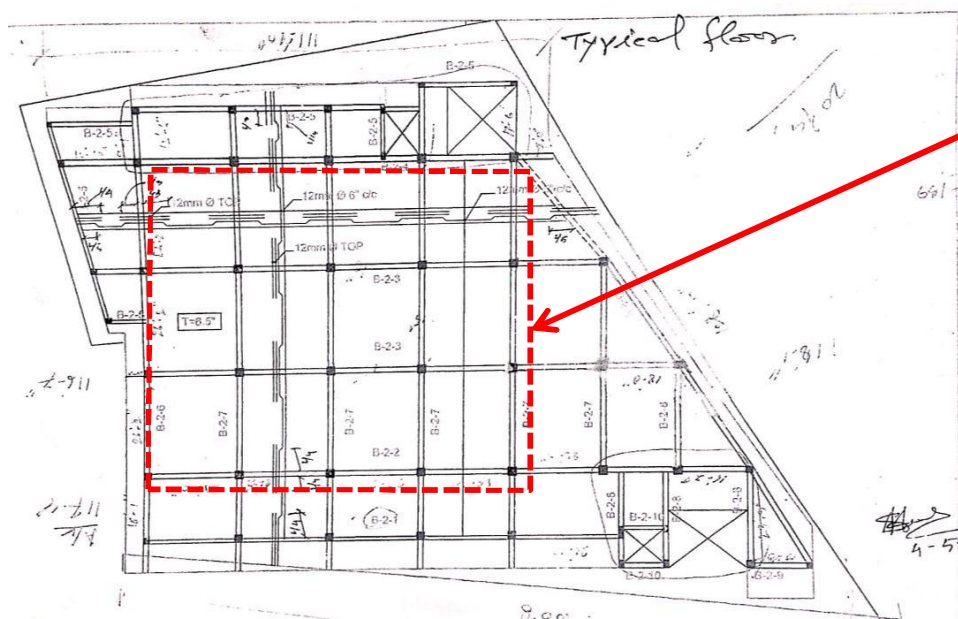
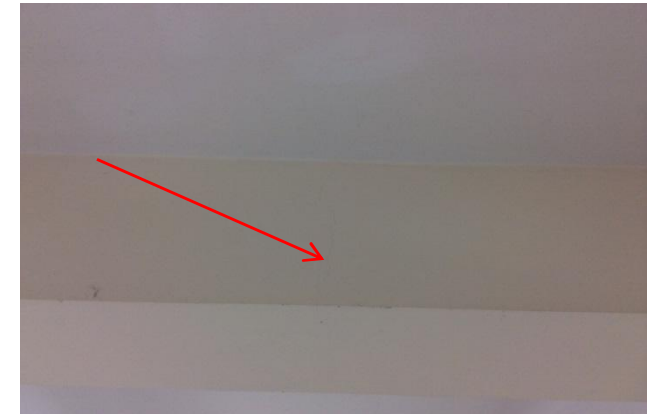
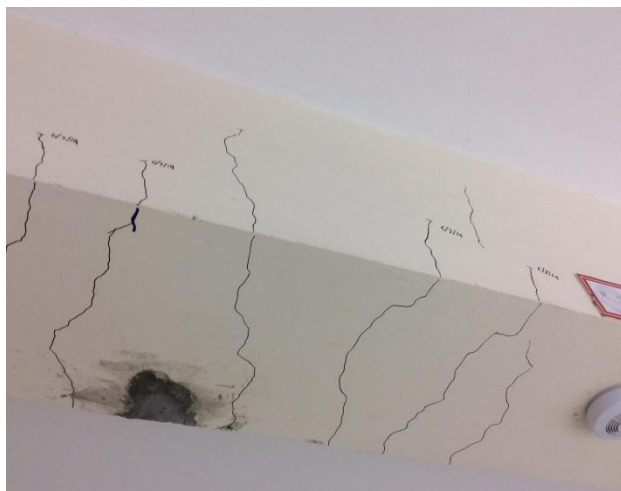
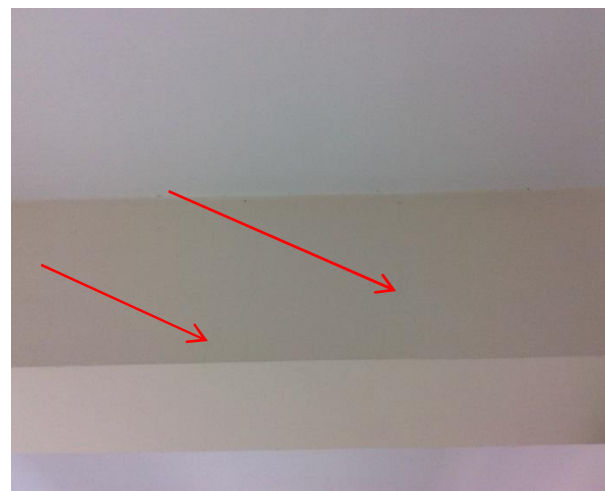
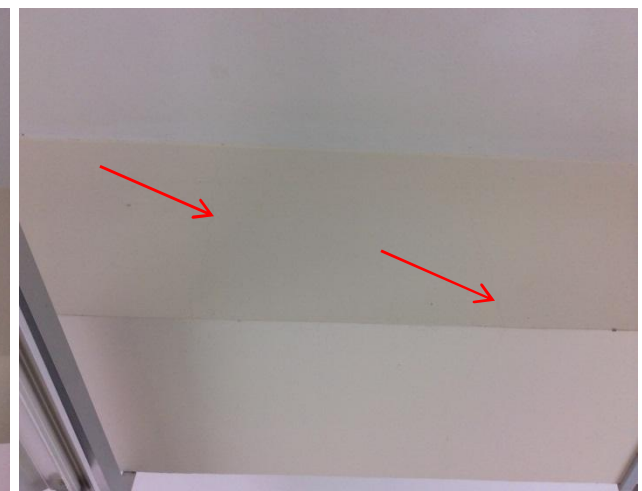
1st Priority 1 Concern

Cracks on beams, as shown, on 6<sup>th</sup> floor which may be from uncontrolled heavy loading above.

Capacity checks are required prior to repairing.

- A Detailed Engineering Assessment of the factory is to be carried out, investigating in particular the cause of this cracking.

- The distress found is to be rectified and then suitably repaired.
- Simply plastering over is not allowed.
- Develop a loading plan for each level.

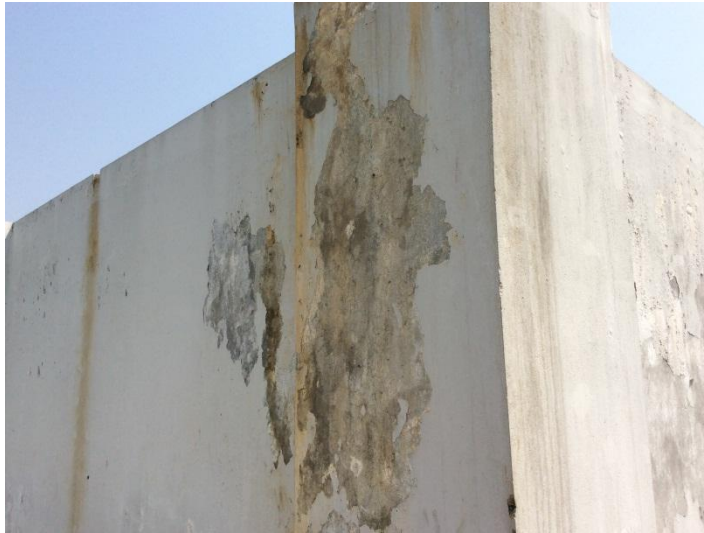
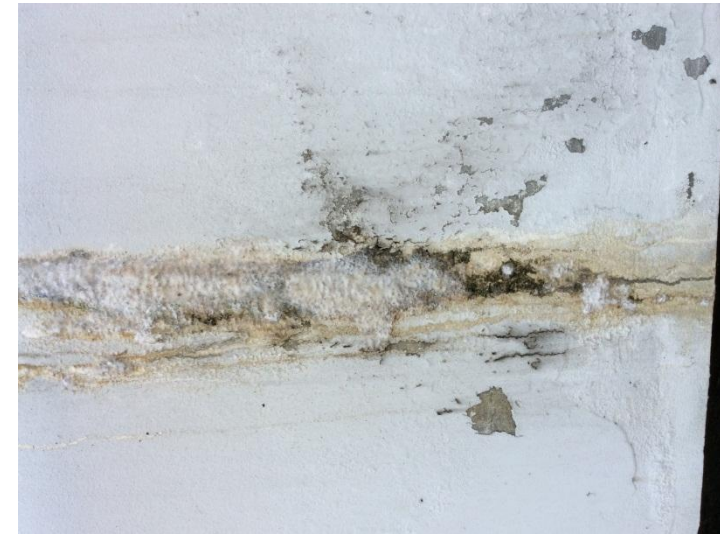
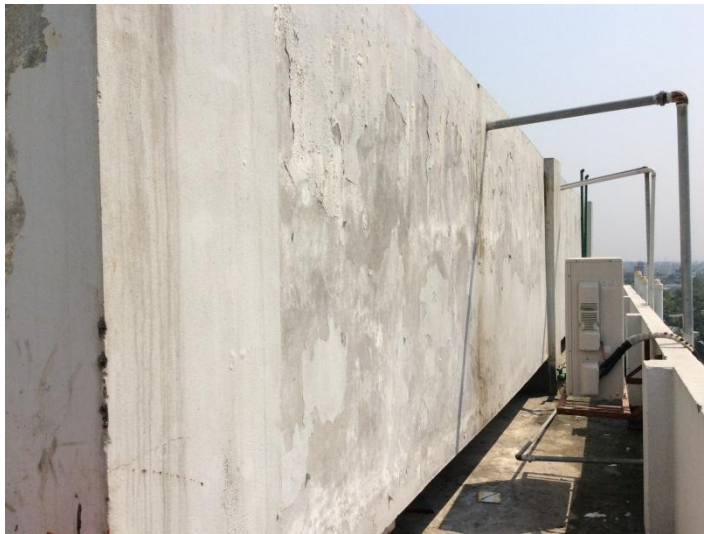
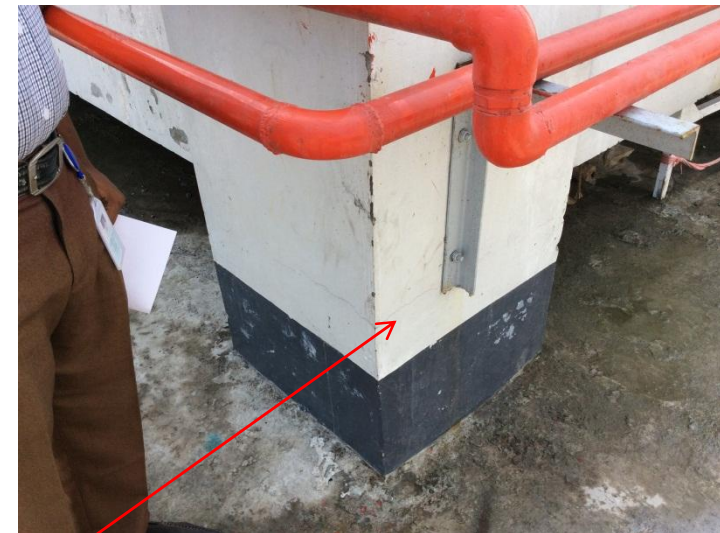
1<sup>st</sup> Priority 2 Concern

Water leaks and corrosion appears on the reinforced concrete walls of the water tank. This will cause deterioration if left unattended. Also, there are also cracks on the column supporting the tank.

- The Factory Engineer is to inspect the water damaged structure including the exterior and propose a suitable method of repair.

- Implement and continuously maintain the waterproofing.

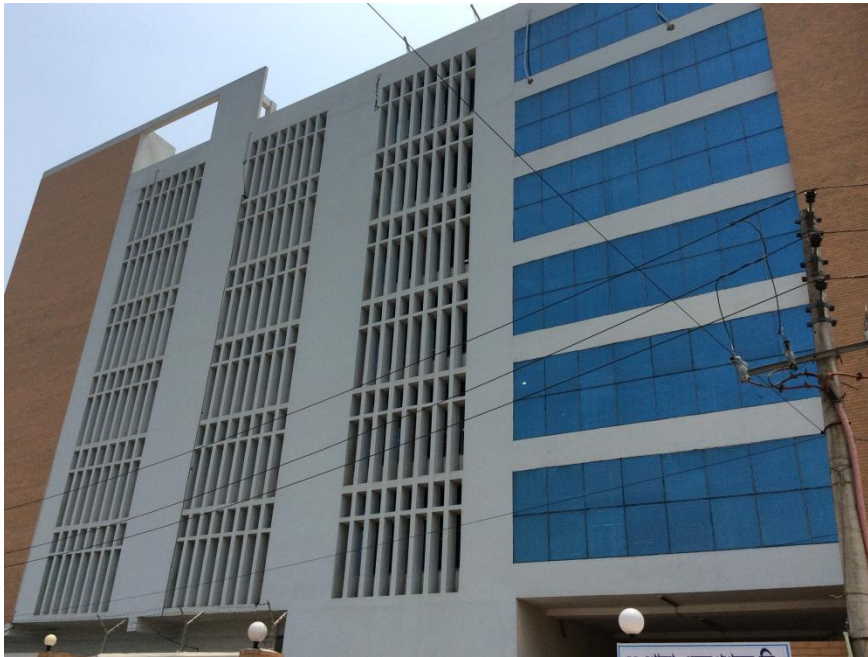
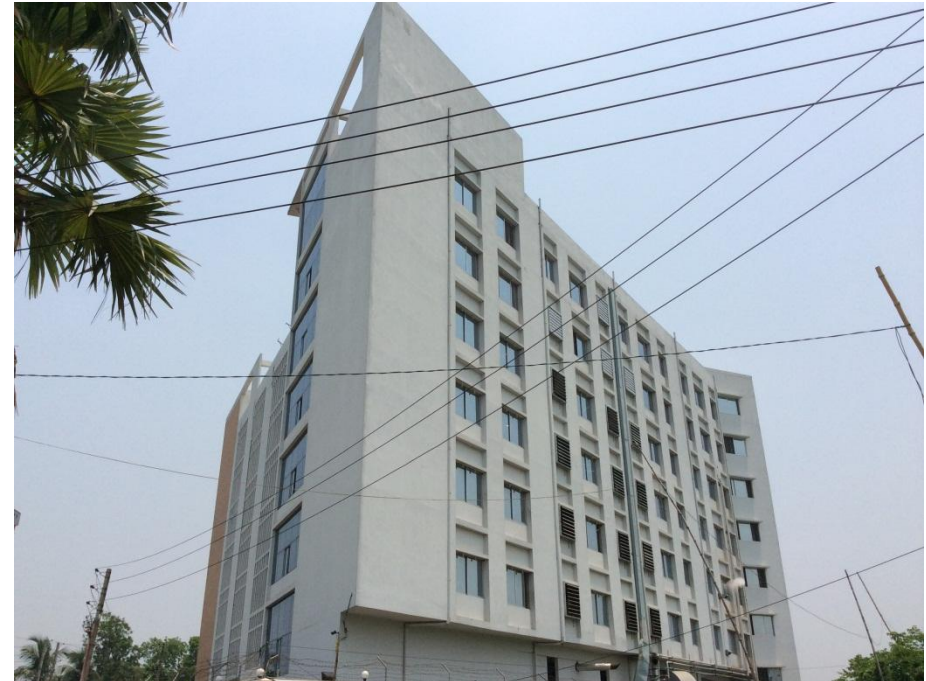
## 2<sup>nd</sup> Priority 2 Concern

Concerns with the stability system dealing with lateral & seismic loading. Façade brickwork walls lack moment capacity due to their poor connection with columns and beams.

We require that these concerns are investigated as part of a Detailed Engineering Assessment

- The Detailed Engineering Assessment of the building is to be carried out and in particular, stability and foundation aspects should be investigated in detail.

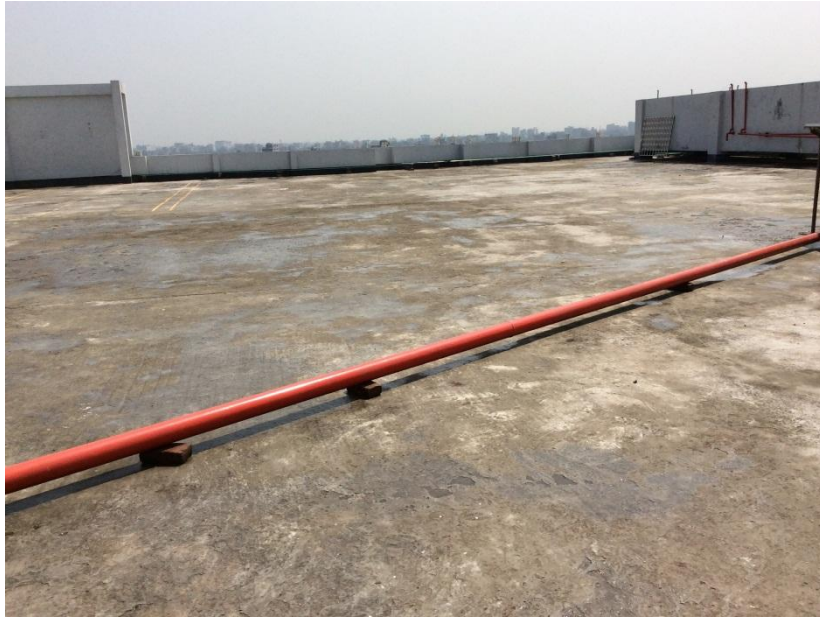
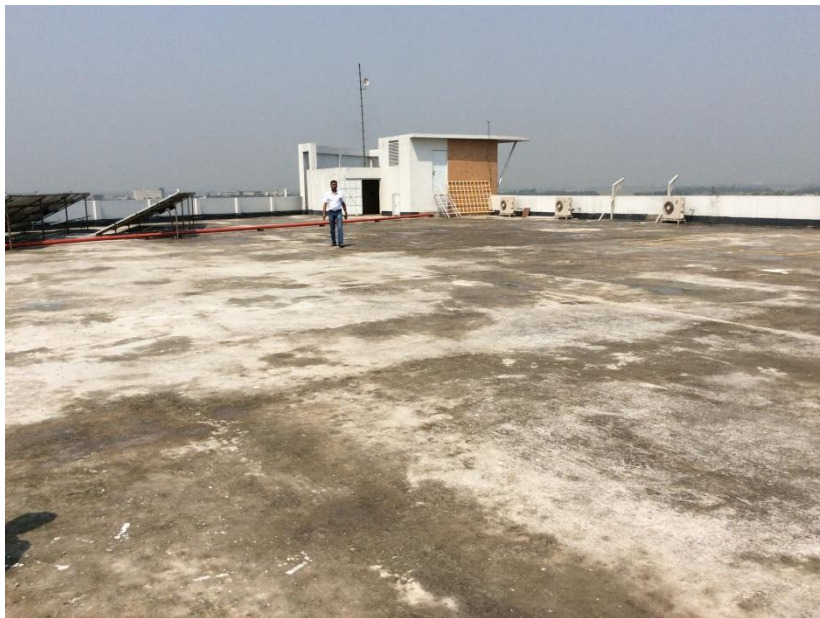
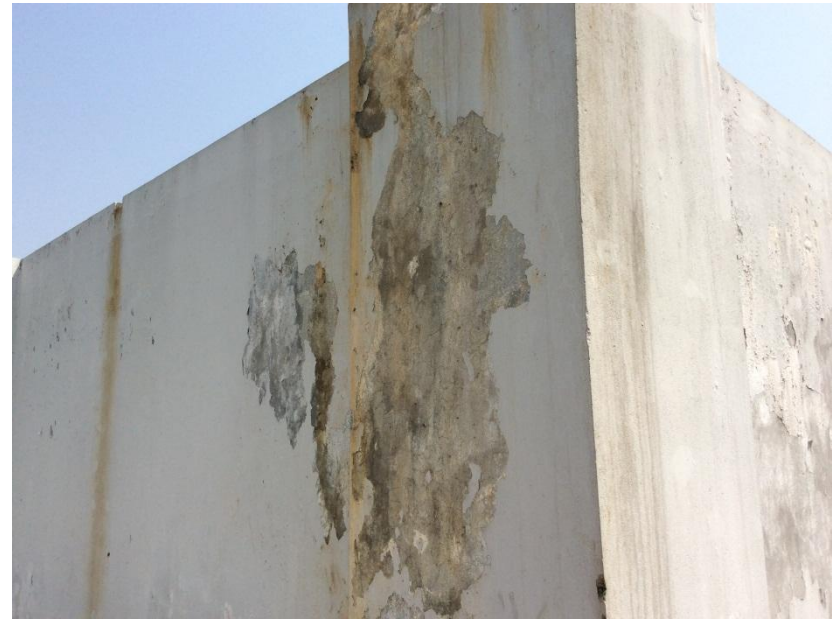
1<sup>st</sup> Priority 3 Concern

- No waterproofing material at roof slab level or on the water tank.
- Water ingress due to cracks on external facade potentially causing damage to the brick infill walls.

An appropriate layer of waterproofing needs to be applied.

- Waterproofing material to be applied and maintained.

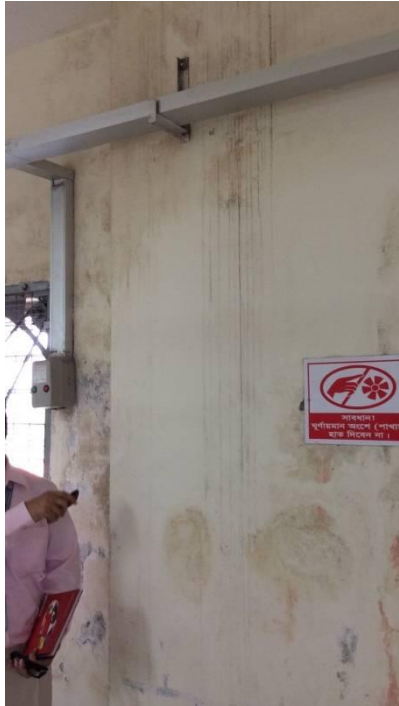
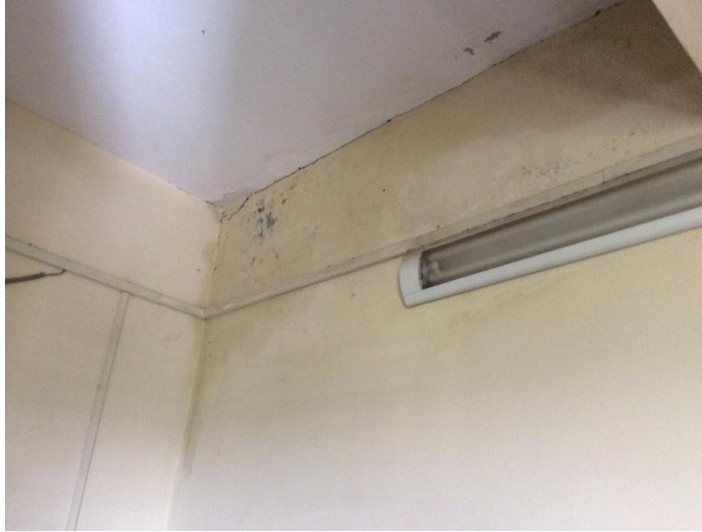
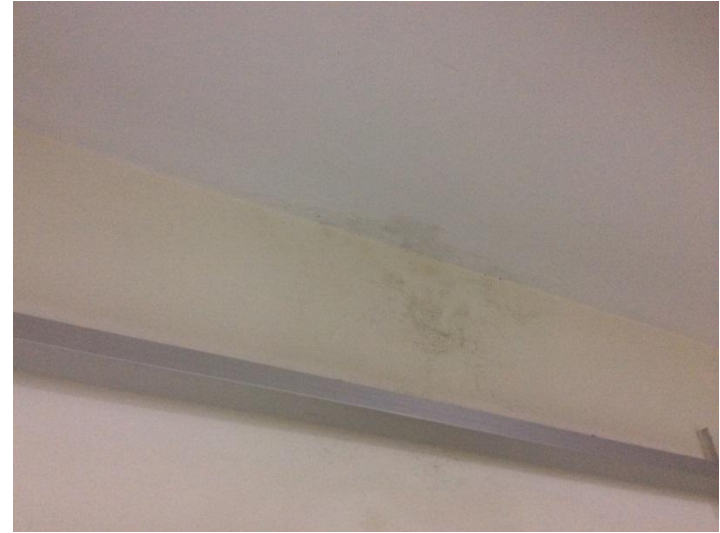
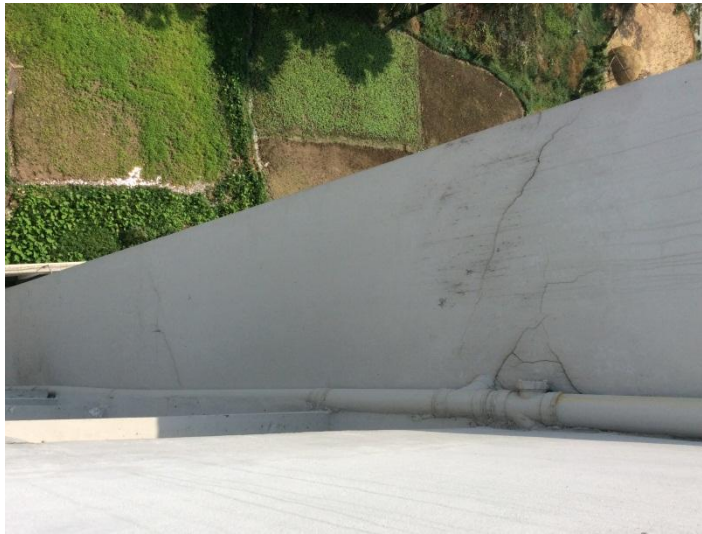
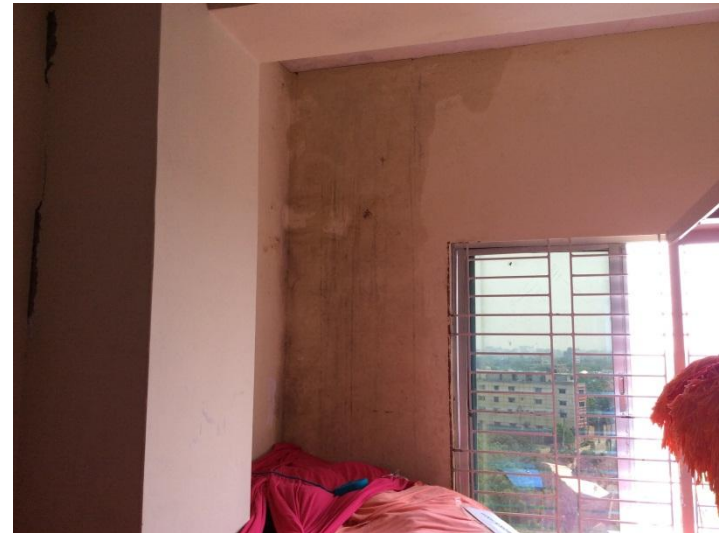
2<sup>nd</sup> Priority 3 Concern

Water ingress due to cracks on external façade could cause further damage to the brick infill walls. Cracks on the external façade should be identified, investigated and then repaired.

- The Factory Engineer is to inspect the water damage and the external façade cracks and propose a suitable method of repair to avoid further water ingress.

- Implement and continuously maintain the repair systems.
