# Prime Sweater Ltd.

Naibari, Pubail, Gazipur.  
(23.933718N, 90.450326E)

26<sup>th</sup> November 2017

# Observations

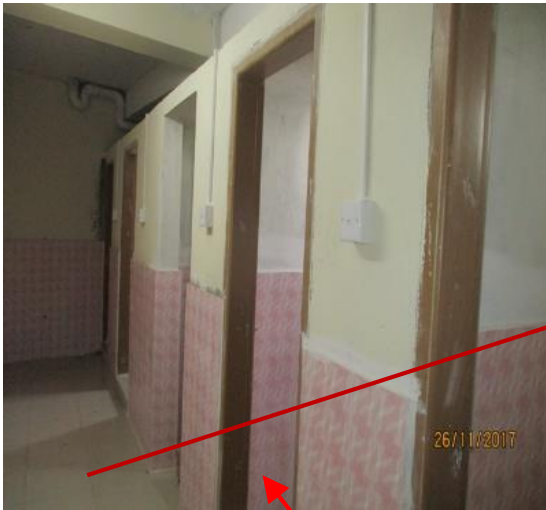
Toilet Zone with masonry walls

Cursory calculations indicate that the column stress are exceed normal design limit. A Detail engineering assessment must carried out immediately.

| Item No. | Observation | Recommended Action Plan | Recommended Timeline |
|---|---|---|---|
| 1 | High stress level in columns that require immediate review | Toilet zone of 4th and 5th floor should remain unoccupied. Loading should be limited up to 1Kpa for 1st floor to 3rd floor toilet zone and surroundings. | <b>Immediate - Now</b> |
| 2 | High stress level in columns that require immediate review | Factory Engineer to review design, loads and columns stresses in all columns. | <b>Immediate - Now</b> |
| 3 | High stress level in columns that require immediate review | Verify grade of steel reinforcement used. | <b>Immediate - Now</b> |
| 4 | High stress level in columns that require immediate review | A Detail Engineering Assessment of Factory to be commenced, see attached Scope. | <b>Immediate - Now</b> |

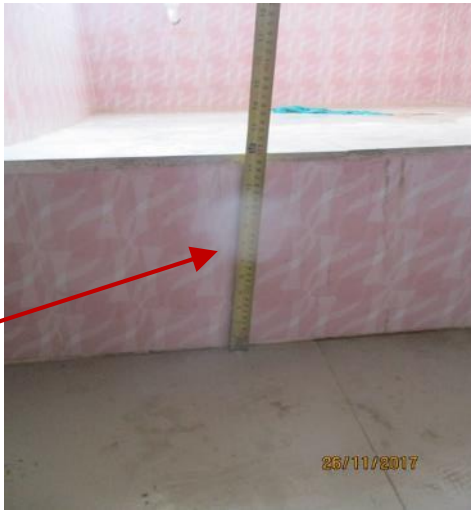
275 mm Toilet build up

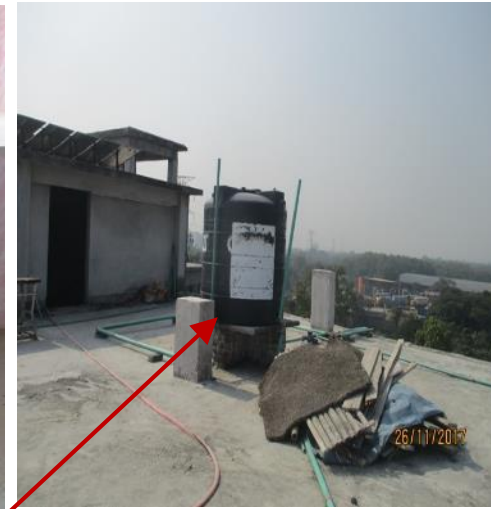
Water reservoir at roof

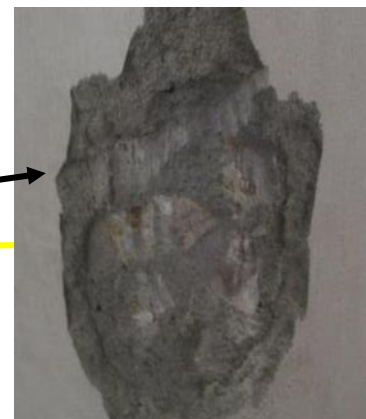
Stone chips  
aggregate found in  
basement floor  
column

Stone aggregate was found in basement floor column but in 1<sup>st</sup> floor column, brick aggregate was found. Moreover, mixture of stone and brick aggregates were found in ground floor column. Whereas, stone aggregate was mentioned in all provided reports of compressive strength test. For this reason, except basement column cores test result were not considered in cursory calculation.

| Item No. | Observation | Recommended Action Plan | Recommended Timeline |
|---|---|---|---|
| 9 | Evaluation of concrete compressive strength based on aggregate type | Factory engineer to investigate the aggregate type of the columns. Evaluate the compressive strength of concrete by taking 100mm diameter cores from columns based on aggregate type. | 6-weeks |

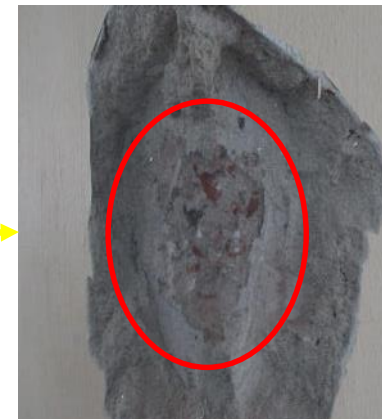
Brick chips  
aggregate found in  
1<sup>st</sup> floor column

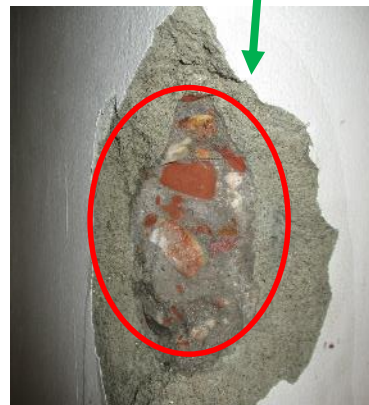
Mixed of stone  
and brick  
aggregate found in  
ground floor  
column

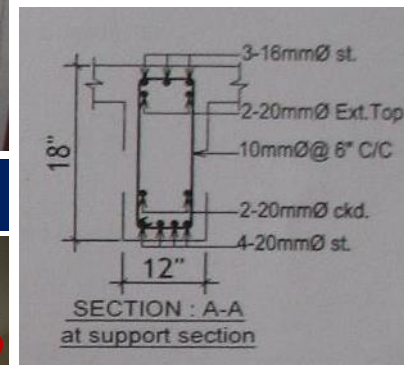
B-2 beam size  
shown 300mm x  
450mm in provided  
drawing

| Item No. | Observation | Recommended Action Plan | Recommended Timeline |
|---|---|---|---|
| 10 | Discrepancies between provided drawing and on site condition | Building Engineer required to prepare As –Built drawings reflecting the on site condition. | 6-weeks |

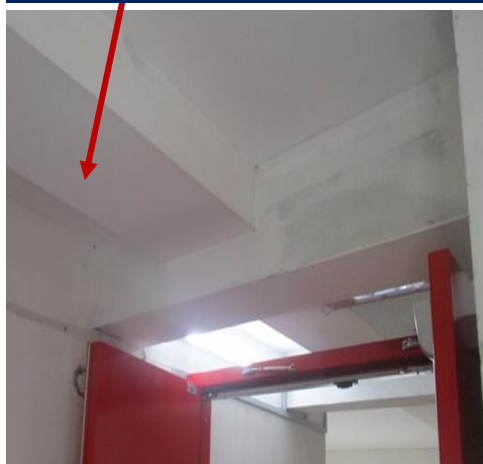
Marked beam size  
measured 300mm x  
375mm which was not  
shown in beam layout

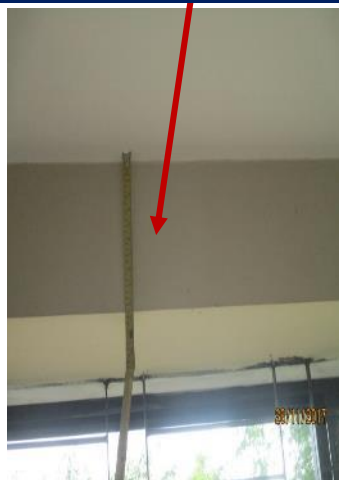
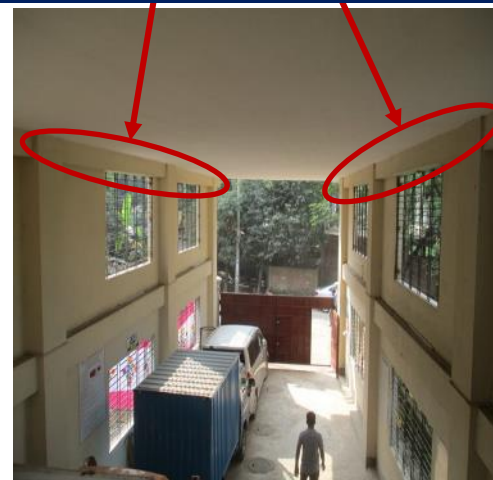
Marked Beam size found 300mm x 400mm at  
1<sup>st</sup> floor which are denoted as B2 (300mm x  
450mm) type beam in beam layout

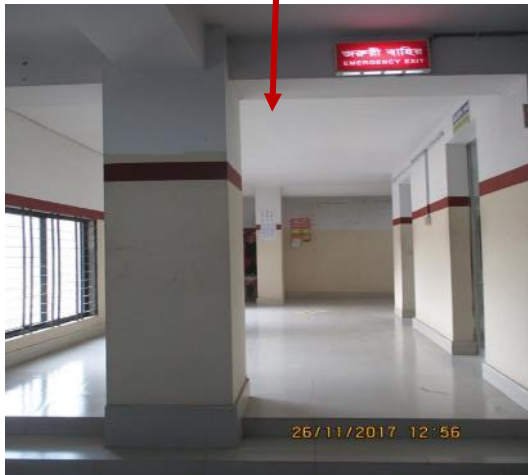
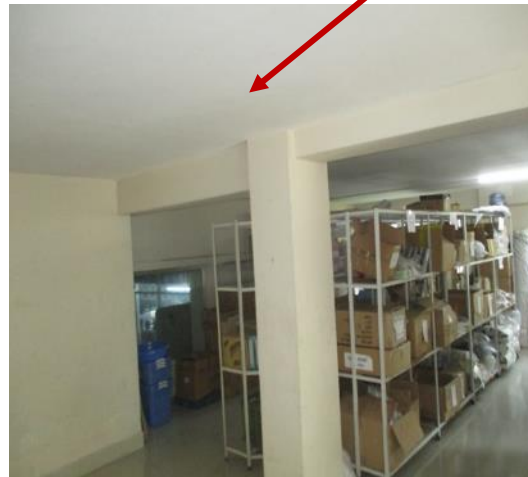
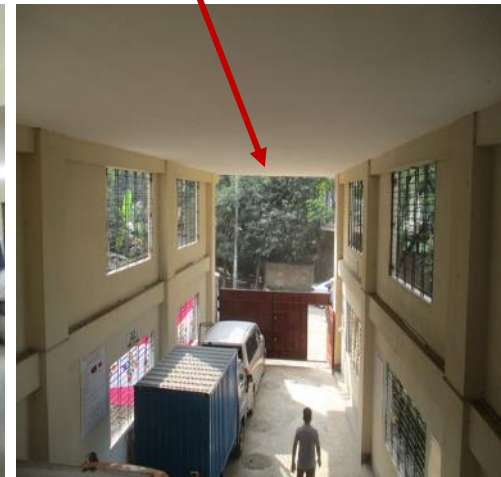
Marked Beams were missing in 1<sup>st</sup> floor which are denoted as B2 type beam in beam layout

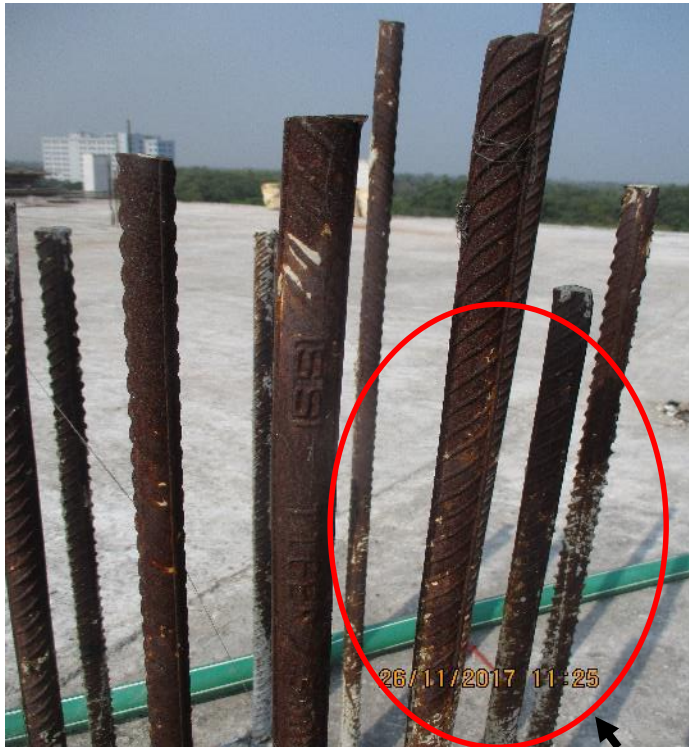
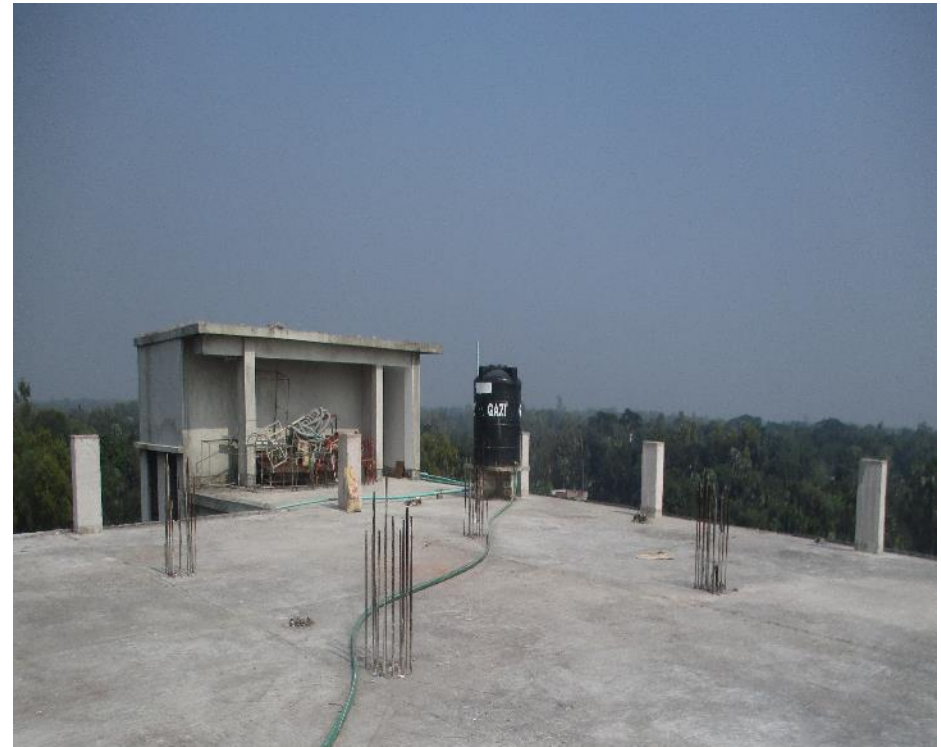
Exposed Rebar on roof top tends to corrosion

Exposed rebar was observed on roof top which tends to corrosion. Some corroded rebar was observed. Factory is required to take necessary steps to avoid corrosion.

| Item No. | Observation | Recommended Action Plan | Recommended Timeline |
|---|---|---|---|
| 11 | Corrosion on roof top exposed reinforcement | Building engineer to check the reinforcement for corrosion and take proper remedial action. | 6-weeks |

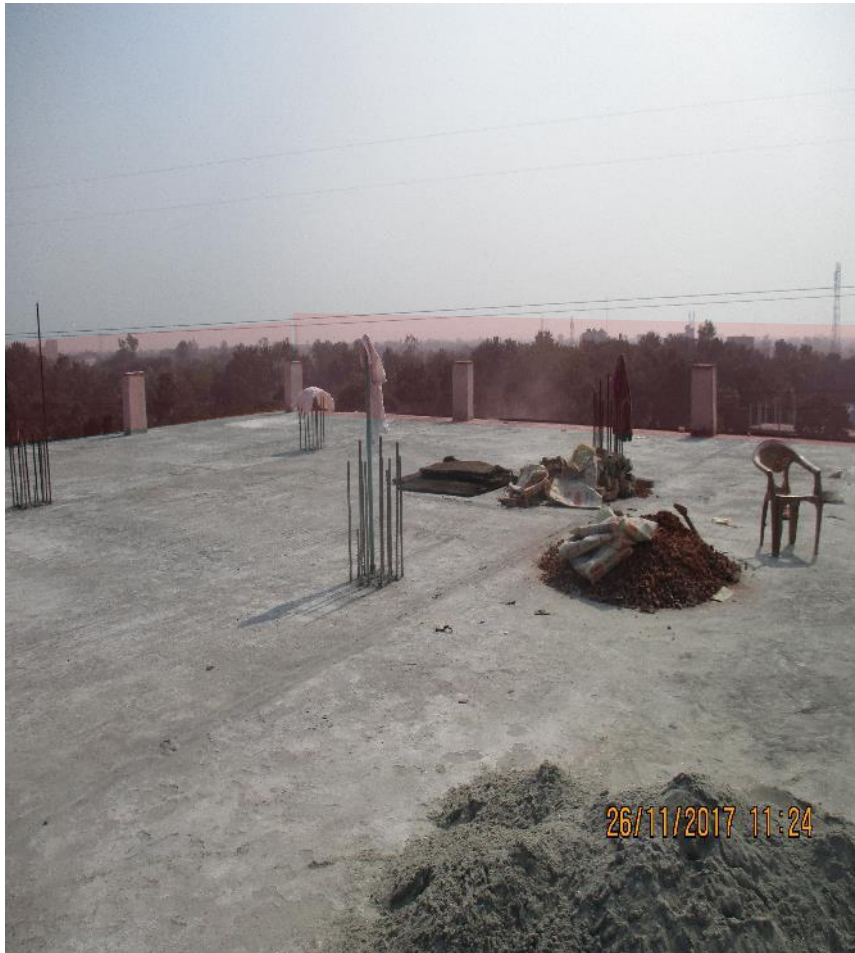
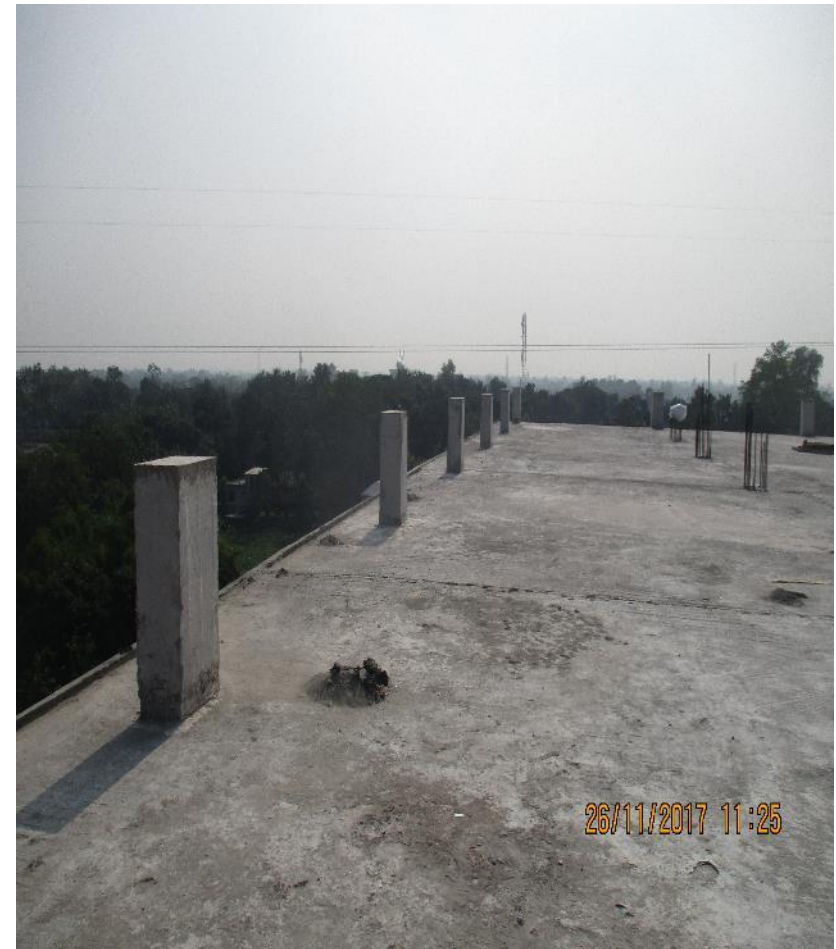
**Water proofing and edge protection were  
not observed on roof**

Edge protection was not observed on roof. Besides, no proper water proofing or drainage system was observed.

| Item No. | Observation | Recommended Action Plan | Recommended Timeline |
|---|---|---|---|
| 12 | Water proofing and proper edge protection were not present at roof | Install adequate edge protection on roof level. | Immediate - Now |
| 13 | Water proofing and proper edge protection were not present at roof | Provide proper drainage and water proofing layer with appropriate water proofing materials. | 6-weeks |
