Rezaul Apparels (Pvt.) Ltd.

Plot No : 371-372, BSCIC Industrial Estate, Konabari
(24.008837N, 90.324597E)

19th December 2017

Observations

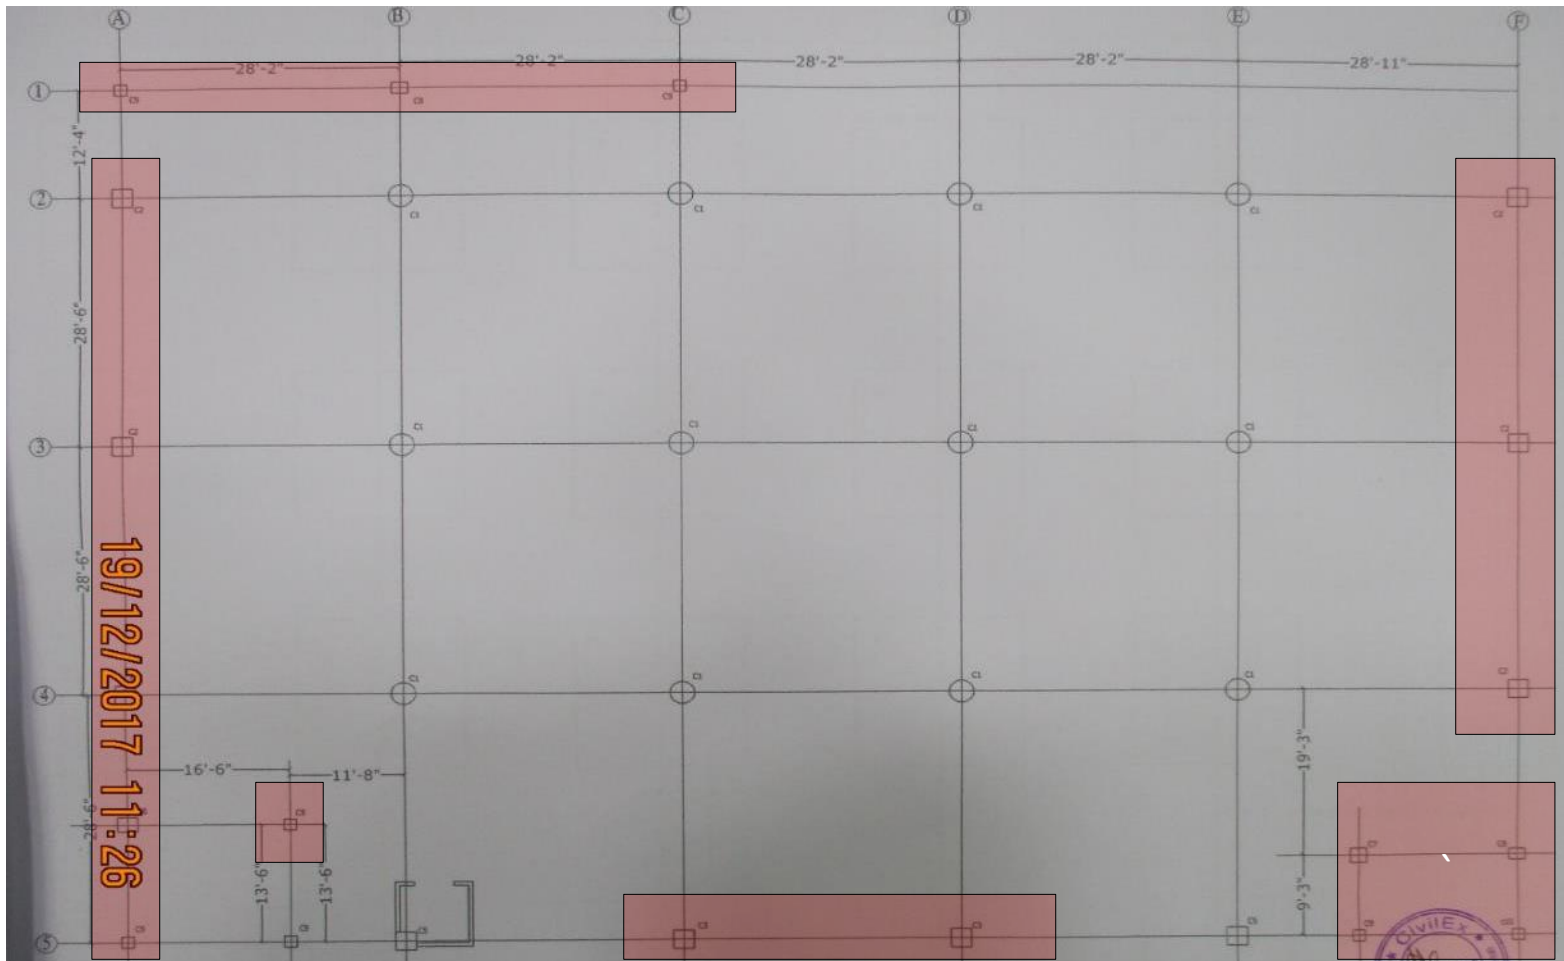
**Columns appeared to be stressed in excess
of normal design limits**

Cursory calculation indicates that highlighted columns appear to be stressed above normal design limits due to over head water tank, brick wall of toilet area and large grid dimension. Factory engineer need to check column stress and a Detail Engineering Assessment (DEA) must be carried out and factory should take necessary action according to report.

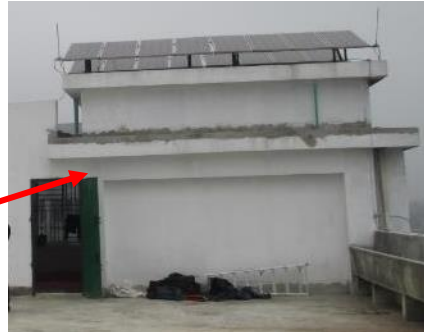
Water tank
(4.8mx3.9mx1m)

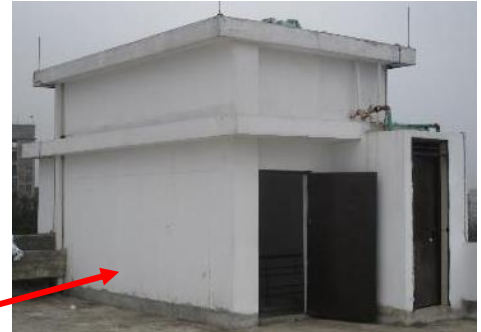
Water tank
(4.9mx2.4mx1m)

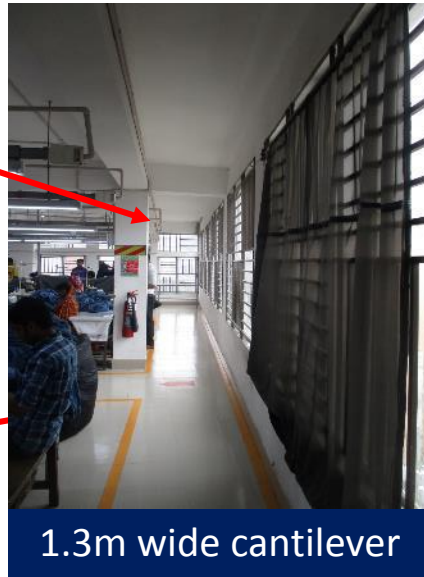
1.3m wide cantilever

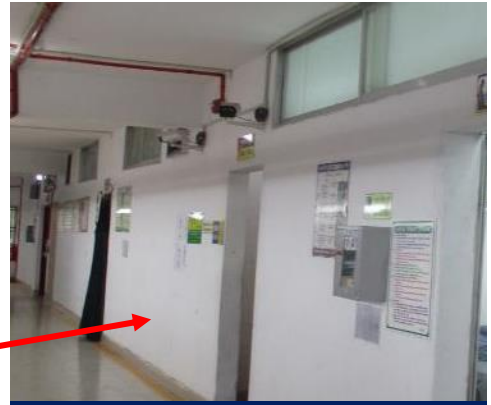
125mm built-up and
125mm thick outer brick
wall on toilet area

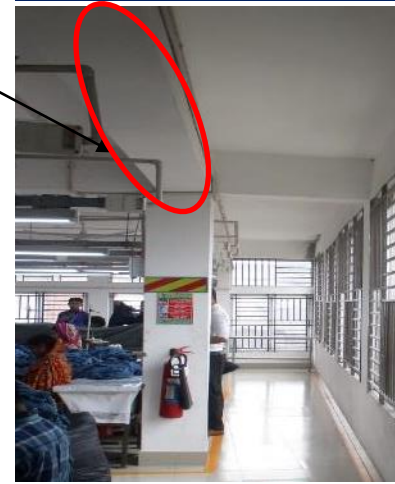
Uniform beam was found instead of tapered beam on south side cantilever part

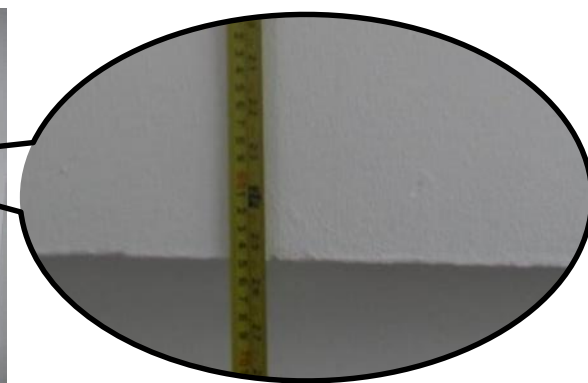
B-4 type beam on staircase was measured 625mm instead of 500mm

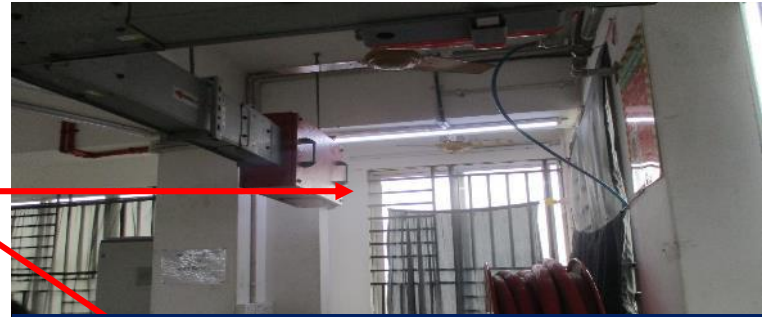
The marked cantilever on south side was not mentioned in as built drawing

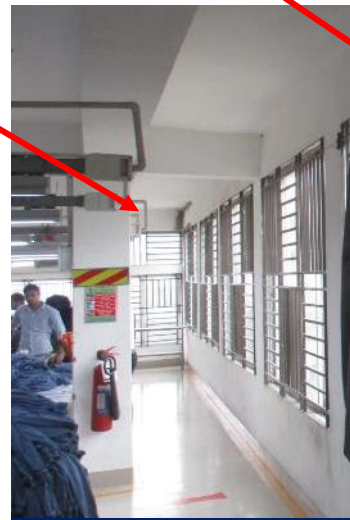
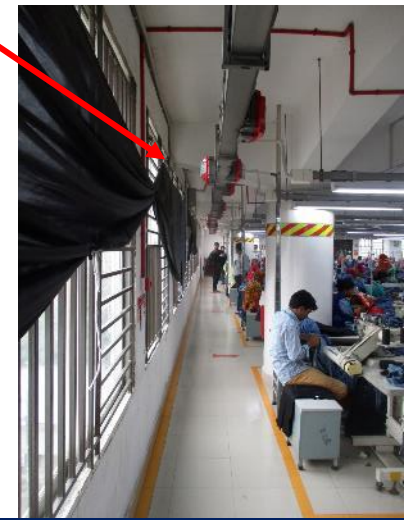
Both uniformed and tapered beams were found on south side however the beams were not mentioned in drawing

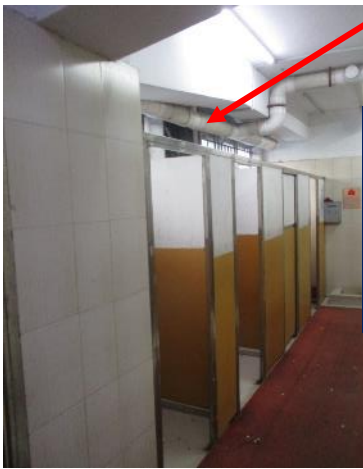
In north side cantilever portion some toilets were found which were not shown in as-built drawing.

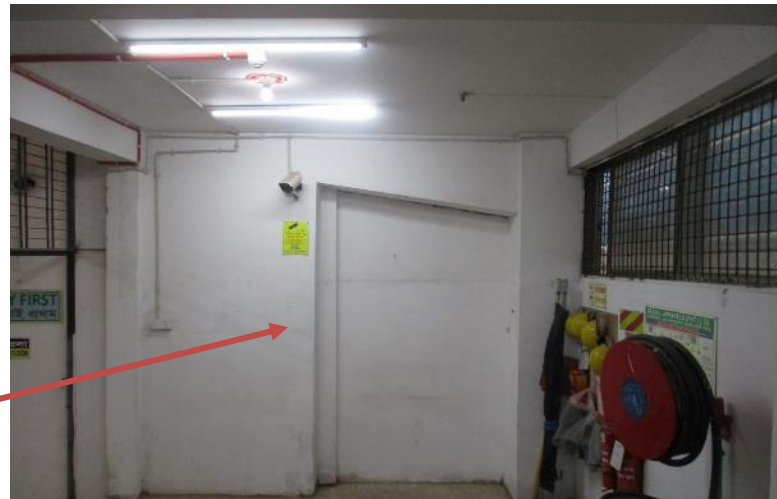
No core wall was found around the lift, only L-shaped column found

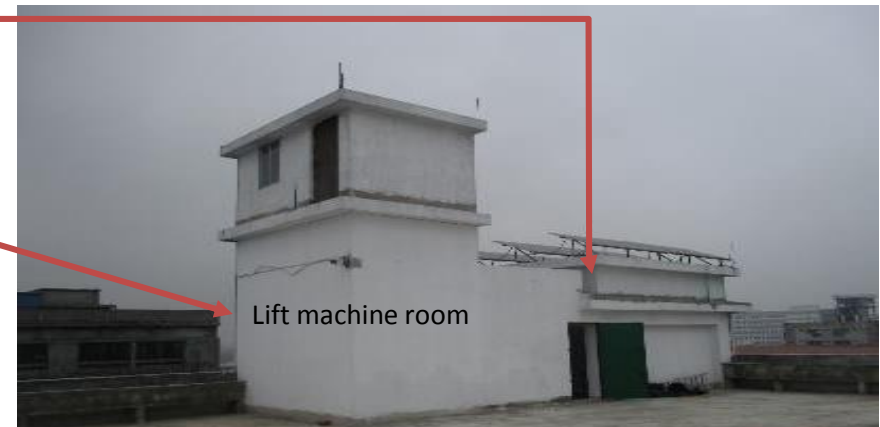
Height of the lift machine room was measured 6.5m instead of 4m. Also, the over head water tank height was measured 1m in place of 1.6m
