# Fiat Fashion Ltd

878,879 Sharifpur, Gazipur Sadar, Gazipur, Dhaka  
(+ 23.966146 N, 90.37799 E)

07 November 2013

# Building Observations

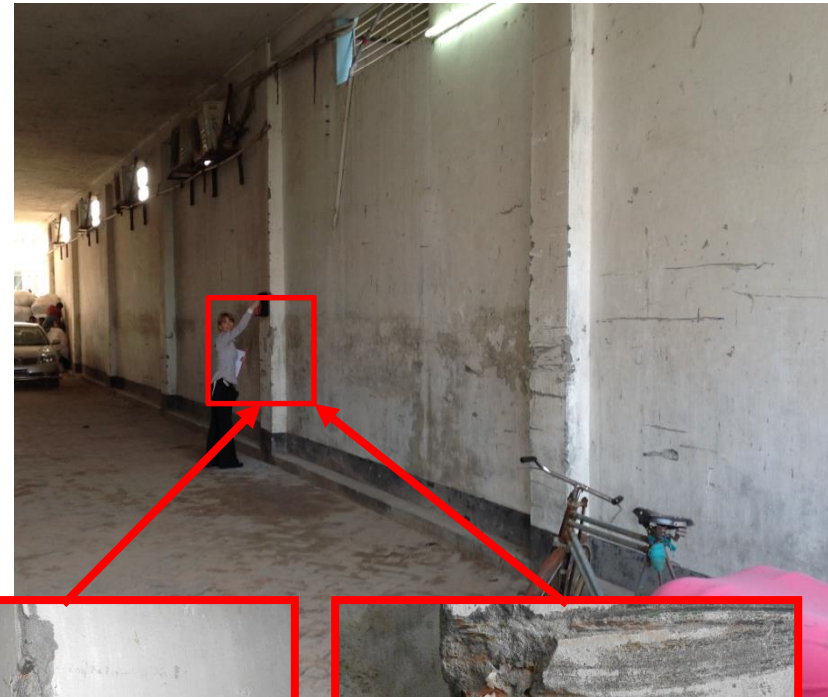
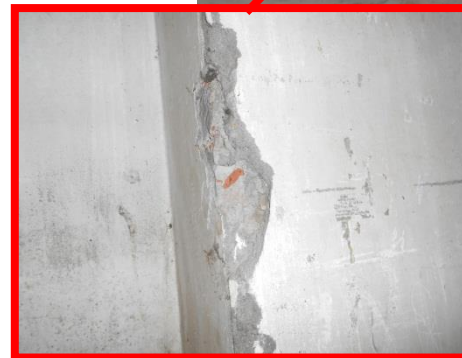
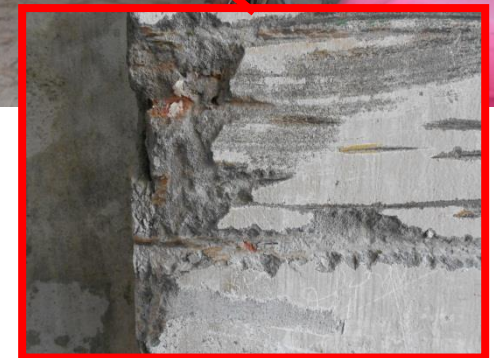
# Check required on column design

Cursory calculations indicate column working stress is at high level for edge columns and along Grid B

Engineer is to perform detailed calculations and concrete tests to prove column size and (if required) :

- Reduce loads by vacating floors
- Reinforce columns

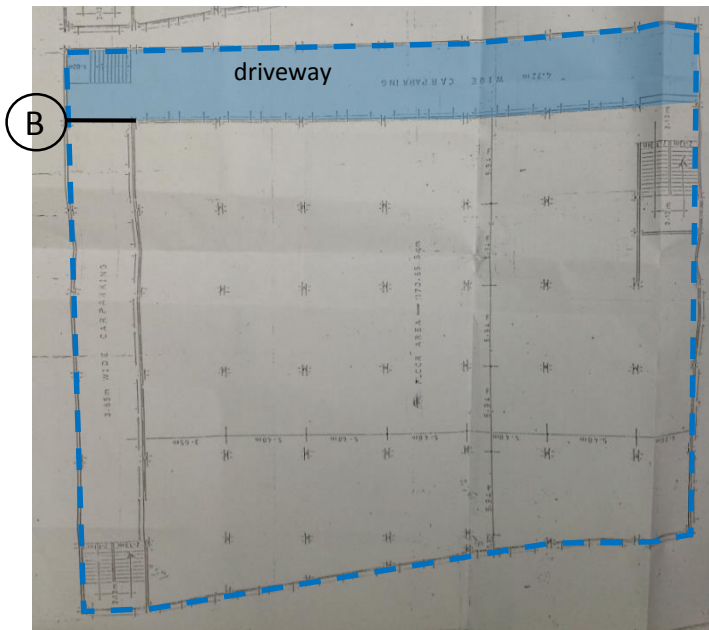
Testing carried out.  
Column material is found to be brick chip aggregate

Check column design required

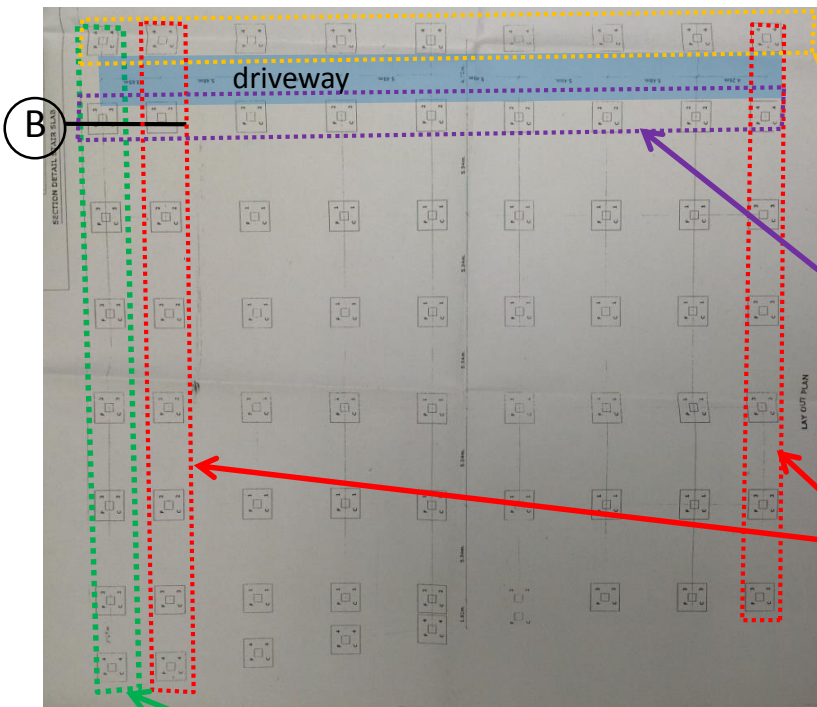
# As built drawings

**Edge Columns**  
 Per drawing: 356mm x 430mm (14"x17")  
 Measured on site: 250mm x 370mm

**Grid B Columns**  
 Per drawing: 457mm x 457mm (18"x 18")  
 Measured on site: 380mm x 300mm

**Edge columns support a 2m cantilever slab, which is not represented on the drawings**

**This column line does not exist**

**Current structural drawings do not match the as built conditions – accurate as built drawings are required**

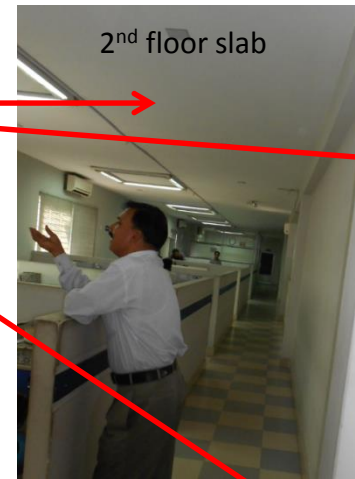
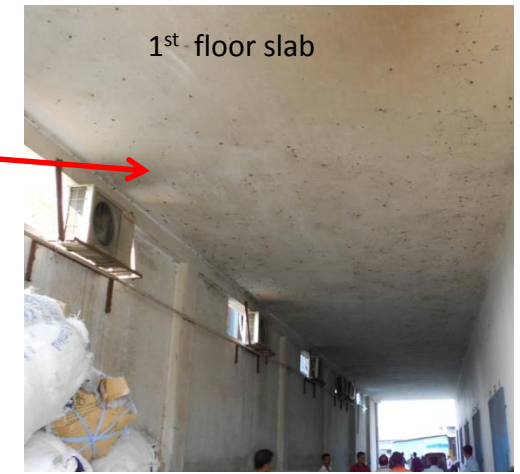
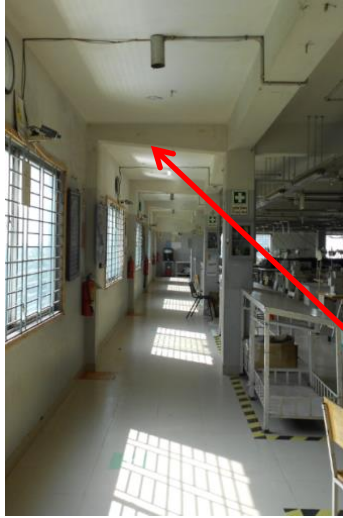
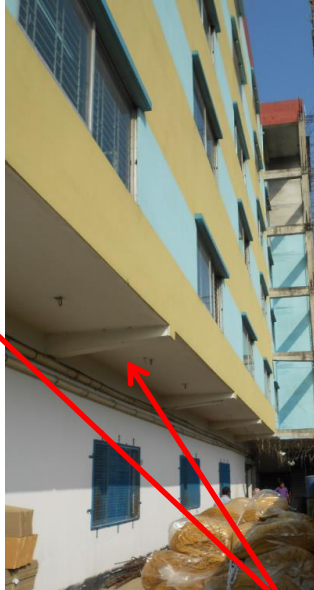
No downstand beams in this area. This is not reflected on the drawings

2m cantilever is not shown on drawings

Current structural drawings do not match the as built conditions – accurate as built drawings are required

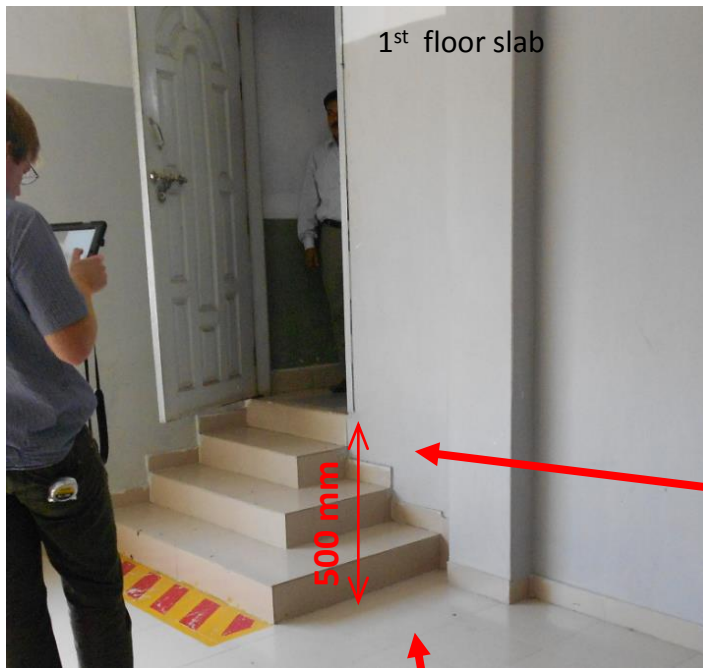
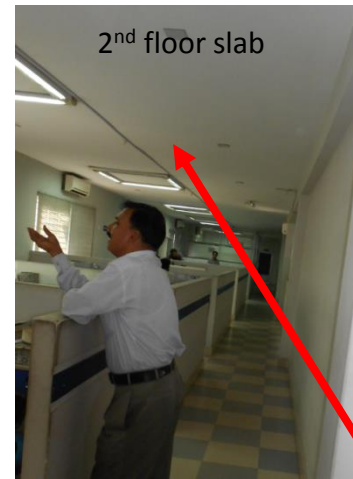
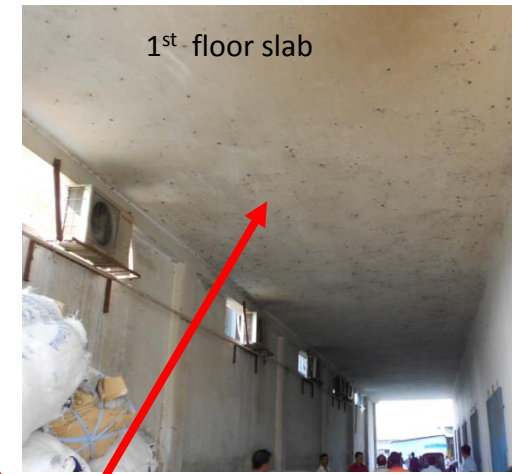
# Check required on slab design

Heavy additional loads due to 500mm raised floor on 1<sup>st</sup> floor office area

As built condition shows no beam at this location (Drawings assume beams at in all bays)

Check on slab design required

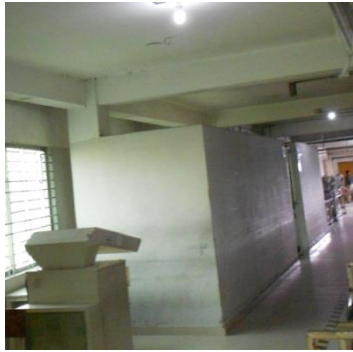
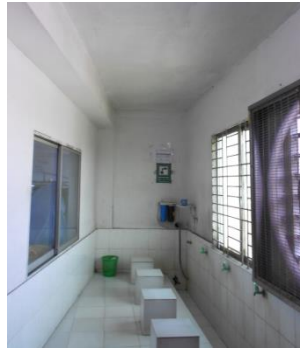
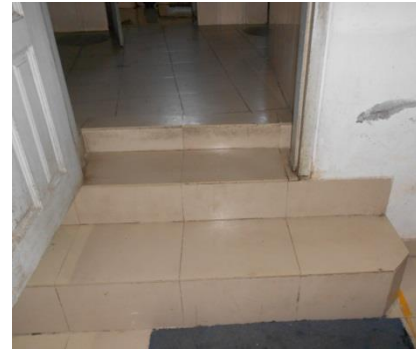
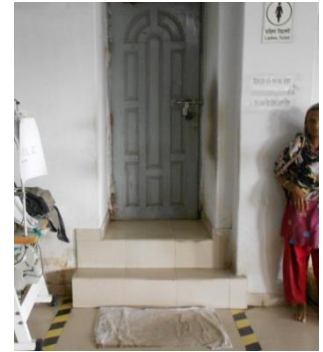
**Permanent loading due to raised floors and partition walls:**

**Engineer to produce loading plans based on as built conditions. Load management set in place.**

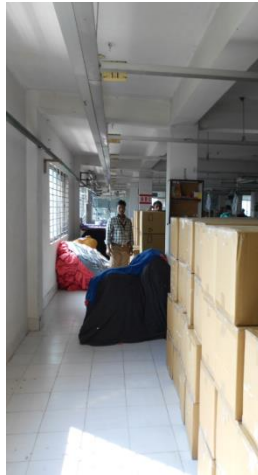
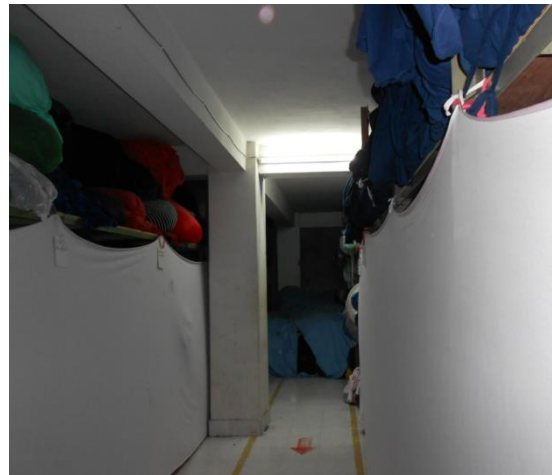
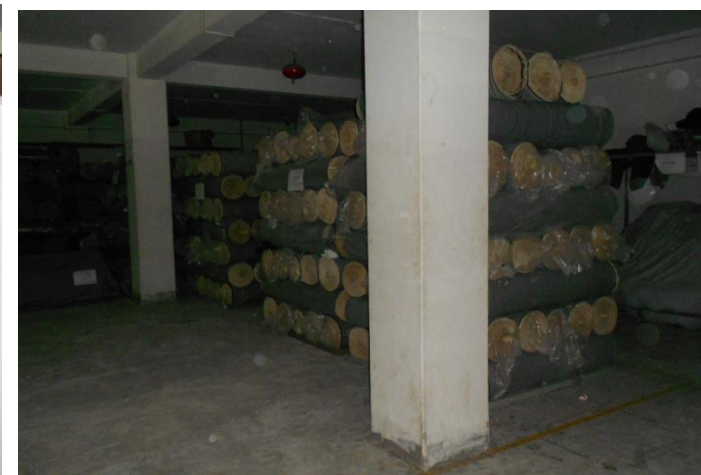
**Factory loading on cantilevers and in storage areas:**

**Cantilever slabs are not part of the existing design drawings**

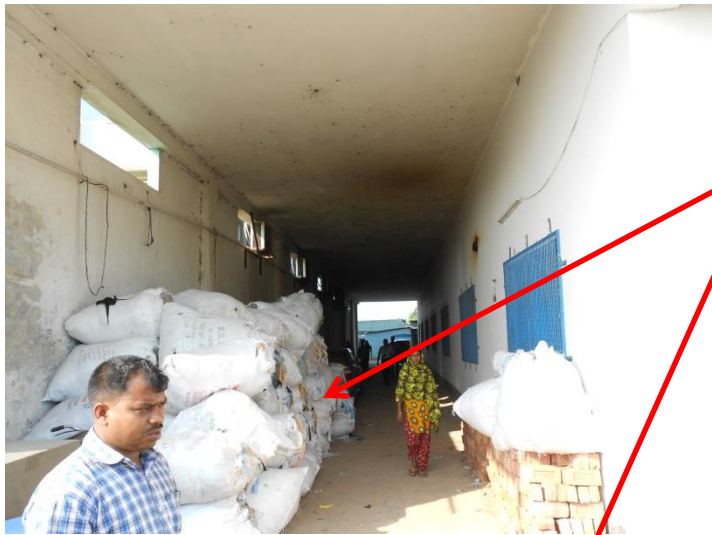
# Fabric bag pile loading perimeter columns

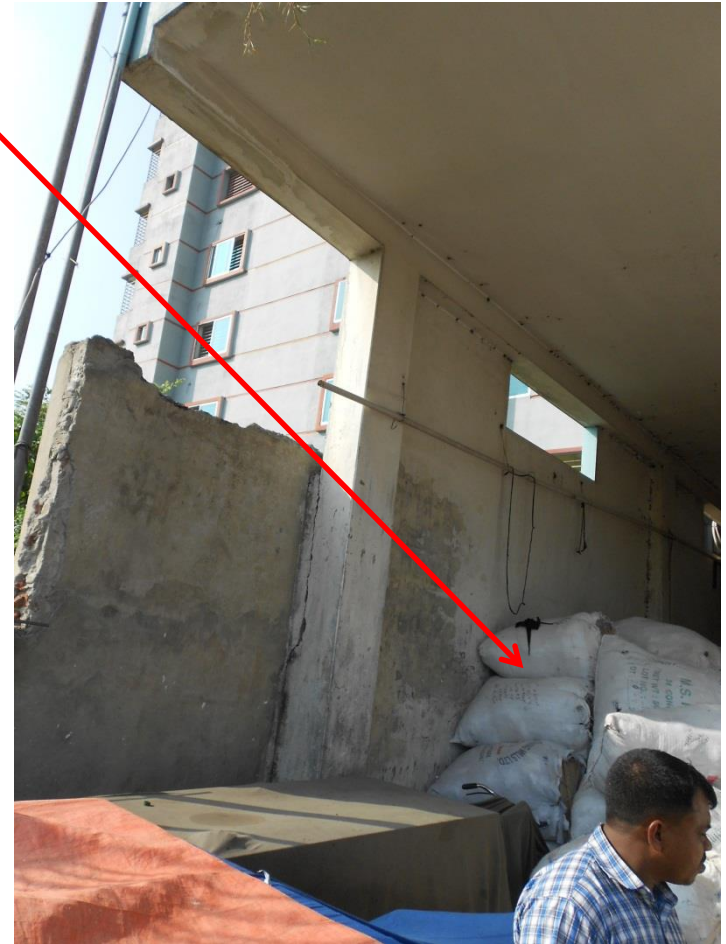
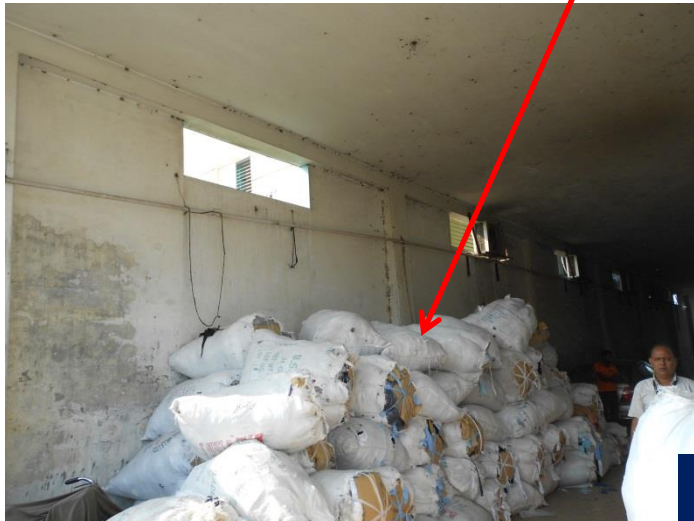
Fabric bag  
pile loading  
perimeter  
columns

Do not store loads against wall  
and columns, on either side of  
the wall

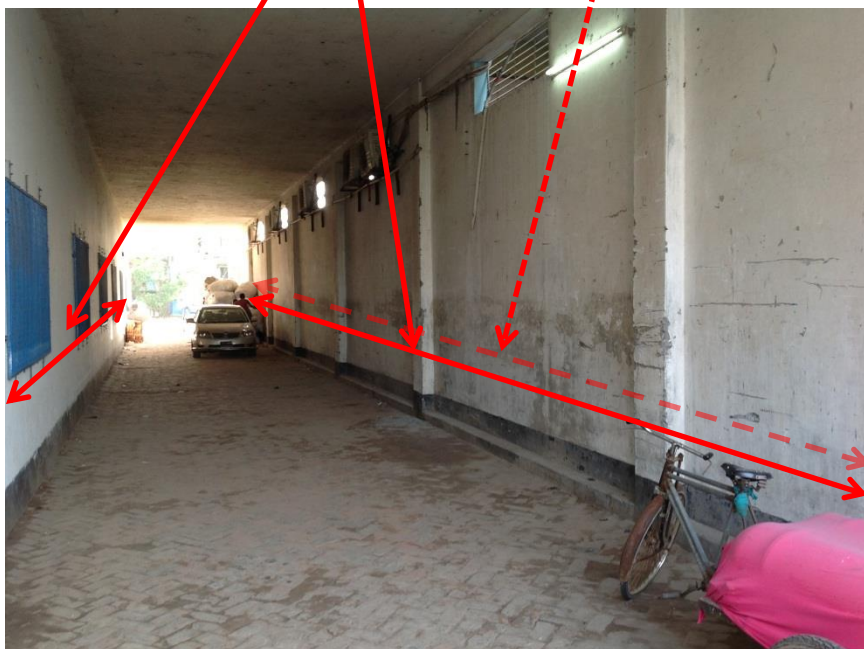
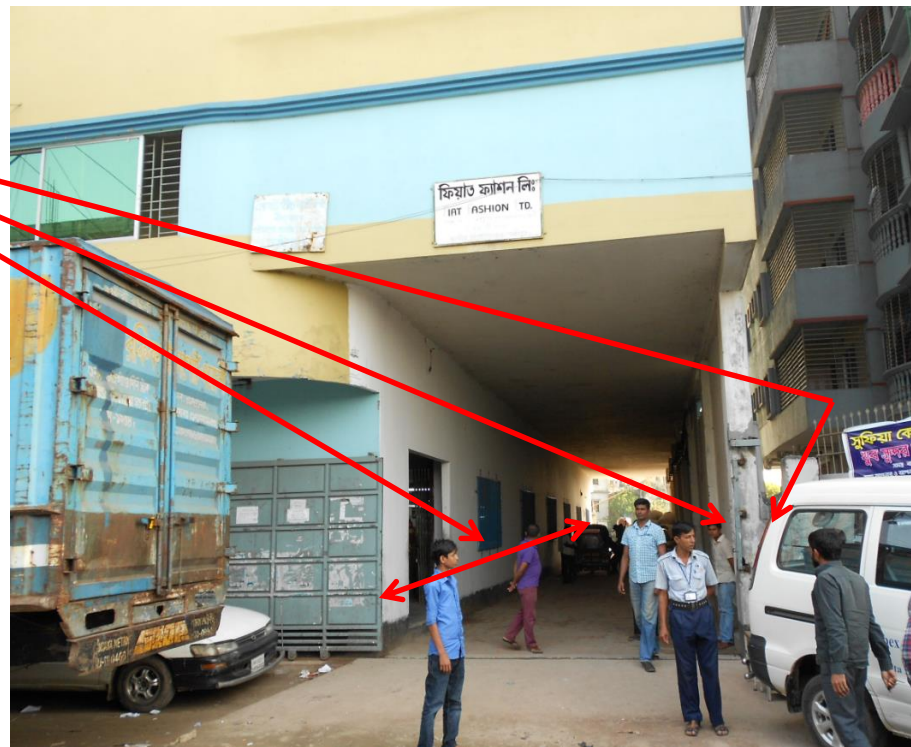
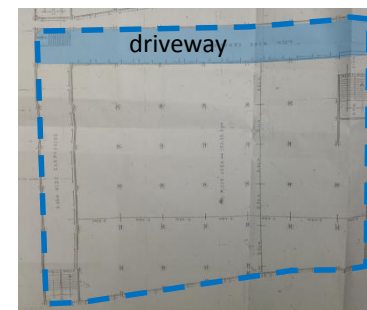
# Protect columns from Vehicle Impact

Columns on all sides of the driveway to be protected from vehicle impact

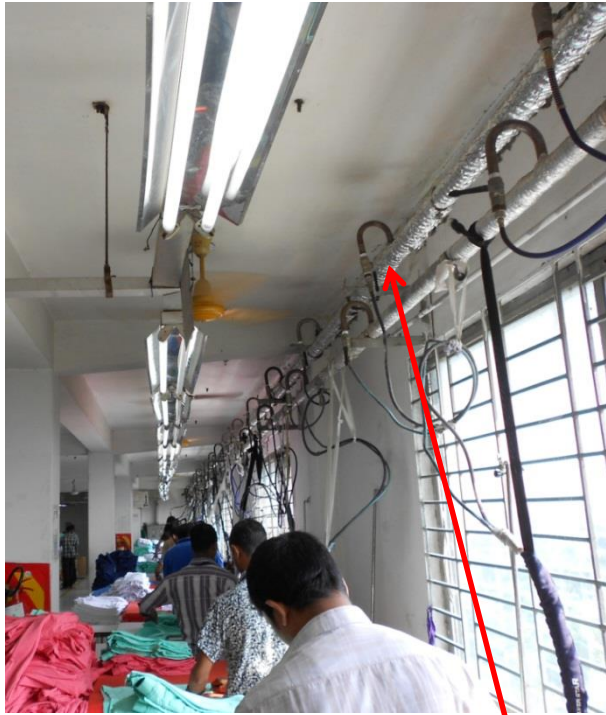
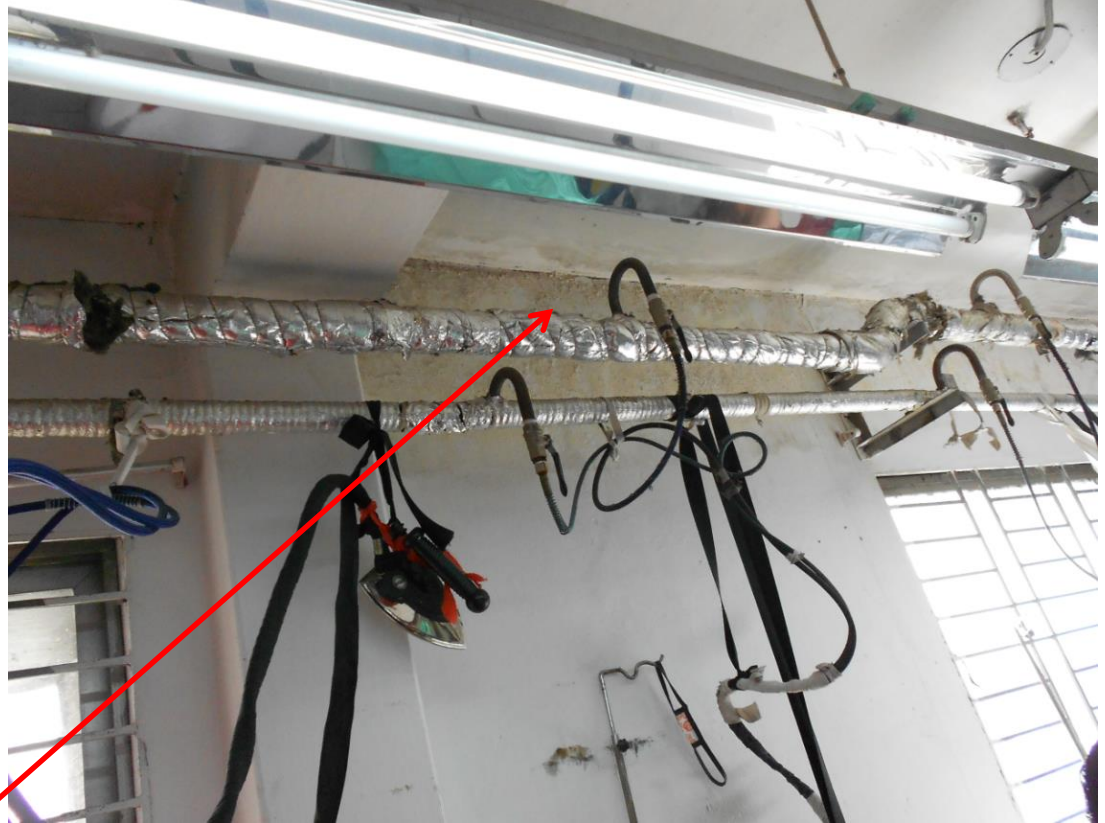
# Water causing damage and risk or corrosion

**Water damage due to condensation from ironing**

**Water causing damage and risk of corrosion**
