# Ragadi Textiles Ltd

Kainjanul, Mirazapur, Dhaka  
(24.0788N, 90.3569 E)

30 October, 2013

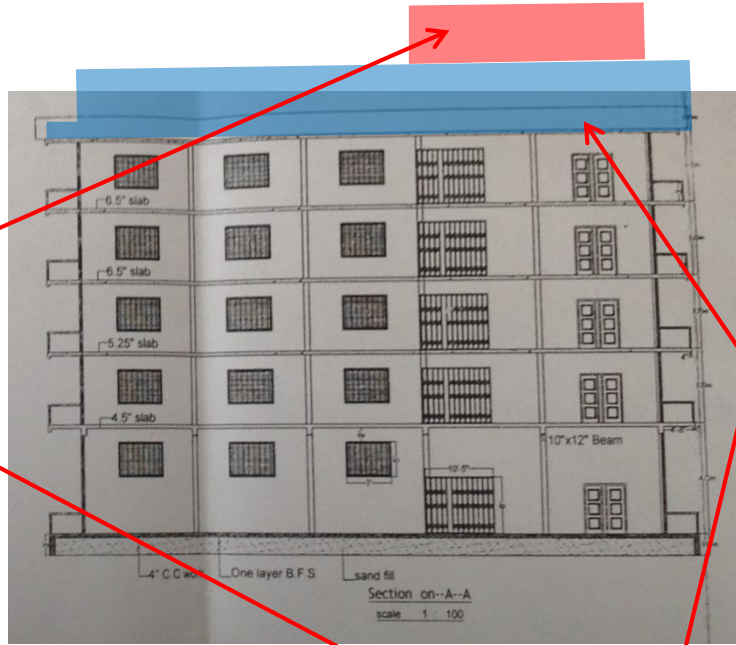
# Check on columns required

Not shown on  
either  
Engineering OR  
Permit drawings

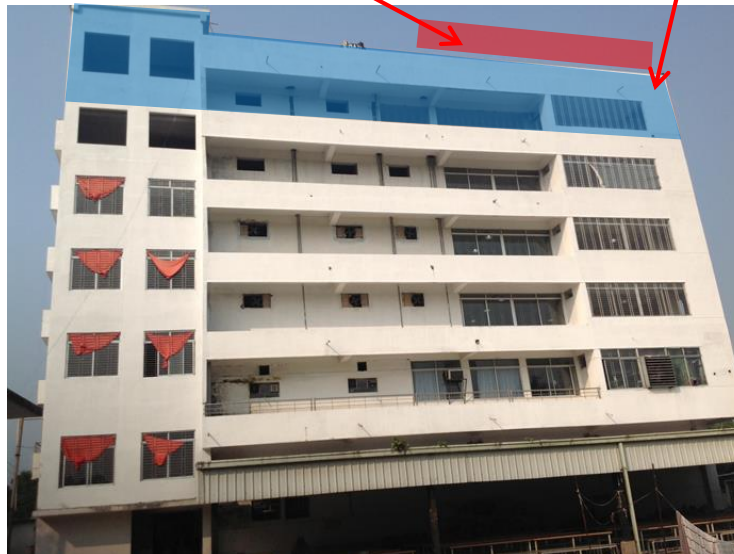
Not shown on  
permit drawings,  
but shown on  
engineering  
drawings

4 storey + roof permit has  
been obtained. 5 stories plus  
additional roof structure has  
been constructed so far –  
engineering drawings show 6  
storey building, but no roof  
structure.

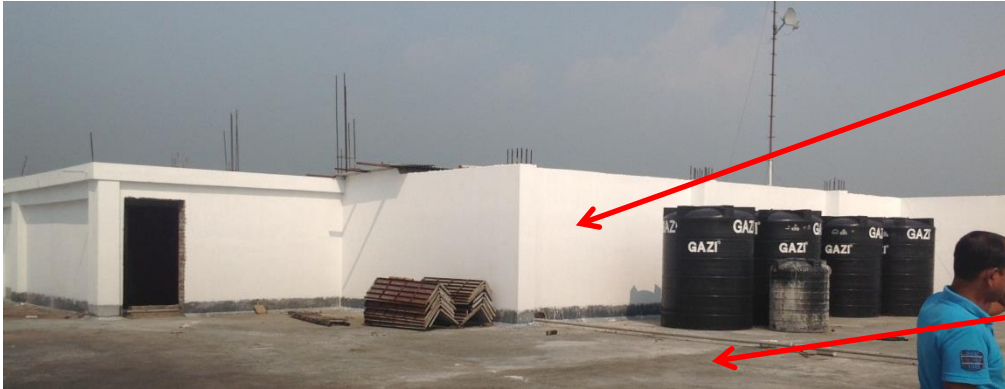
6<sup>th</sup> floor/roof level

Unreinforced masonry walls and concrete roof

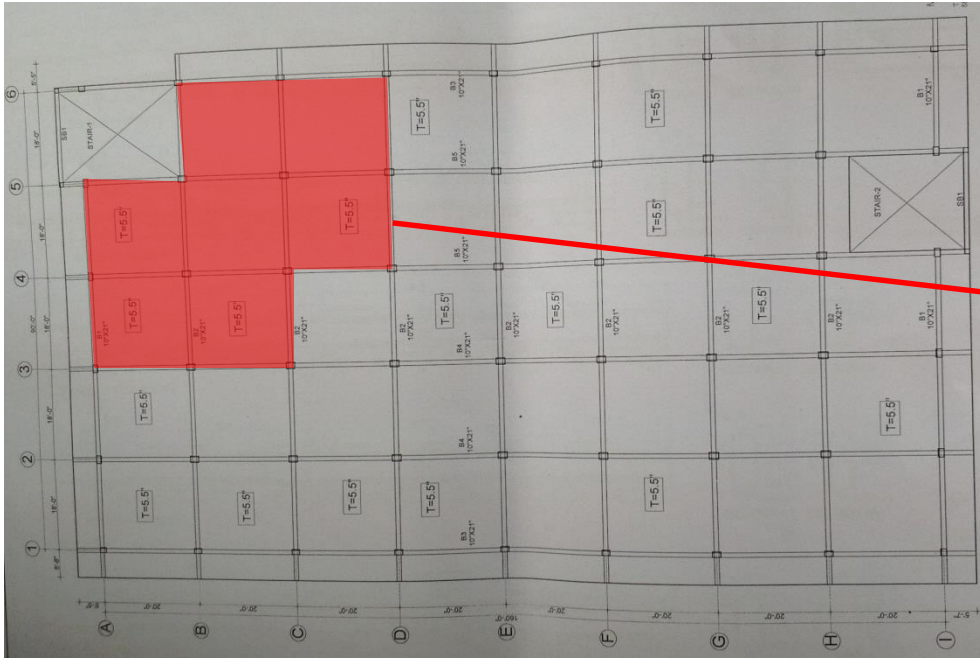
Extent of constructed additional roof structure

Check on additional floor and roof additions required

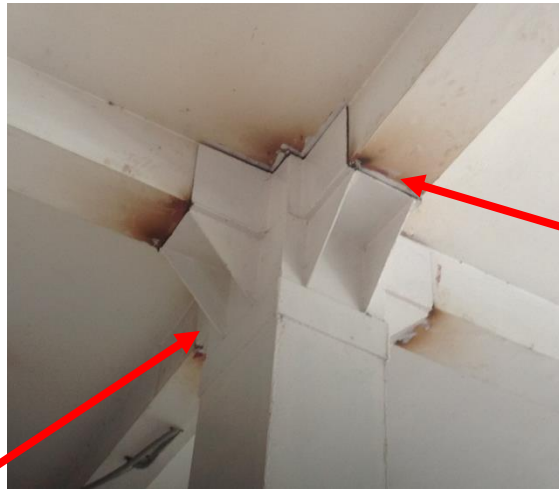
Cursory calculations indicate column working stress is NOT at high risk level – 9MPa interior columns, 11MPa corner columns.

Current steel strengthening measures appears ineffective as it seems steel is not in contact with concrete

Steel jacking of interior columns at Ground Level

Steel belting and partial concrete jacking of exterior columns at Ground Level, and 3 corner columns at Levels 1 and 2.

Check that steel is in contact with concrete (not render). Where there is a gap, gap is to be packed with suitable material to transfer load.

| Item No. | Observation | Recommended Action Plan | Recommended Timeline |
|---|---|---|---|
| 15 | Assess existing column strengthening | Check that steel is in contact with concrete (not render). Where there is a gap, gap is to be packed with suitable material to transfer load. | 6-months |

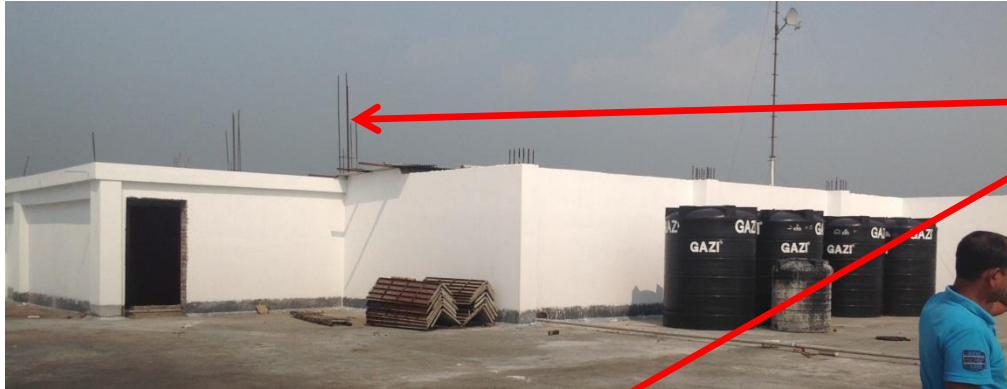
**Starter bars left to  
continue further  
construction of columns**

| Item No. | Observation | Recommended Action Plan | Recommended Timeline |
|---|---|---|---|
| 12 | Uncertainty over roof loading | Further construction of roof additions to cease until column check (Item 1) is complete. | Immediate - Now |

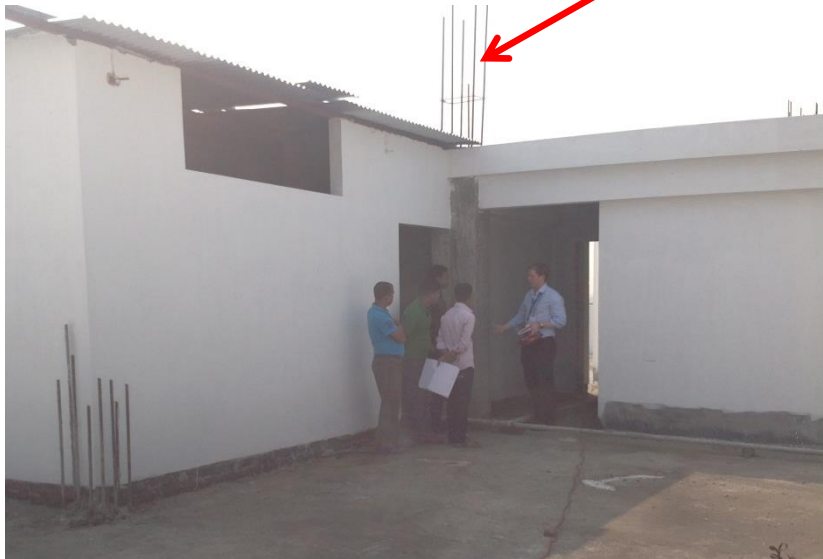
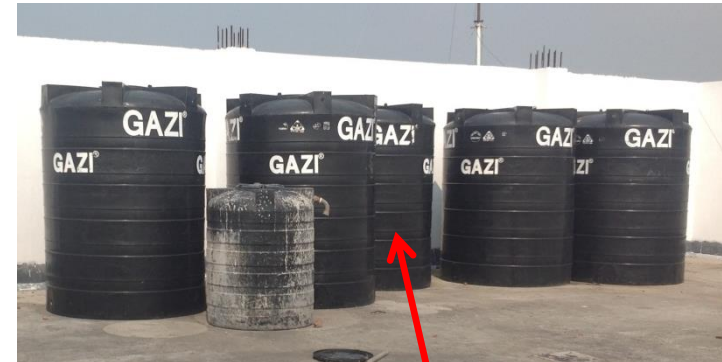
**Position of empty water tanks on  
roof to be confirmed with engineer  
prior to filling and connection**

**Check on additional floor  
and roof additions required**

| Item No. | Observation | Recommended Action Plan | Recommended Timeline |
|---|---|---|---|
| 13 | Uncertainty over roof loading | Location of water tanks to be confirmed with engineer. | 6-weeks |
| 14 | Uncertainty over roof loading | Include water tank locations in loading plan | 6-weeks |

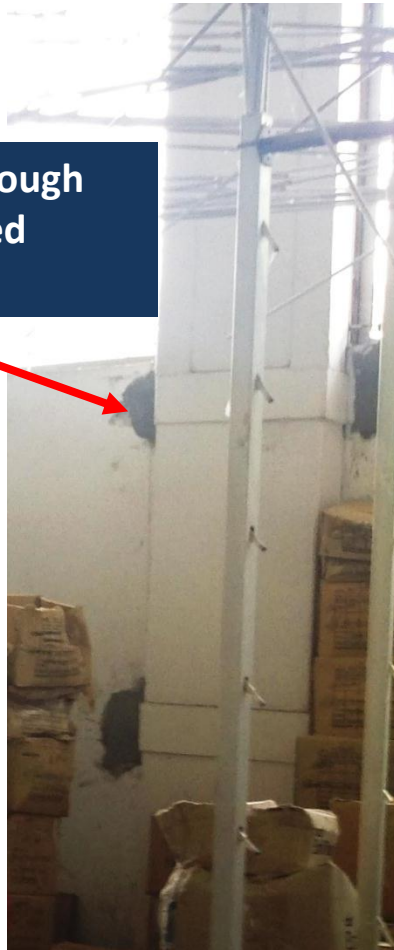
**Steel belting placed through exterior wall and welded during installation**

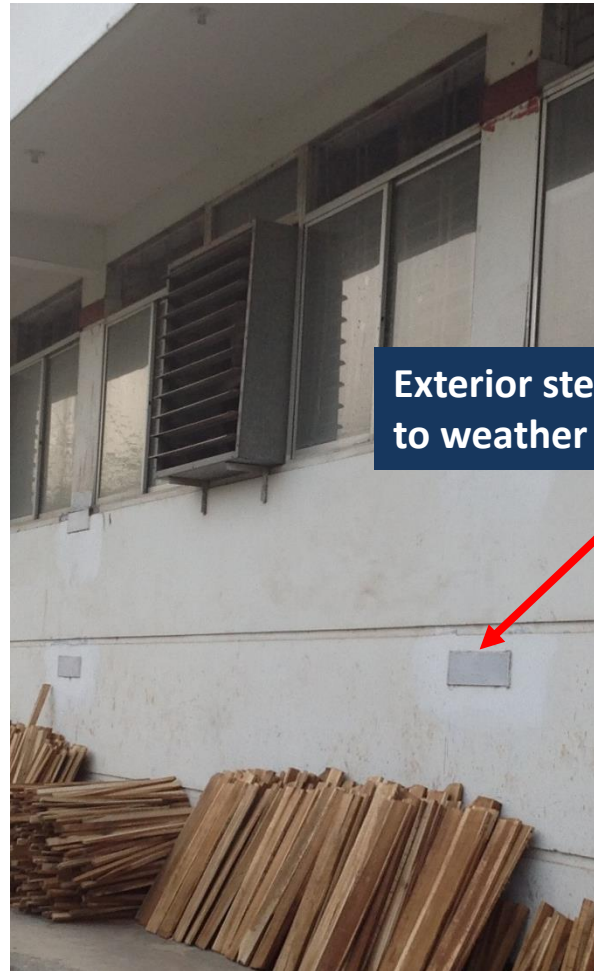
**Exterior steel belting exposed to weather**

**Protect exterior steel belting**

| Item No. | Observation | Recommended Action Plan | Recommended Timeline |
|---|---|---|---|
| 17 | Protect exterior steel belting from the environment | Protect exterior steel belting with render or epoxy/chemical waterproofing. | 6-months |

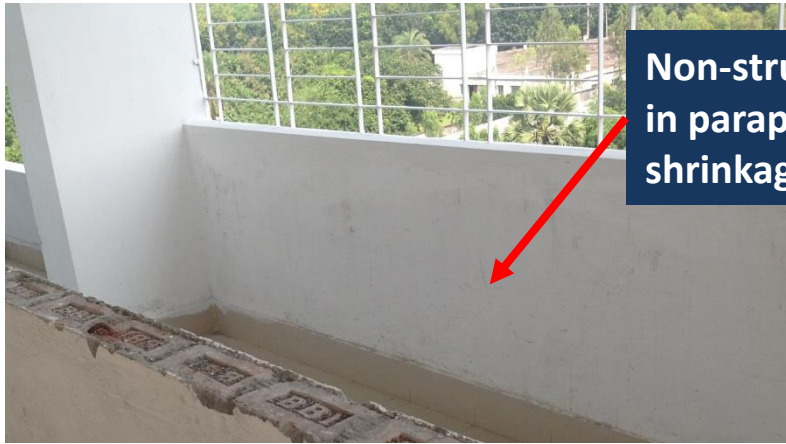
**Non-structural hairline cracks in parapets, likely caused by shrinkage of concrete**

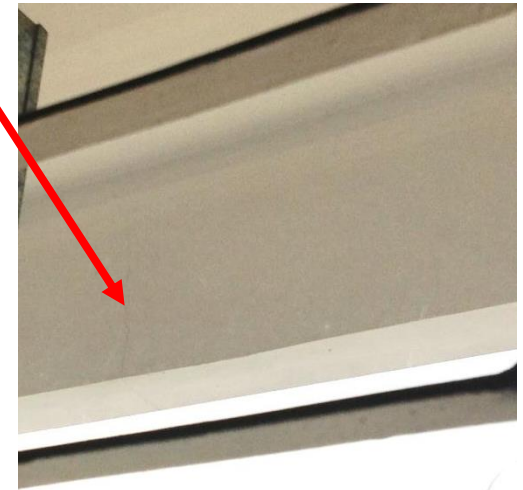
**Non-structural hairline cracks in brick in-fill, likely caused by beam movement**

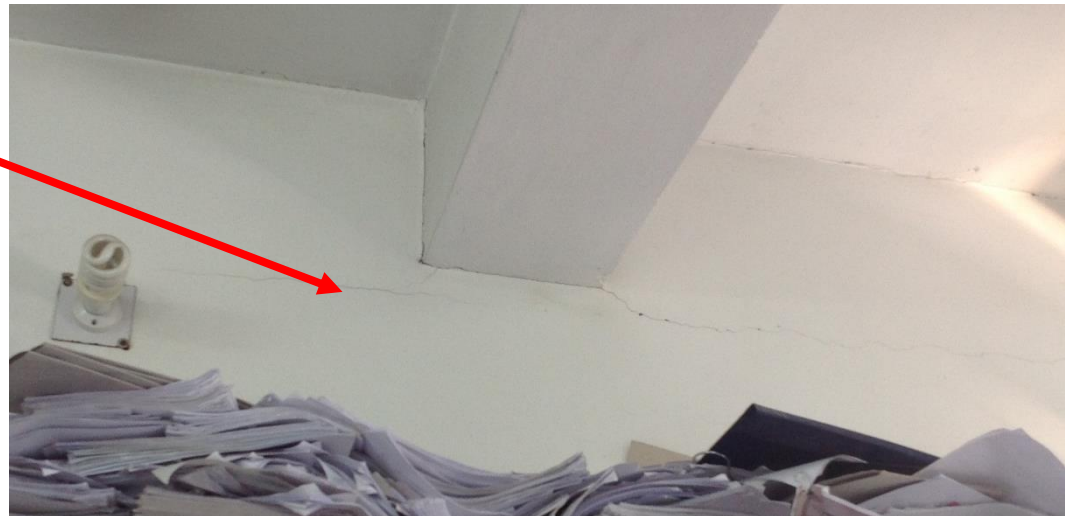
## **Non-structural hairline cracking**

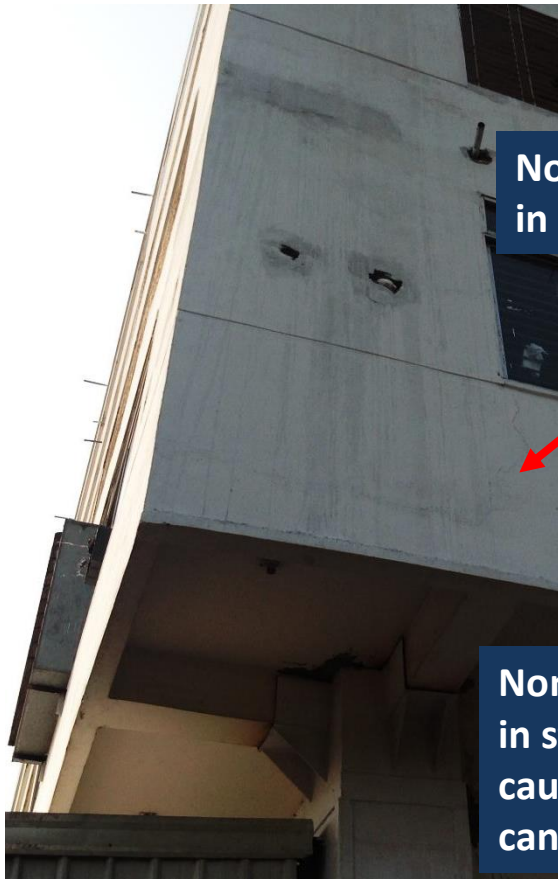
**Non-structural hairline cracks  
in brick in-fill wall and beam**

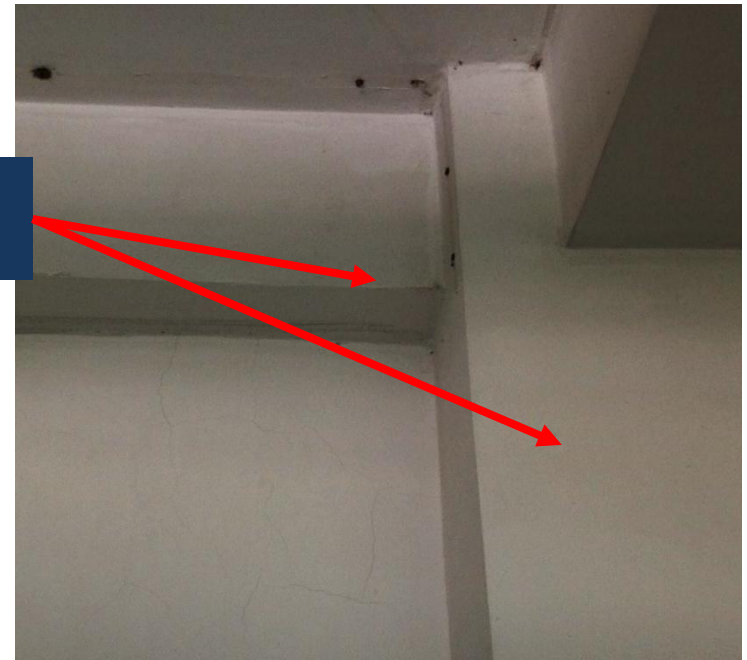
**Non-structural hairline cracks  
in stair wall brick in-fill, likely  
caused by deflection of  
cantilever landing**

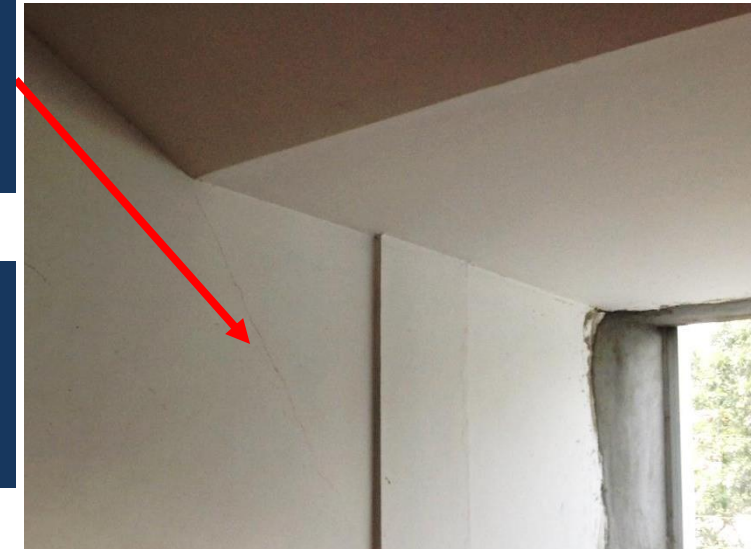
**Evidence of some crack repairs  
noted. Repair method  
provided to factory owner by  
BUET**

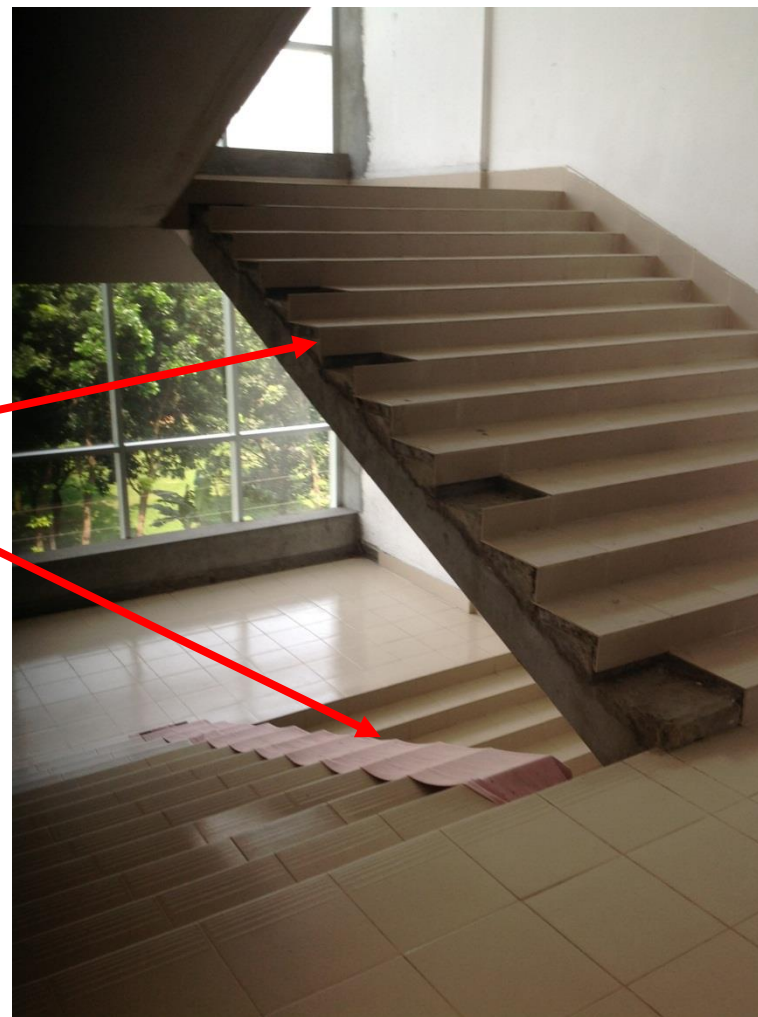
**Fire escape handrail**

**Handrail missing from fire  
escape stairs**

**Manager gave assurances this  
would be rectified within the  
next week.**

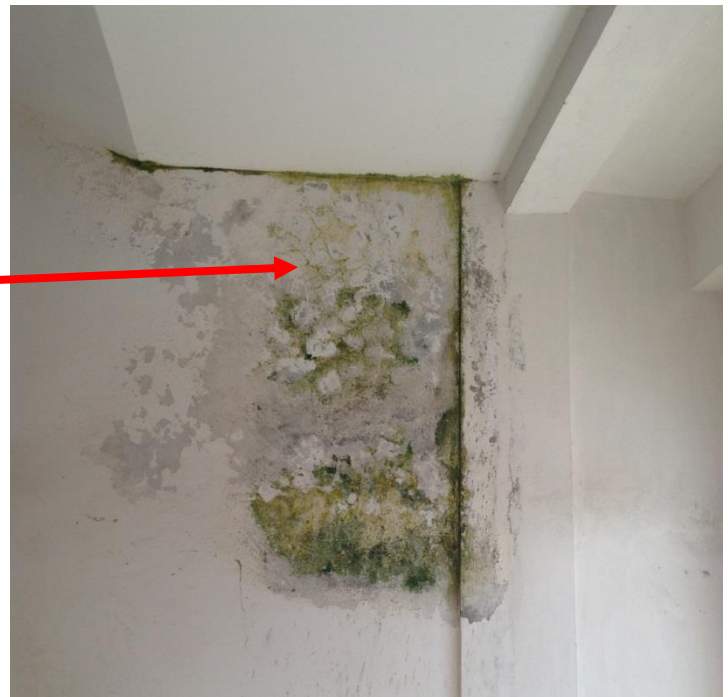
Water damage to wall on rear elevation in stair cores both internal and **external**

No evidence of structural damage or deterioration of concrete elements

**Water damage near concrete**
