TM Fashion Ltd.

Jobeda Tower, Chandana, Chowrasta, Gazipur Sadar, Gazipur, Bangladesh
(23.986522N, 90.381394E)
18 December 2013

Observations

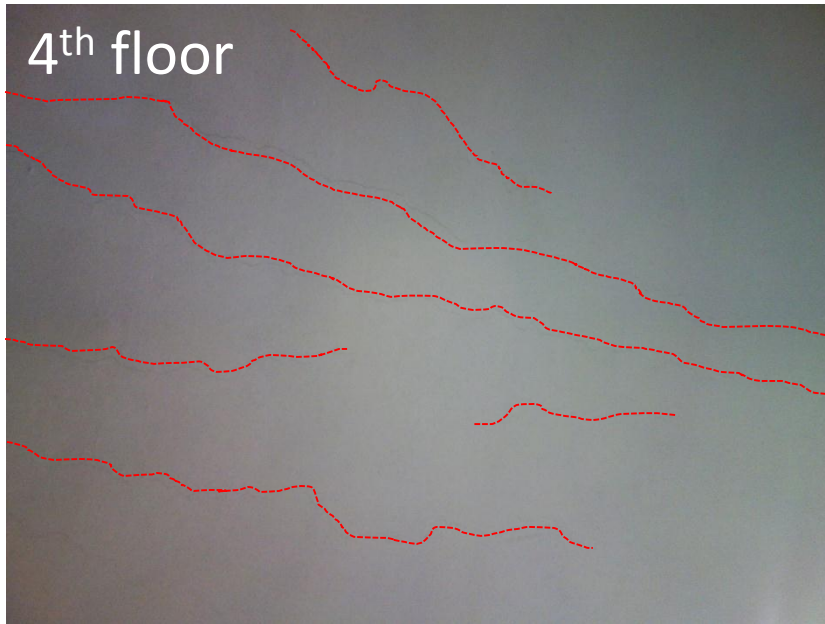
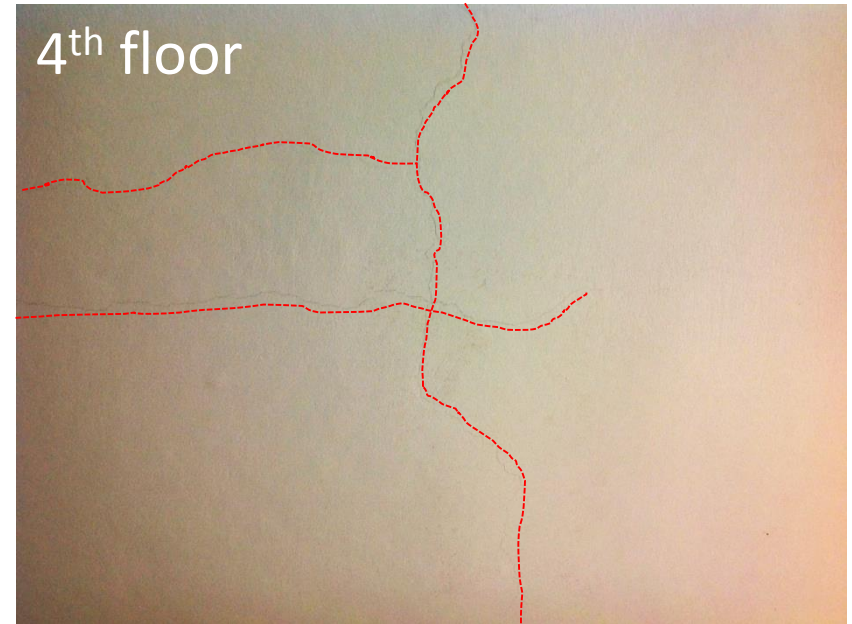
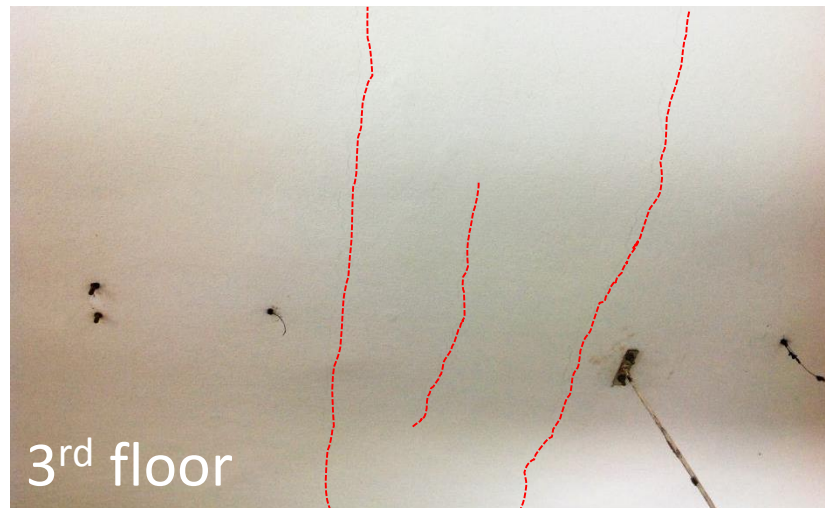
Cracking in slabs and beams

Cracks parallel to longest span detected in several floors. Cracks appeared concentrated at midspan area.

Building's Engineer to check cracks are only into the plaster and to ensure crack do not continue into concrete slab.

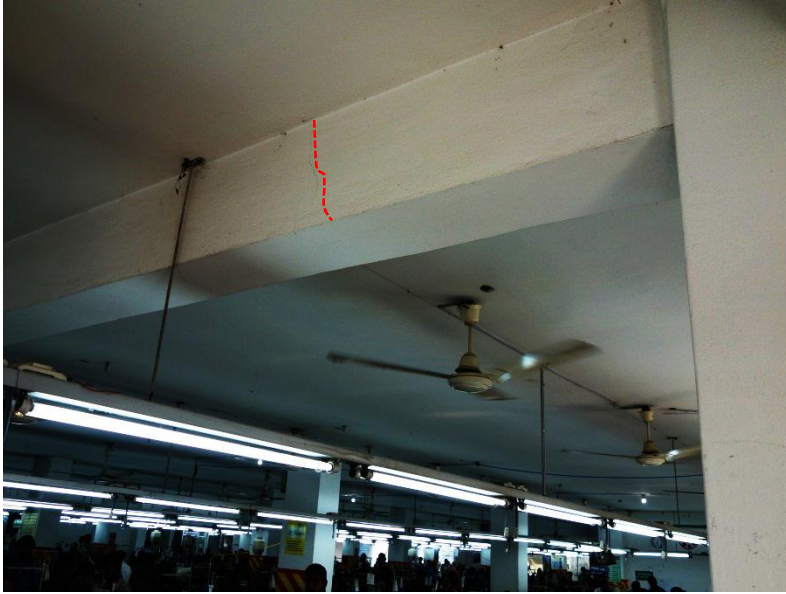
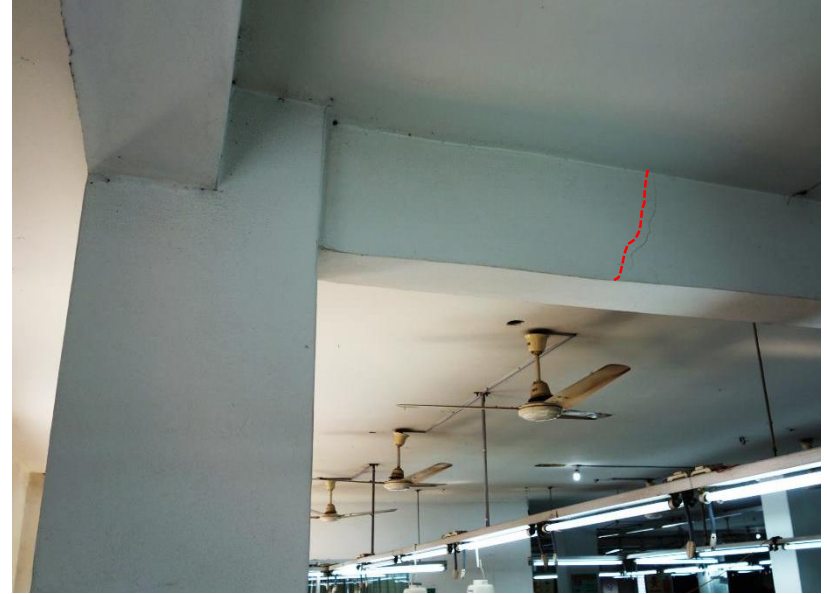
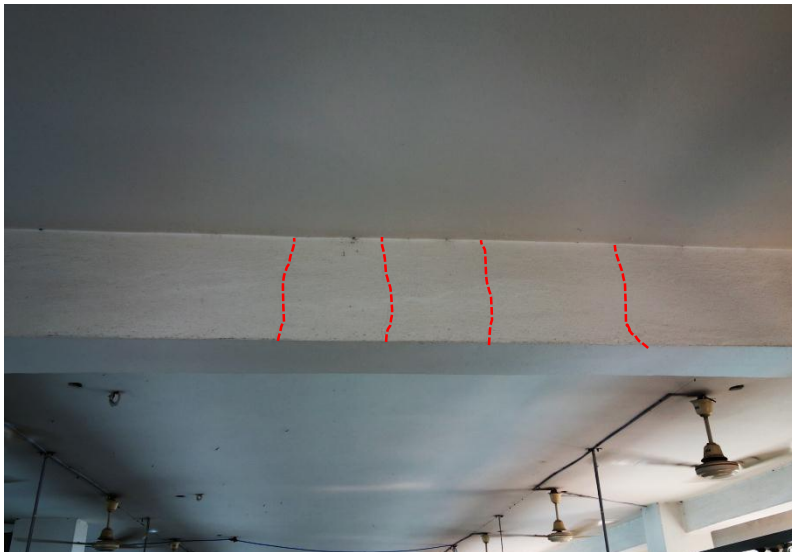
Cracking in beams at level 3

Some cracks on beams detected.

Many of the cracks appear to be shrinkage related - others not.

Building Engineer to ensure inclined cracks on beams are only in the plaster.

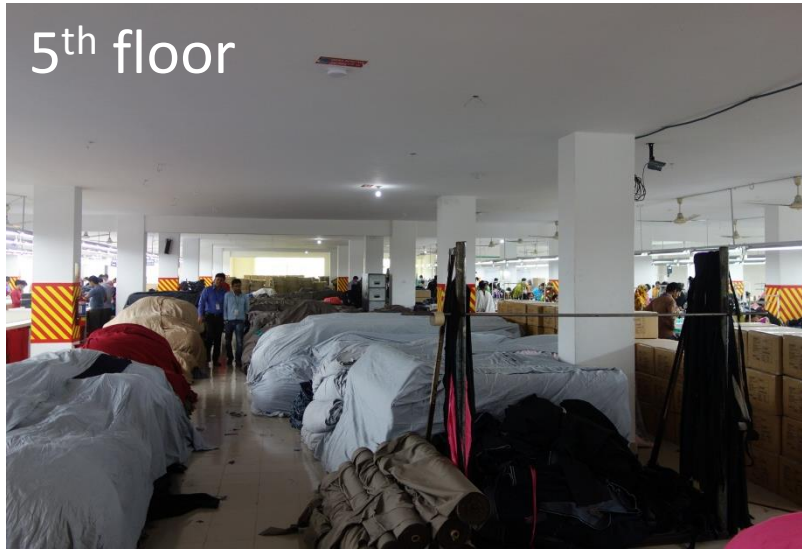
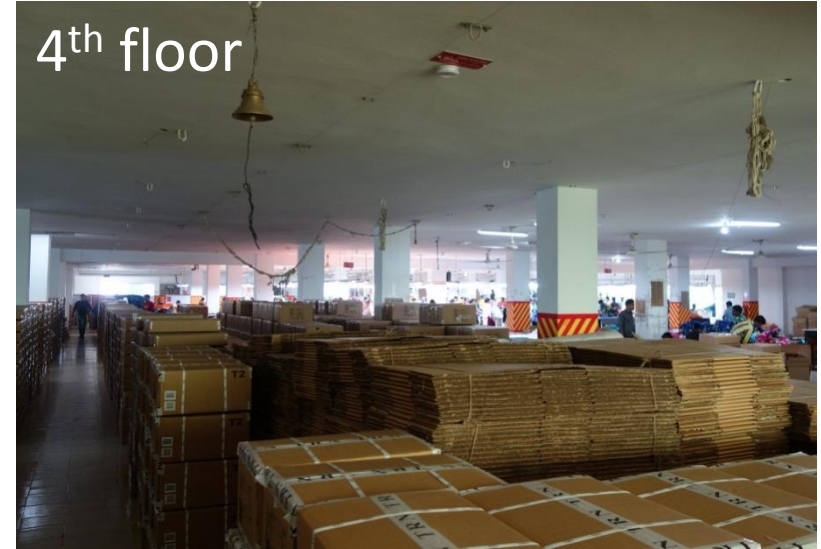
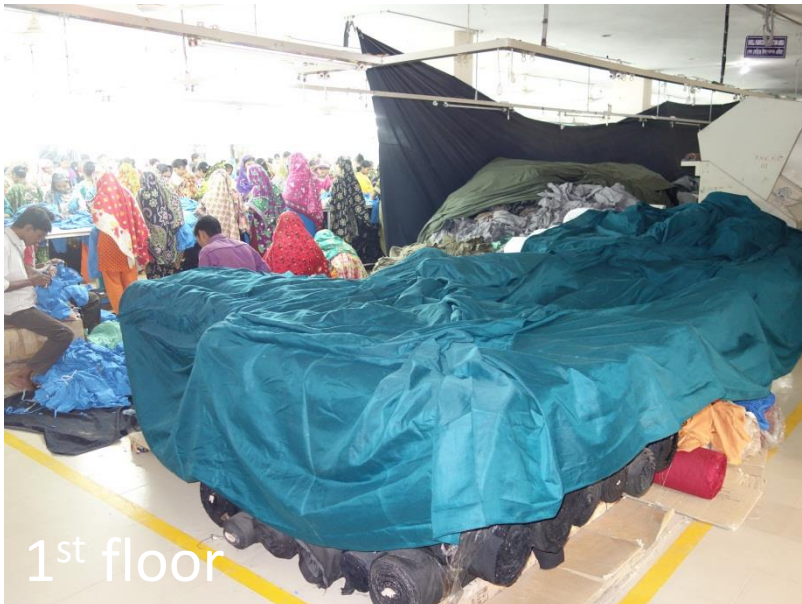
High loads on bonded/storage areas

Building designed for Commercial use.
Live load assumed 3.0 kPa.

Limit stack height to 1.80 m (1.50x1.50 area) and keep 0.5-0.6 m cleared strip around.

Limit loose clothing storage to 1.80 m high

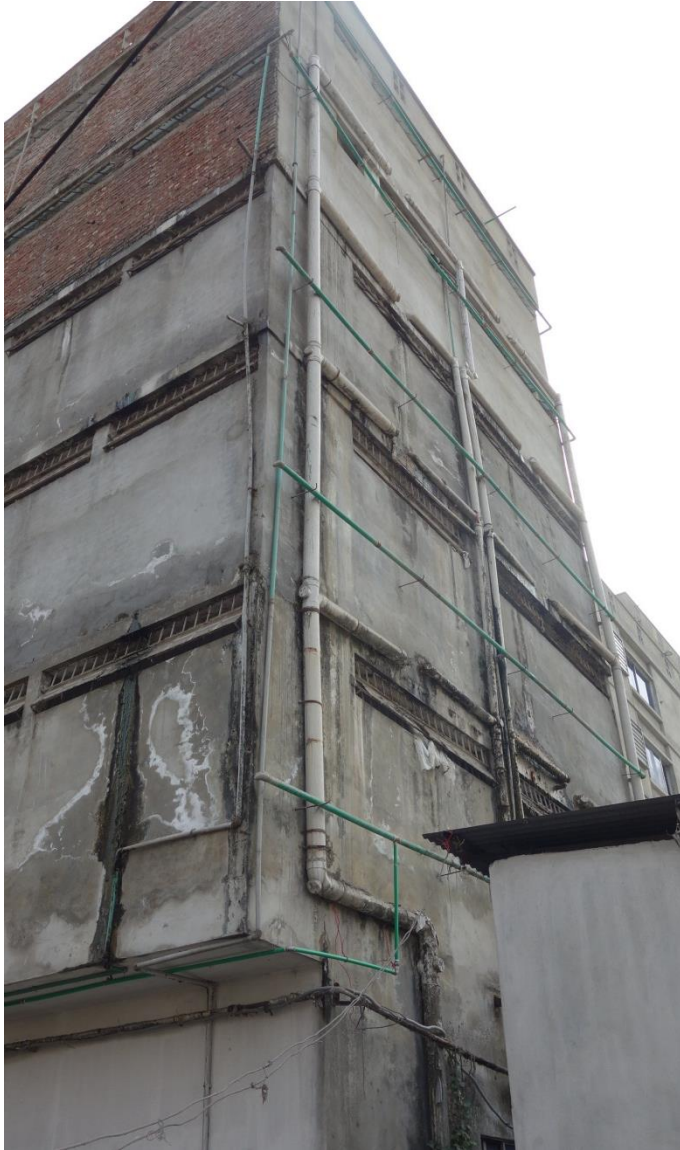
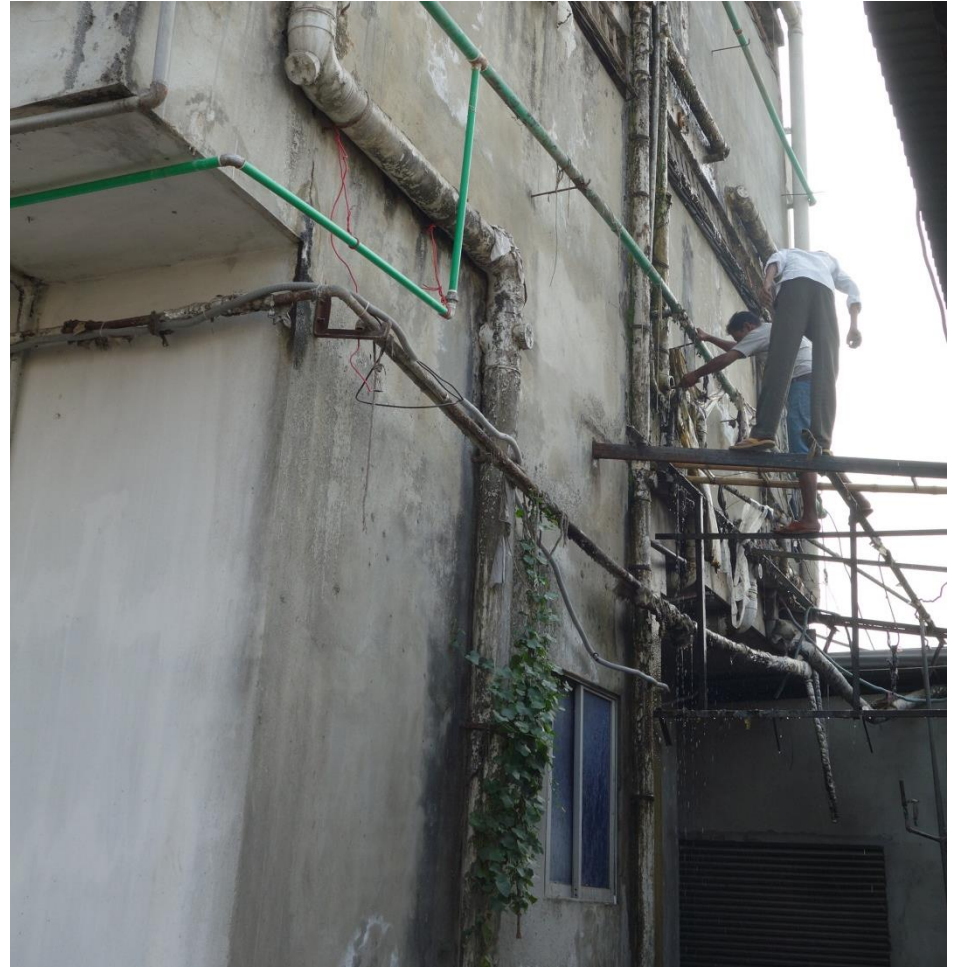
Water causing local damage

Water causing damage and corrosion

Leaking drainage pipes on façade.
Running water visible.
