# Vintage Garments Ltd. (9637)

30.April.2014

ACCORD  
on Fire and Building Safety in Bangladesh

## Identified Priority 3 Concerns

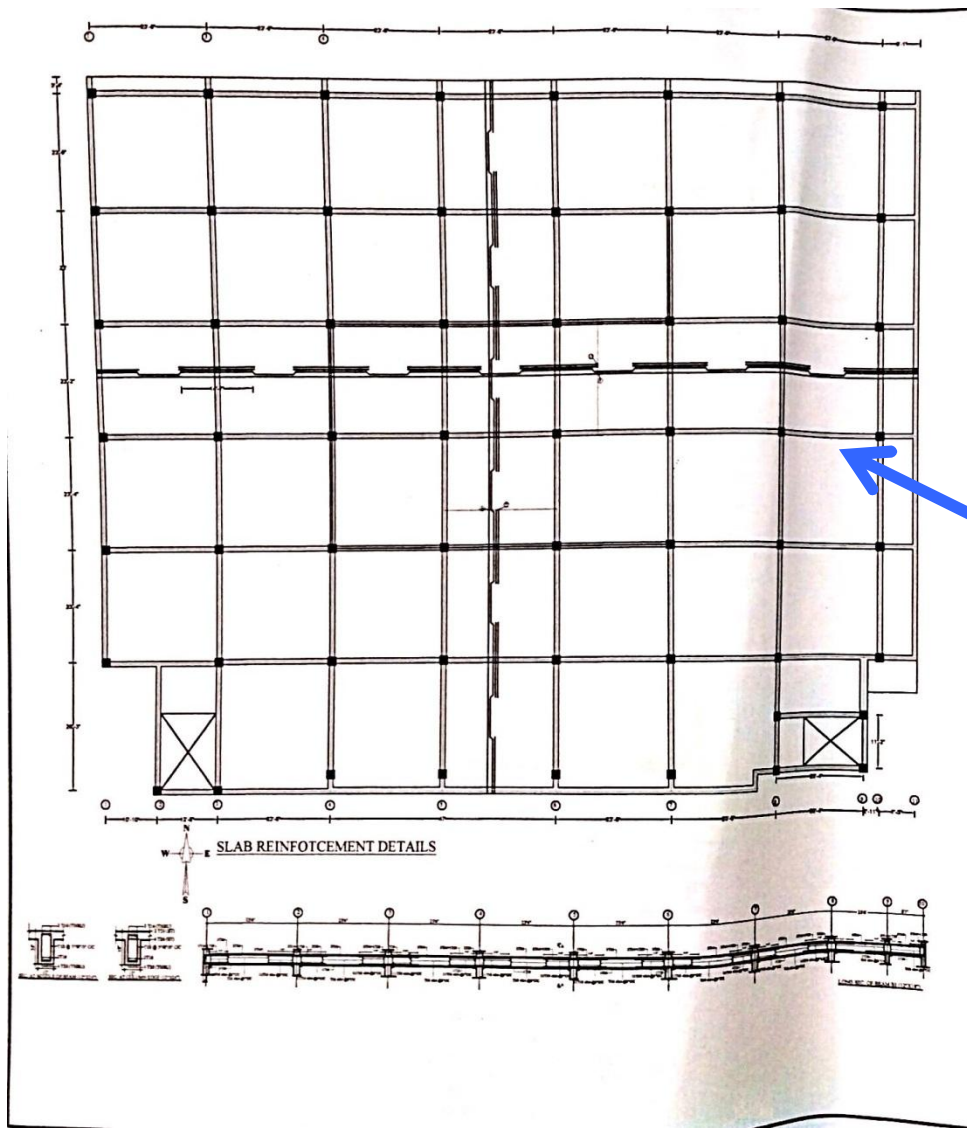
1<sup>st</sup> Priority 3 concern

As mentioned previously, the construction documents do match the actual site conditions

There are no downstand beams in this building

**ITEM 1: Priority 3** - Construction documentation does not match site conditions.

- The Factory Engineer is to survey the actual site conditions and provide accurate as built drawings.

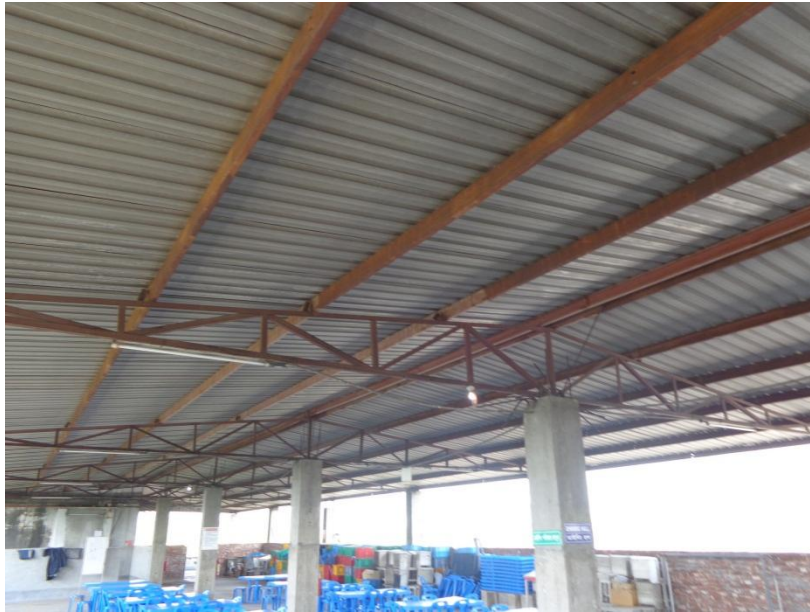
2<sup>nd</sup> Priority 3 concern

We require an Engineering Assessment of the steel sheds at the ground floor and the roof. Unrestrained flanges for purlins. Unrestrained condition for uplift forces on the main trusses.

**ITEM 2: Priority 3** - Steel shed at roof and ground floor level with poor detailing.

- Produce an Engineering Assessment of the steelwork roofs.
- Improve with proper connections, fixing and bracing as necessary.

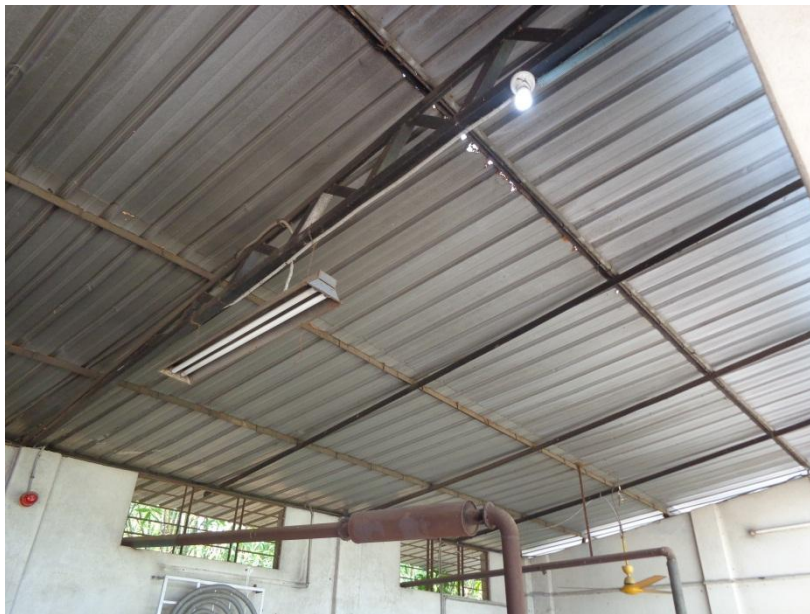
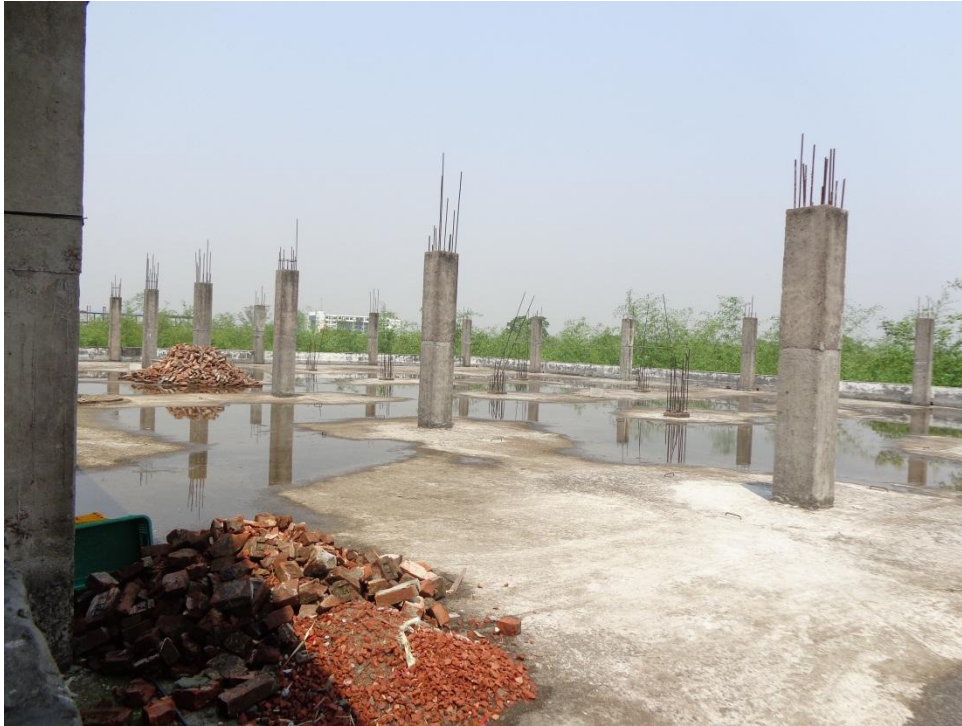
### 3<sup>rd</sup> Priority 3 concern

No waterproofing membrane was visible on the roof of the building. This means that any cracks in the surface finishes on the roof will allow water to seep into the concrete slab beneath the finishes, and cause long-term soaking of the slab. The same applies for water tanks at roof level.

**ITEM 3: Priority 3** - No waterproofing at roof level.

- Apply and maintain a new waterproofing membrane.

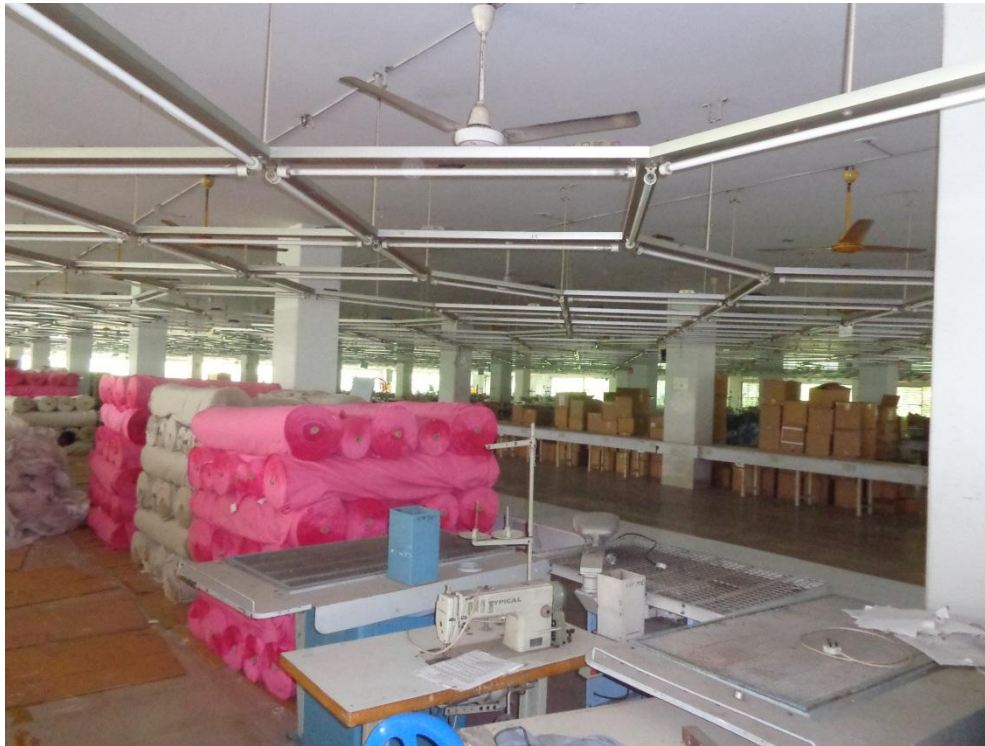
# Overall Stability System

Sway stability of the building could probably be expected from a rigid frame system (slab and column participation) although no ductile detailing is provided in structural plans.

Masonry infill is unrestrained and cannot be considered as helpful.

We require that these items be investigated in an Engineering Assessment
