Reedisha Knitex Ltd.

Dhanua, Nayanpur, Sreepur, Gazipur
(+24.2595360 N, 90.3963070 E)

28 September 2013

Building Observations

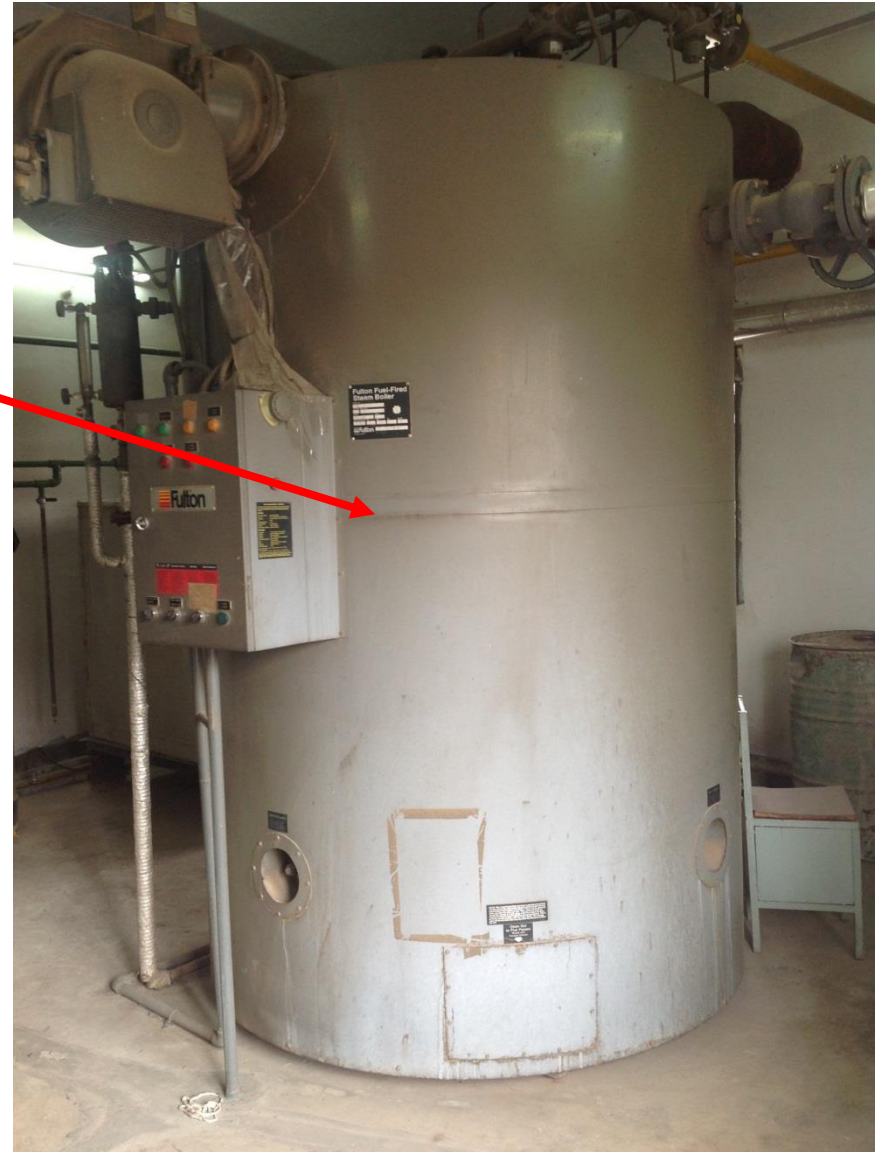
Garment Building: Check on design of floor structure supporting boiler required

Potentially large boiler loading on 4th floor

**Engineer is to perform detailed calculations to prove slab size and (if required) :
Reduce loads by vacating and discarding boiler, or reinforce supporting structure.**

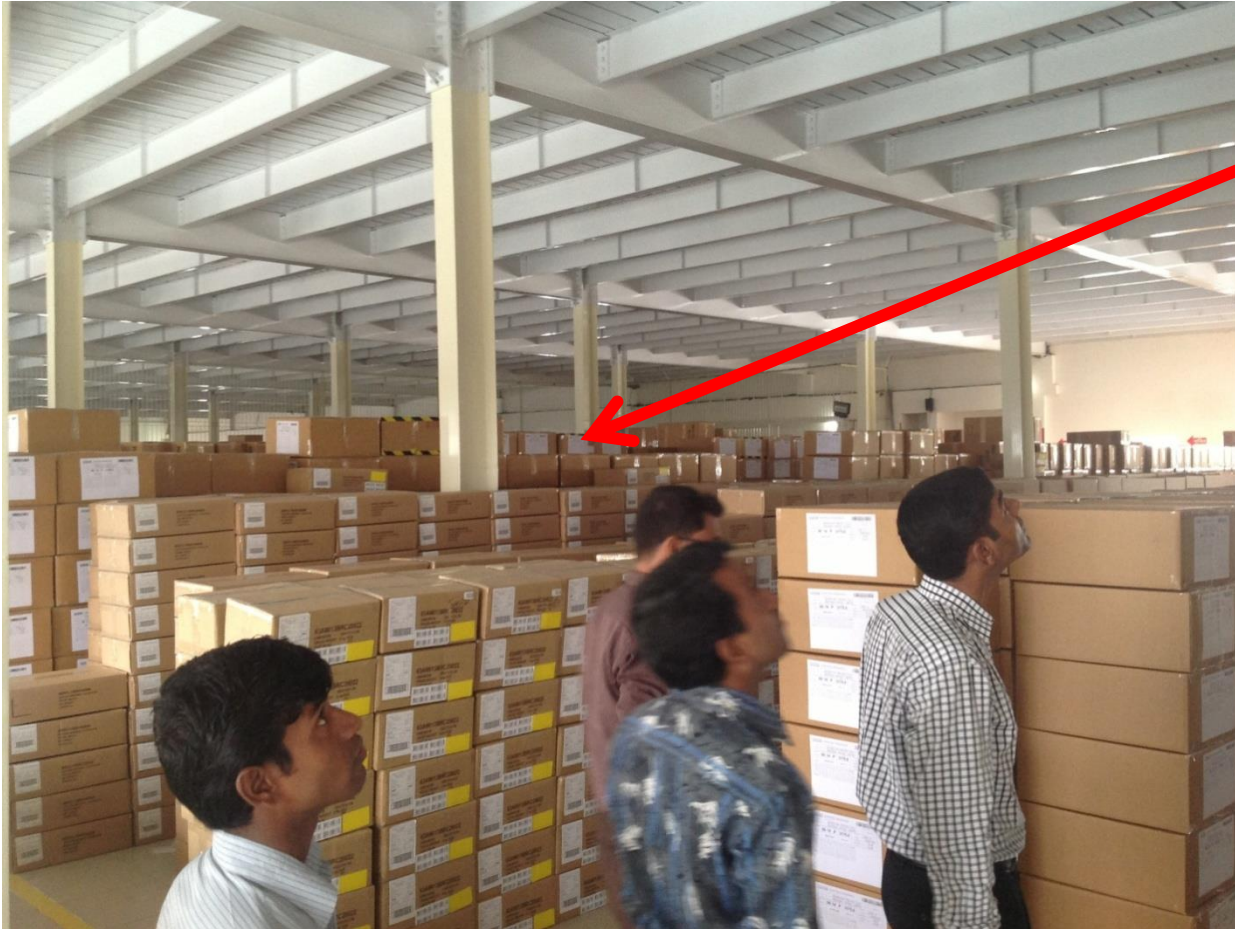
Material stacked high on 6th floor.

Plan and height restrictions to be introduced to prevent future overloading.

Restriction to be based on design floor loading.

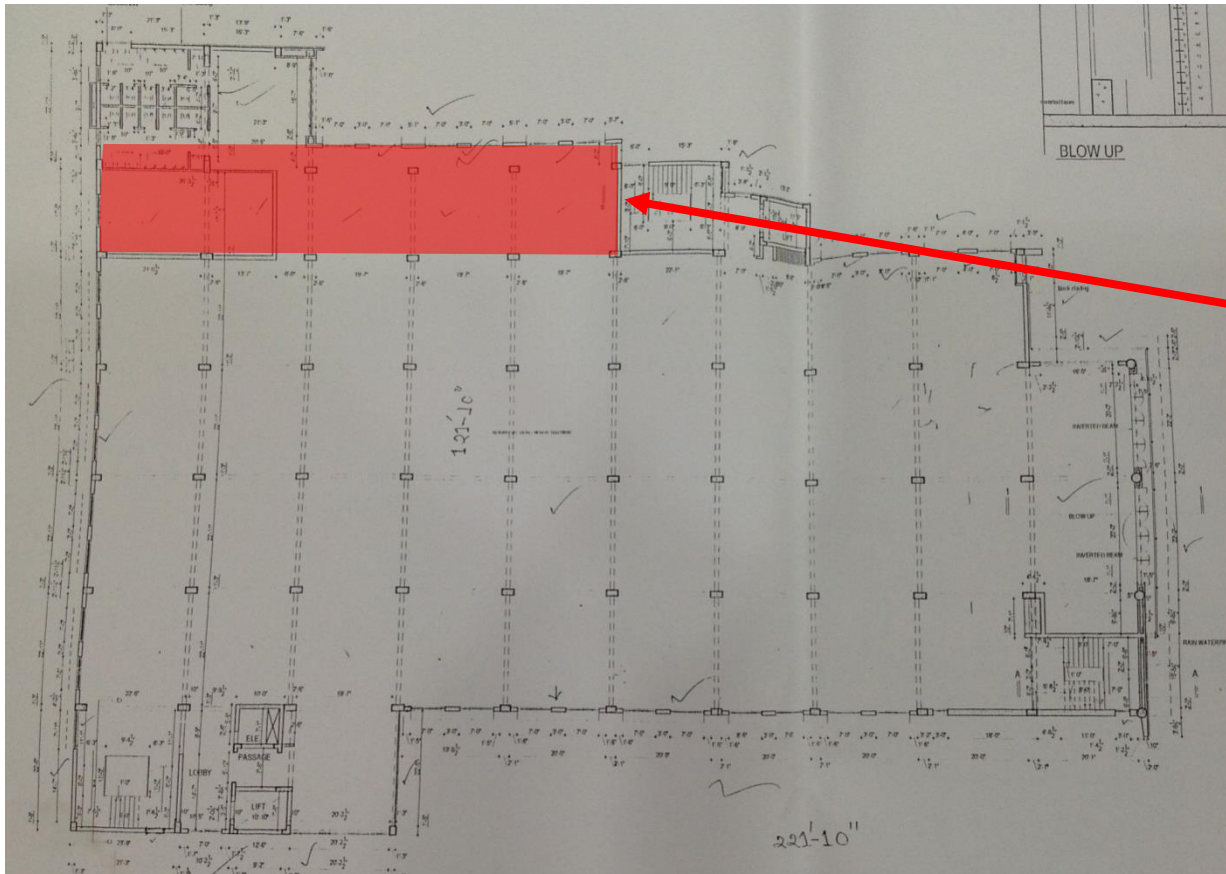
Garment building: Check on design of roof slab regarding water tank loading

Water tanks located on roof

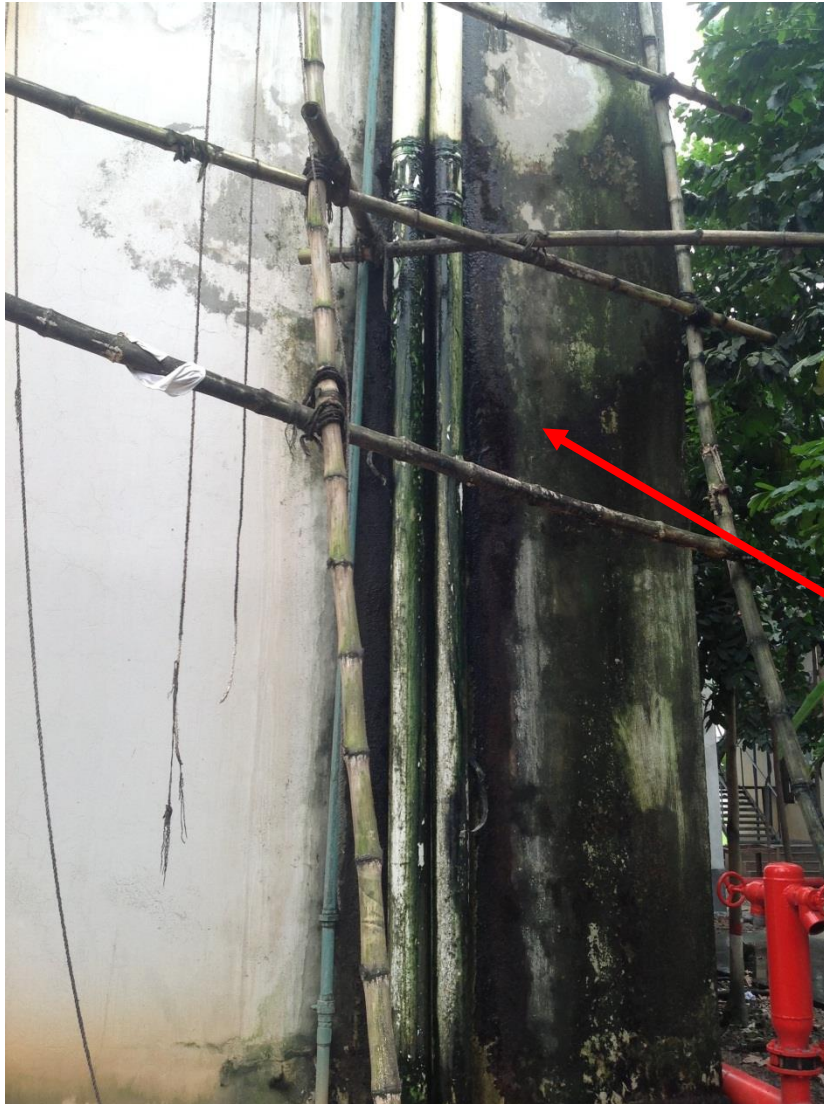
**Unmanaged drainage
causing corrosion to
façade and structure**

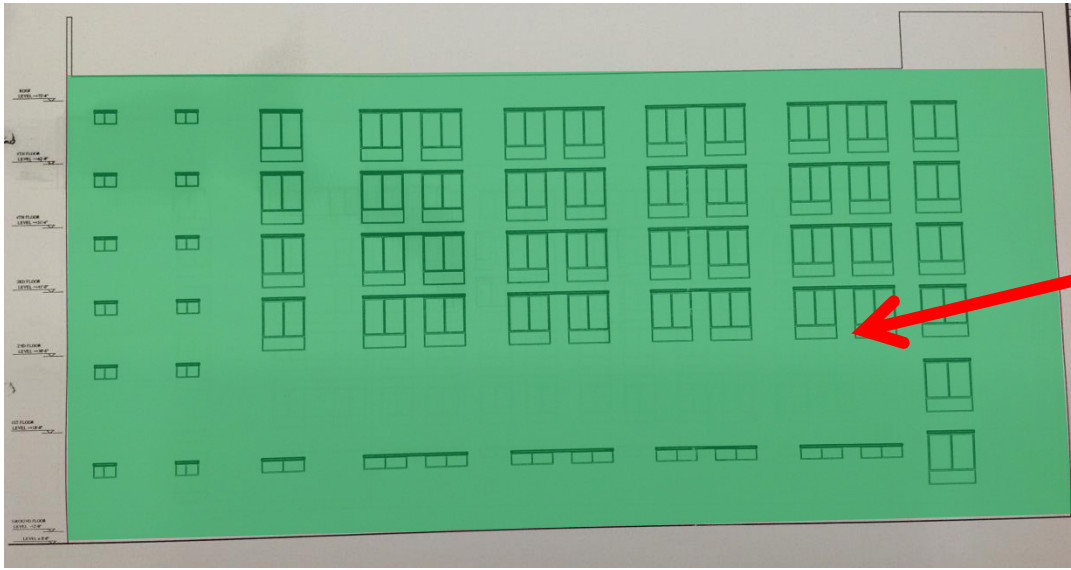
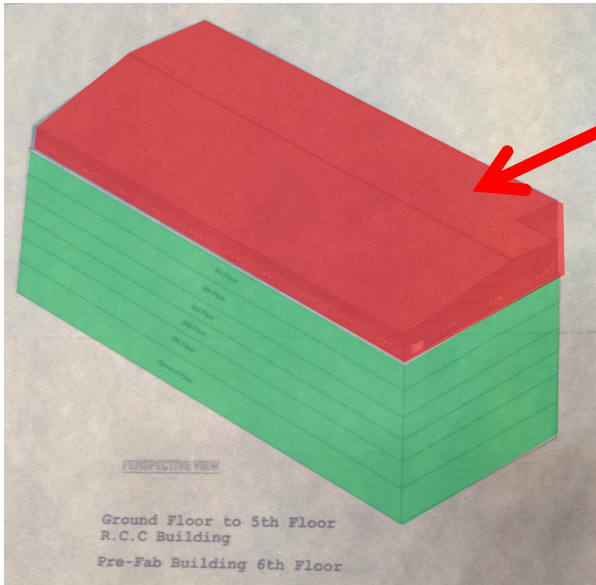
Garment building: Check on structure required due to additional roof extension

Original 6 storey permit for RC building (ground floor – 5th floor).

**Extension:
Pre-fabricated steel floor (6th floor).**

**Engineer is to perform detailed calculations to prove column sizes and (if required) :
Reduce loads by vacating floors and removing addition structures
Reinforce columns**

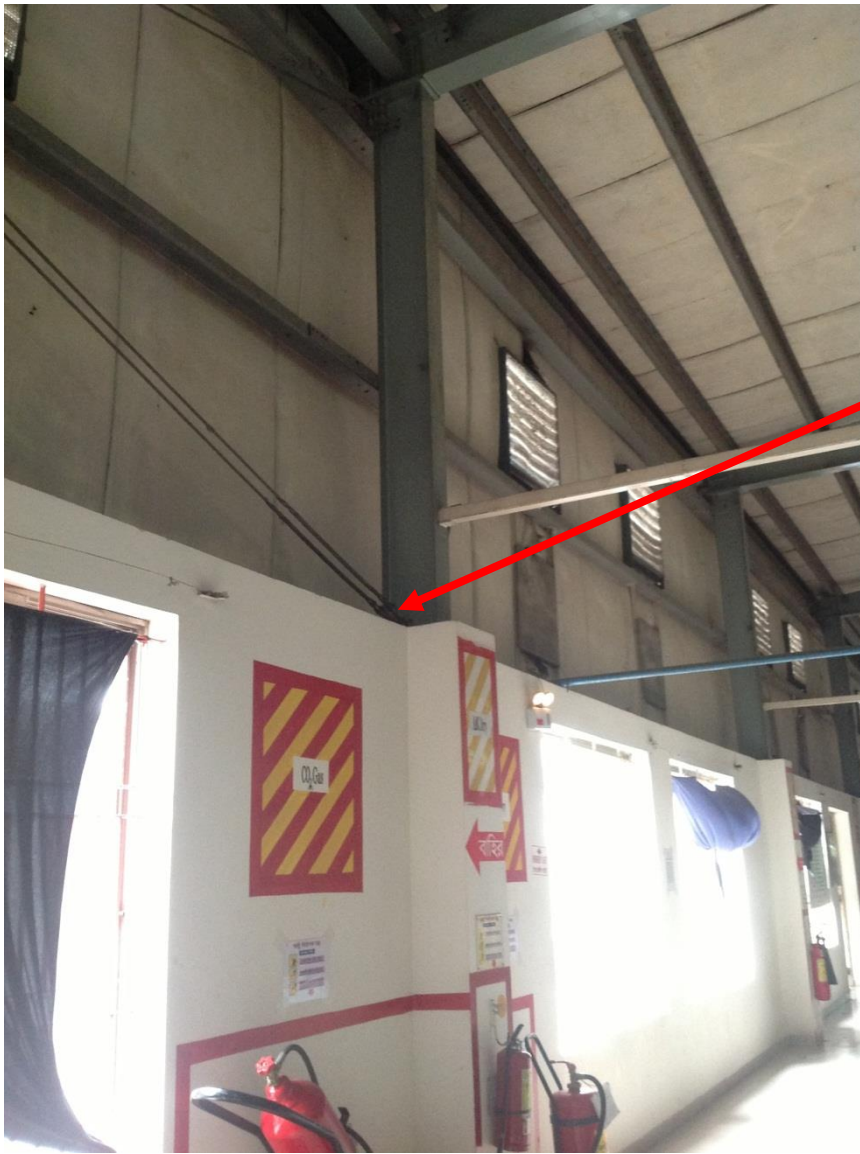
Knitting Building: Check on design of column supporting bracing member at mid-height required

Diagonal bracing supported at mid-height of column

Engineer is to perform detailed calculations to prove load path and column design.

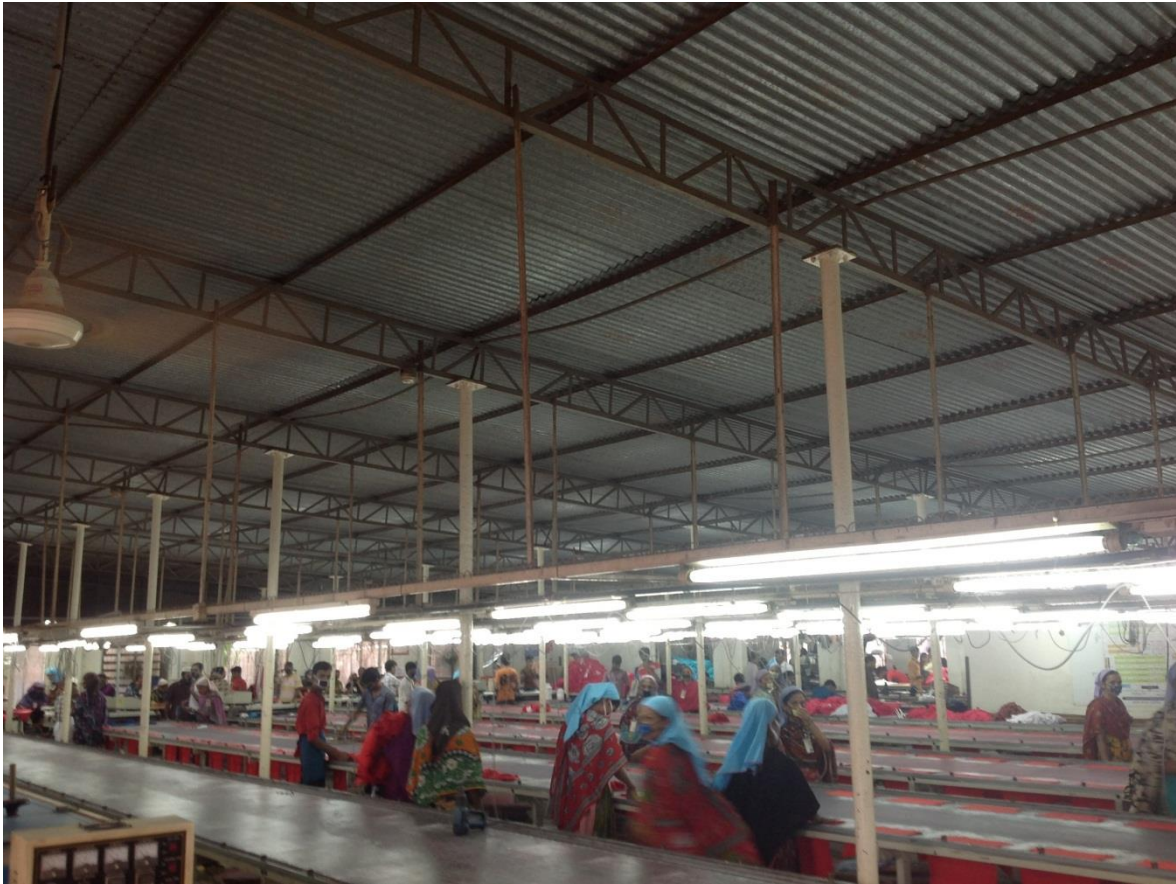
Check on structure, stability system, and roof connection of shed buildings

“Tin sheds”:

Engineer is to perform detailed calculations to prove design of structure, the vertical and horizontal stability system, and the connection between the vertical structure and the roof and remove/ replace if necessary
