# Smug Sweaters Ltd

Telipara, Gazipur  
(23.997564N ,90.382987E)

15 December 2013

# Building Observations

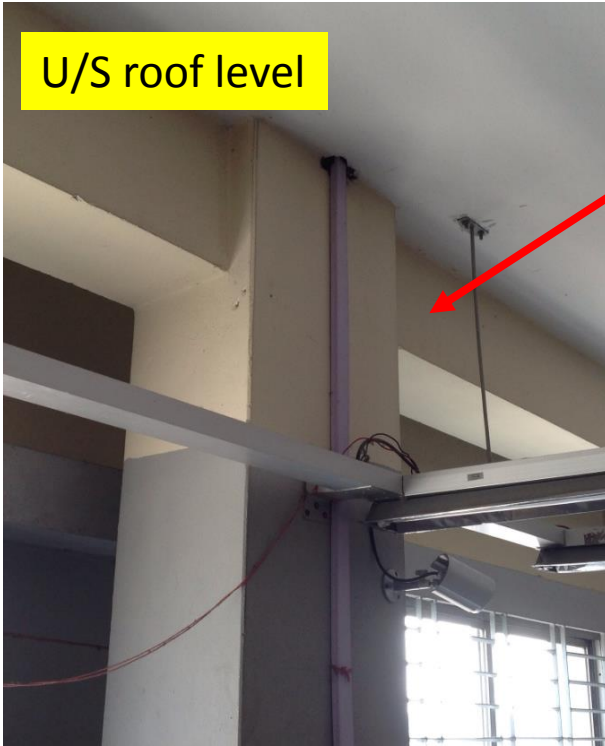
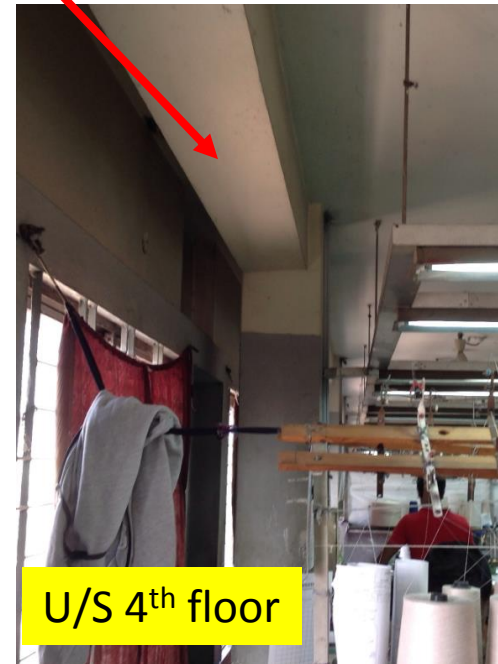
**Structural drawings not matching as built  
condition (minor)**

Edge beam shown on drawings at underside of roof (6<sup>th</sup> floor) but also present at underside of 4<sup>th</sup> floor

| Item No. | Observation | Recommended Action Plan | Recommended Timeline |
|---|---|---|---|
| 4 | Structural drawings do not match as constructed condition (minor) | Design check all columns, beams and slabs. Produce As-Built drawings showing actual conditions and arrangement for building. | 6-months |

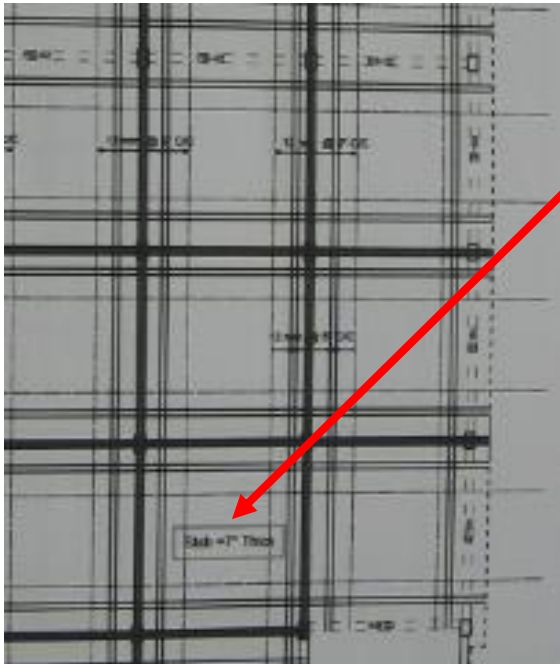
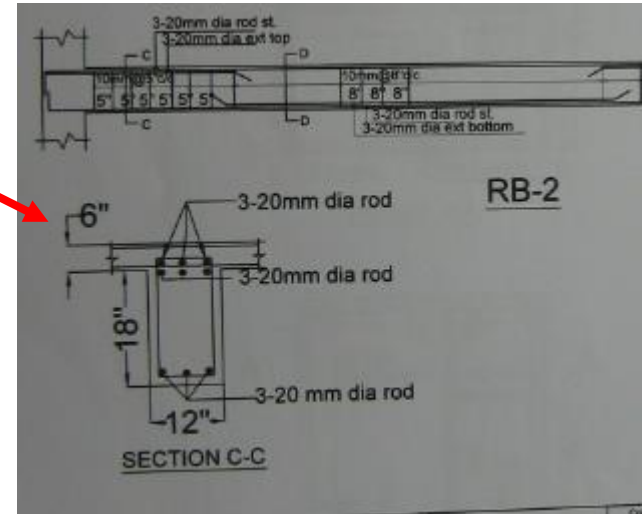
**Structural drawings not matching as built**

Roof slab shown as 7" on structural floor plans and 6" in roof beam sections. Roof slab appeared to be more active when jump test done. Thickness to be confirmed by engineer

Drawings titles do not correspond with the information shown on drawings. For example roof slab structural reinforcing drawings has title of Ground Floor

Incomplete set of structural drawings. For example there is no ground floor reinforcing drawings

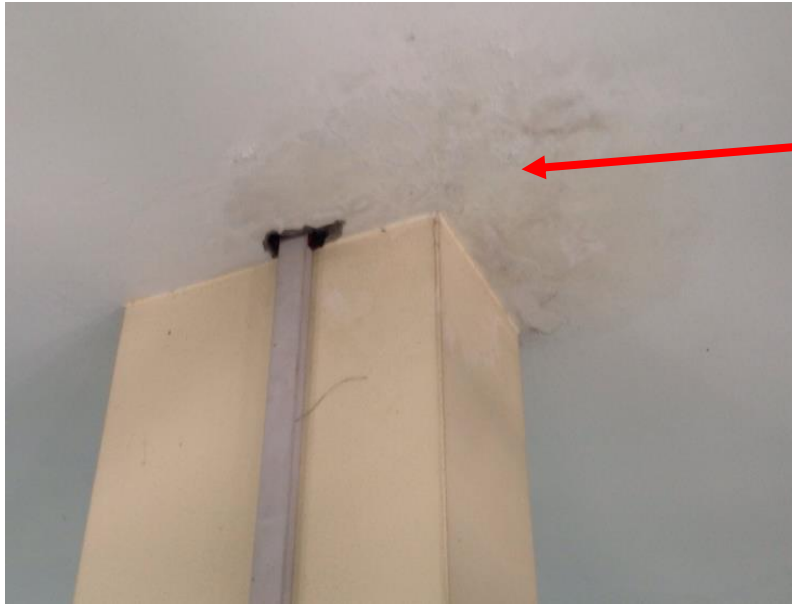
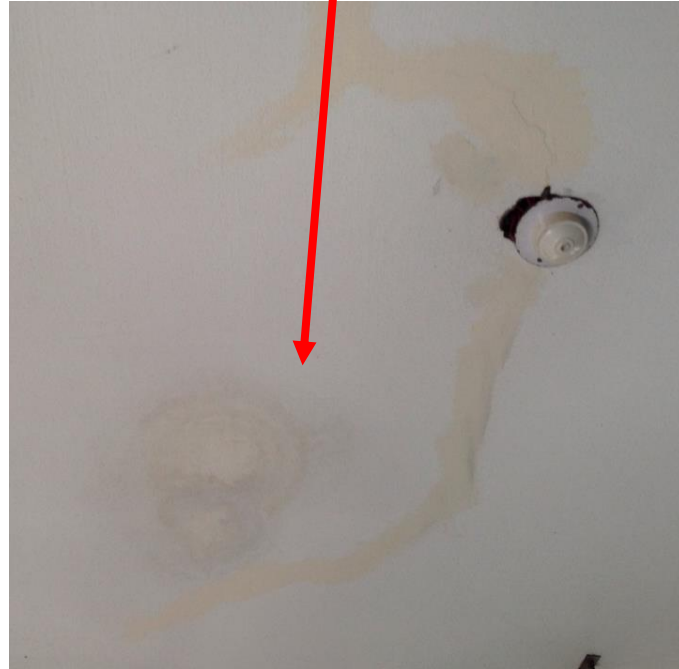
**Water damage to roof slab (area now not covered by steel roof)**

Water damage showing  
to ceiling of 5<sup>th</sup> floor (to  
area now without steel  
roof over)

**Water damage below uncovered roof area**

| Item No. | Observation | Recommended Action Plan | Recommended Timeline |
|---|---|---|---|
| 5 | Water damage evident to ceiling of 5th floor under area that has had steel roof removed | Ensure exposed roof slab is waterproofed | 6-months |

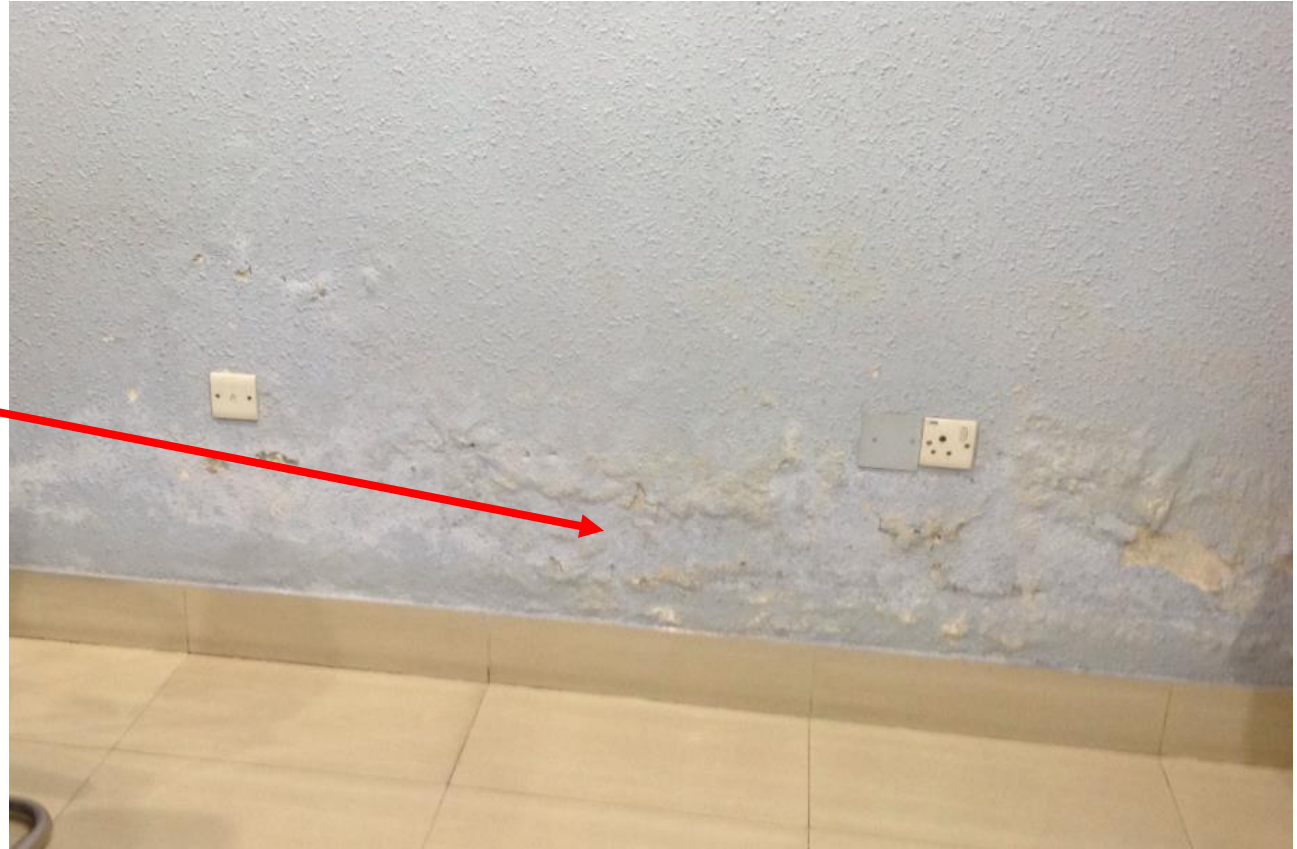
**Water damage  
to internal wall  
at Level 1 office  
area – toilet  
behind**

**Water causing damage and risk of corrosion**

| Item No. | Observation | Recommended Action Plan | Recommended Timeline |
|---|---|---|---|
| 6 | Water damage to internal wall at level 1 from toilet area | Rectify waterproofing to toilet to ensure that water penetration does not corrode reinforcing steel. | 6-months |

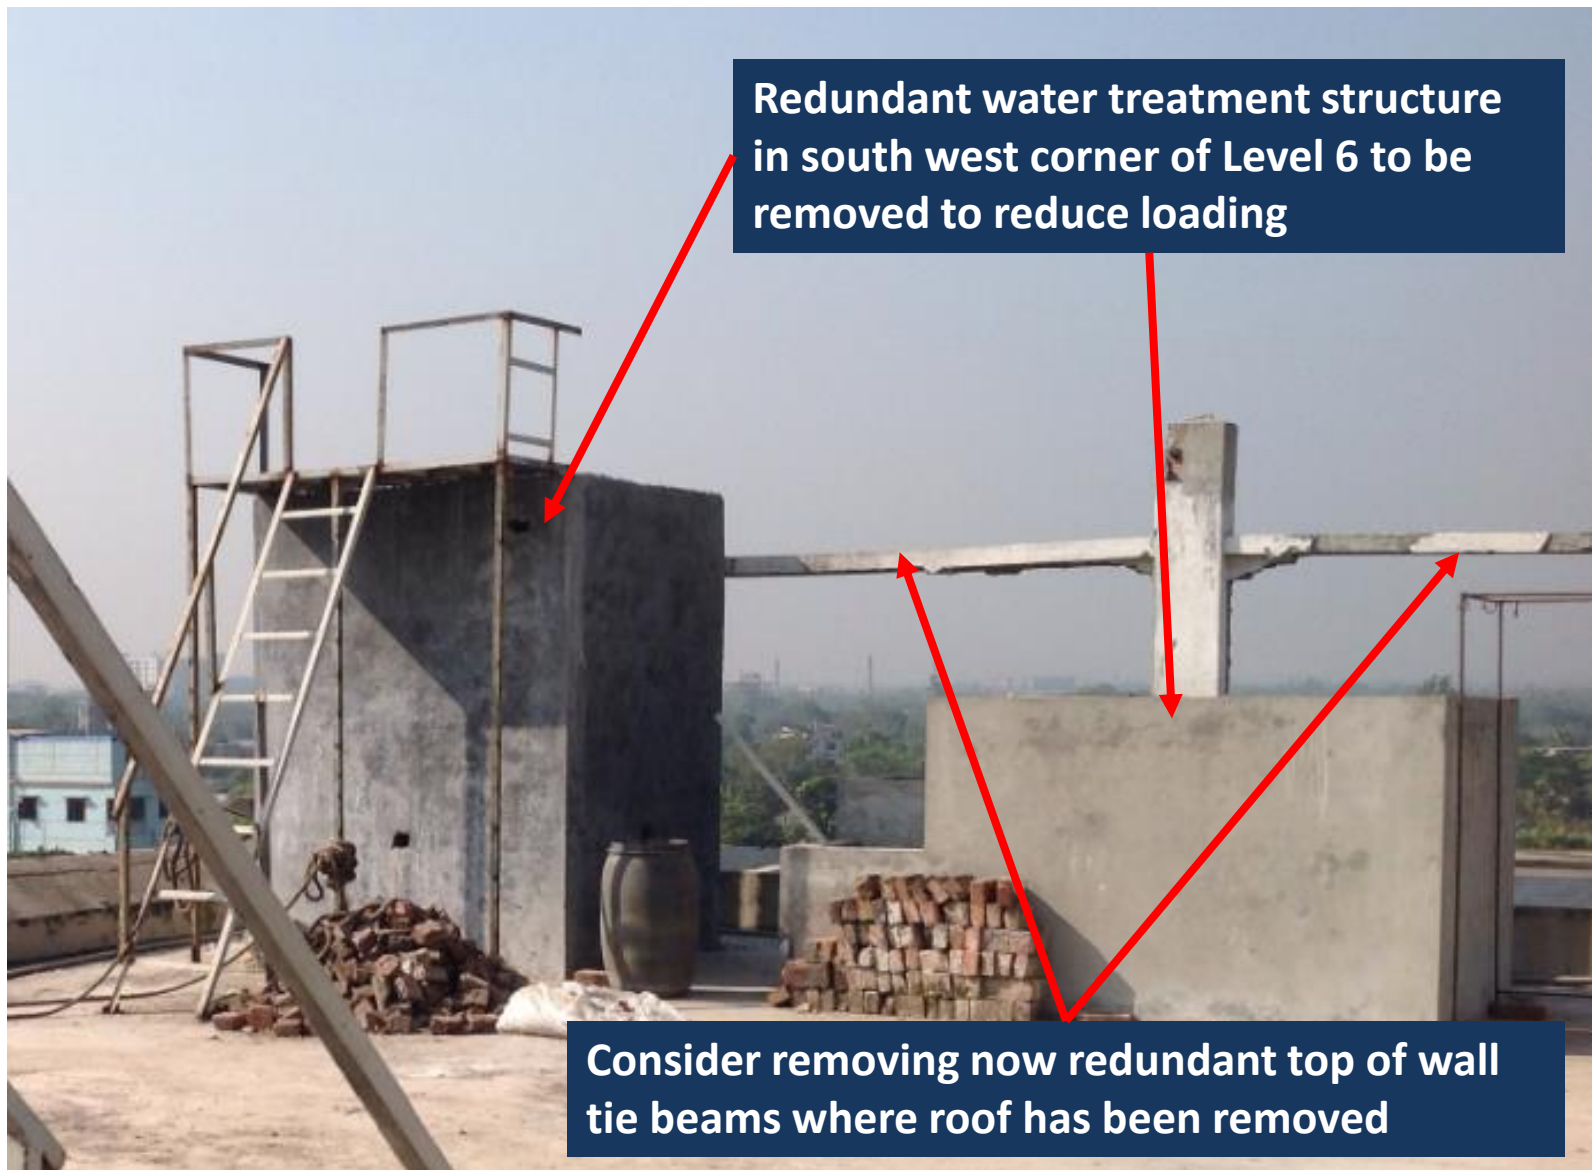
**Redundant secondary structure to be removed (water treatment plant and roof structure)**

## Redundant secondary structures

| Item No. | Observation | Recommended Action Plan | Recommended Timeline |
|---|---|---|---|
| 7 | Redundant structure at roof level (to be removed) | Consider Removing water treatment and redundant tie beams | 6-months |
