B2B Excellence Ltd. (9691)

Seablue Apparels Ltd.

Mirzapur Purbapara, 8 no. Mirzapur Mouza, Mirzapur.

25.06.2014

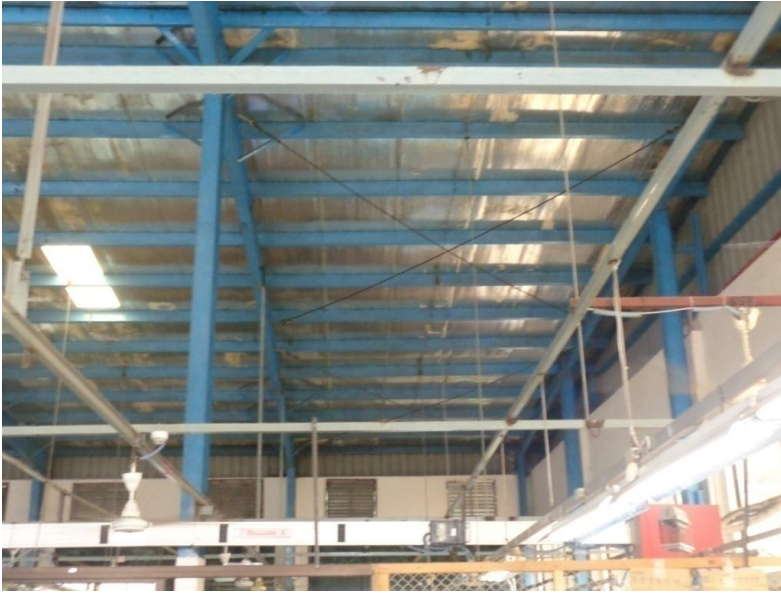
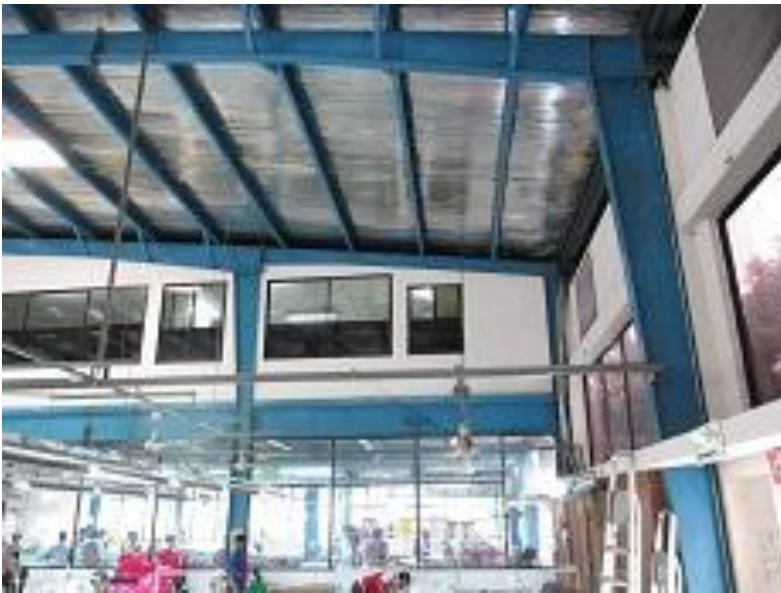
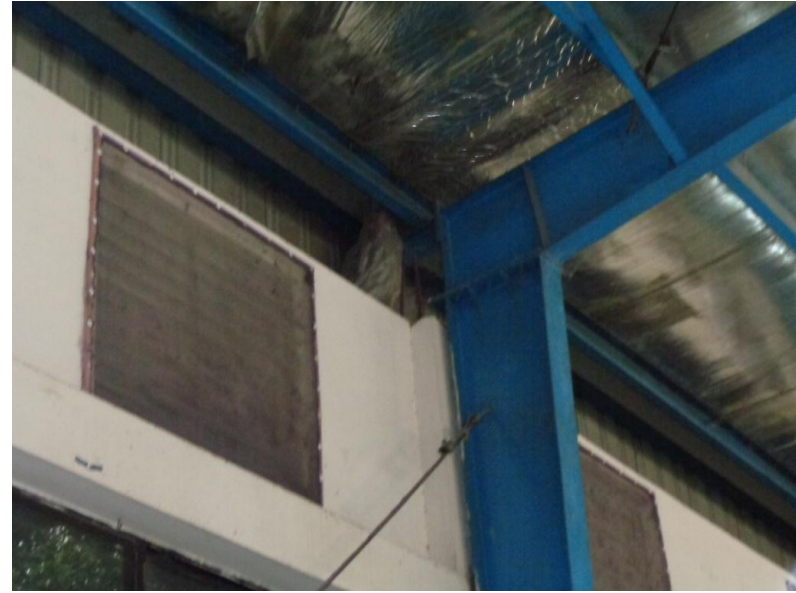
1st Priority 2 Concern

B2b's main building bracing were loose.

The bracings do not seem properly connected to the column.

According to our verification, the steel columns are highly stressed.

Item No.	Observation	Recommended Action Plan	Recommended Timeline
1	Priority 2 - Lateral bracings of B2B's main factory are loose and the column are highly stressed.	Carry out an Engineering Assessment to verify if the stability system and the columns of the building are adequately designed to BNBC.	6-weeks
2	Priority 2 - Lateral bracings of B2B's main factory are loose and the column are highly stressed.	Carry out recommendations of the Engineering Assessment.	6-months
3	Priority 2 - There is no obvious lateral stability system in Seablue Apparels Ltd. Building	Carry out an Engineering Assessment to review the lateral stability of the building as per BNBC.	6-weeks
4	Priority 2 - There is no obvious lateral stability system in Seablue Apparels Ltd. Building	Carry out recommendations of the Engineering Assessment.	6-months
5	Priority 2 - Utility building staircase is poorly designed.	Carry out an Engineering Assessment to review the conditions and the stability of the staircase.	6-weeks

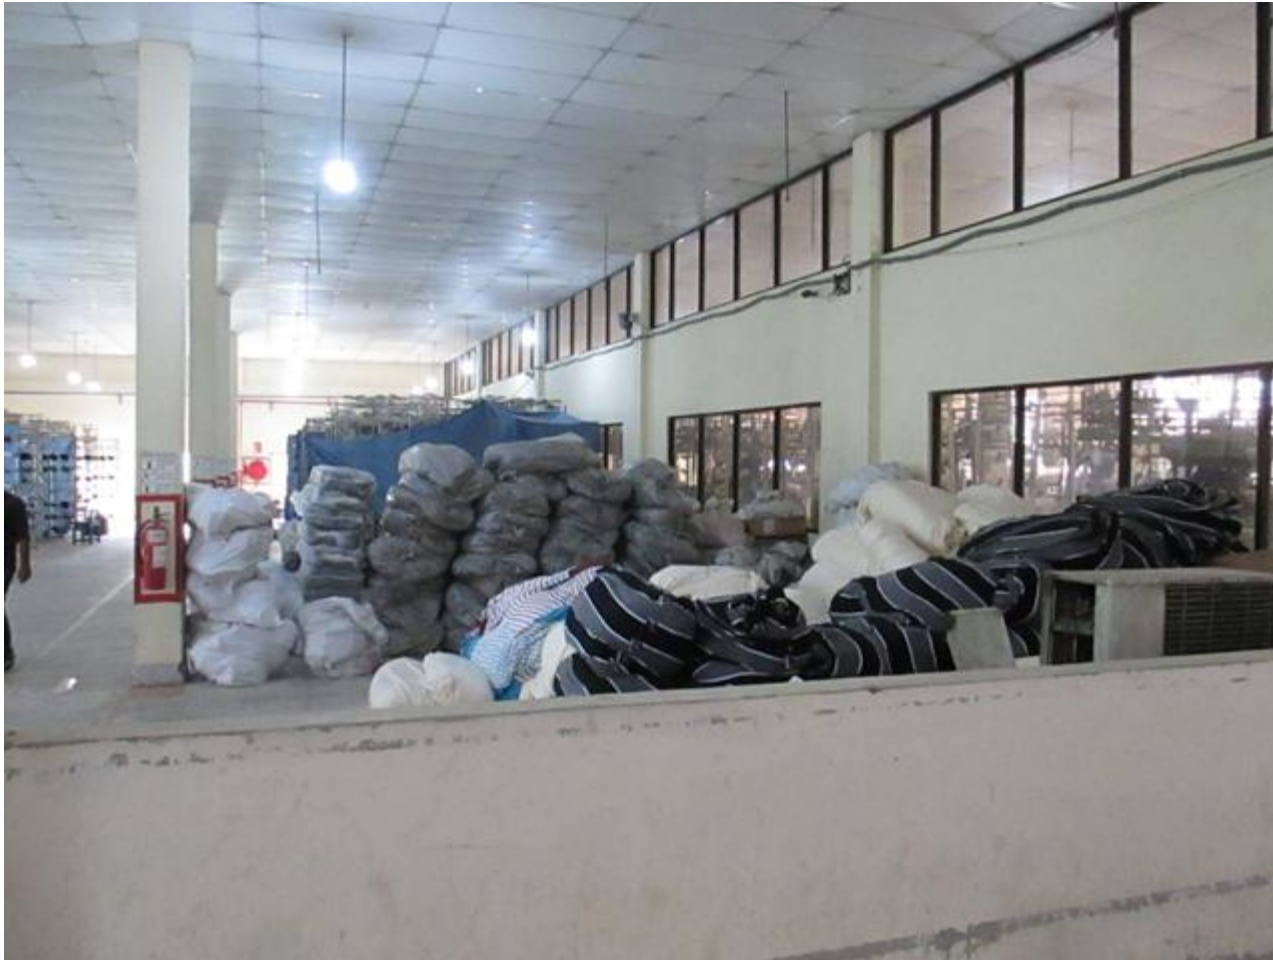
2nd Priority 2 Concern

There was no obvious lateral stability system in Seablue Apparels Ltd. factory building.

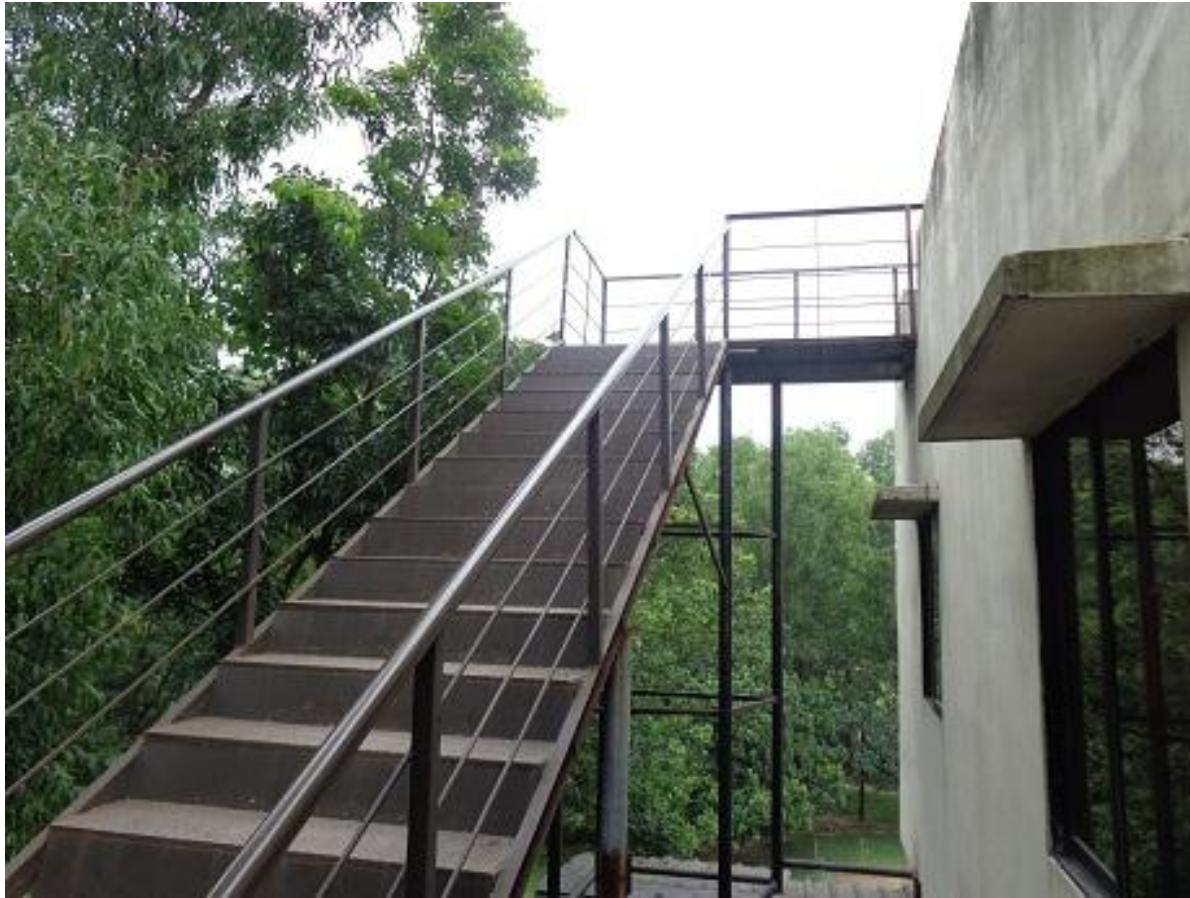
3rd Priority 2 Concern

Utility building staircase was not properly connected to the slab.

6	Priority 2 - Utility building staircase is poorly designed.	Carry out recommendations of Engineering Assessment.	6-months
7	Priority 2 - Inadequate steel detailing of roofs	Carry out an Engineering Assessment to verified that the steel roof structures are properly designed and anchored.	6-weeks
8	Priority 2 - Inadequate steel detailing of roofs	Carry out recommendations of Engineering Assessment.	6-months

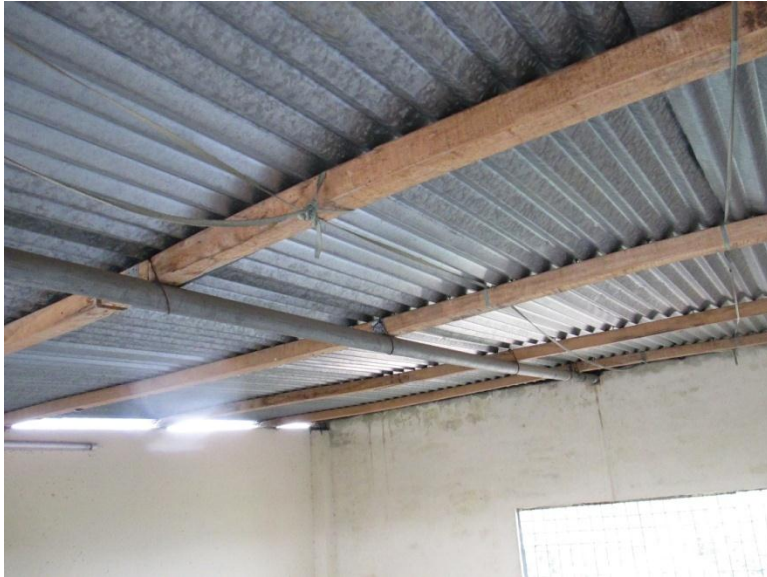
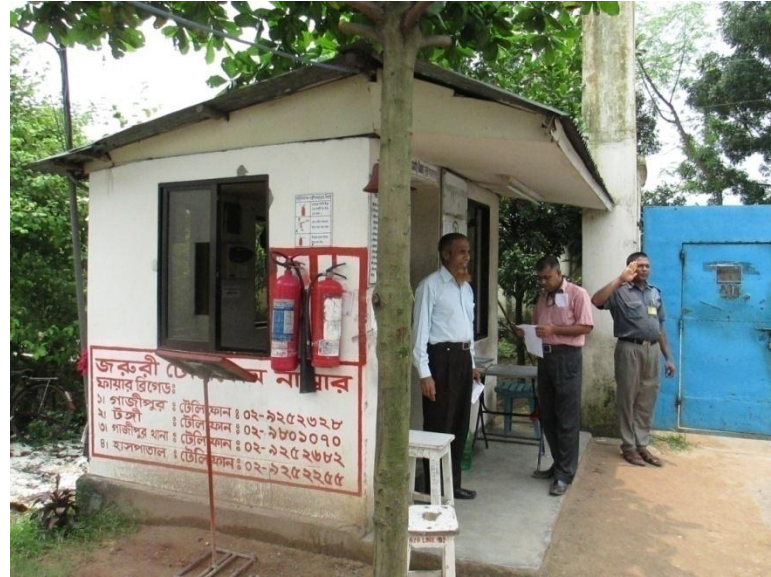
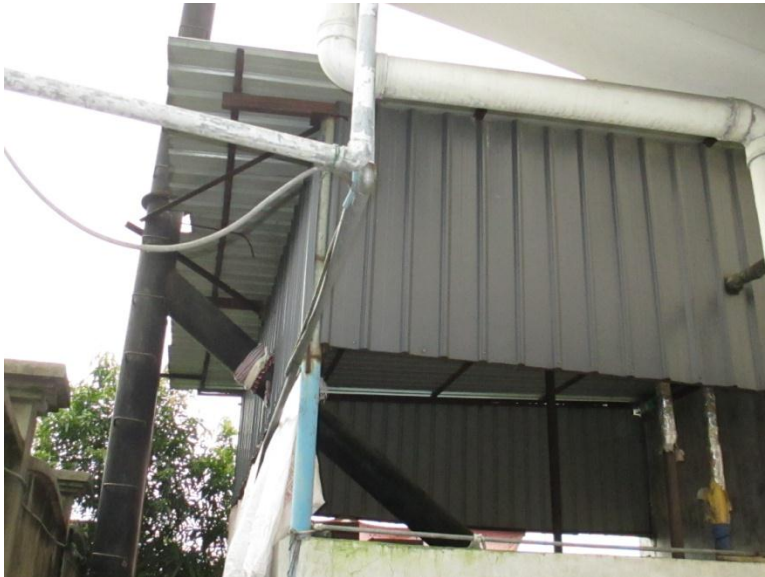
4th Priority 2 Concern

Poor detailing of steel roof connections at the shed buildings..

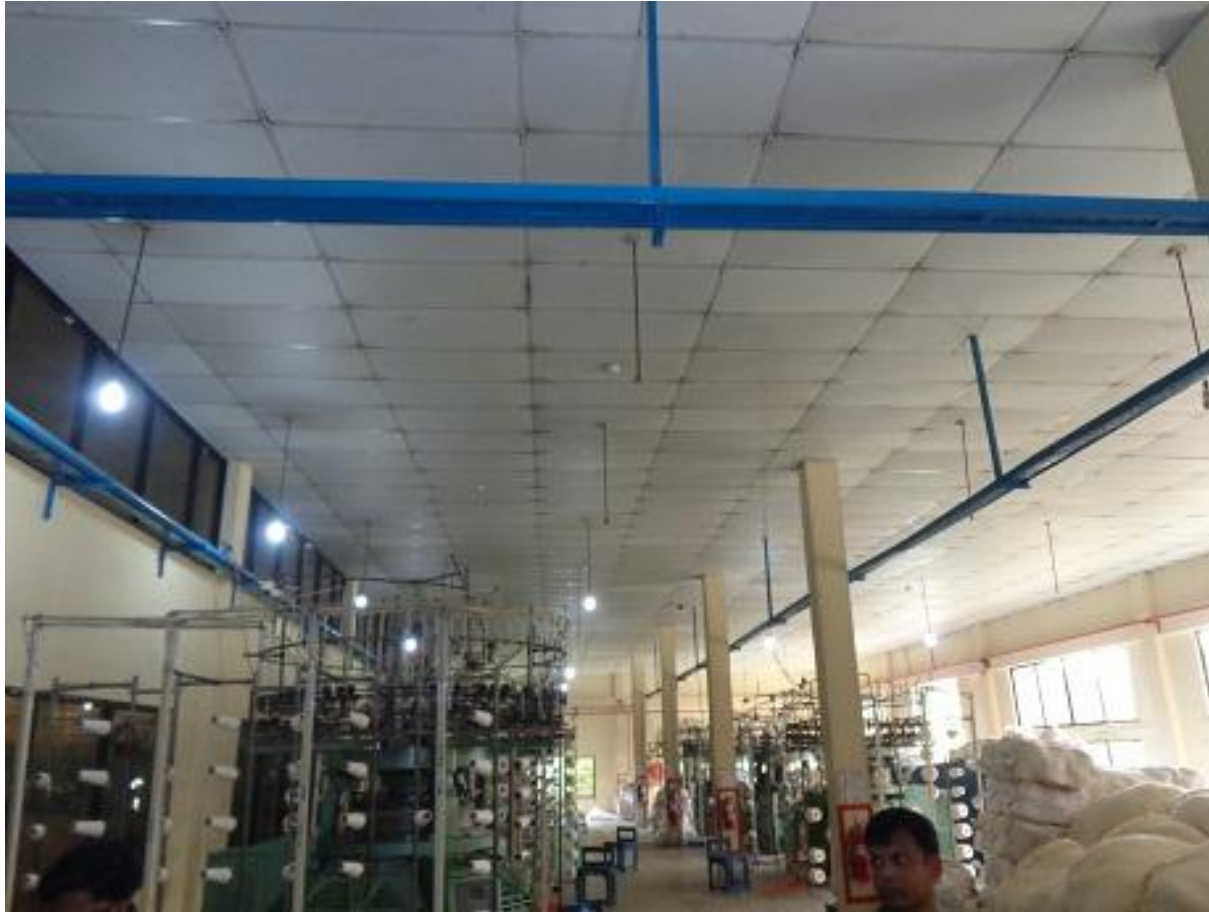
Overall Stability System

Several buildings did not feature any shear walls or lateral bracing. Stability was achieved through masonry infill walls except for inadequate bracing in the B2B factory.

We require that these items be investigated in an Engineering Assessment

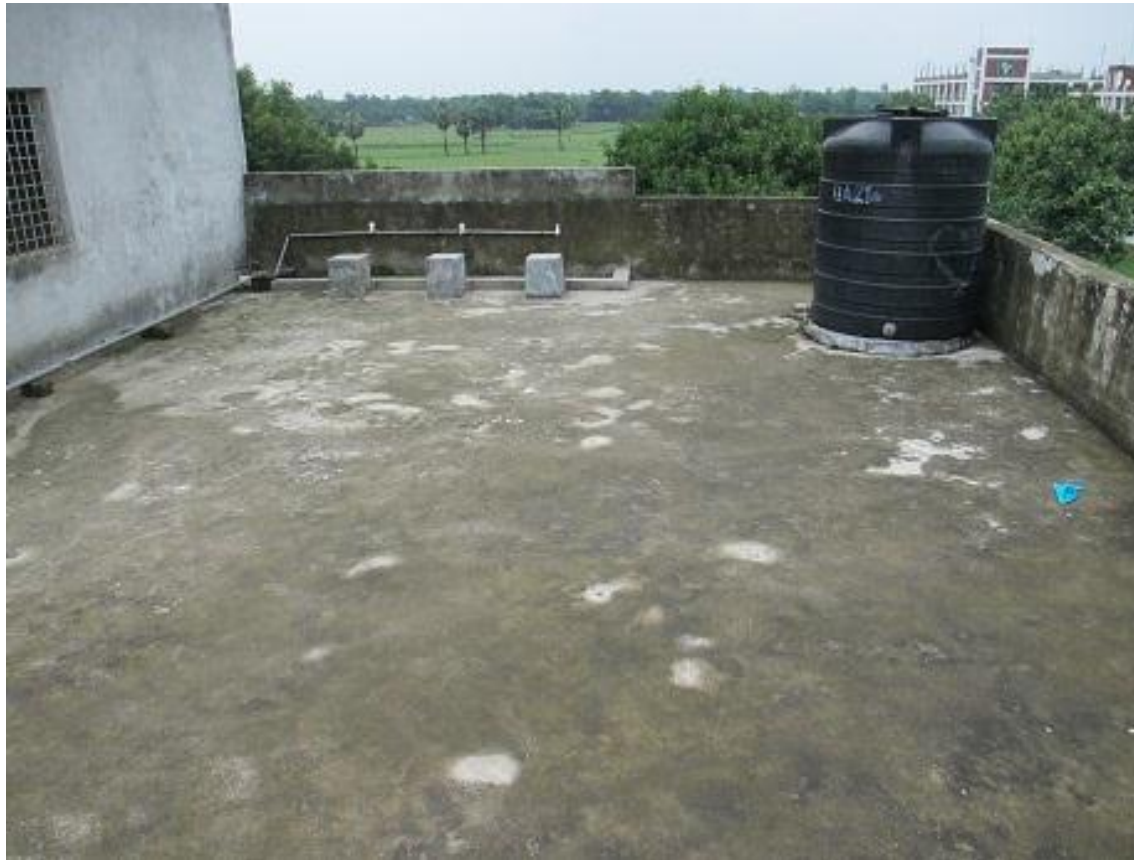
Water Ingress at Roof Level

No waterproofing membrane was visible on the roof of the utility building. This means that any cracks in the surface finishes on the roof will allow water to seep into the concrete slab beneath the finishes, and cause corrosion of the reinforcing steel.
