# Natural Denims Ltd

Tonga bari, Ashulia, Dhaka  
(+23.901N, 90.3259E)

22 September 2013

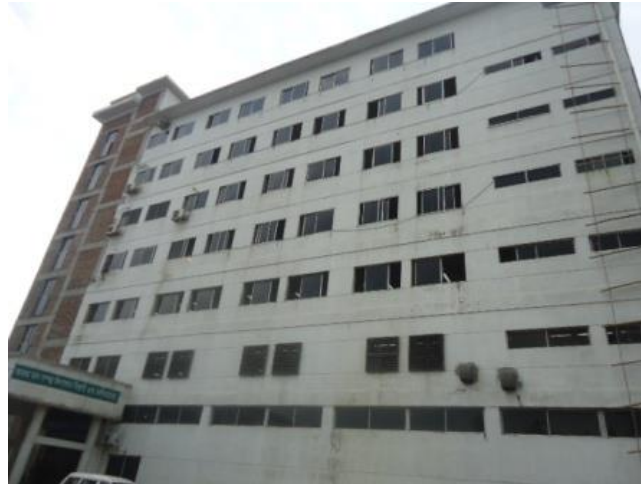
**Steel frame supported on the concrete roof slab has no obvious horizontal stability system, in the plane of the steel roof, to resist high wind loads.**

| Item No. | Observation | Recommended Action Plan | Recommended Timeline |
|---|---|---|---|
| 4 | The steel framed structure at roof level has no obvious horizontal bracing system in the plane of the steel roof to resist high wind loads. | Steel frame stability system to be designed by the Building Engineer and upgraded to support code lateral/wind loads. | 6-months |

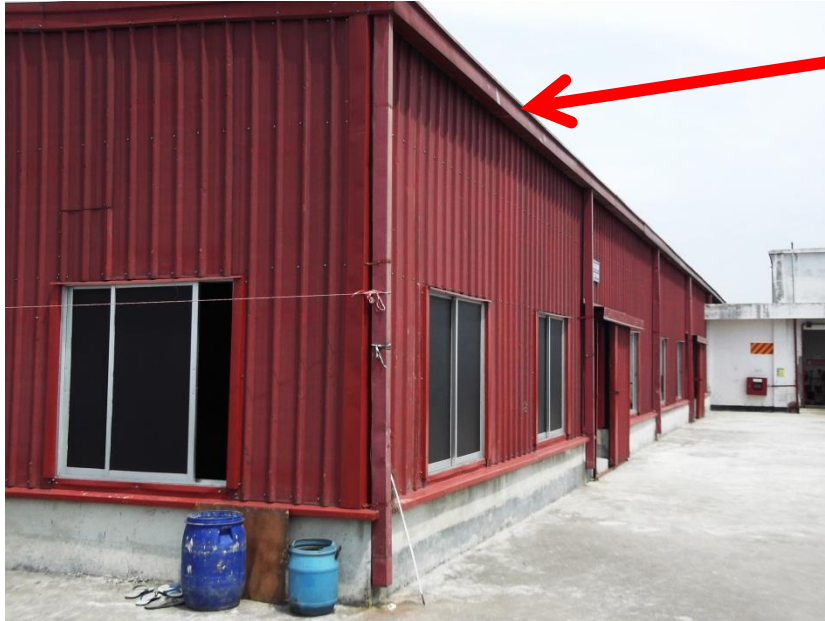
**Clad steel framed dining  
area located at roof  
level**

**Roof system has no  
obvious horizontal  
bracing to provide  
stability in high winds**

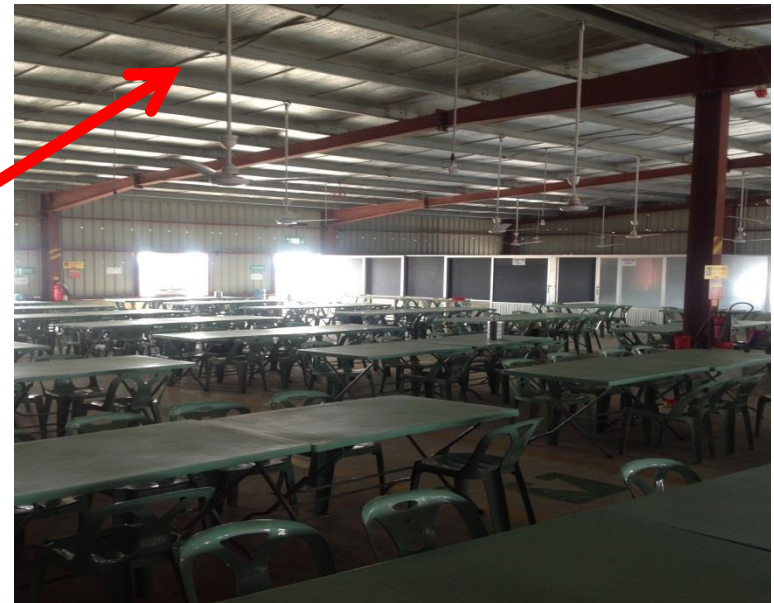
**Significant Floor Loads at 6<sup>th</sup> Floor Level.  
Determine Design Imposed Floor Load  
capacity and limit storage loading accordingly**

| Item No. | Observation | Recommended Action Plan | Recommended Timeline |
|---|---|---|---|
| 5 | Significant floor loads at 6 <sup>th</sup> floor level | Ensure that stacks of materials are separated by a 0.5m gap all around | 6-weeks |
| 6 | Significant floor loads at 6 <sup>th</sup> floor level | Building Engineer to create controlled loading plans for all floors designating where storage can be placed and cannot be placed. | 6-months |

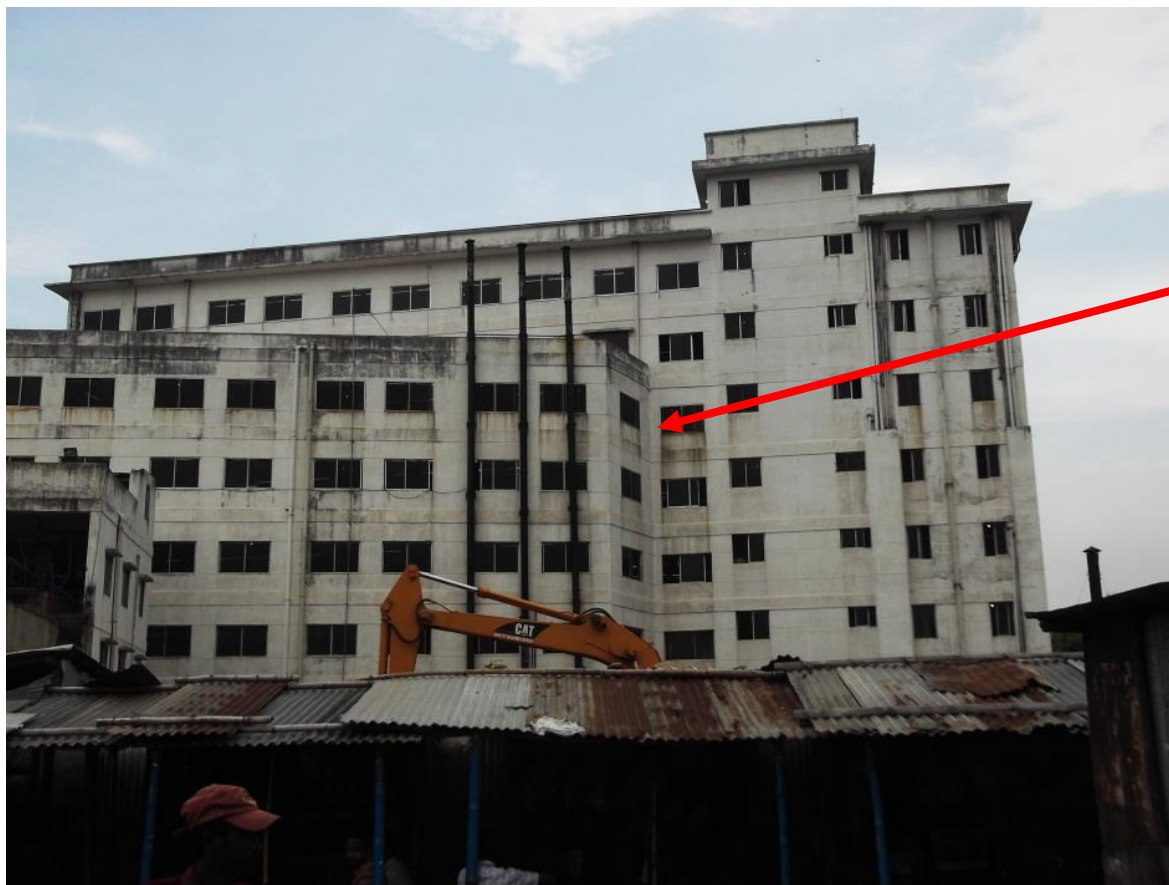
**Junction between Annex  
and the main building**

- 3<sup>rd</sup> floor slab and above  
are tied structurally
- 2<sup>nd</sup> floor slab and below  
are not tied structurally

**Cracking at Interface  
Between Main Building and  
5 Storey Annex**

| Item No. | Observation | Recommended Action Plan | Recommended Timeline |
|---|---|---|---|
| 7 | Cracking of perimeter rendered brick façade wall and structural beam at the interface between the main building and the 5 storey annex. | Building Engineer to inspect areas where cracking has occurred and propose a suitable repair to ensure that rainwater does not penetrate the building fabric. | 6-months |

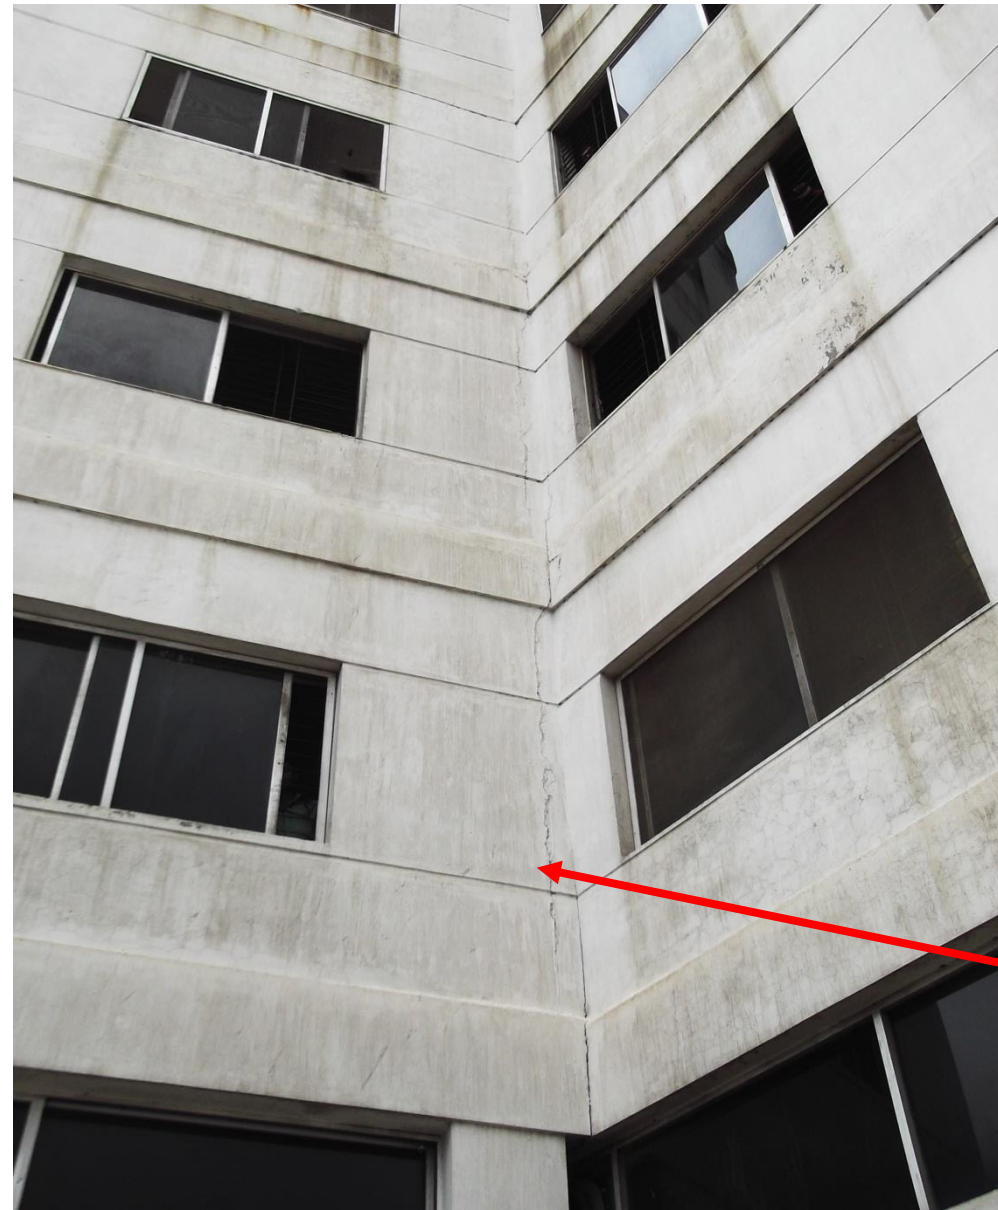
**Cracking at Interface  
Between Main Building and  
5 Storey Annex**

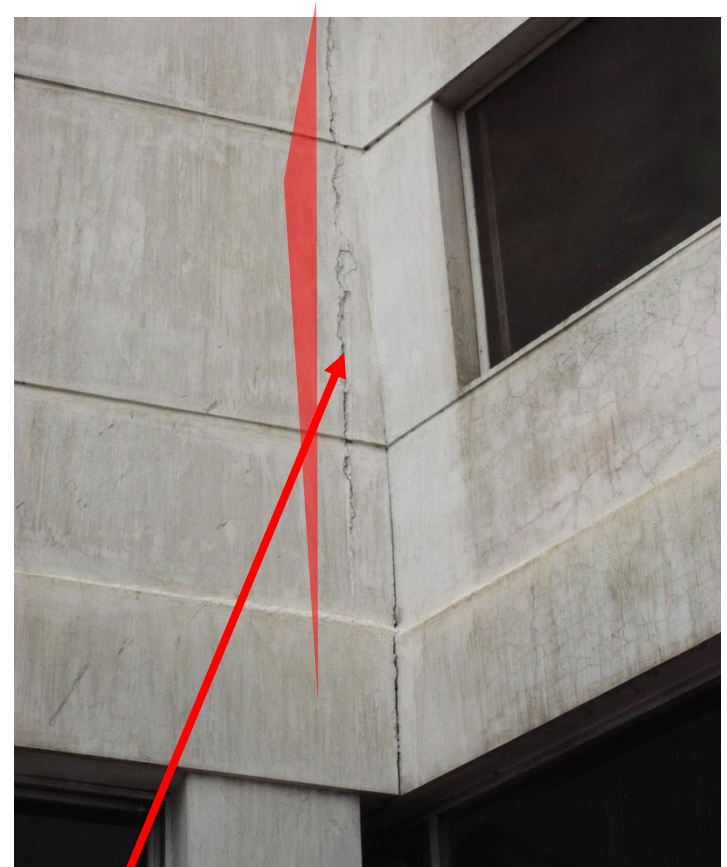
**Vertical Crack in Rendered  
Brick Façade Wall at South  
East Corner of Annex to  
Main Building**

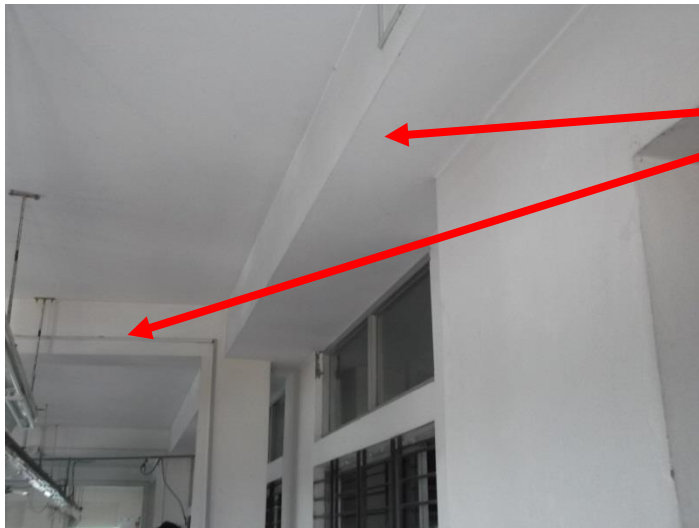
**Structure at Annex joint line is linked at the upper floors**

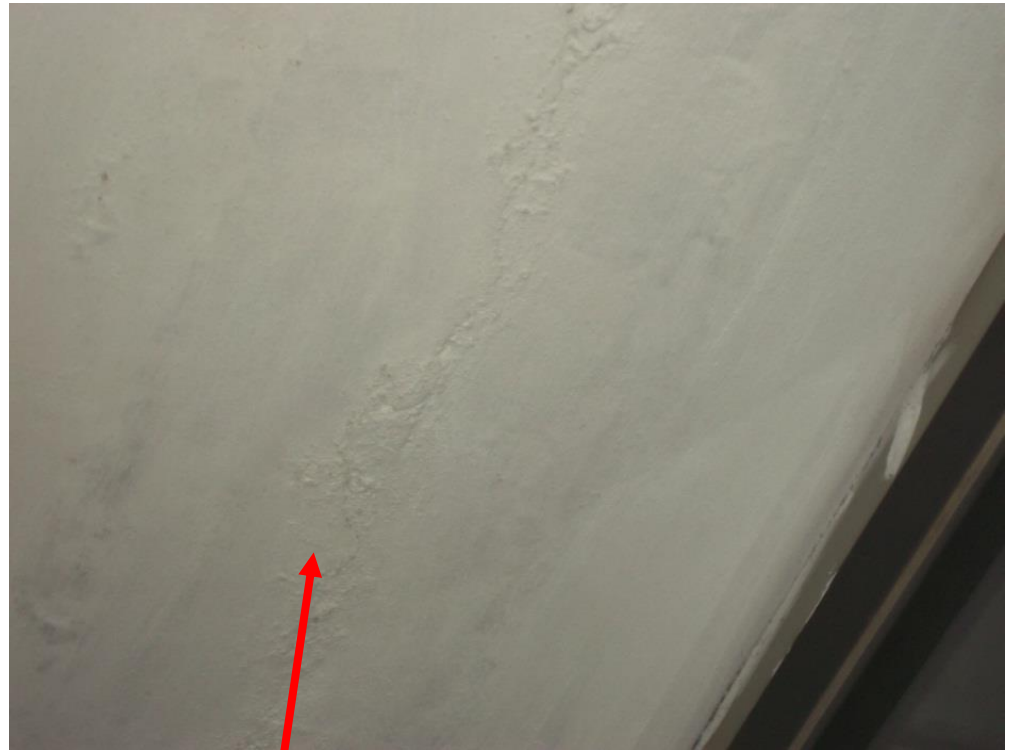
**Cracking along internal beam at Interface Between Annex and Main Structure**

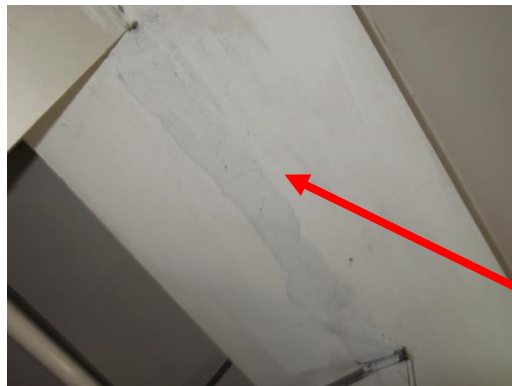
**Cracking at Interface Between Main Building and 5 Storey Annex**
