# Fakir Fashion Ltd

Dohargaon, Balipara, Rupgonj, Narayanganj  
(+23.784289N, 90.587415E)

26 October 2013

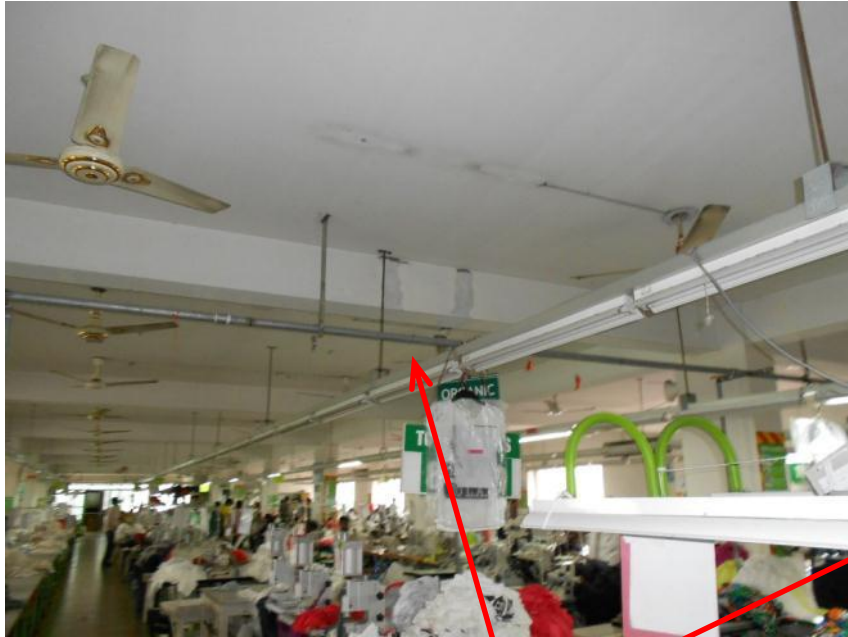
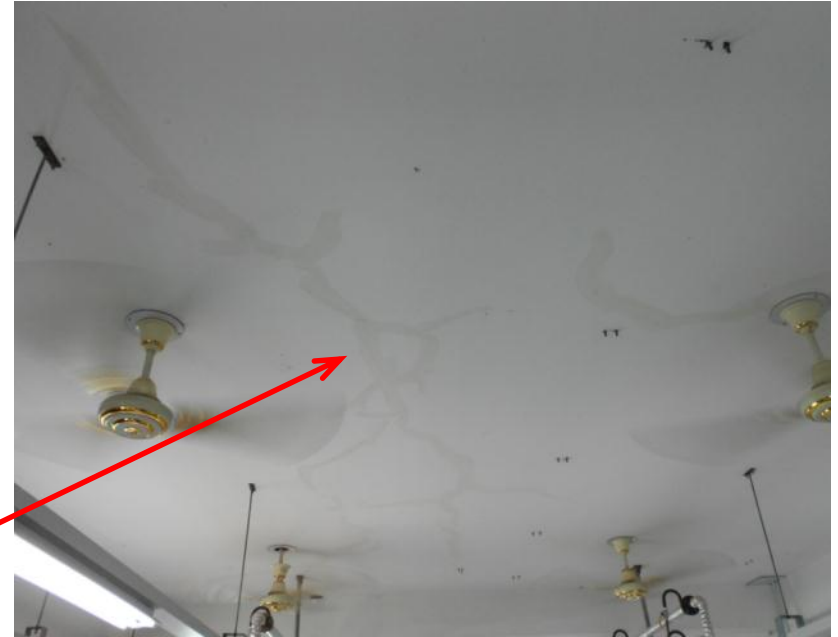
# Cracking in beams and slabs

## Repaired cracking in beams and slab

Engineer is to perform/provide calculations to prove slab and beam are satisfactory for factory loading, and permanent build up load, and (if required) :

- Reduce loads by vacating floors
- Reinforce structural elements
- Produce loading plans

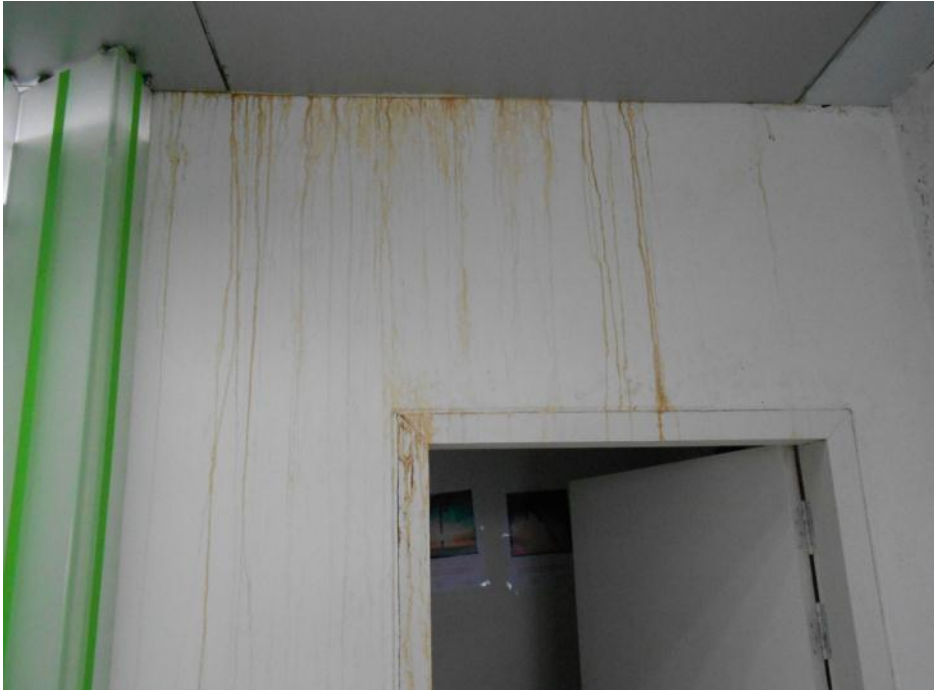
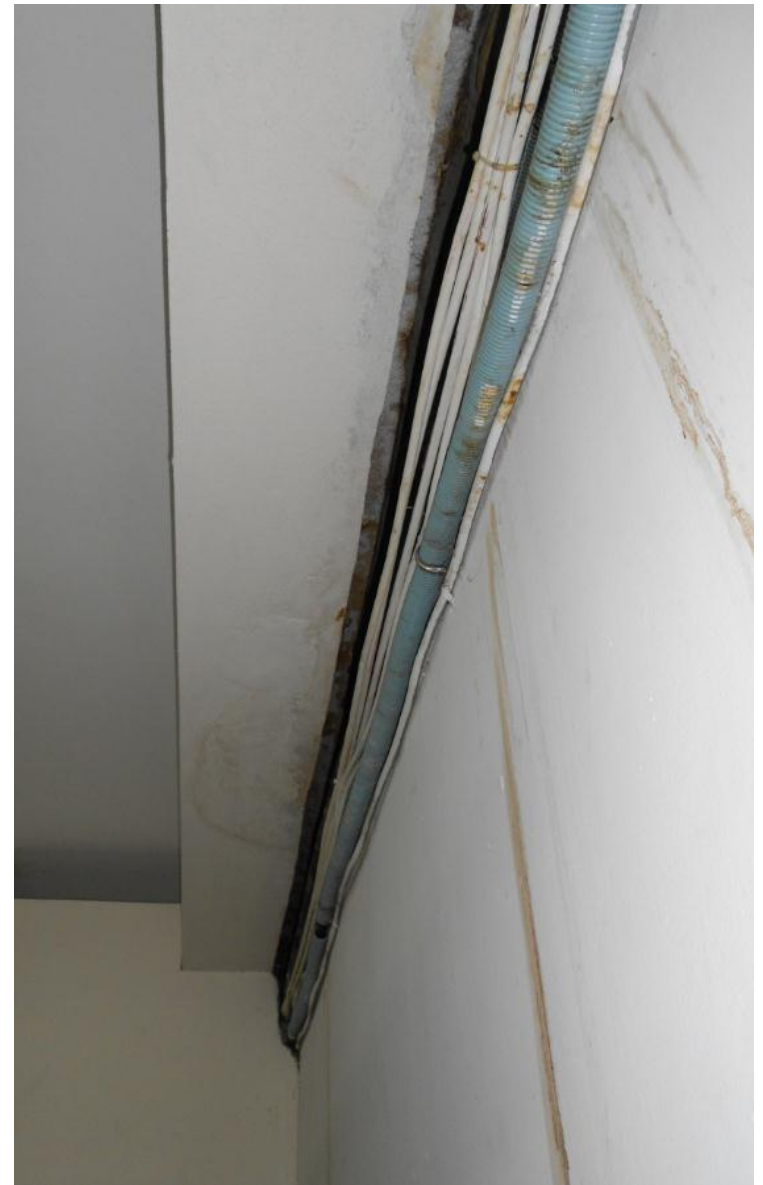
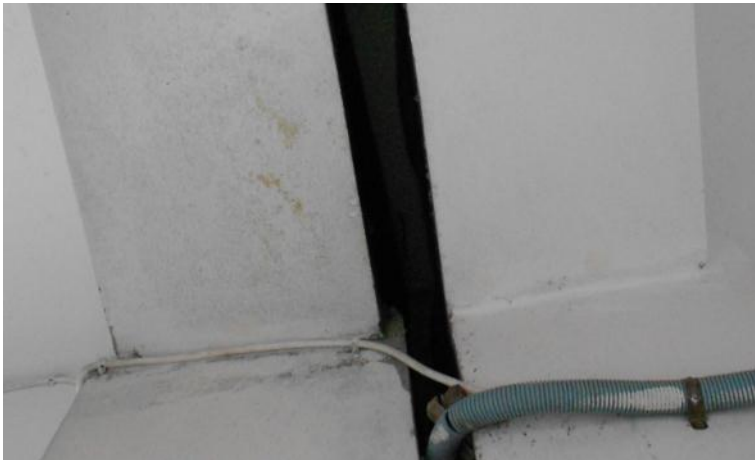
## Cracking in beams

**Water causing damage and corrosion (generally  
at movement joint)**

**Water causing damage and possible corrosion**

| Item No. | Observation | Recommended Action Plan | Recommended Timeline |
|---|---|---|---|
| 8 | Building-1:Water causing damage and corrosion | Engineer to inspect water damaged structure and propose a suitable repair. Water proofing detail over Movement joint to be installed | 6-months |

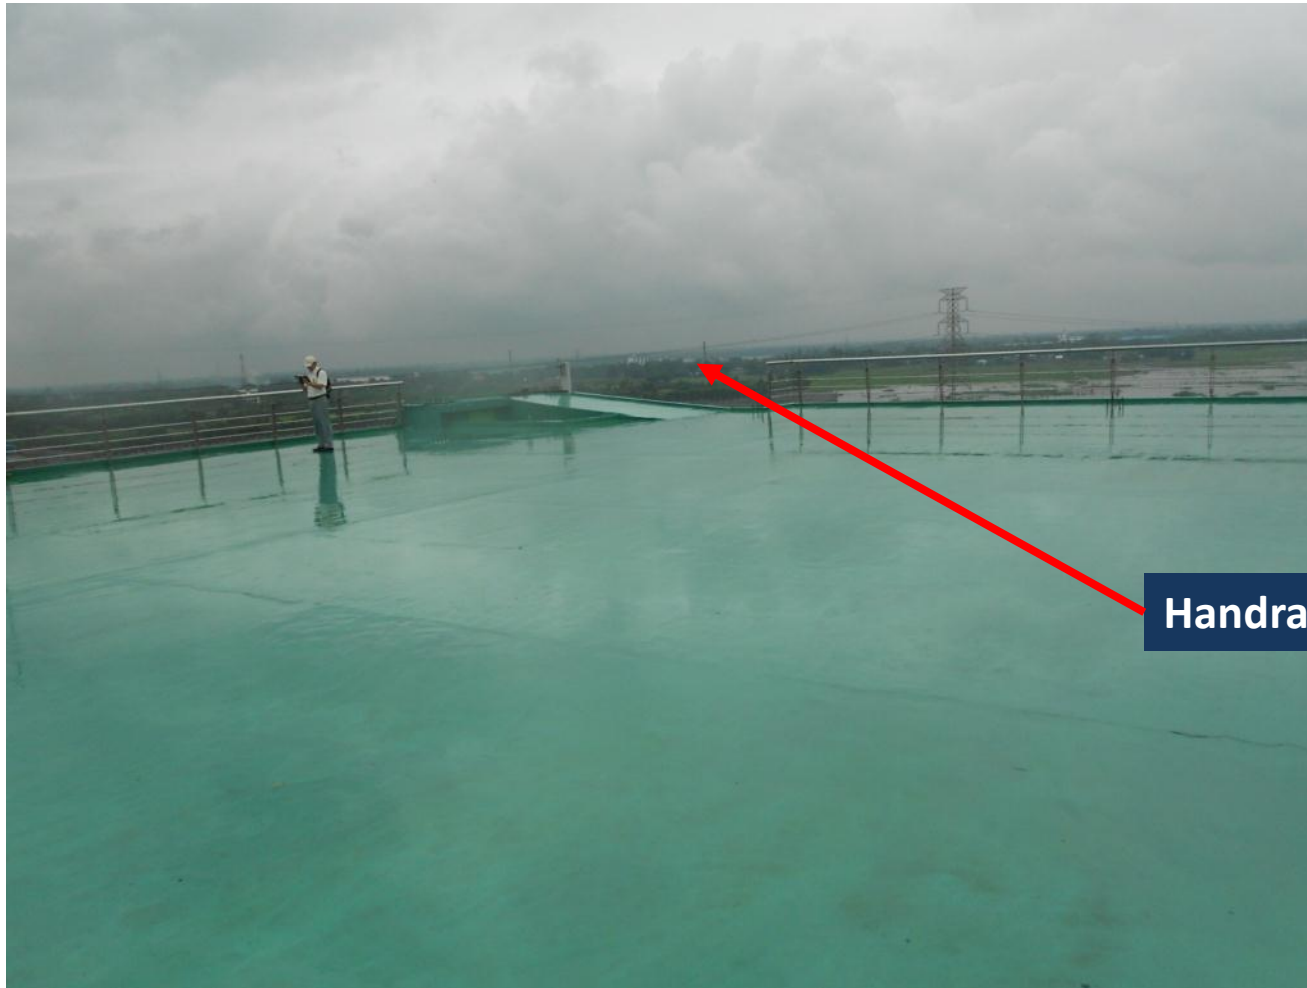
# **Non-Structural Observation Handrail on roof slab**

**Handrail on roof slab**

| Item No. | Observation | Recommended Action Plan | Recommended Timeline |
|---|---|---|---|
| 9 | Building-1:Install handrails on roof (non-structural) | Install handrails on roof, where it is currently missing next to stair | 6-months |

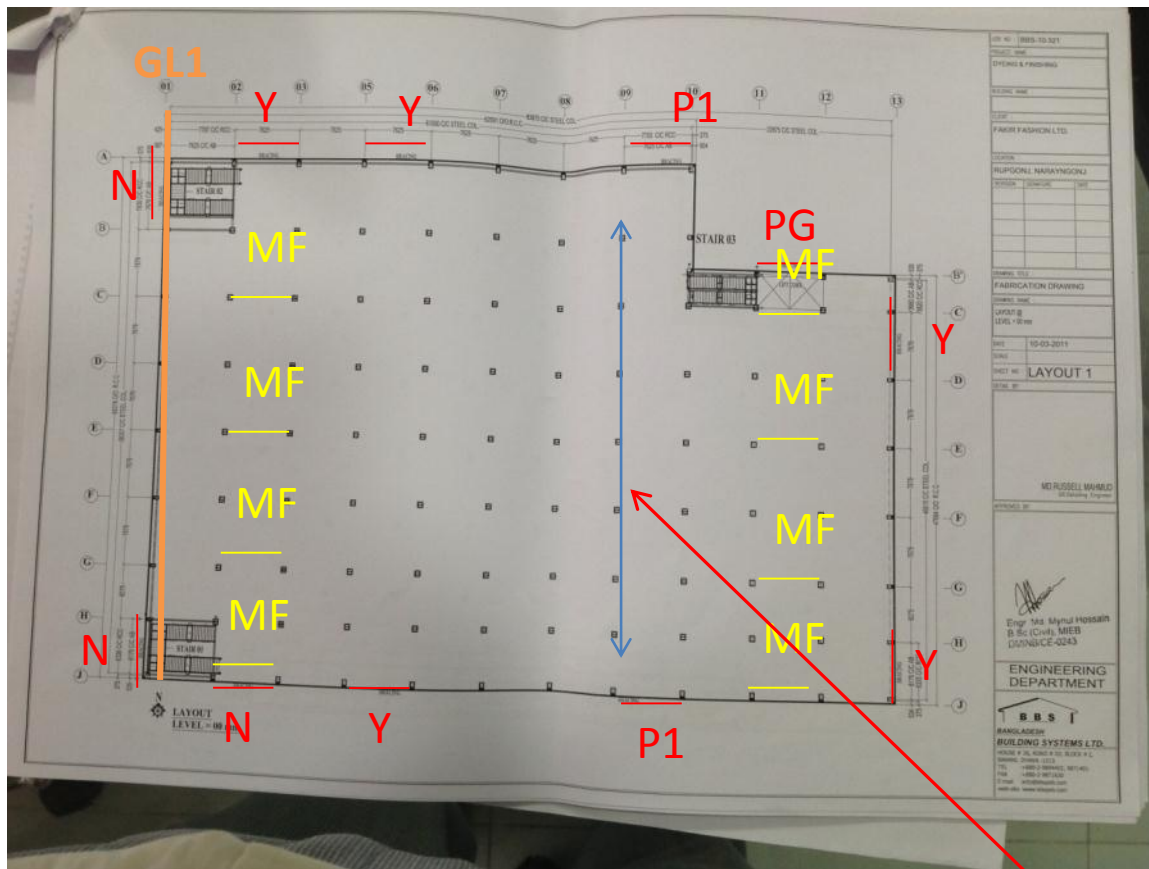
**Building only 2 of 4 stories and hence all bracing may not be required at this stage however lack of X bracing along Gridline 1 (GL1) needs to be justified.**

**Lateral stability in this direction to be justified**

| Item No. | Observation | Recommended Action Plan | Recommended Timeline |
|---|---|---|---|
| 10 | Building-2:Missing bracing compared to drawings and modified bracing to be rectified (pipe support frame) | Install X bracing where it is indicated on drawings unless engineer can justify reduced bracing for current building configuration and rectify X bracing where it has been modified | 6-months |

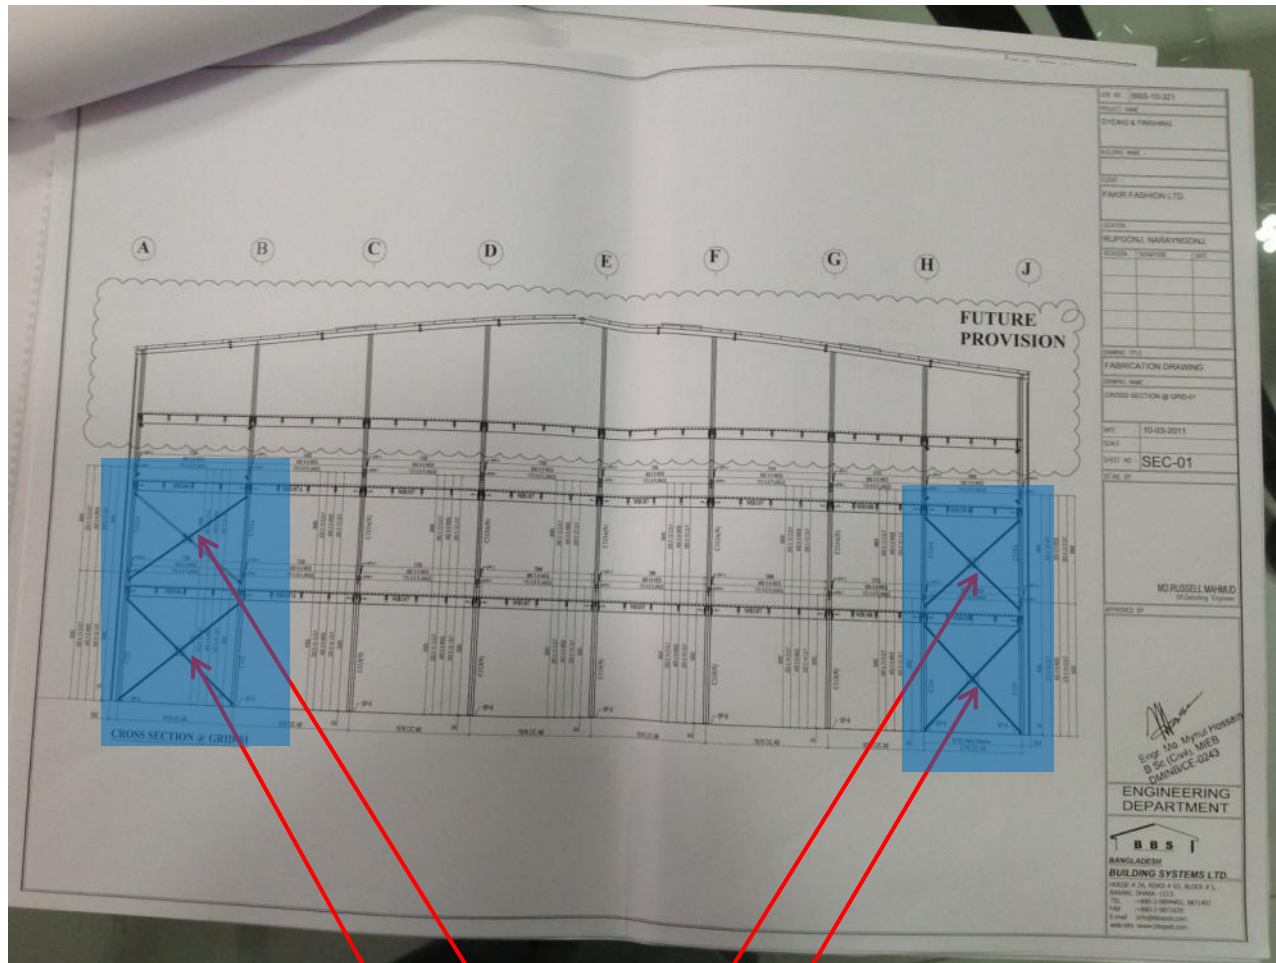
The bracing shown on grid line 1 is not present in building. Note also no bracing shown to future provision (levels).

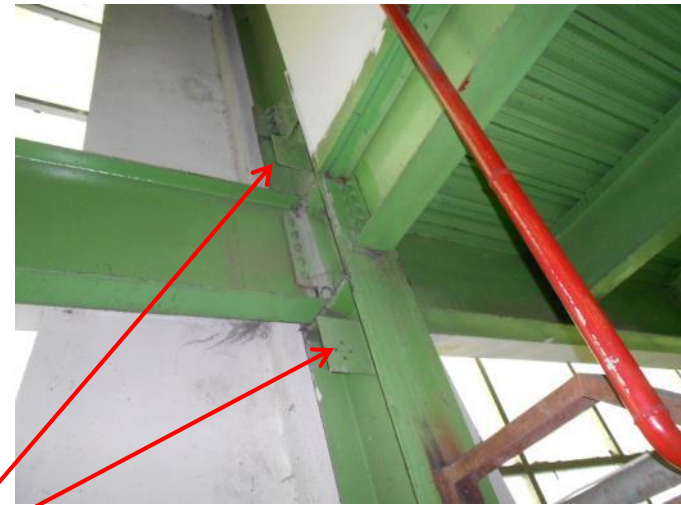
**Missing X bracing along GL1 – cleat plates present**

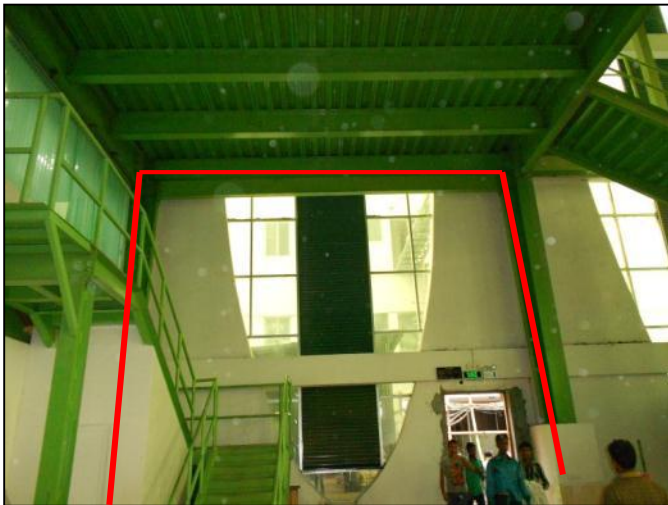
**Additional moment frames (MF)  
– purpose and capacity unknown**

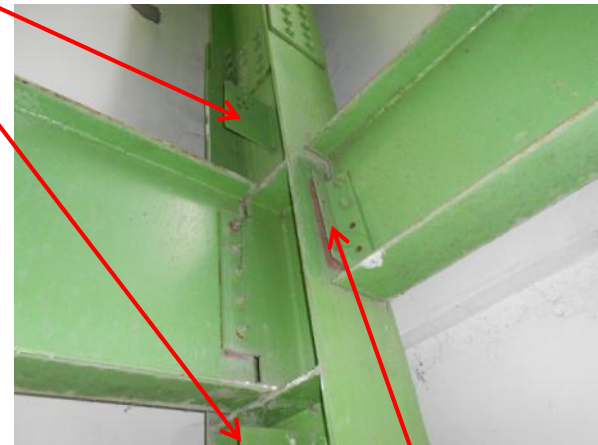
**Missing bolts to angle cleat –  
stair GL 1/A**

| Item No. | Observation | Recommended Action Plan | Recommended Timeline |
|---|---|---|---|
| 11 | Building-2:Missing bolts in connection | Replace missing bolts | 6-months |

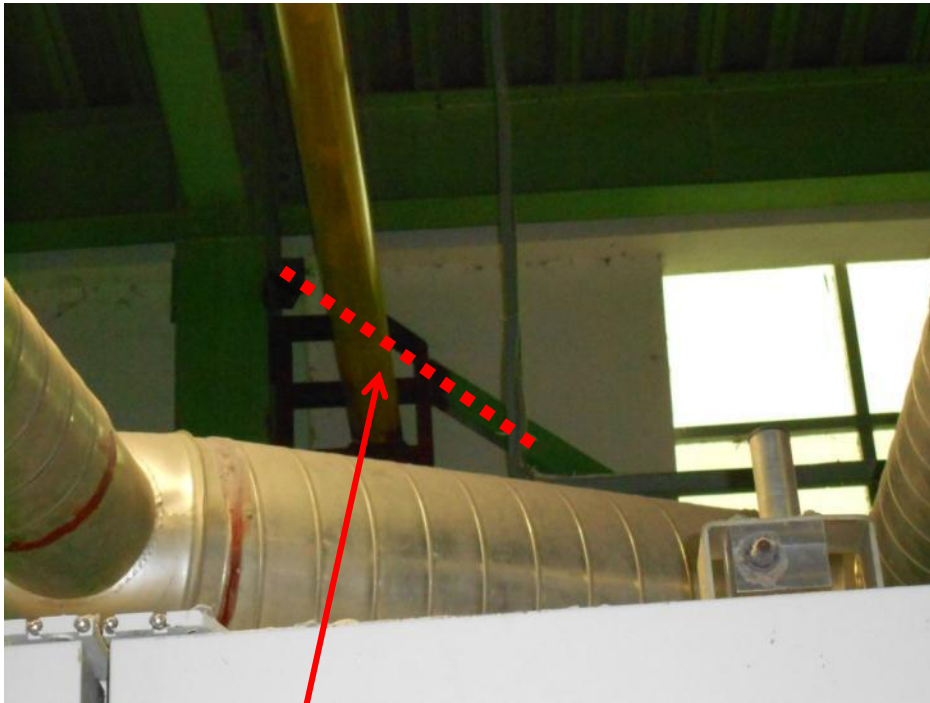
## **Modified X bracing**

**Bracing at Gridline J / 9-10 Level 1 has been cut and re-welded to pipe support steelwork. Bracing is the principal element and must be continuous. Rectify bracing and modify pipe support.**

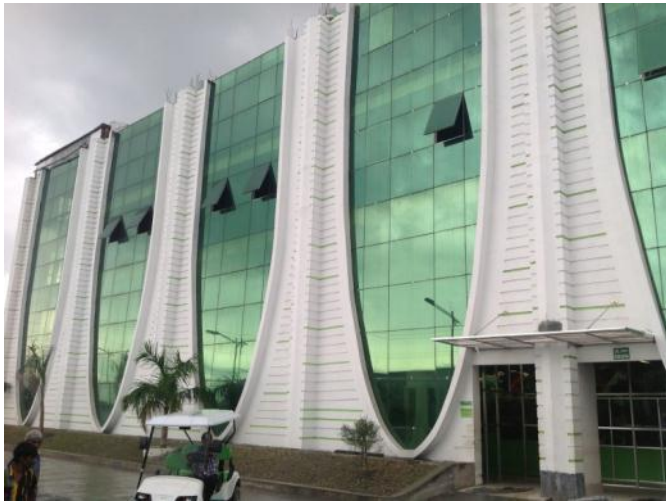
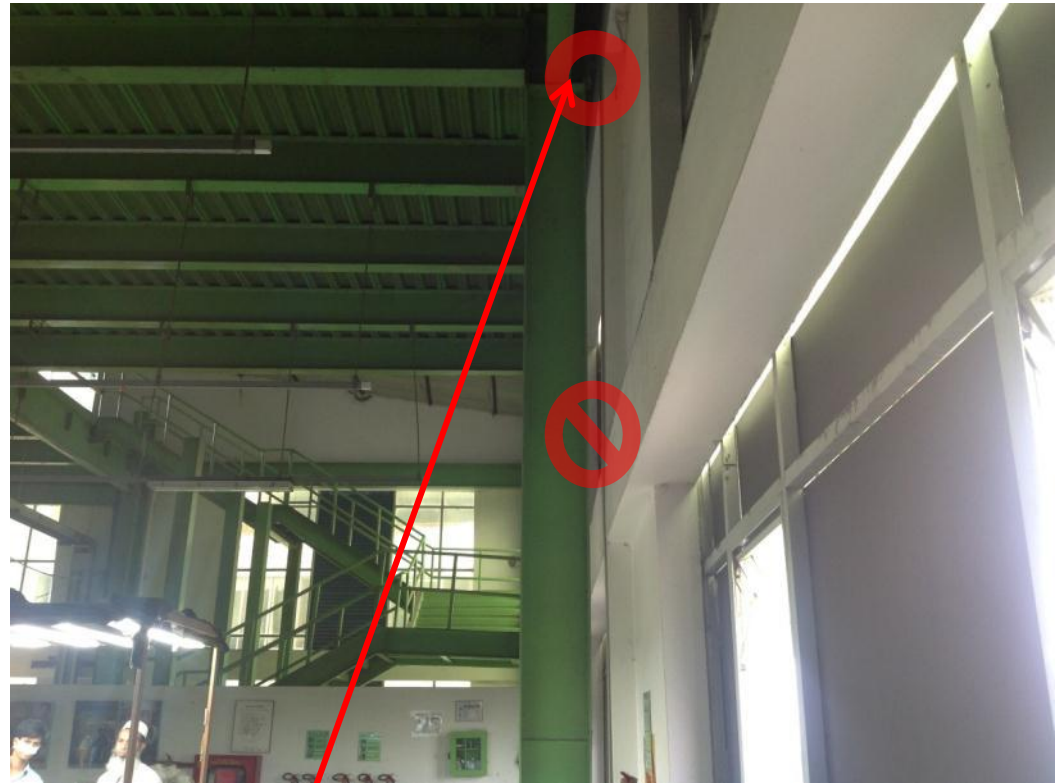
## Façade connection to structure

External façade (RC beam and column with glazing infill) appears to be connected to the steel frame at floor levels only (ie Ground, First and Second (current roof). No structural drawing of façade provided. Concern with connection of façade to steel structure subject to lateral load.

Façade connected at floor levels – not connected at intermediate façade beam level however no structural drawings of façade available to confirm structural arrangement for façade

| Item No. | Observation | Recommended Action Plan | Recommended Timeline |
|---|---|---|---|
| 12 | Building-2:Stability and connection of façade to steel frame | Structural engineer to verify that façade structure is sufficient and that connection of façade to steel structure is robust and sufficient (produce drawings for façade RC frame and connection) | 6-months |

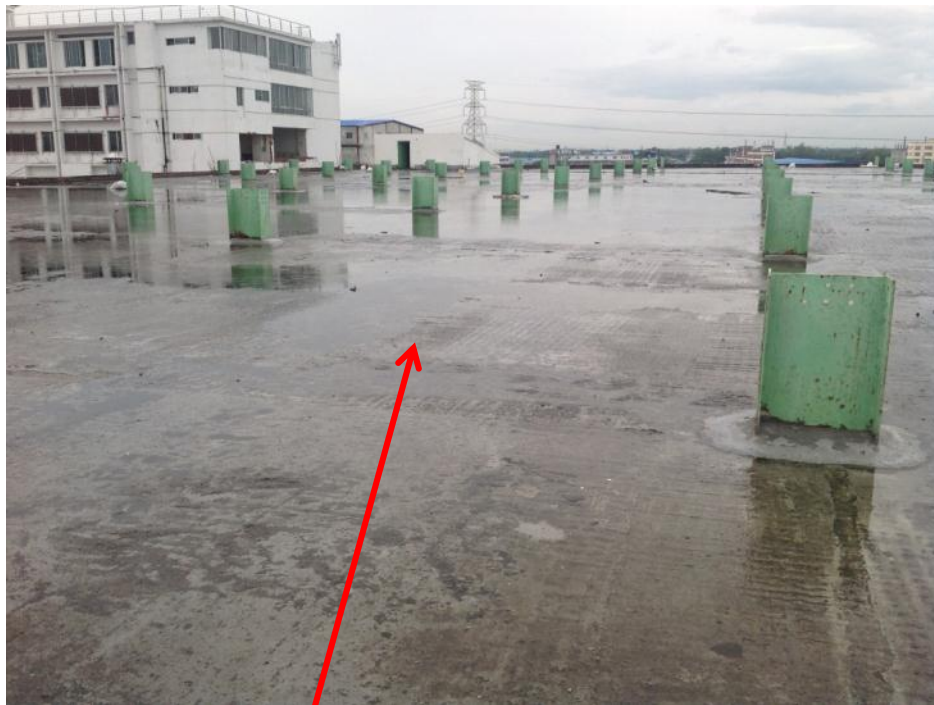
**Exposed steel work durability**

No falls on Level 2 (current roof) leads to water ponding. No evidence of water penetration to below however durability of steelwork at floor level is a concern for future expansion upwards.

| Item No. | Observation | Recommended Action Plan | Recommended Timeline |
|---|---|---|---|
| 13 | Building-2:Water ponding on roof (steel durability for future extension) | Review steelwork durability particularly if and when the building is extended upwards. Water ponding also may affect durability of the concrete slab in the longer term. | 6-months |

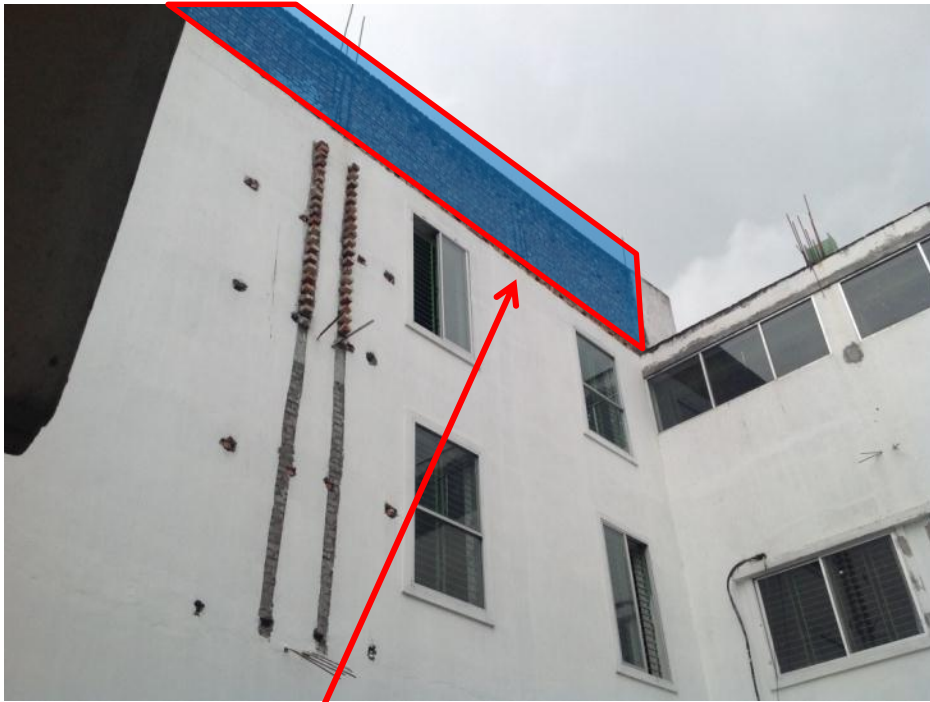
## **Brick infill stability**

**Brick infill at top of stair (3no.) to side of access to roof appears to be poorly restrained. Structural engineer to review stability.**

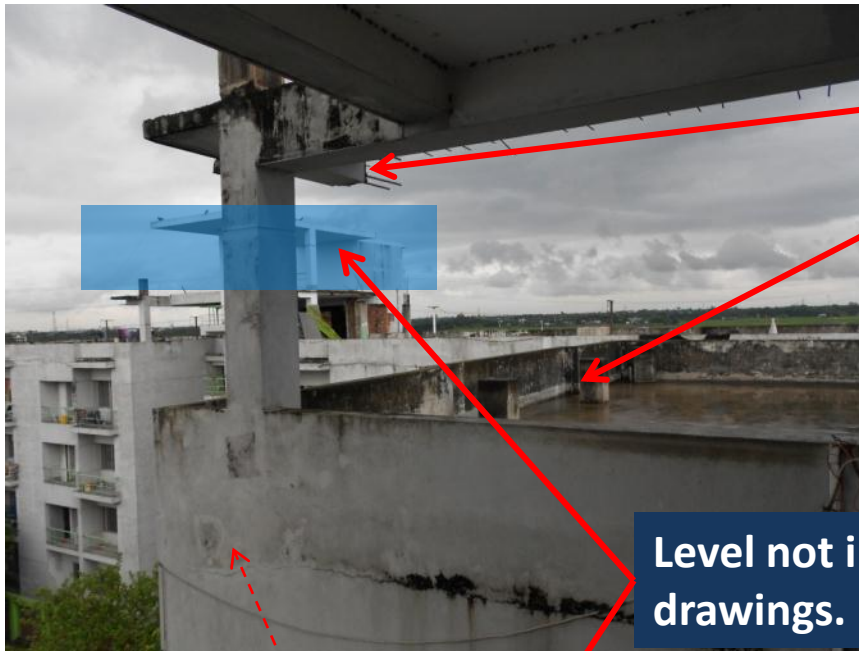
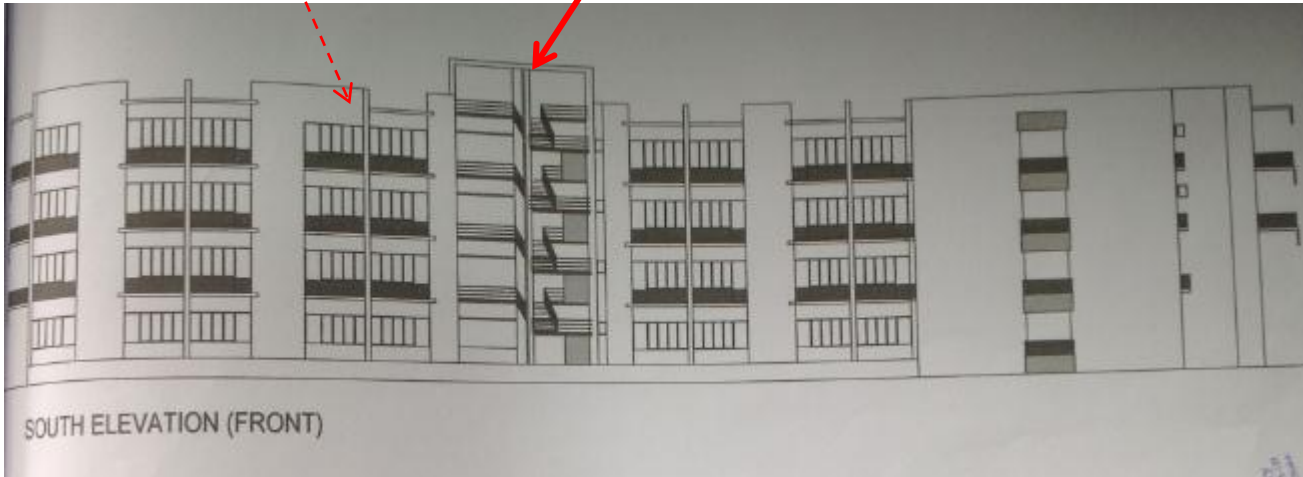
## Additional Structure

Evidence of possible 5th floor preparation (Permit allows 4 stories)

Level not indicated on permit drawings.

| Item No. | Observation | Recommended Action Plan | Recommended Timeline |
|---|---|---|---|
| 14 | Building-4:Extra level above stair cores – engineer to confirm stability | Engineer to review additional structure for loads to core (expected to be adequate) and lateral stability (again expected to be adequate). | 6-months |

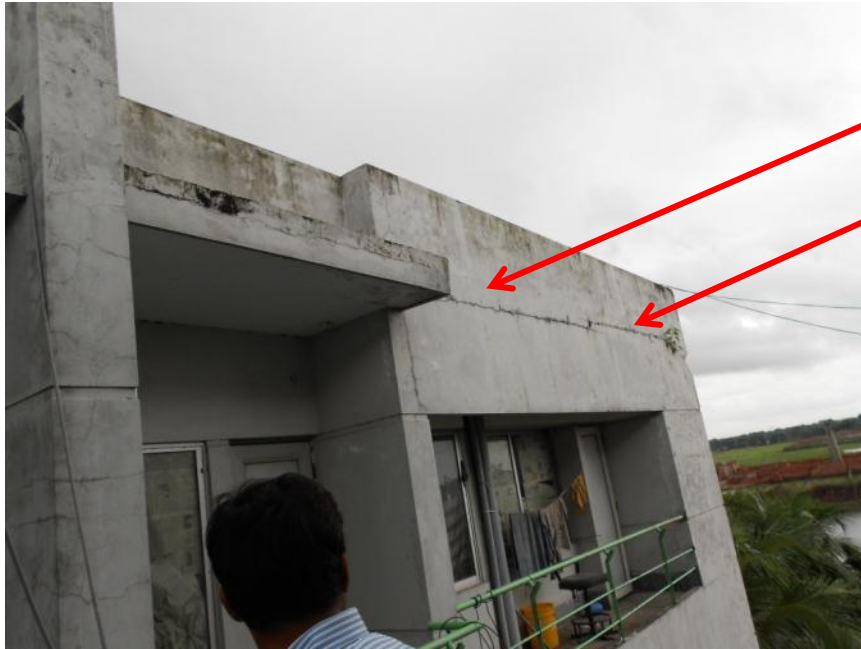
**Parapet stability**

**Cracking at junction between parapet and slab – construction and stability to be confirmed by structural engineer**

| Item No. | Observation | Recommended Action Plan | Recommended Timeline |
|---|---|---|---|
| 15 | Building-4:Stability of parapet at roof level | Engineer to review construction of parapet, connection to structural slab and stability for lateral. | 6-months |

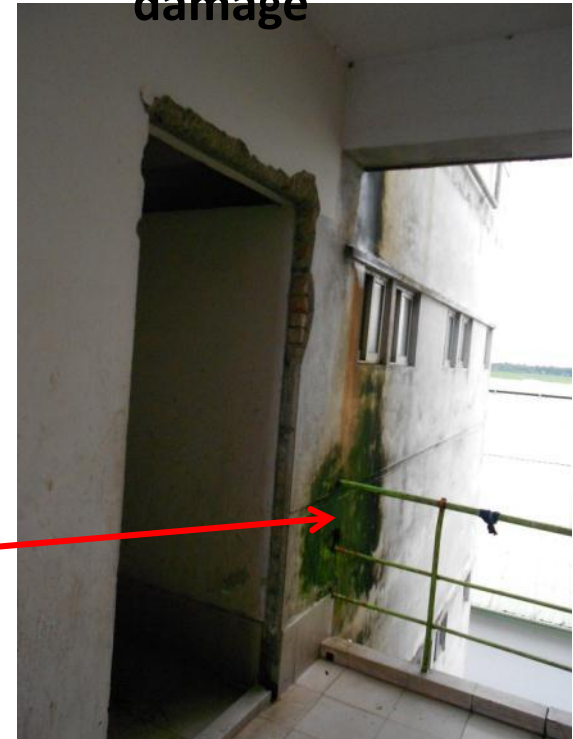
**Water damage**

**Uncontrolled water – durability of structure – control water and pipe away**

| Item No. | Observation | Recommended Action Plan | Recommended Timeline |
|---|---|---|---|
| 16 | Building-4:Water damage to external walls | Control water to prevent it running down building face to improve durability of structure. | 6-months |

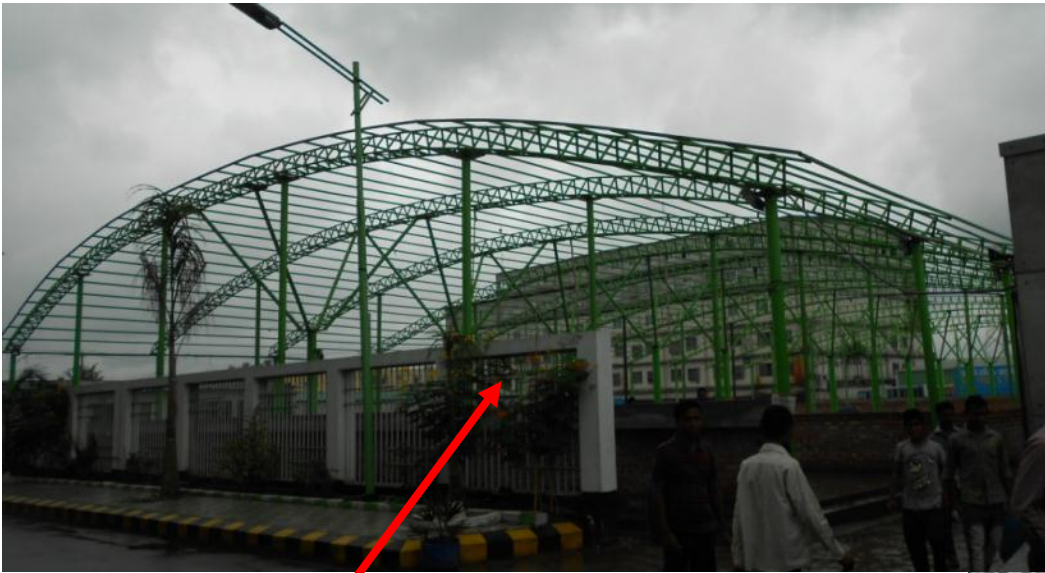
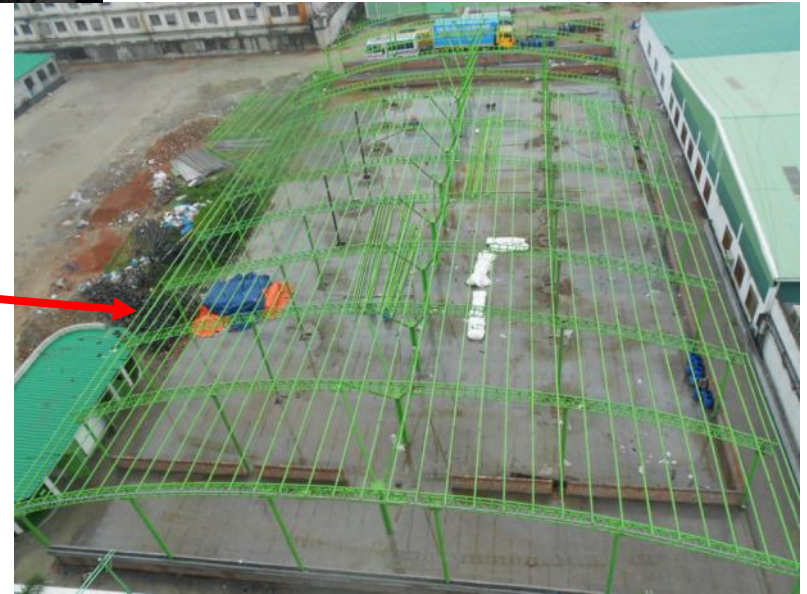
**Steel frame stability**

**Confirm lateral stability  
of steel frame structure  
and install stability  
members before  
installing roof and  
cladding**

| Item No. | Observation | Recommended Action Plan | Recommended Timeline |
|---|---|---|---|
| 17 | Check on Lateral Stability of steel frame | Clarify lateral stability of steel frame and install required stability members prior to installation of roof and cladding. | 6-months |

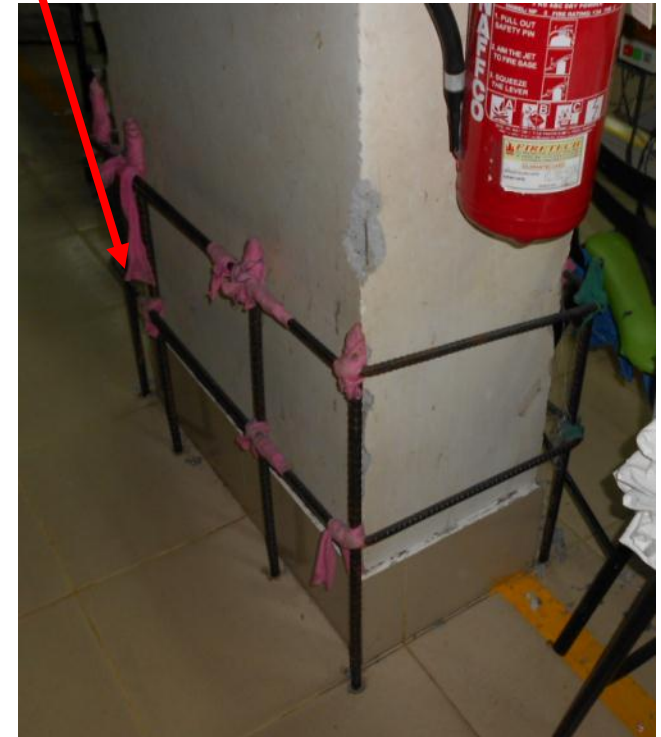
**Revise as-built drawings**

Column size incorrect

Column size correct, but strengthening not indicated

**C2 Column site measured:**  
Ground – 1st: 520mm x 960mm (strengthened)  
2<sup>nd</sup> - Roof: 320mm x 750mm

As-built design drawings do not match the conditions found on site:

- Column sizes are different
- Strengthening of columns is not indicated

| Item No. | Observation | Recommended Action Plan | Recommended Timeline |
|---|---|---|---|
| 4 | All buildings:As-built Drawings are not matching the site conditions | Revise as-build drawings to match conditions on site. Also indicate strengthening (indicate prior state and strengthened additions) | 6-months |

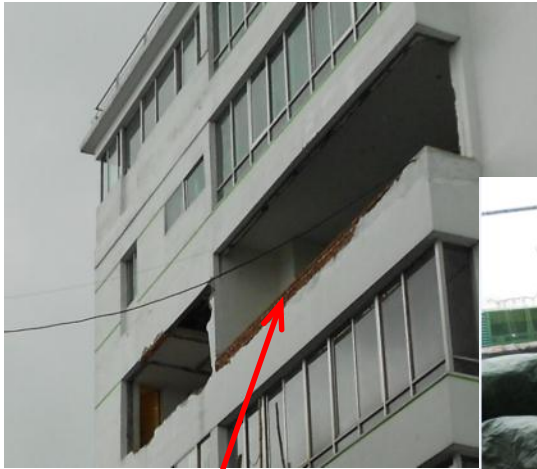
**Ongoing works  
(new bathrooms)**

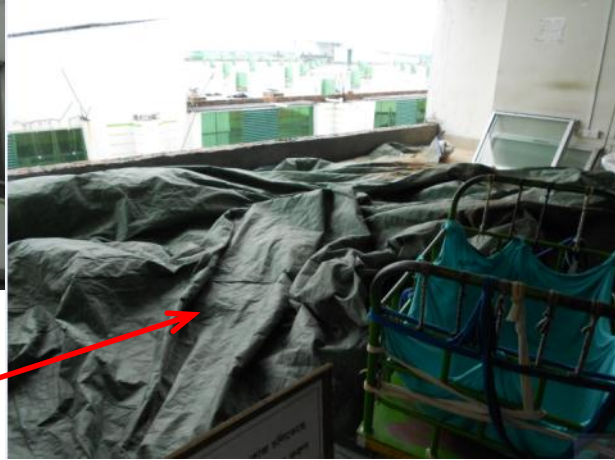
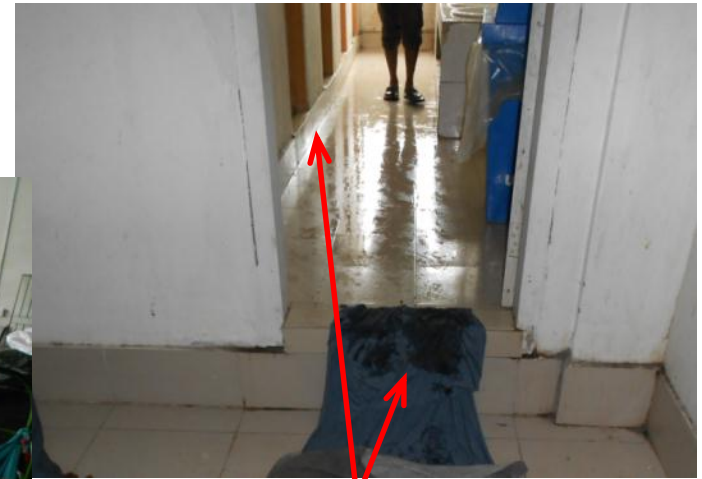
**250 – 350mm new build-up at new bathroom.**

**Engineer is to perform/provide calculations to prove slab, beam and column sizes are satisfactory for factory loading, temporary construction loading, permanent build up load for modified condition, and (if required) :**

- Reduce loads by vacating floors
- Reinforce structural elements
- Produce loading plans

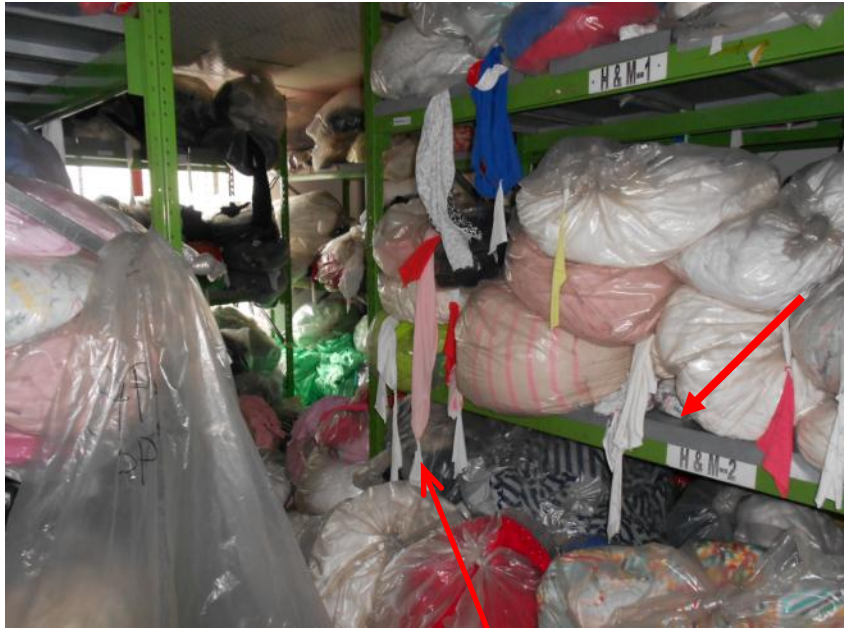
**Load management**

**Storage generally found to be well managed**

**Uncontrolled loading (isolated occurrence)**

**Engineer is to perform/provide calculations to prove slab, beam and column sizes are satisfactory for factory loading, and permanent build up load and (if required) :**

- Reduce loads by vacating floors
- Reinforce structural elements
- Produce loading plans
