# Far East Knitting & Dyeing Industries Ltd.

East Chandara, Kaliakoir, Gazipur  
(+24.042354N, +90.263318E)

06 October 2013

# Building Observations

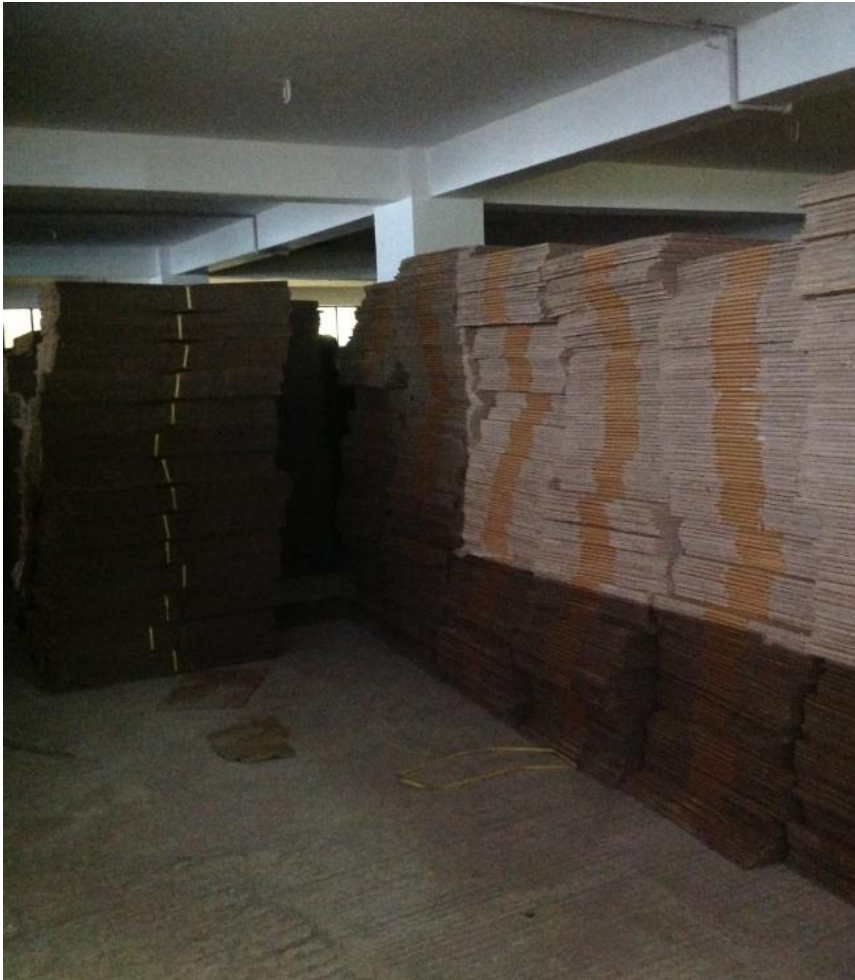
## Building 1

**Uncontrolled loading**

**Load Management**

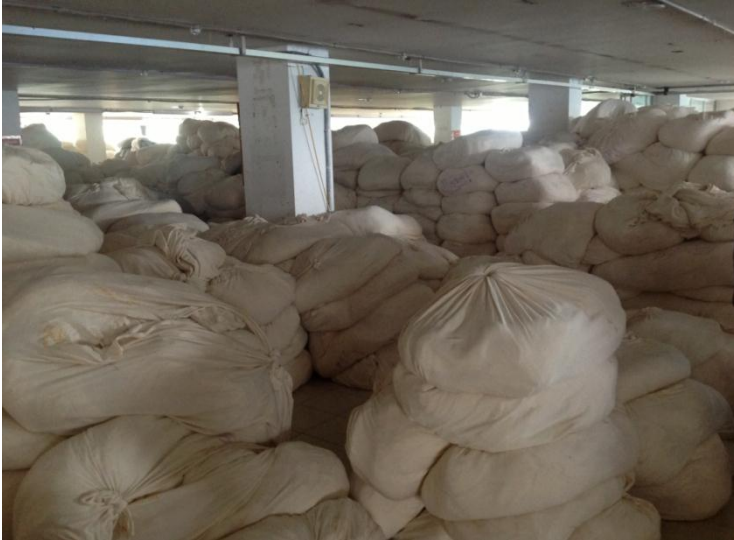
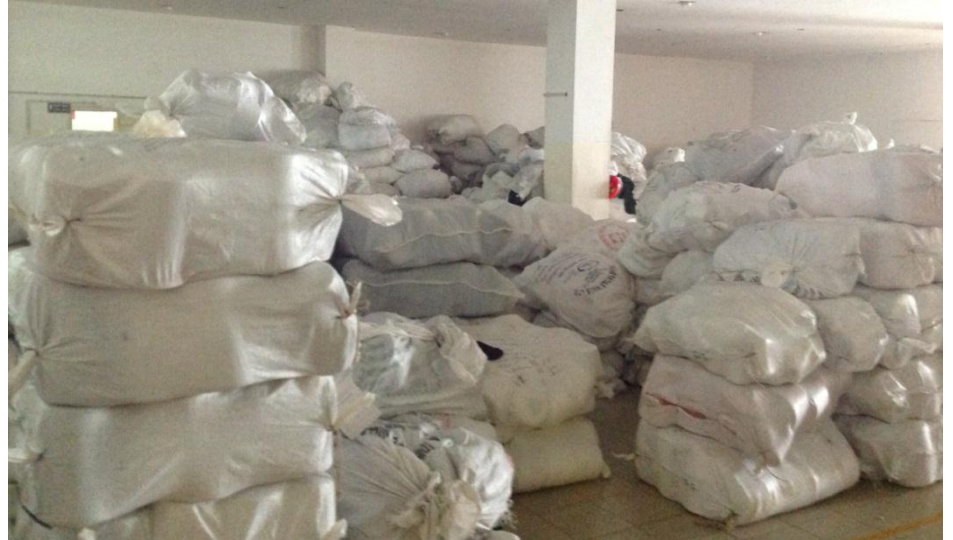
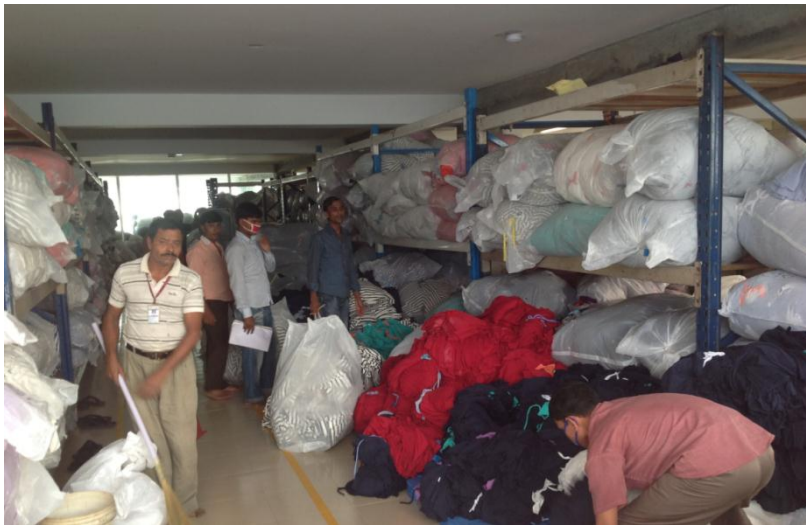
## Building 2

**Uncontrolled loading**

**Load Management**

| Item No. | Observation | Recommended Action Plan | Recommended Timeline |
|---|---|---|---|
| 5 | Building 1 – Mixed structural systems – drawings do not match the as built conditions – high column stresses. | Produce and actively manage a loading plan for all floor plates. within the factory giving consideration to floor capacity and column capacity. | 6-weeks |

| Item No. | Observation | Recommended Action Plan | Recommended Timeline |
|---|---|---|---|
| 12 | Building 2 – Mixed structural systems – drawings do not match the as built conditions – high column stresses. | Produce and actively manage a loading plan for all floor plates. within the factory giving consideration to floor capacity and column capacity. | 6-months |

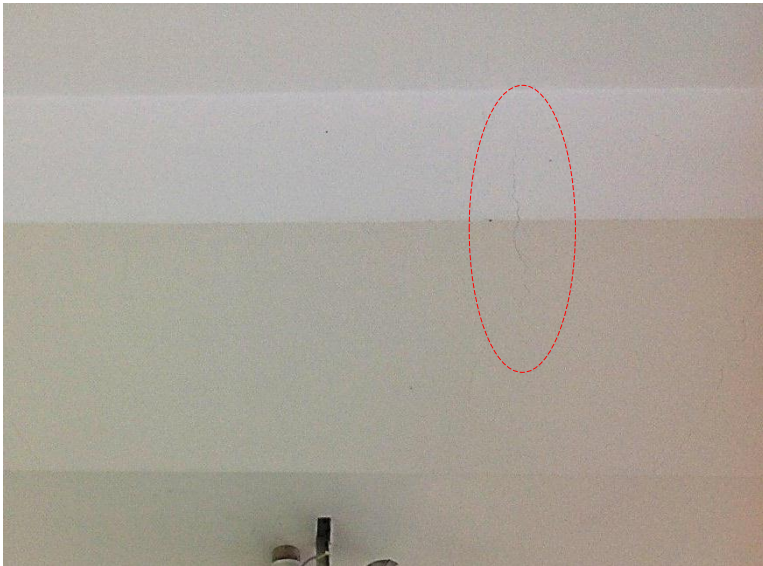
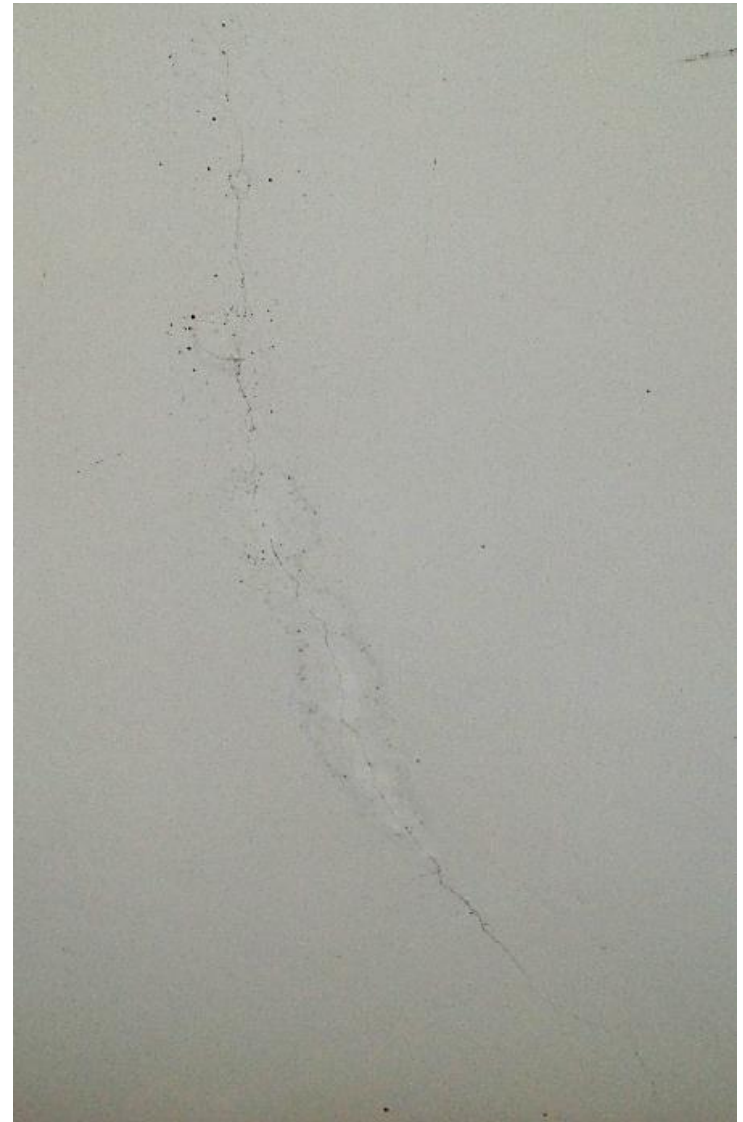
**Hairline Cracks at Beams and Slabs**

**Hairline Cracks at underside  
of slab and beams  
throughout both buildings.**

**These did not appear to  
coincide with the heavily  
loaded areas.**

| Item No. | Observation | Recommended Action Plan | Recommended Timeline |
|---|---|---|---|
| 14 | Hairline cracks in both buildings | Verify that beam/slab has sufficient capacity to support the full slab load. | 6-weeks |
| 15 | Hairline cracks in both buildings | Monitor the cracks to ensure no further cracks appear and the existing cracks do not increase in size. | 6-months |

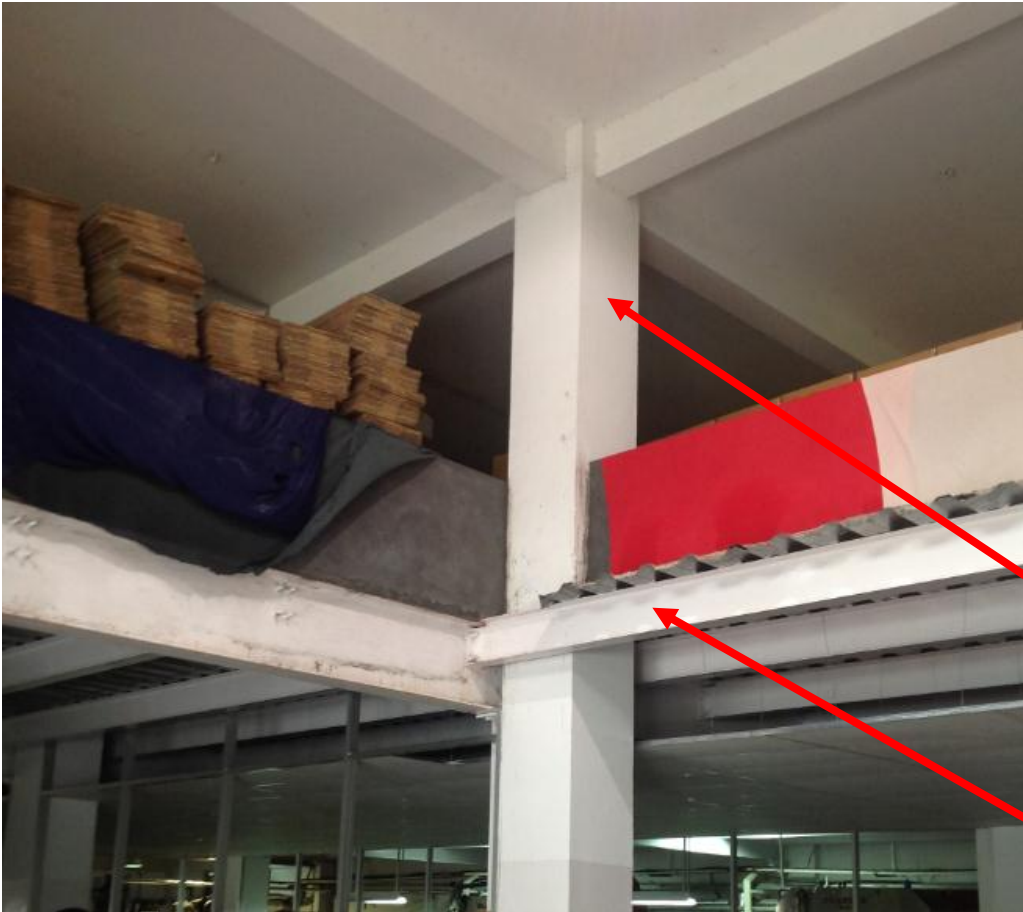
## Building 1

**Steel structure and R.C. structure are both used interchangeably. A clear logic how the two systems work together or are separated from each other is not apparent**

| Item No. | Observation | Recommended Action Plan | Recommended Timeline |
|---|---|---|---|
| 1 | Building 1 – Mixed structural systems – drawings do not match the as built conditions – high column stresses. | Factory Engineer to review design and structural system | Immediate - Now |

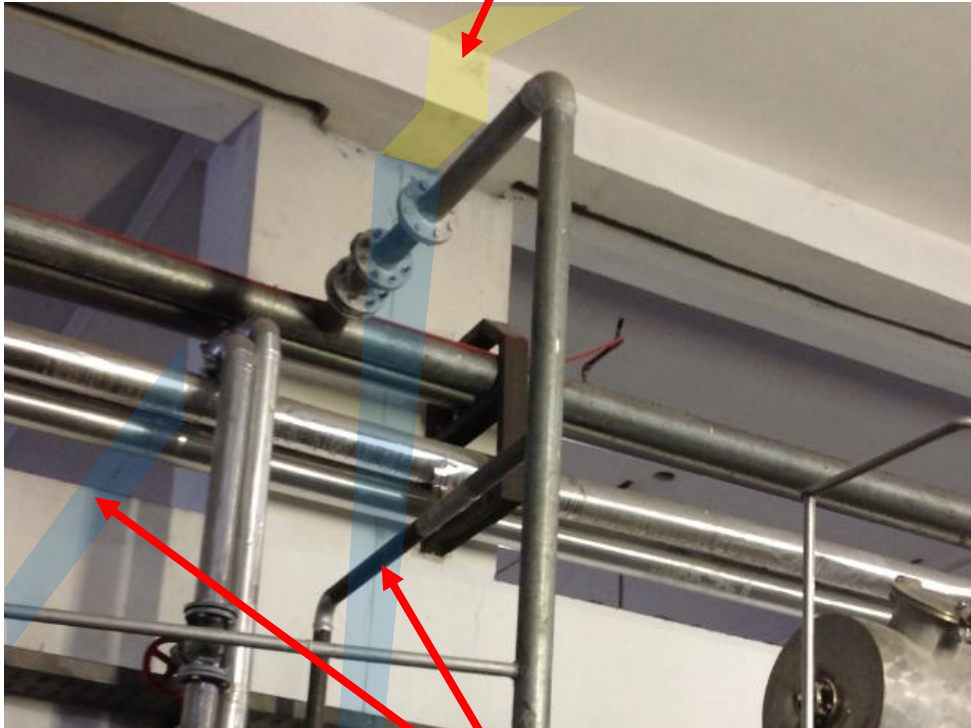
No Movement joint

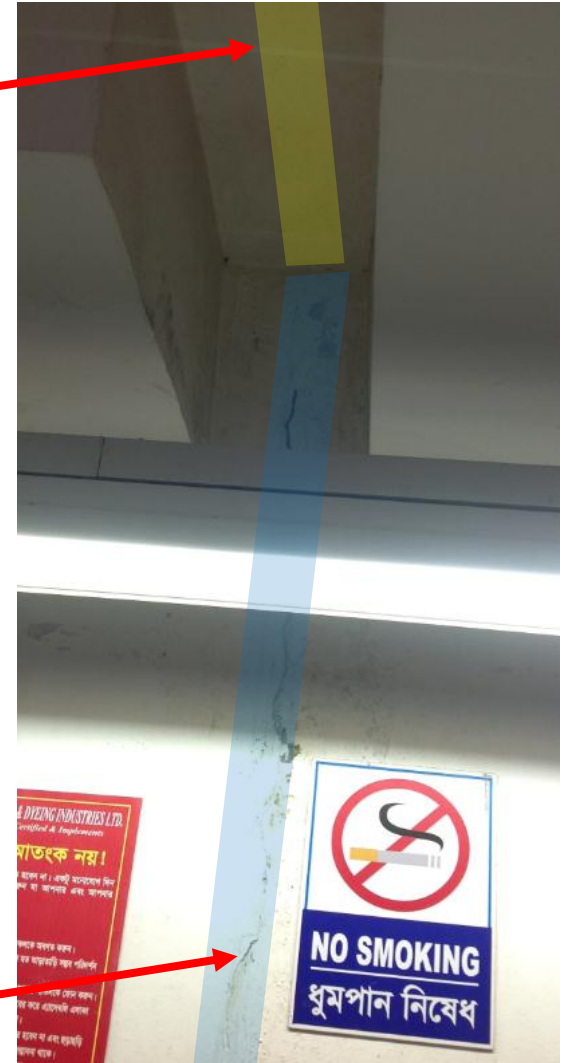
Movement joint

**Movement Joint not continuous**

| Item No. | Observation | Recommended Action Plan | Recommended Timeline |
|---|---|---|---|
| 16 | Movement joint in Building 2 not continuous | Revise As-Built drawings showing actual joints. | 6-weeks |
| 17 | Movement joint in Building 2 not continuous | Building Engineer to verify integrity built structure under factory design loading. | 6-weeks |
| 18 | Movement joint in Building 2 not continuous | Building Engineer to verify lateral stability for wind and seismic loading. | 6-weeks |

| Item No. | Observation | Recommended Action Plan | Recommended Timeline |
|---|---|---|---|
| 19 | Movement joint in Building 2 not continuous | Monitor the differential movements between the joints and possible cracks in the continuation of the joints, to insure structural integrity of the structure. | 6-weeks |

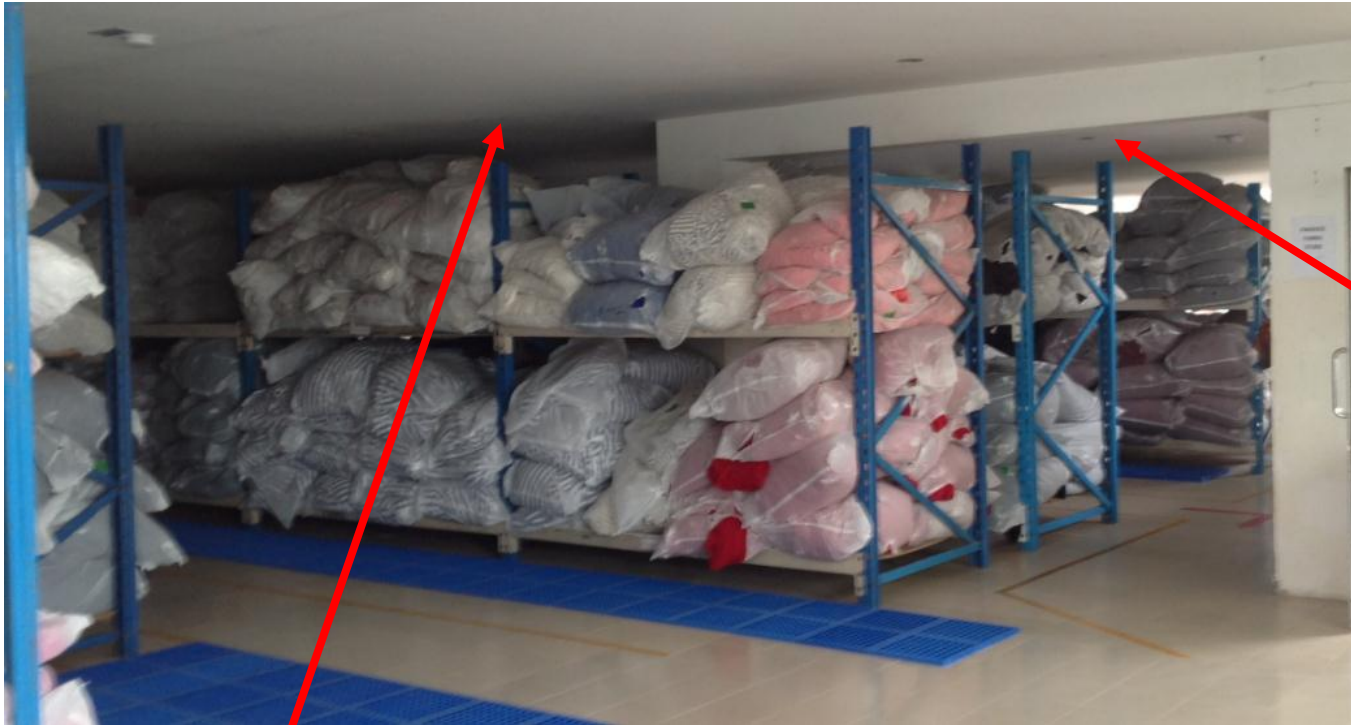
## Building 2

R.C. Flat Slab and R.C. Slab on Beam structure are both used interchangeably. A clear logic why the one or the other is selected is not apparent

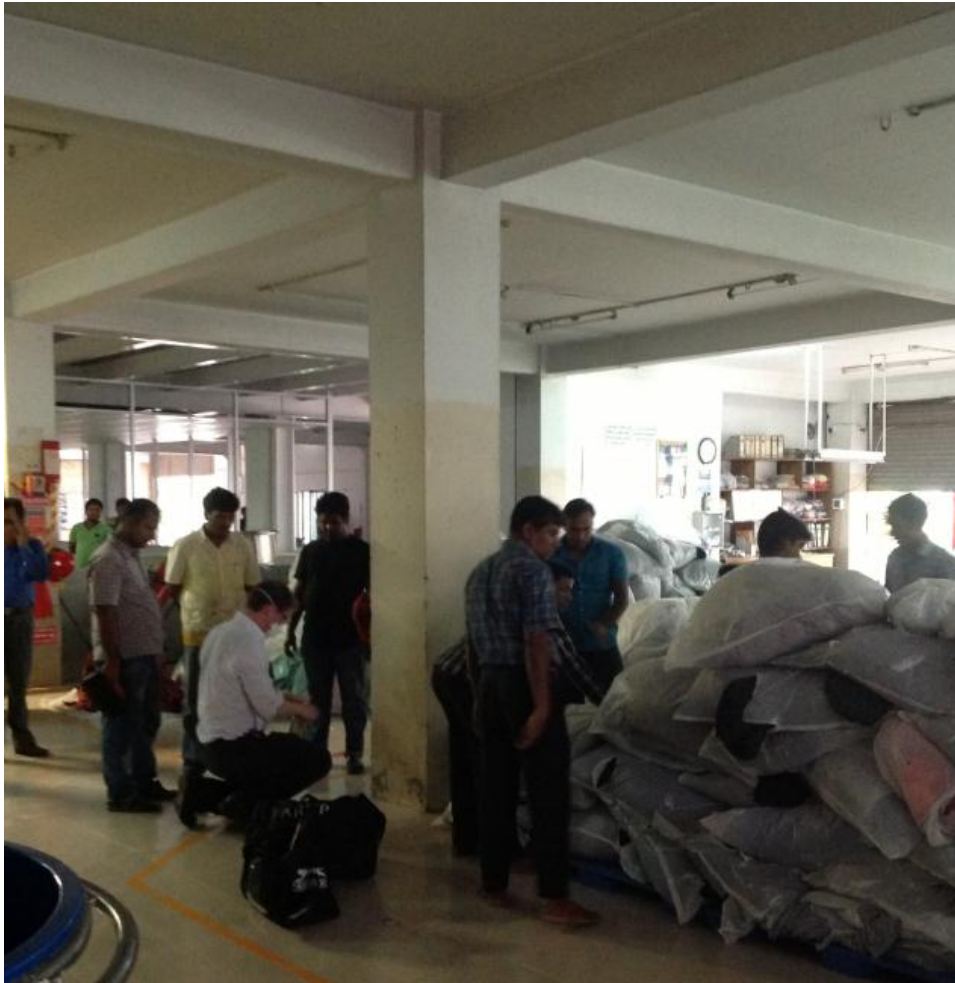
## **Column stresses**

**As-built drawings and structural drawings are not available.**

**Cursory calculations indicate high column stresses (building 1 and building 2)**

**Engineer is to perform detailed calculations and concrete tests to prove column size and (if required) :**

- Reduce loads by vacating floors and removing addition structures**
- Reinforce columns**

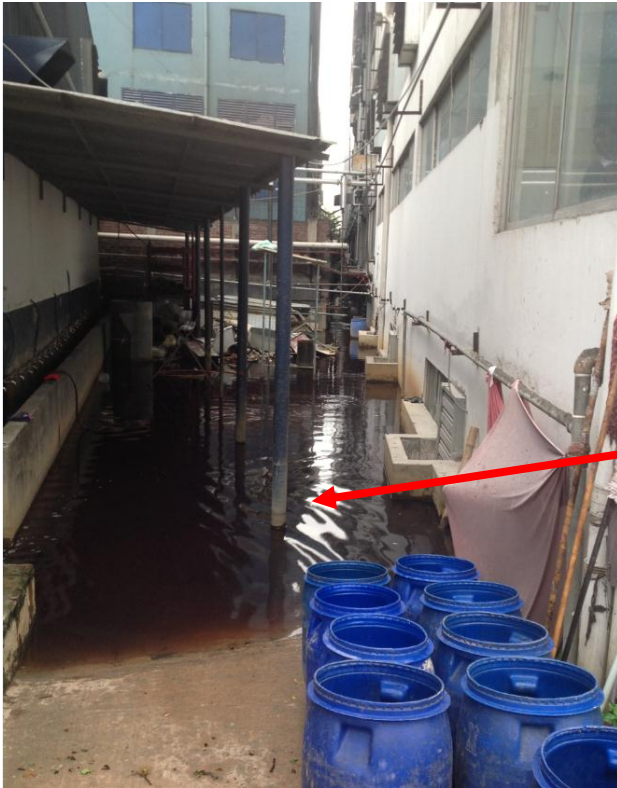
## Building 2

Flooding to side of Building 2 basement due to surface drain backing up following heavy rain. Reported to occur every time after heavy rain. At the time of survey, there is no sign of water damage in the basement.

| Item No. | Observation | Recommended Action Plan | Recommended Timeline |
|---|---|---|---|
| 20 | Surface Flooding to side of Building 2 basement | If possible, mitigate surface flooding by installing appropriate drainage. | 6-months |
| 21 | Surface Flooding to side of Building 2 basement | Periodically inspect basement wall for possible dampness or water ingress from the outside. | 6-weeks |

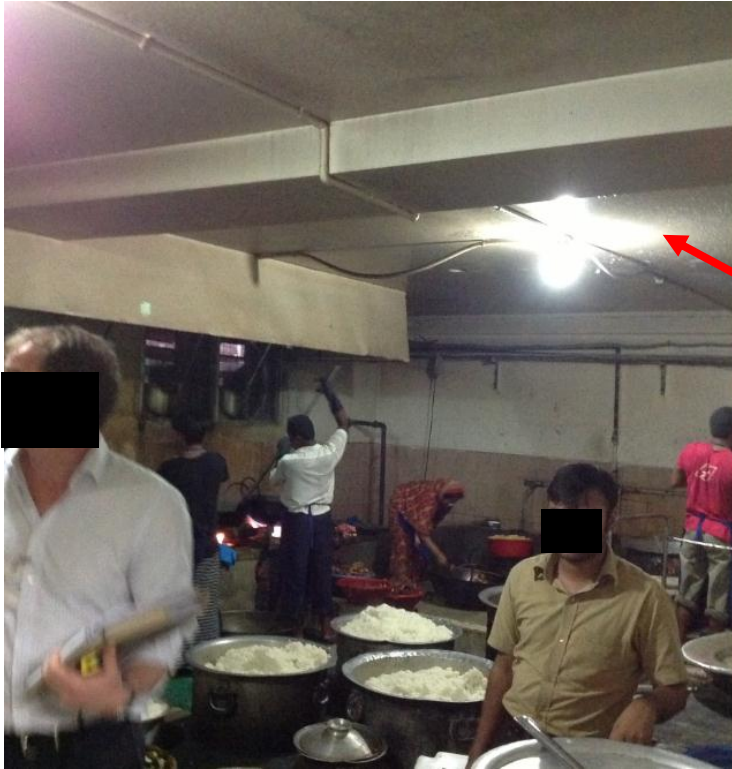
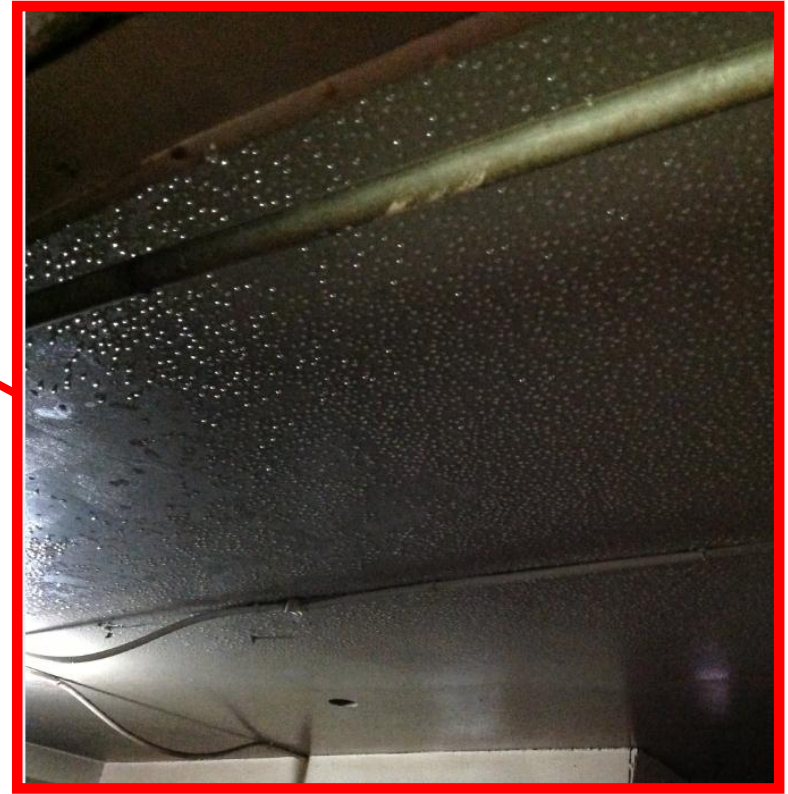
## Condensation

Condensation in soffit of kitchen in basement. Currently there is no damage, but it should be managed

| Item No. | Observation | Recommended Action Plan | Recommended Timeline |
|---|---|---|---|
| 22 | Condensation on soffit in Kitchen of Building 2 | If possible, eliminate condensation by installing better ventilation. | 6-months |
| 23 | Condensation on soffit in Kitchen of Building 2 | Protect soffit with water- and damp-proof protection. | 6-months |
| 24 | Condensation on soffit in Kitchen of Building 2 | Periodically inspect slab for possible damage. In case of signs of corrosion, remove heavy loads above and close kitchen for access. | 6-months |
