# Fakir Knitwears Ltd.

Kayempur, Fatullah, Narayanganj-1400, Bangladesh

19 December 2013

# Observations

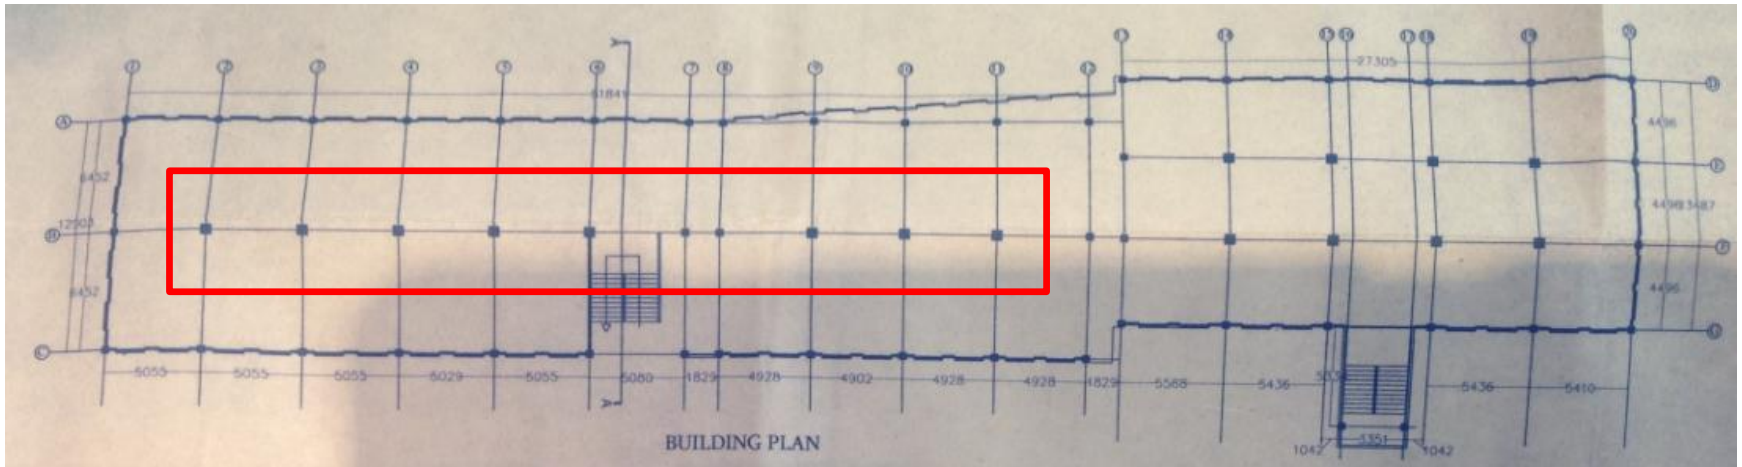
## Columns strength

# High Column Loads - Main Building Engineering Assessment Required

Cursory calculations indicate that internal and external columns working stress is at a high level in main building

A Detailed Engineering Assessment of the building is required (See attached Scope) . Engineer is to perform detailed calculations based on as constructed dimensions and concrete tests to prove column size and (if required) :

- Reduce loads by vacating floors and removing additional structures
- Reinforce columns

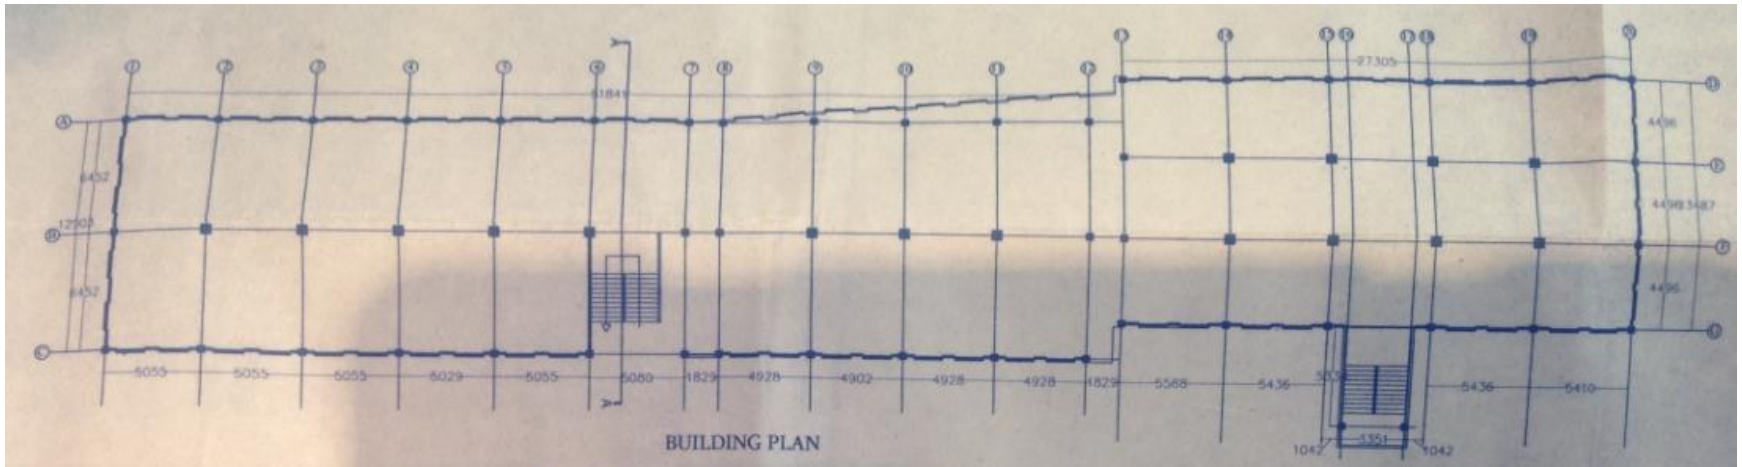
## Lateral Stability

# **Lateral Stability of Main Building Engineering Assessment Required**

Lateral stability of building to be assessed, considering movement joint locations and flat slab construction  
 A Detailed Engineering Assessment of the building is required (See attached Scope) .

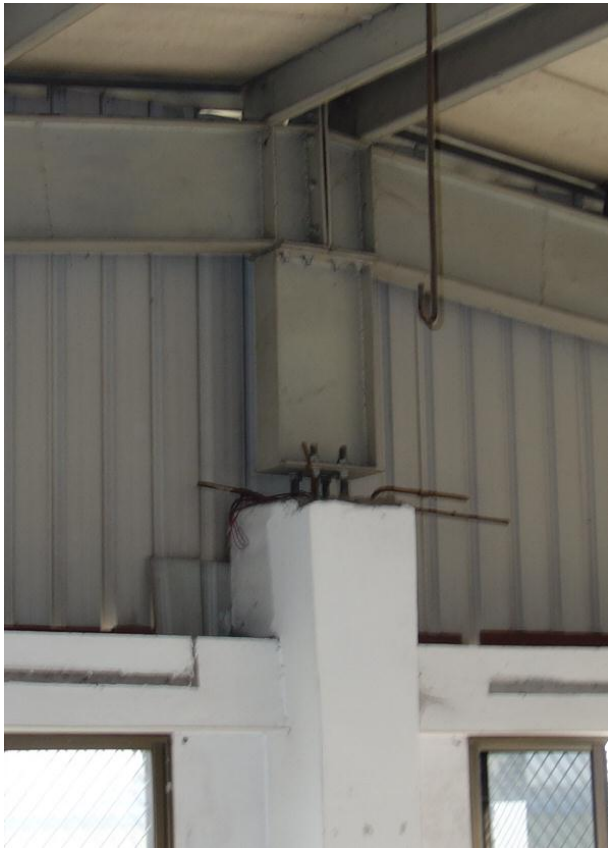
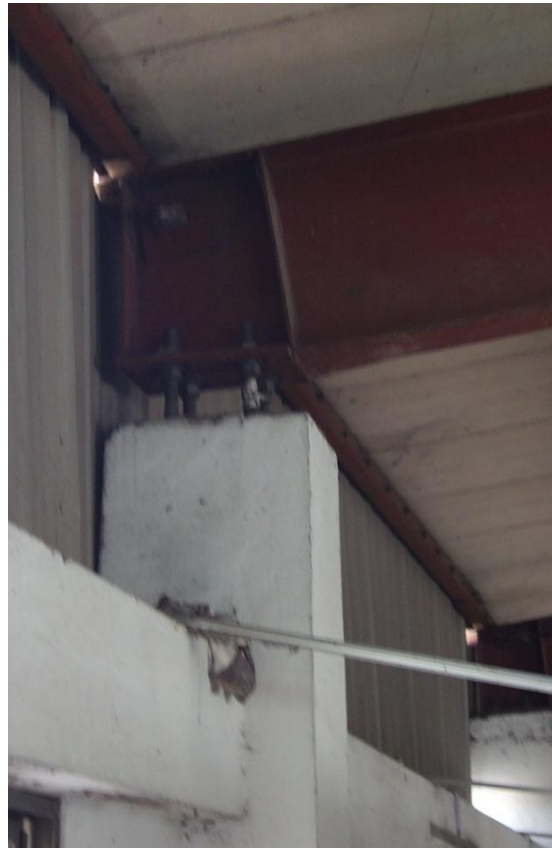
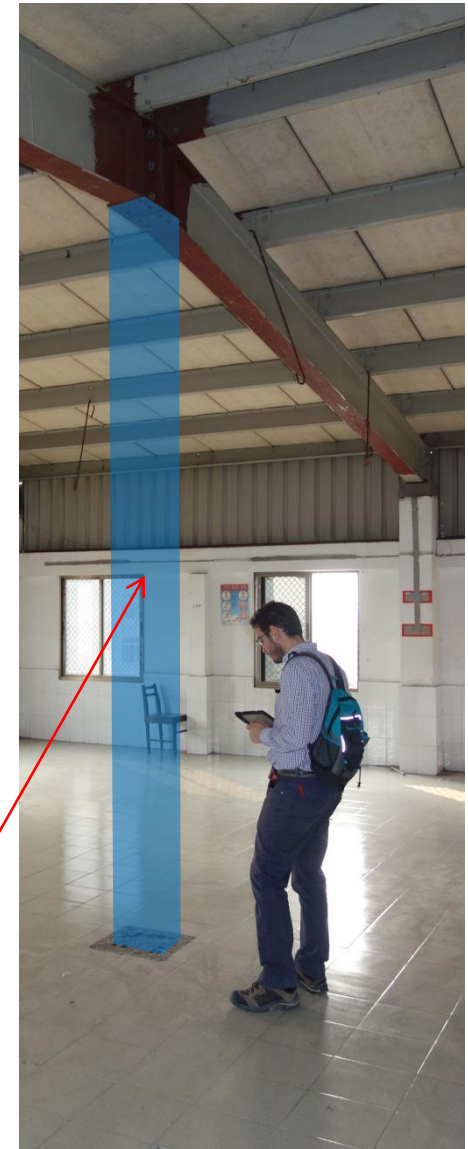
## Non engineered structure

# Non engineered steel structure in Main building roof

- One column missed in one of the frames without an obvious transfer element, this column is in all the frames except one.
- Connections do not appear to be designed.
- Connections do not appear to be constructed properly.

Item No.	Observation	Recommended Action Plan	Recommended Timeline
13	Non engineered steel structure in Main building's roof	Building Engineer to check the structure and connections and any required strengthening works to be implemented to ensure the proper functioning of the structure.	6-months
14	Cracking in slabs	Monitor cracks on slab. Conduct regular inspection of cracks. Investigate if cracks are only in the plastering/finishes.	6-weeks
15	Cracking in slabs	If cracks grow larger, removing all items above the slab and close working areas below the affected areas . Building Engineer to investigate, repair and strengthen the slab.	6-months
16	Slender columns in printing building's ground floor	Factory engineer to review design.	6-months
17	Slender columns in printing building's ground floor	If required, strengthen the columns.	6-months
18	Steel connections in Warehouse building. Connections not designed or executed improperly	Factory engineer to check connections.	6-weeks

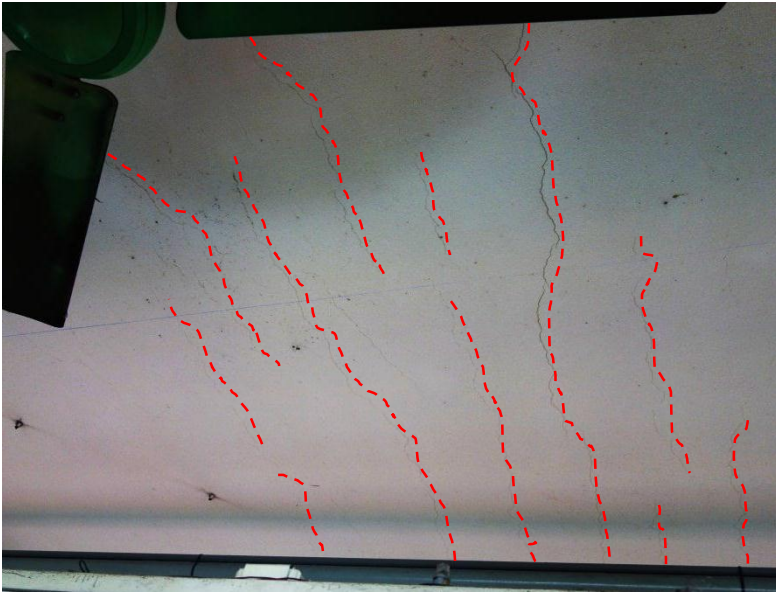
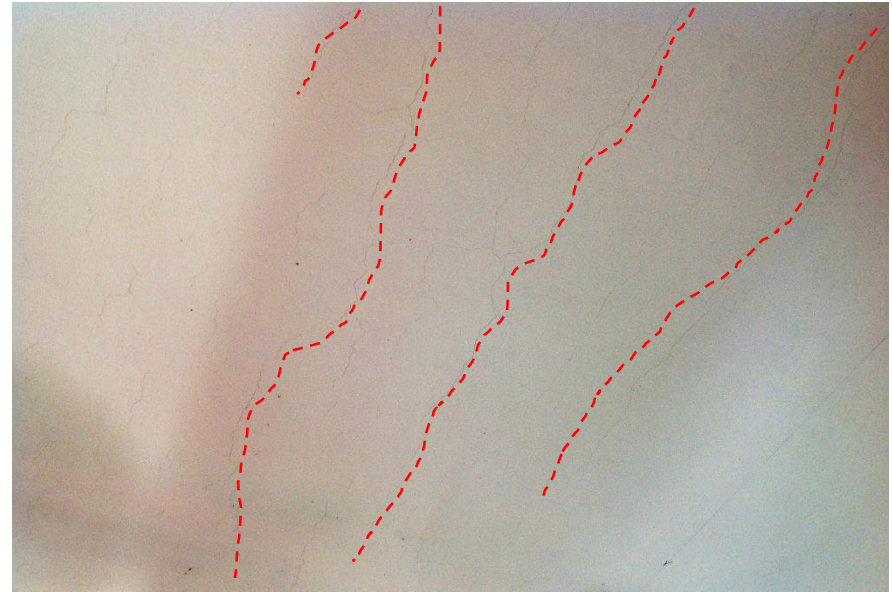
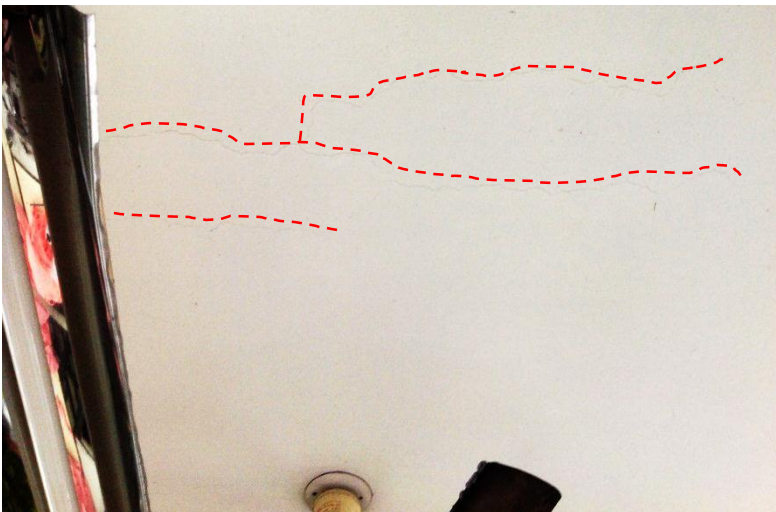
## Cracking in slabs – Main & Printing

Cracks parallel to longest span detected in several floors. Cracks appeared concentrated at midspan area.

Building Engineer to check cracks are only into the plaster and to ensure crack do not continue into concrete slab.

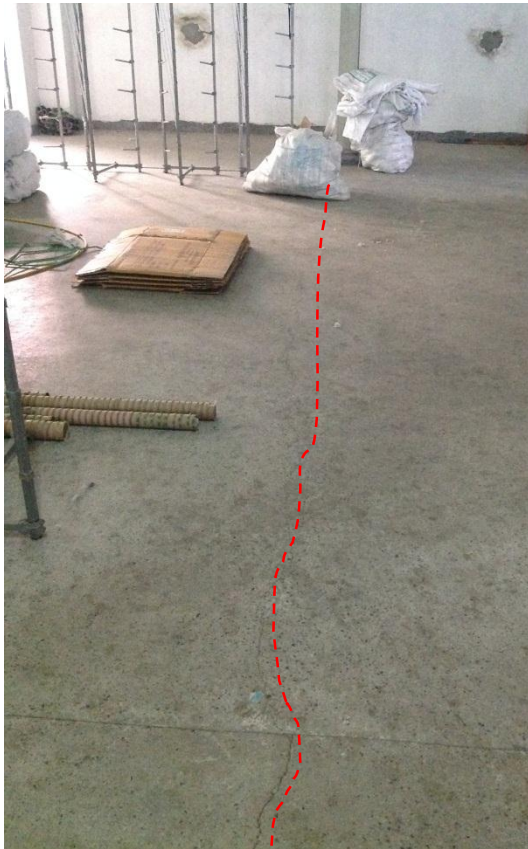
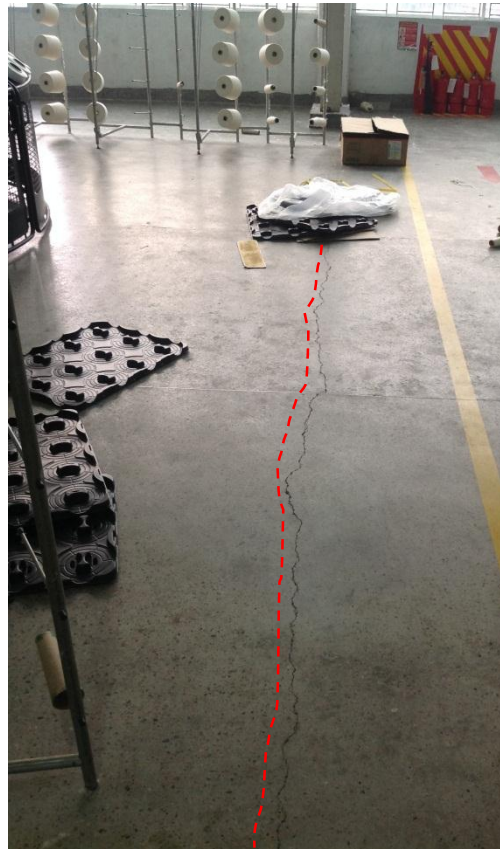
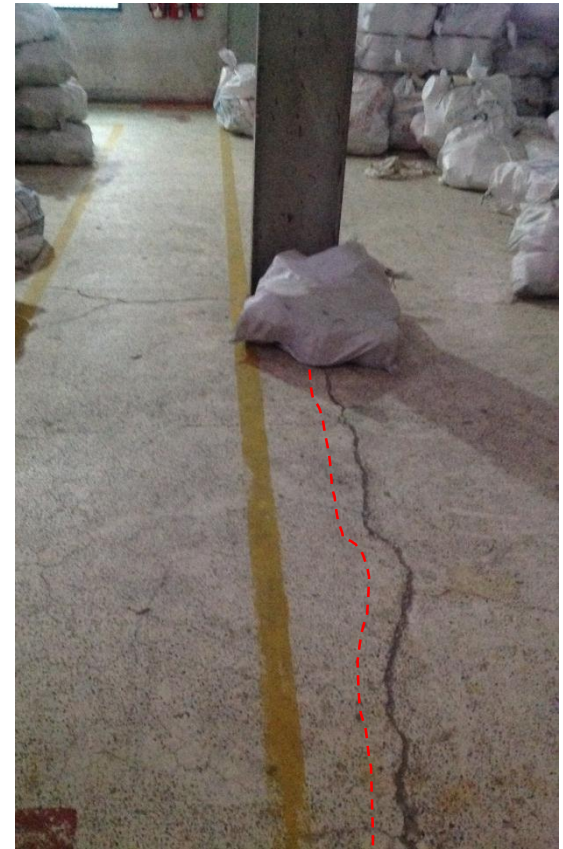
## Cracking in slabs Warehouse & Knitting

Cracks parallel to longest span detected on several floors. Cracks appeared concentrated at support area, aligned with column gridlines. Building Engineer to check cracks are only into the finishes and to ensure cracks do not continue into concrete slab.

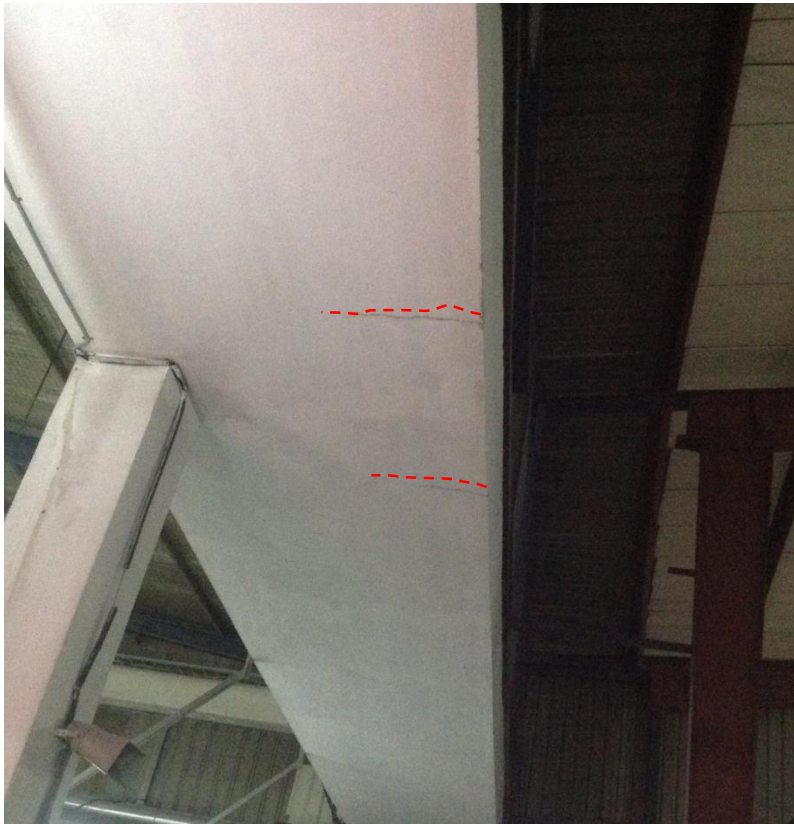
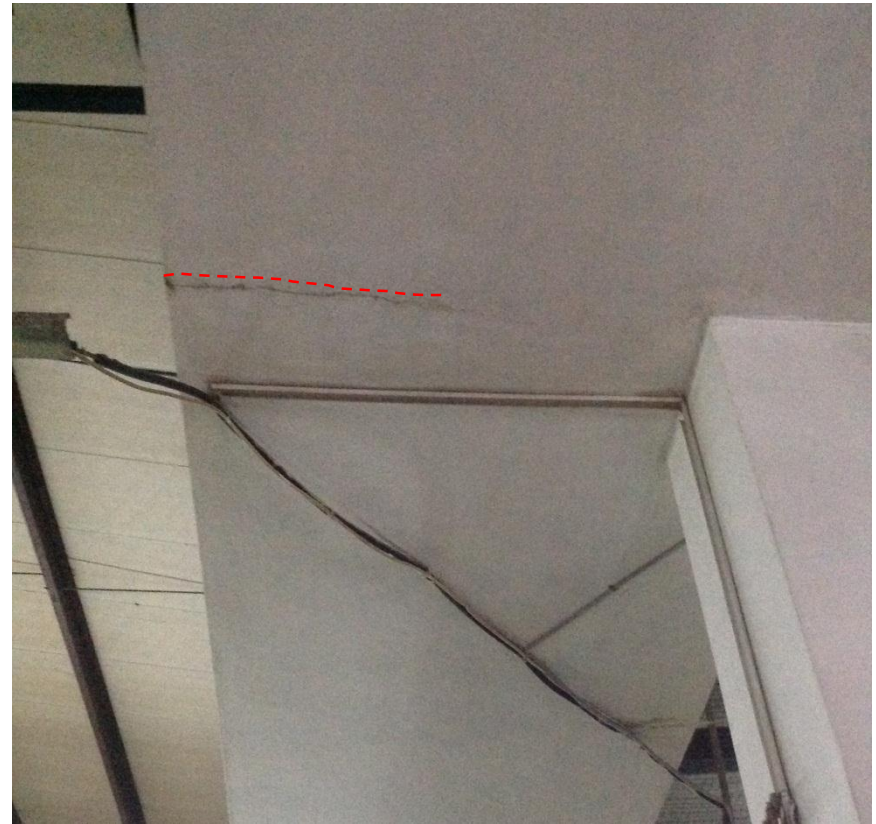
## Cracking in slabs Knitting & Dyeing

Cracks parallel to cantilever detected in slab between Knitting and Dyeing buildings. Cracks appeared concentrated at support area. Building Engineer to review support and check cracks are only in the plaster and to ensure cracks do not continue into concrete slab.

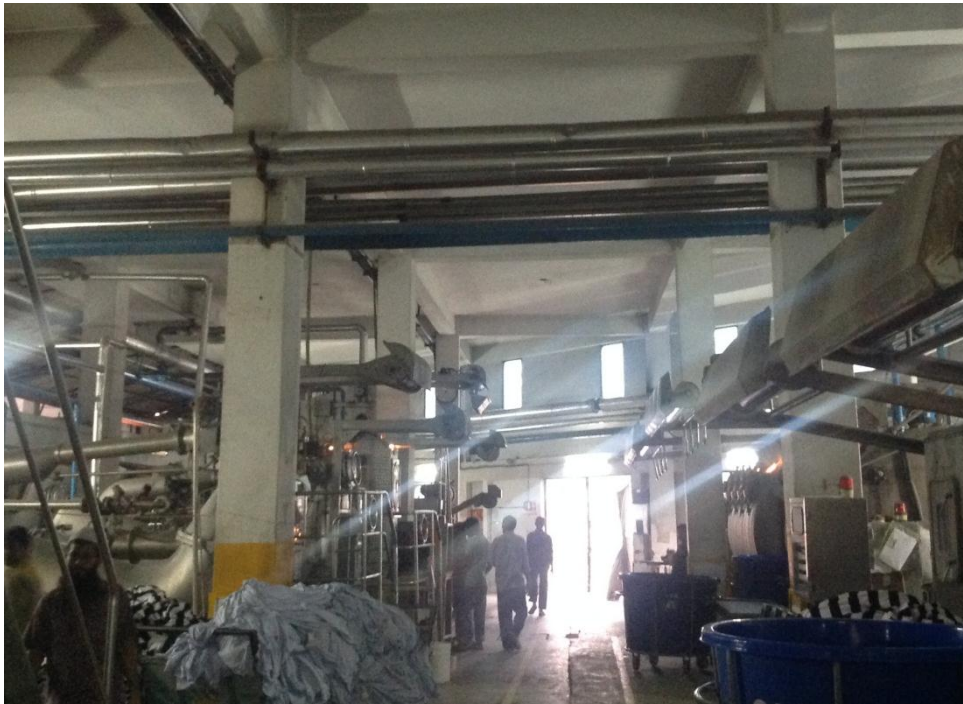
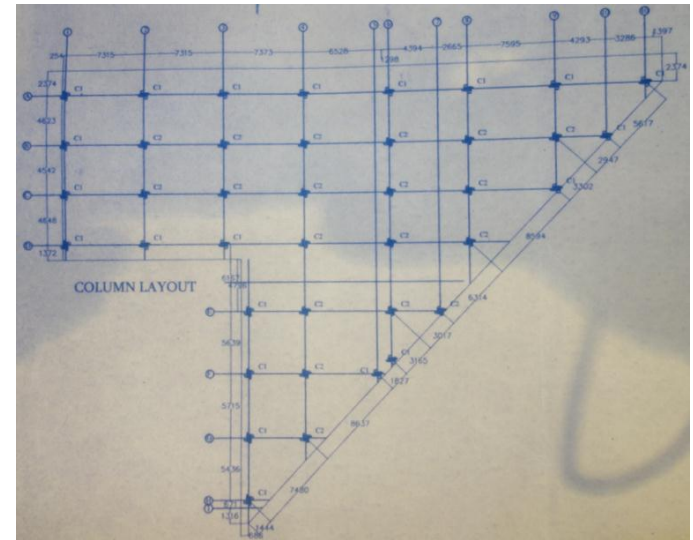
## Slender columns

# Slender columns in Printing building ground floor

**Slender Columns**  
 Columns with dimensions 450x450 mm and 5900 mm high has been observed in the Printing building at ground floor. These columns do not match with the dimensions shown on drawings.

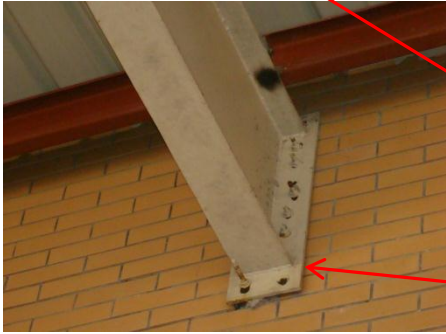
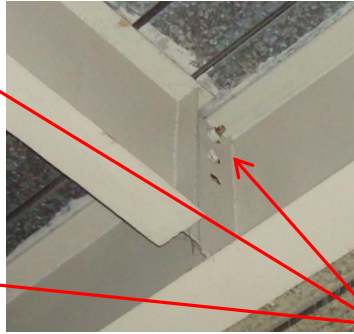
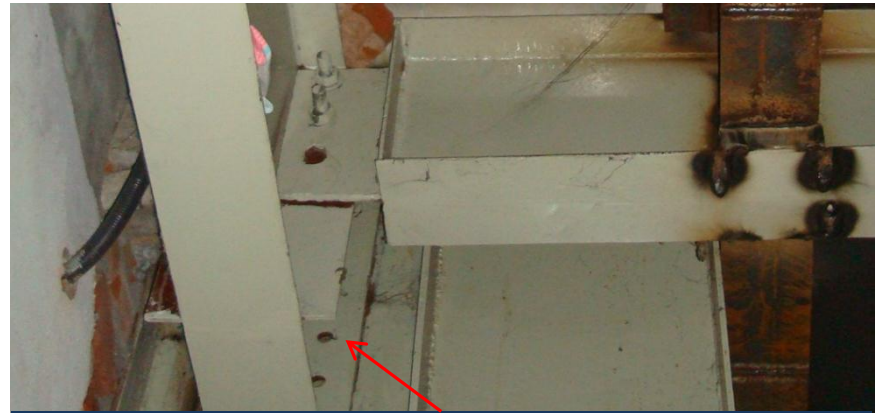
Connection missing bolts, Building Engineer to check if welds provided are adequate

Building Engineer to review steel connections

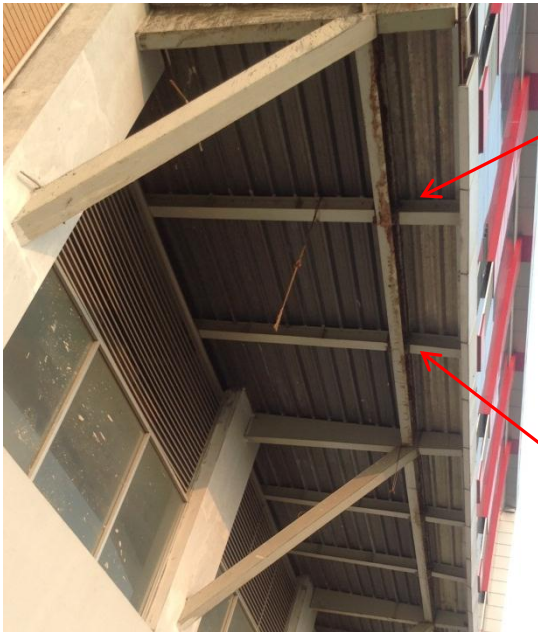
Cantilever connections do not appear to provide moment capacity

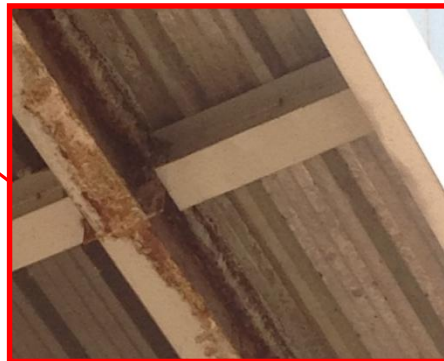
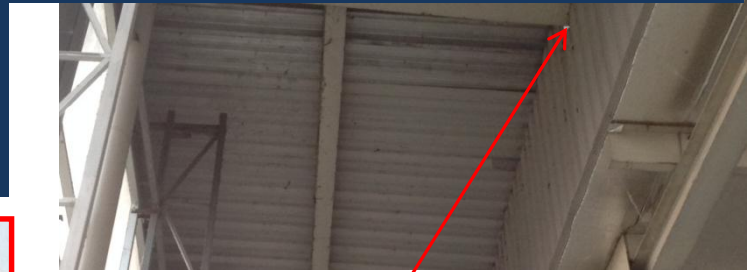
Beam support is not clear

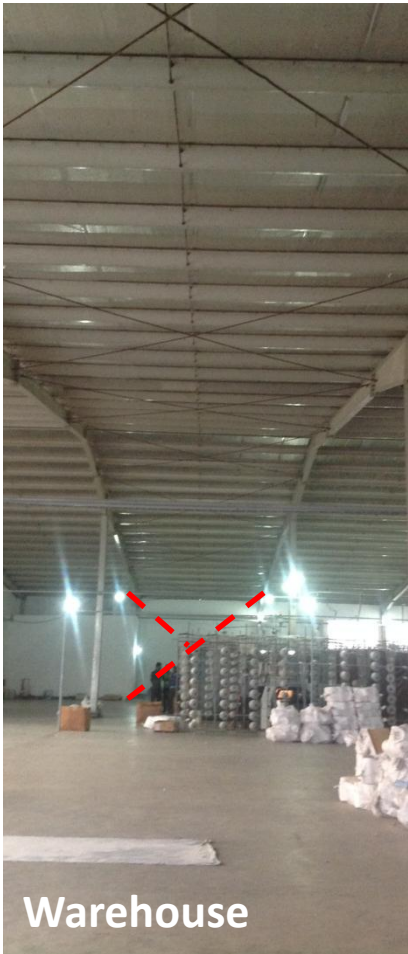
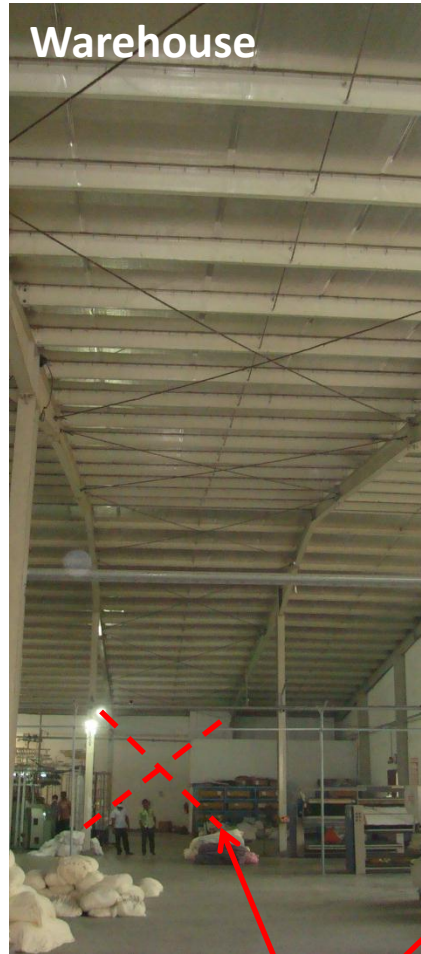
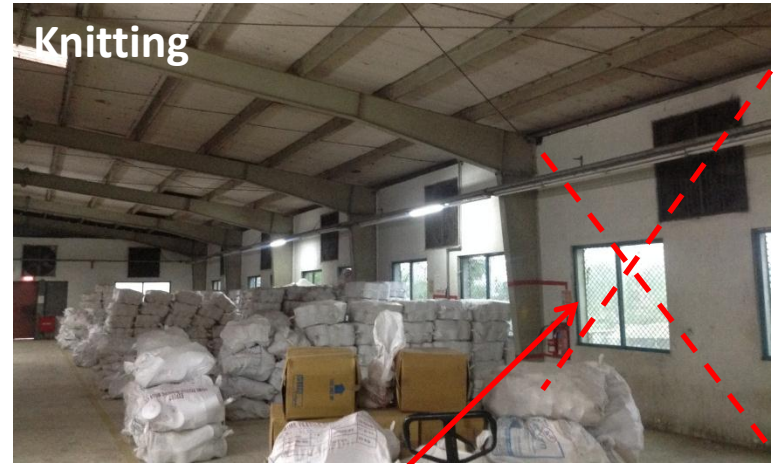
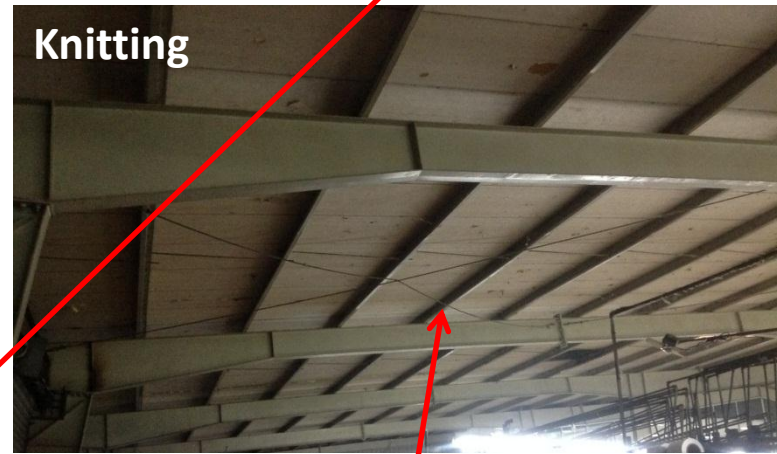
## Vertical and Horizontal stability

# Vertical stability in Warehouse building roof and Knitting building roof

**Knitting and Warehouse buildings**  
Vertical stability system may be required  
Horizontal stability system on the roof plane needs to be tensioned

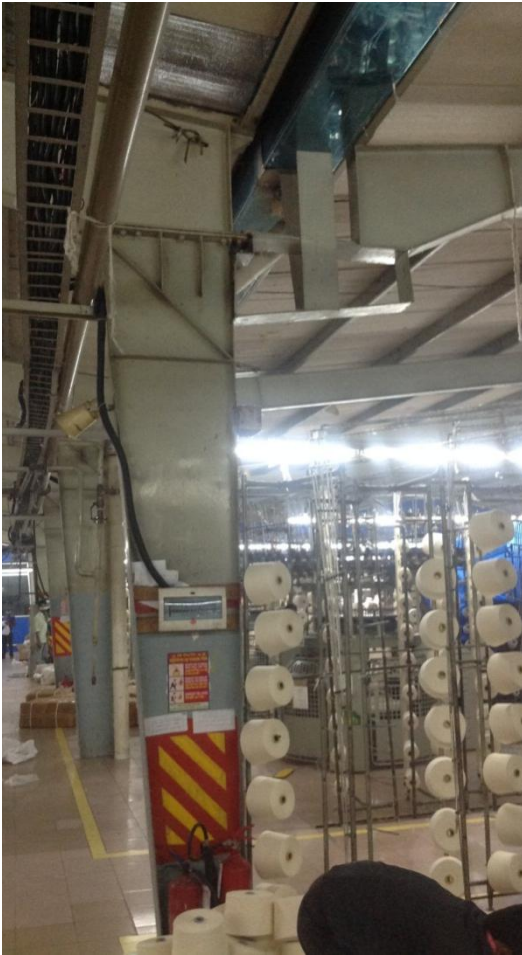
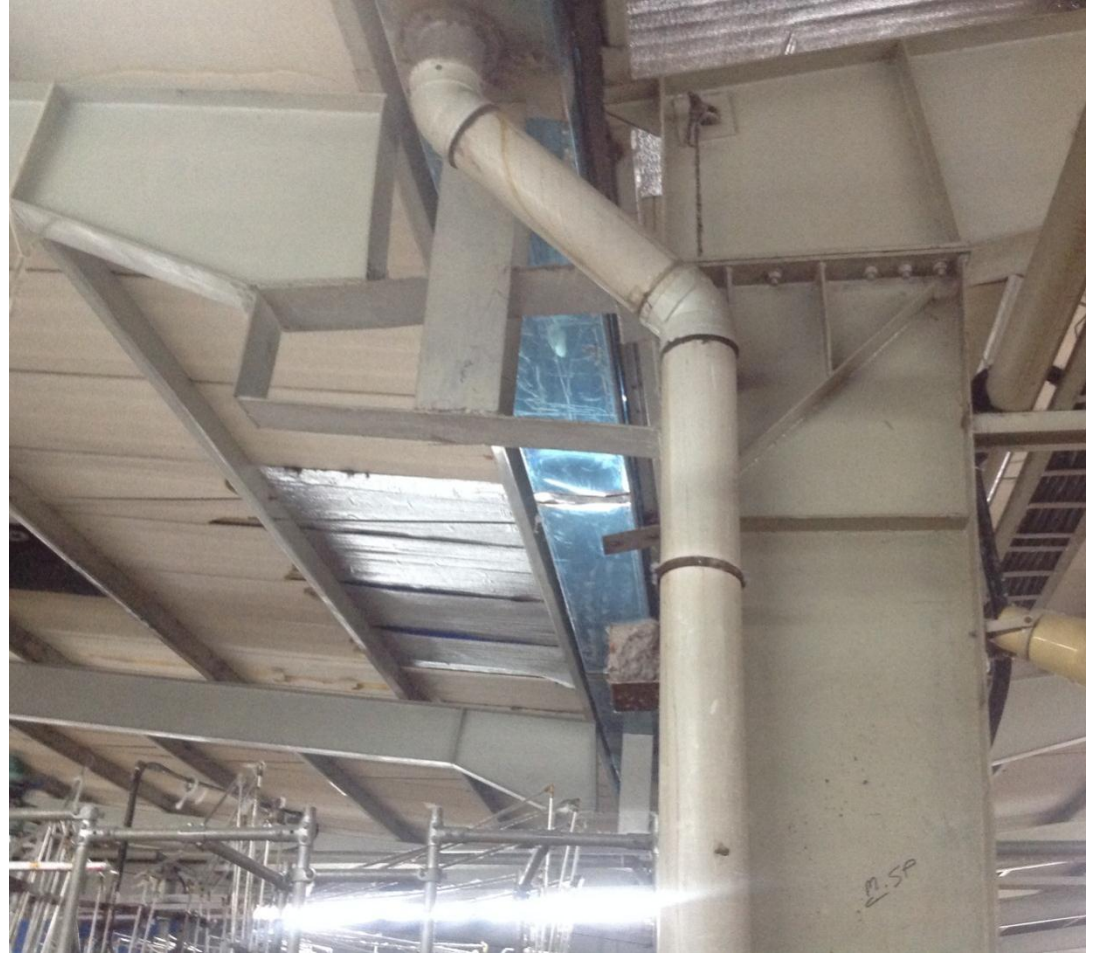
**Rafter support**

# Non engineered frame support in Knitting building roof

Non engineered support, the frame has been interrupted in the gutter zone

24	Non engineered support, the frame has been interrupted to give way to the gutter	All required remedial works and actions to be implemented.	6-months

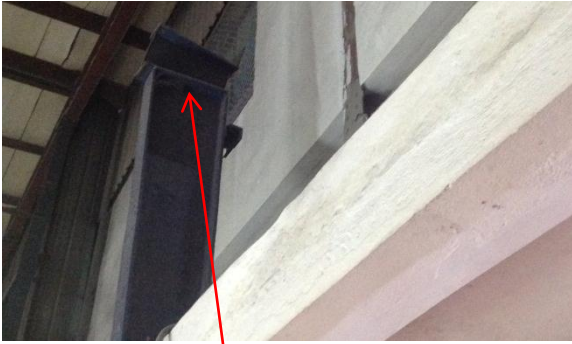
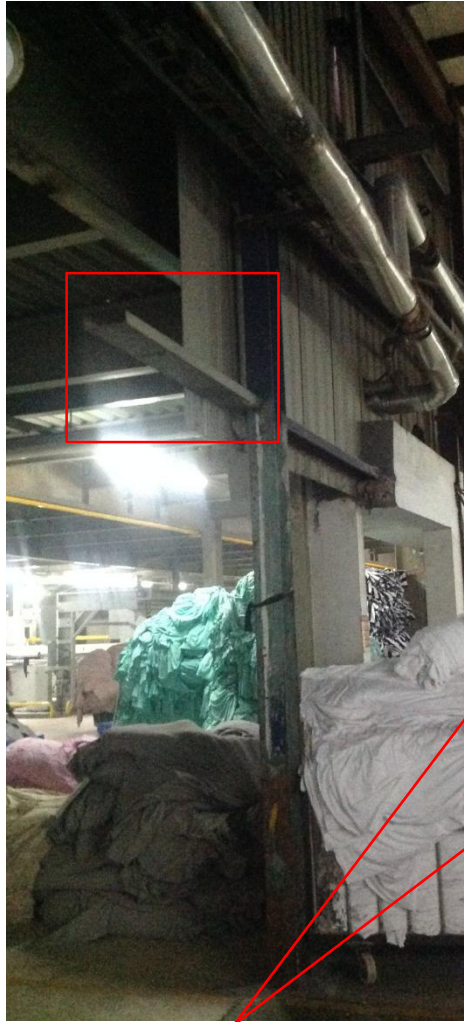
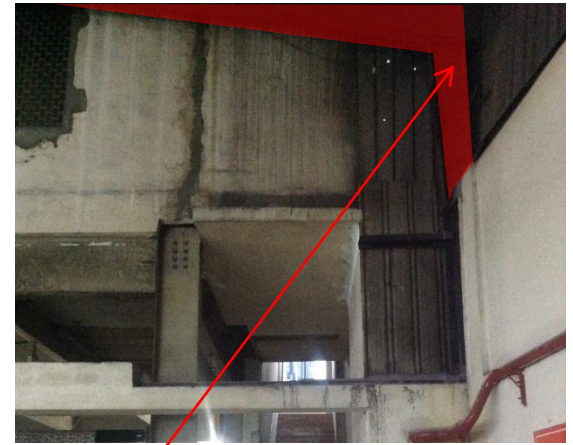
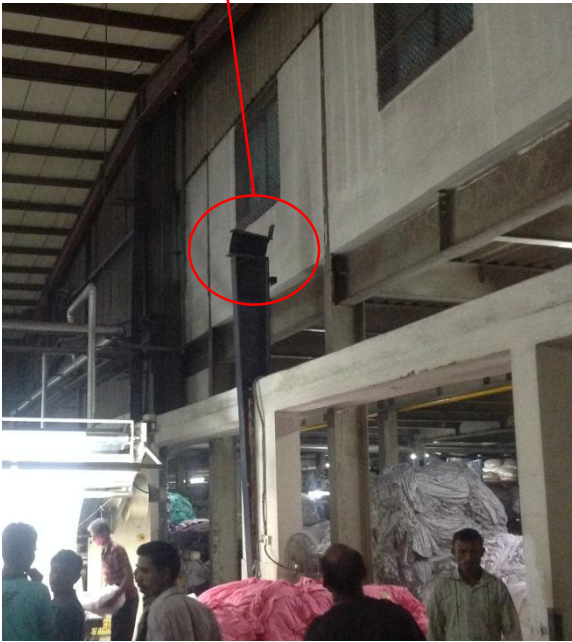
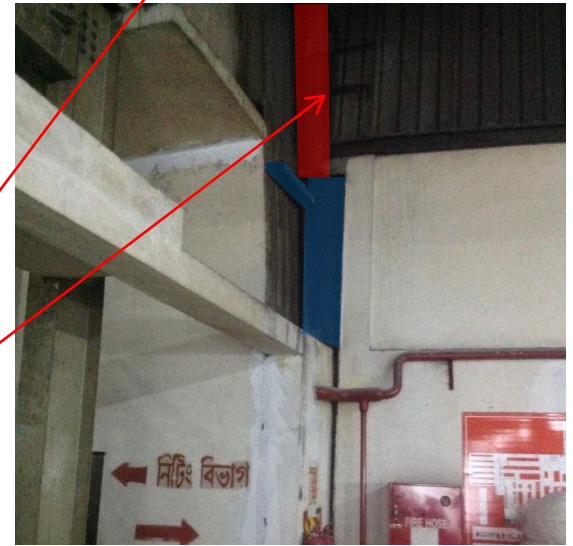
## Internal structure

# Dyeing building internal structure

Internal structure partially removed, this structure serves to support some of the main structural elements of Dyeing building roof but does not appear to be a designed solution

Item No.	Observation	Recommended Action Plan	Recommended Timeline
25	Internal structure partially removed, this structure serves to support some of the main elements of Dyeing building roof	Factory engineer to check the support between the internal structure and the main frame and propose additional reinforcements if required.	<b>6-weeks</b>
26	Internal structure partially removed, this structure serves to support some of the main elements of Dyeing building roof	All required remedial works and actions to be implemented	<b>6-months</b>
27	Limit density of loading in storage areas	Building Engineer to ensure the structure is not loaded beyond capacity. Limit stack height to 1.80m (1.50x1.50m area) and keep 0.60-0.70 m cleared strip around. Limit height to 1.80 m for loose clothing.	<b>Immediate - Now</b>
28	Limit density of loading in storage areas	Produce and actively manage a loading plan for all floor plates within the factory giving consideration to floor capacity and column capacity.	<b>6-weeks</b>

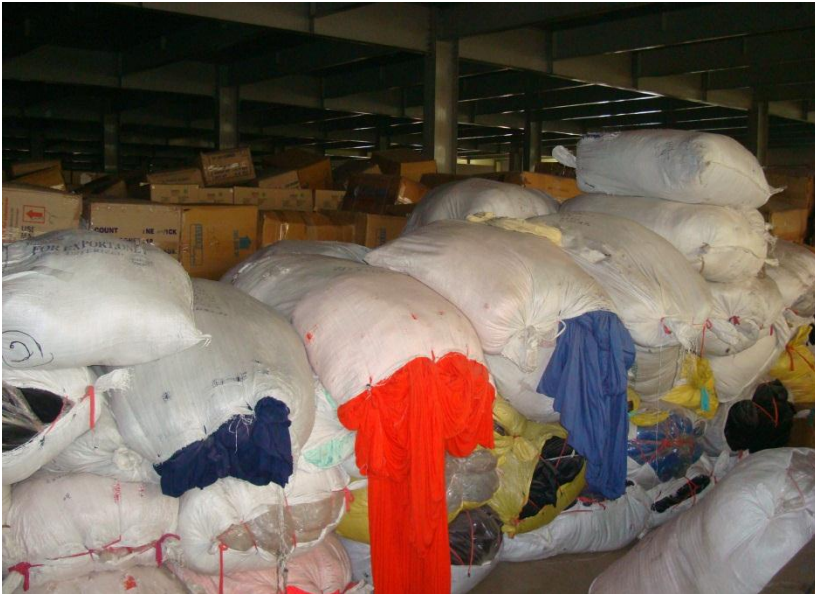
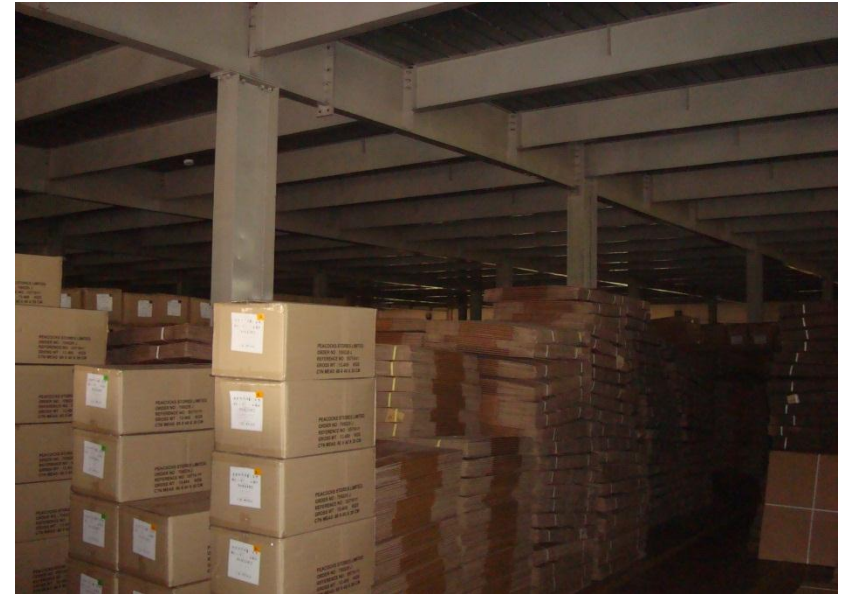
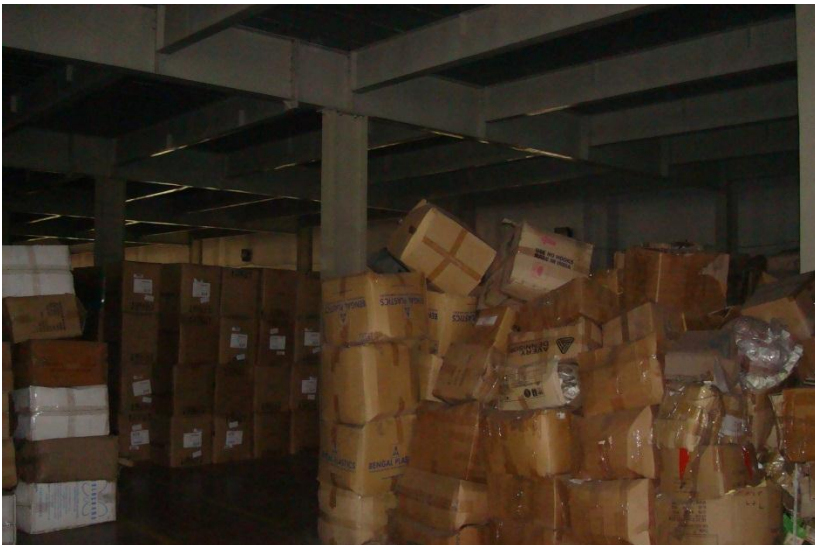
## Floor loading

# High loads on bonded/storage areas on Warehouse 1<sup>st</sup> floor

Plan and height restrictions to be introduced to prevent future overloading.  
Limit stack height to 1.80 m (1.50x1.50 m area) and keep 0.60-0.75 m cleared strip around.

29	Limit density of loading in storage areas	Continue to implement load management plan	<b>6-months</b>
30	Documentation issues	Building engineer to collect information and complete documentation.	<b>6-months</b>

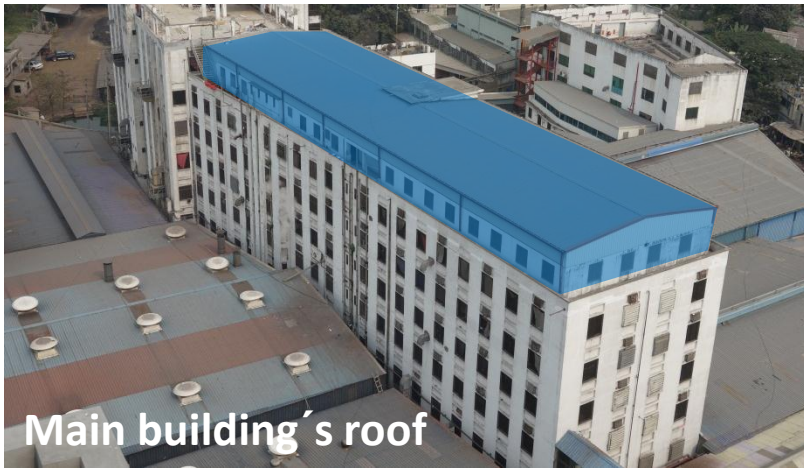
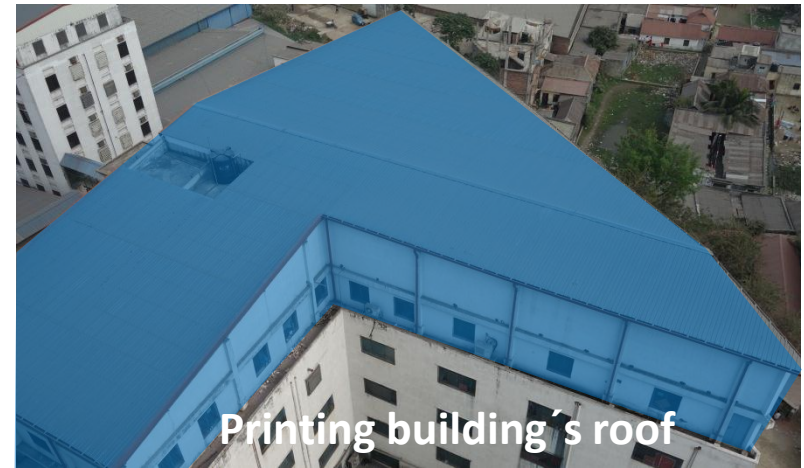
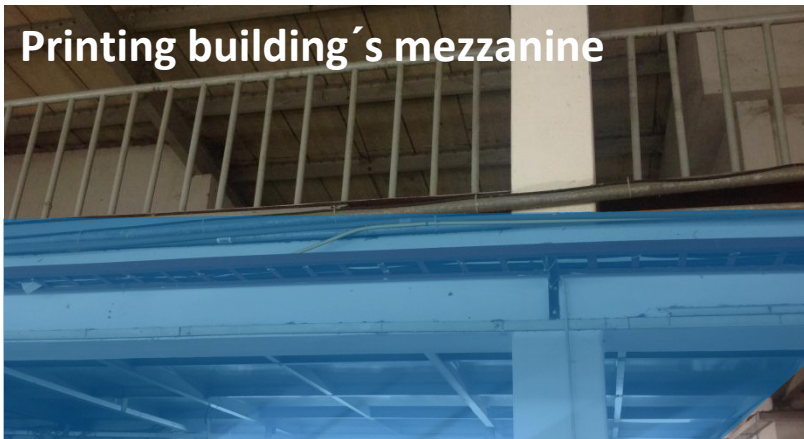
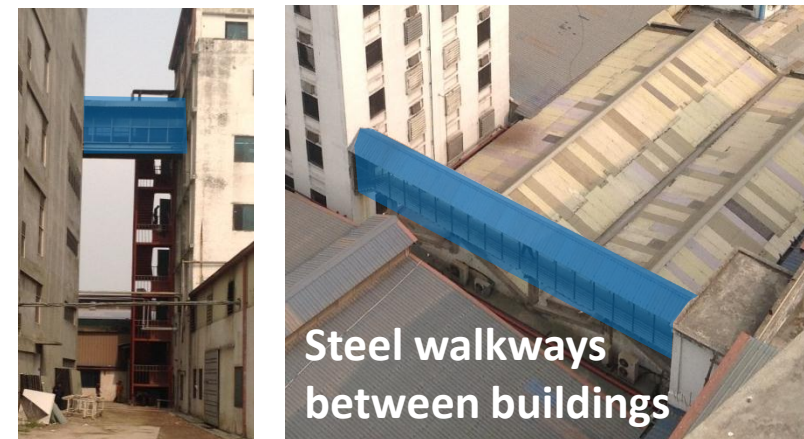
## **Documentation Issues**

**Structural drawings were not shown for steel roofs of main and printing buildings, mezzanine between 5th floor and roof in printing building and steel walkways between buildings**

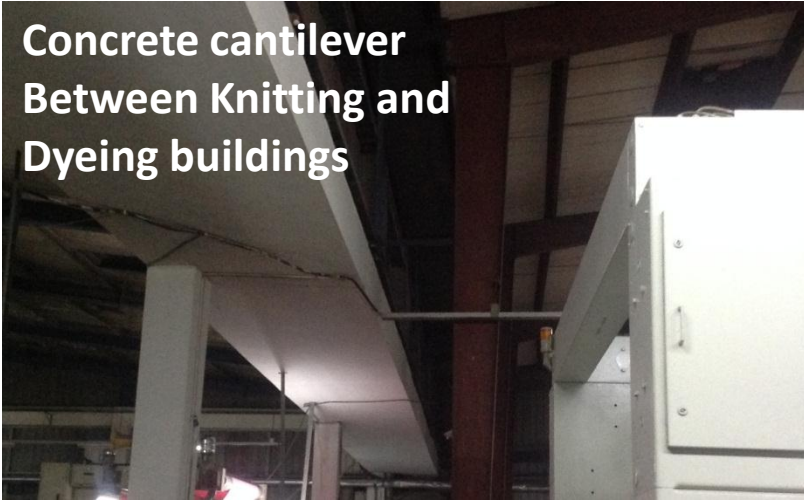
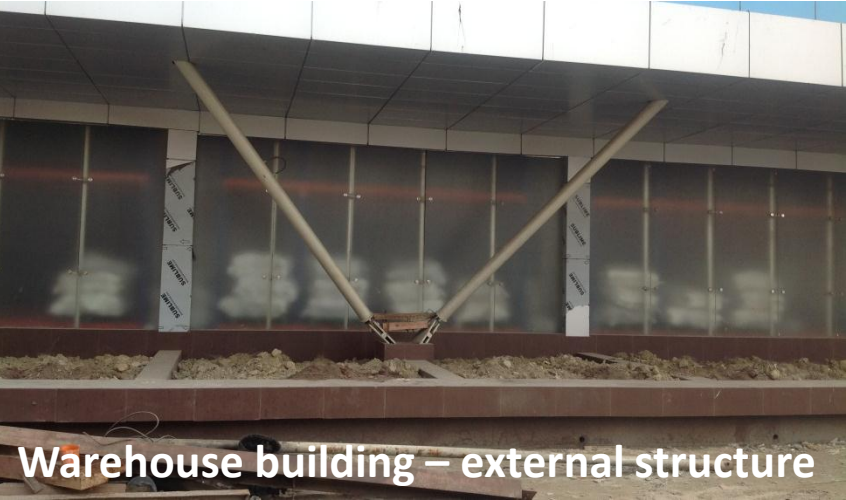
**Concrete cantilever  
Between Knitting and  
Dyeing buildings**

**Structural drawings were not shown for specific areas of Knitting & Warehouse buildings**
