Knit Asia Limited

East Narshingapur, Ashulia, Savar
(+23.930205N, 90.309940E)

01 October 2013

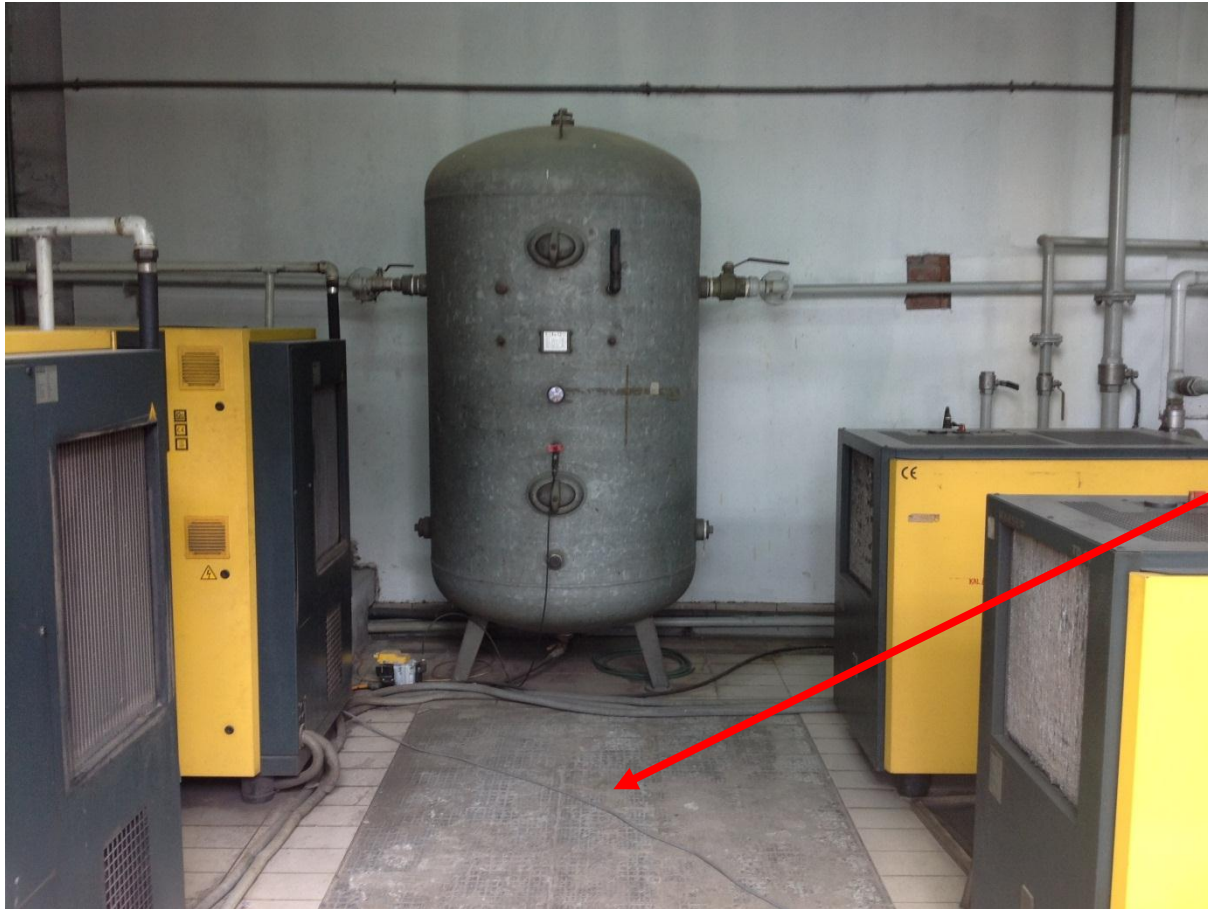
Boilers compressors located on Ground Floor slab (suspended over water tank)

Engineer is to perform detailed calculations to prove slab thickness and (if required) :

- Reduce loads by removing machinery
- Reinforce slab

Item No.	Observation	Recommended Action Plan	Recommended Timeline
4	Boilers/ compressors located on Ground Floor slab (suspended over water tank)	Building Engineer Verify that beam/slab has sufficient capacity to support plant	6-Months
5	Water tanks located on the roof structure mounted on concrete plinths; some cracking observed to mid-spans of slab soffits which support tanks	Building Engineer to verify that beam/slab has sufficient capacity to support fully filled water tanks plus concrete plinth	6-Weeks
6	Materials stacked in densely spaced piles within Accessories & General Stores on 4th Floor	Maintain load as per that observed during inspection	6-Weeks

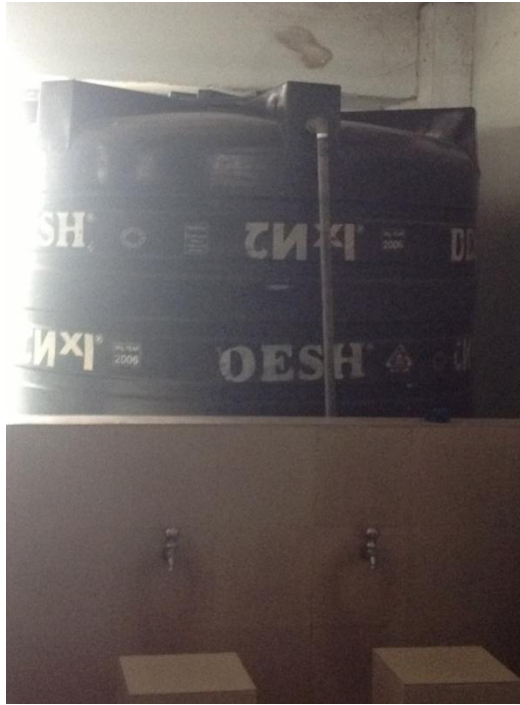
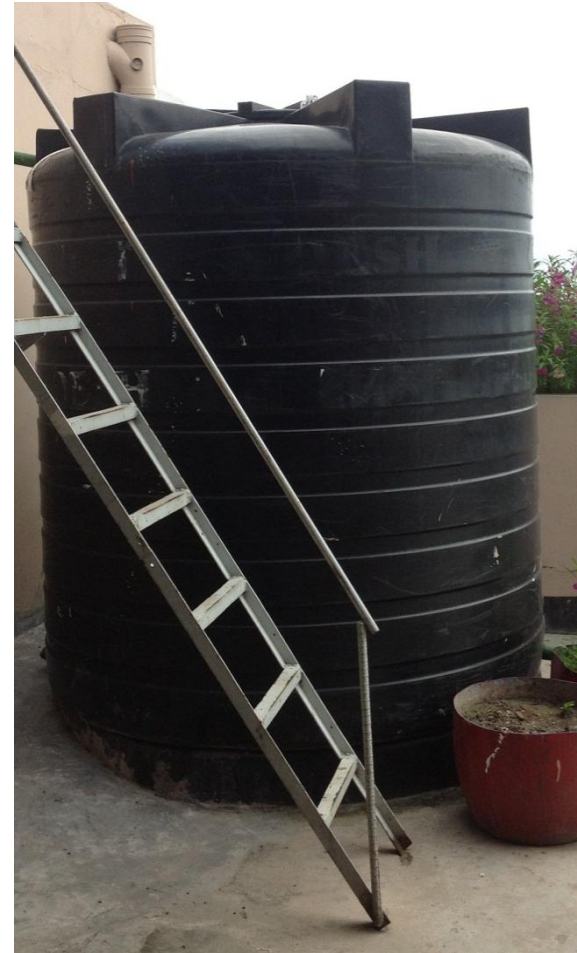
Water tank loading on roof

Engineer is to perform detailed calculations to prove slab thickness and (if required) :

- Reduce loads by emptying tanks
- Reinforce slab

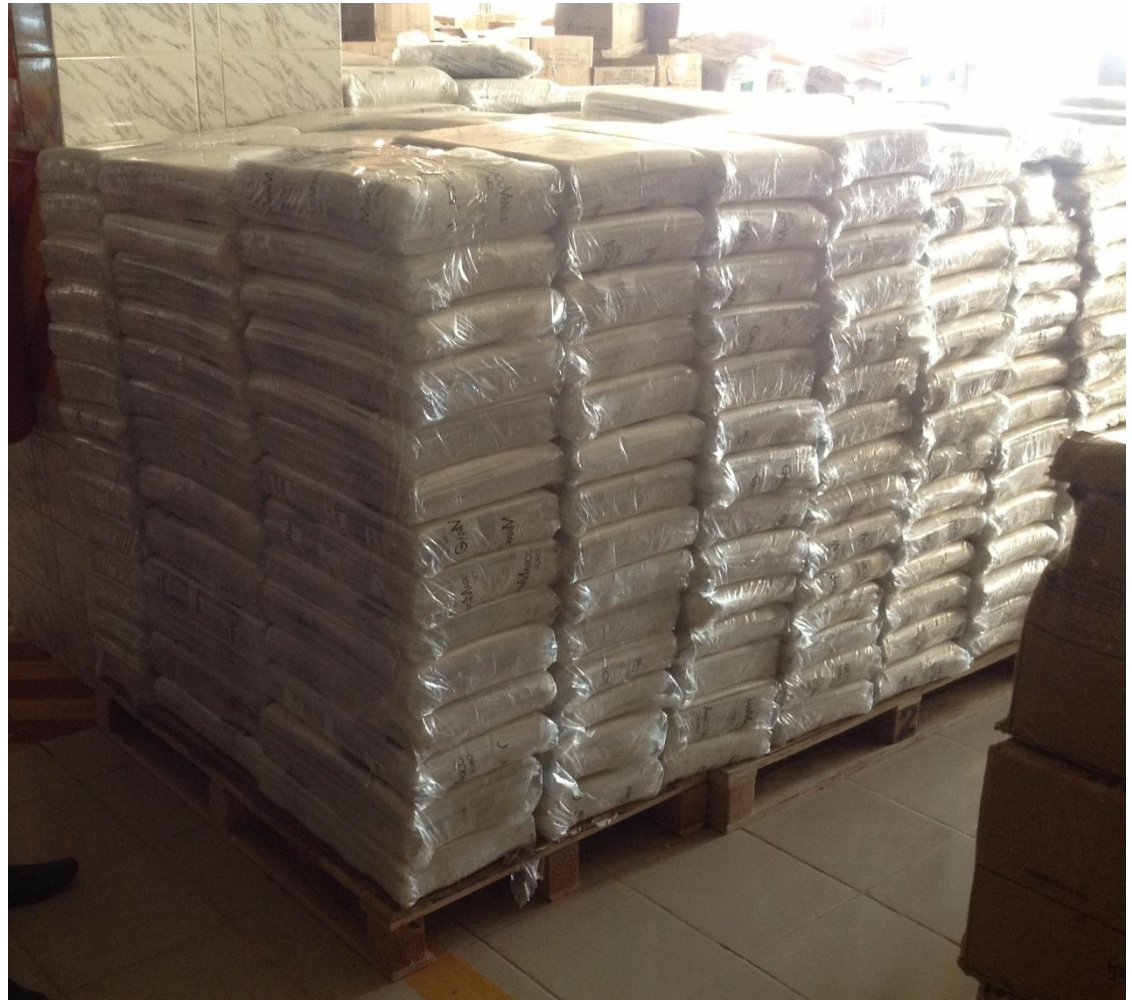
Load management storage (high density items)

Load management in storage

Plan and height restrictions in place to consider high density loading to prevent future overloading.

Restrictions for high density loading to be based on design floor loading.

Item No.	Observation	Recommended Action Plan	Recommended Timeline
7	Materials stacked in densely spaced piles within Accessories & General Stores on 4th Floor	Building Engineer to create controlled loading plans for all floors designating where storage can be placed and can not be placed.	6-Months
8	Lightweight steel roof – vertical bracing not present, roof bracing not tightened and wind girders at gable do not appear to be positively fixed to rafter	Building Engineer to verify if columns can act as vertical cantilevers under lateral loads and install bracing if necessary.	6-Months
9	Lightweight steel roof – vertical bracing not present, roof bracing not tightened and wind girders at gable do not appear to be positively fixed to rafter	Plan bracing to be tightened	6-Months

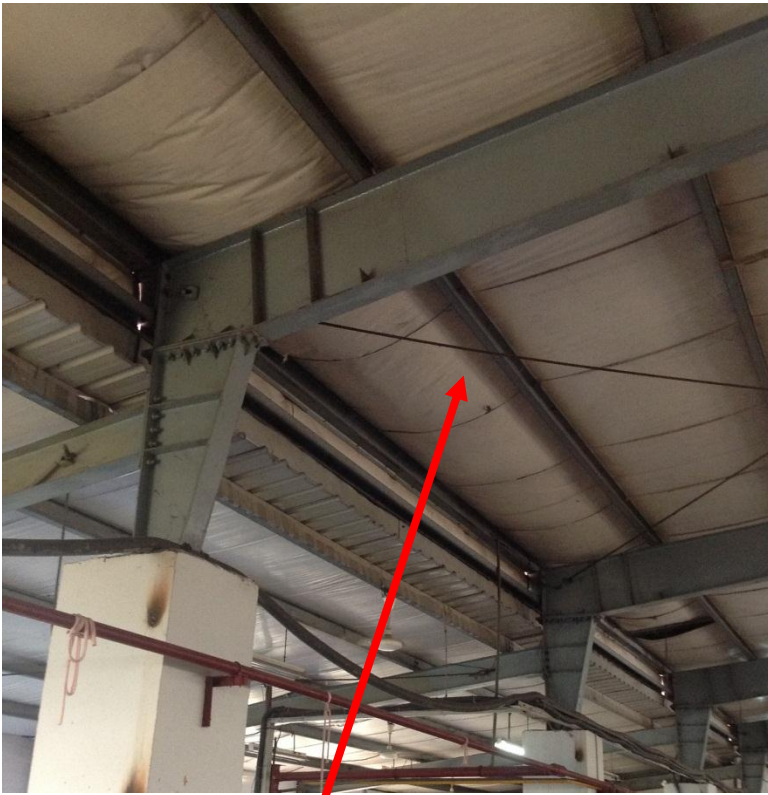
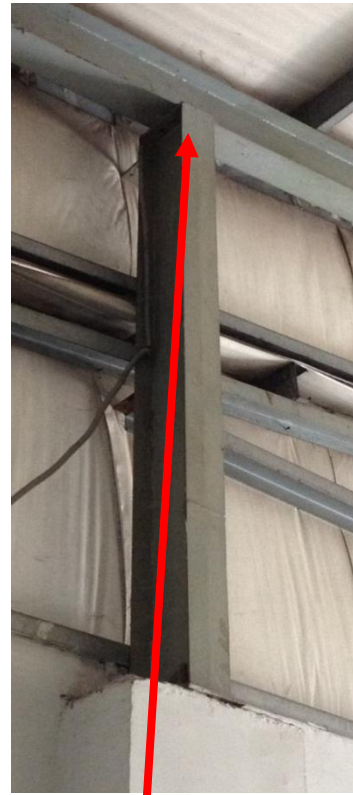
- Horizontal bracing not tightened
- Vertical bracing not present

No positive connection between wind girders and rafters

Stability light weight steel roof structure

Engineer is to perform detailed calculations to prove bracing and connection, and (if required) :

- Install additional bracing
- Reinforce connection

Item No.	Observation	Recommended Action Plan	Recommended Timeline
10	Lightweight steel roof – vertical bracing not present, roof bracing not tightened and wind girders at gable do not appear to be positively fixed to rafter	Wind Girders in Gable wall to be fixed to rafters	6-Months
11	Water causing damage and corrosion	Building Engineer to inspect water damaged structure including the exterior and propose a suitable repair.	6-Months
12	Movement between brick cladding and concrete columns along GL 07	Building Engineer to investigate and propose a suitable repair/restraint detail if necessary	6-Weeks

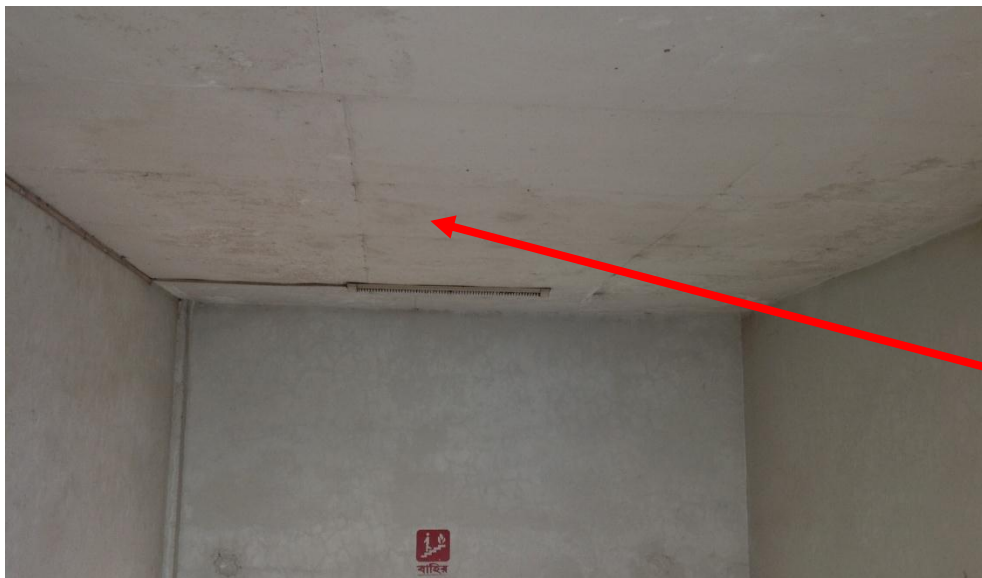
Water causing damage and corrosion

Water damage in staircase below water tank

Repair internal and external water damage. Examples of current damage shown below.

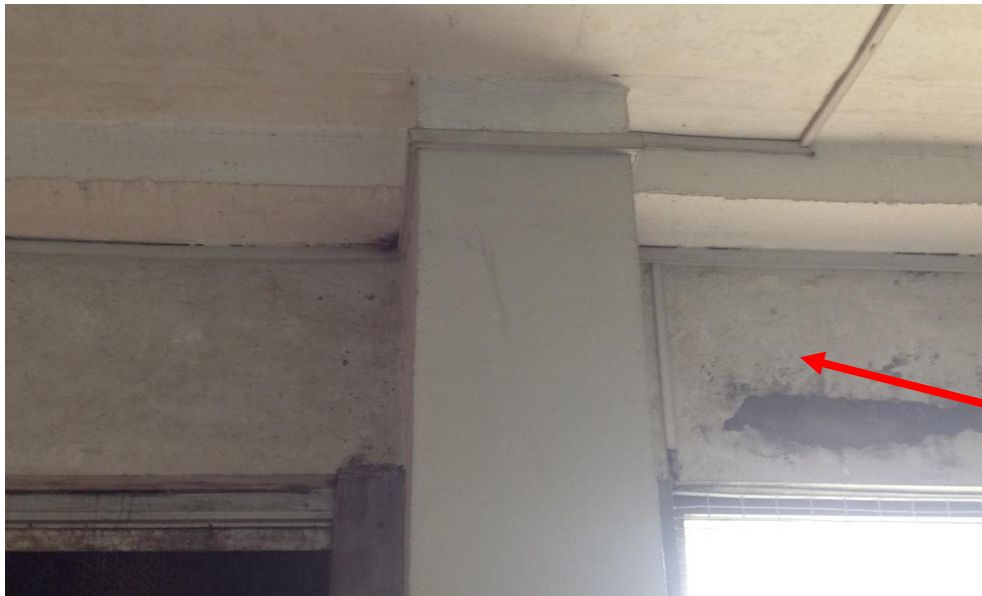
Lintel beam above windows

Water causing damage and corrosion

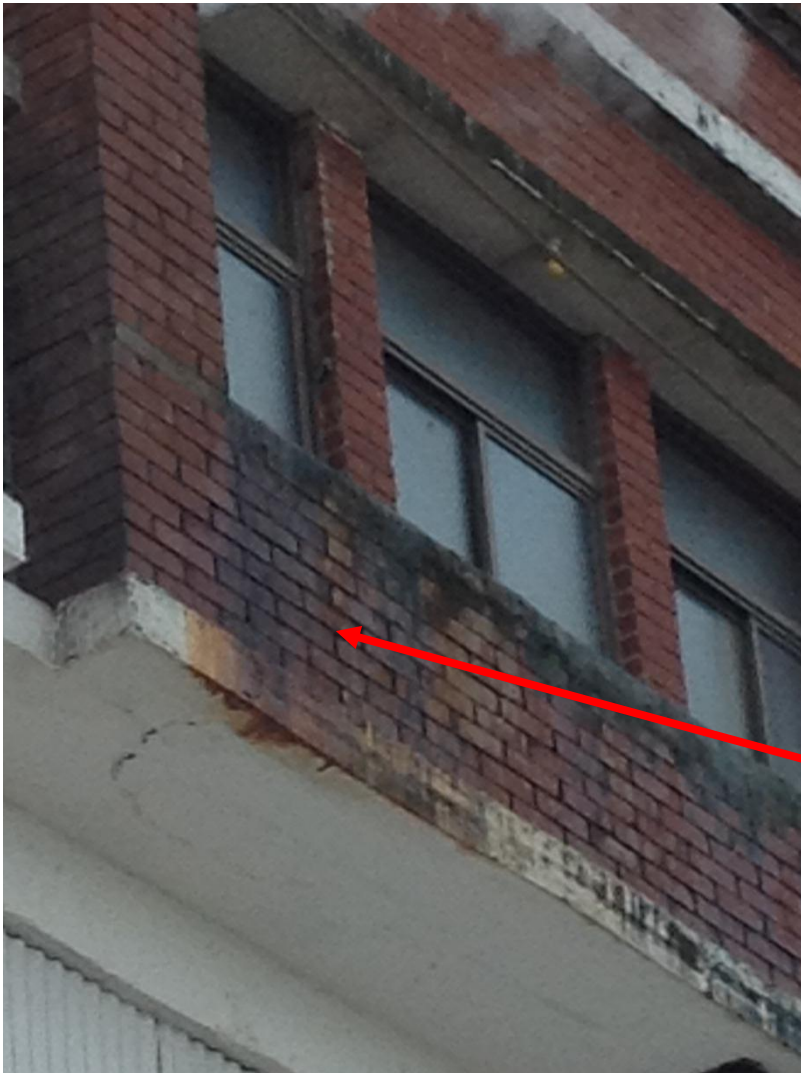
Water damage on external facade

Water causing damage and corrosion

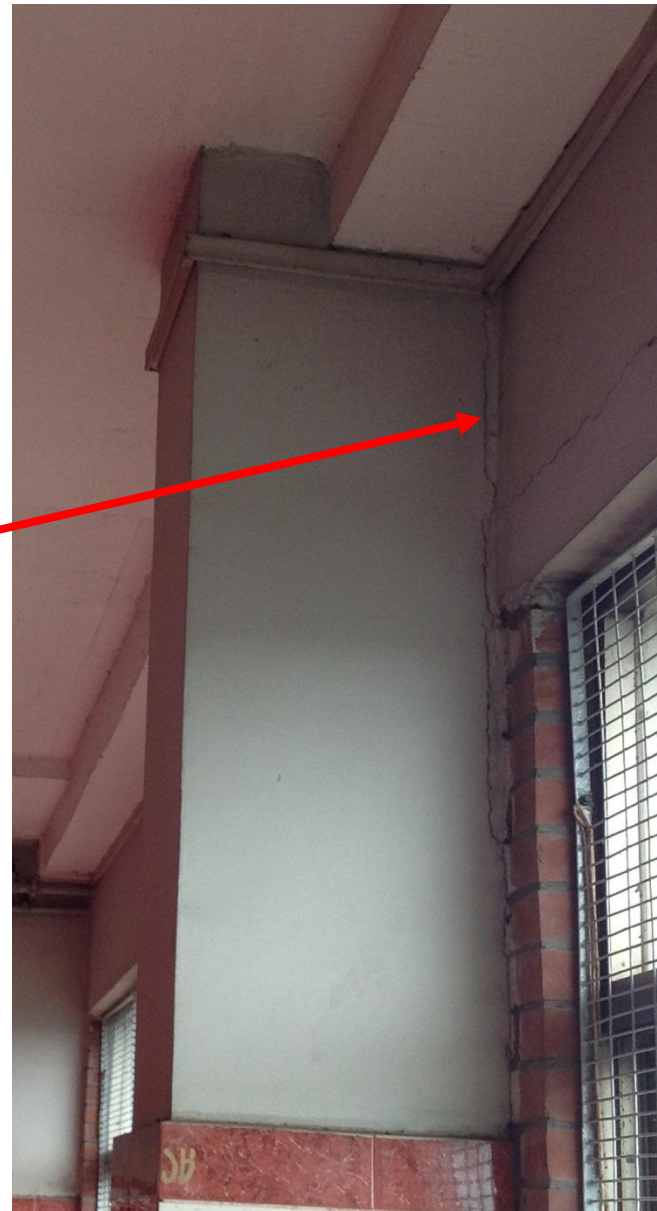
Movement between brick cladding and concrete column

**Crack between column
and façade**

**Movement between brick cladding
and concrete column**

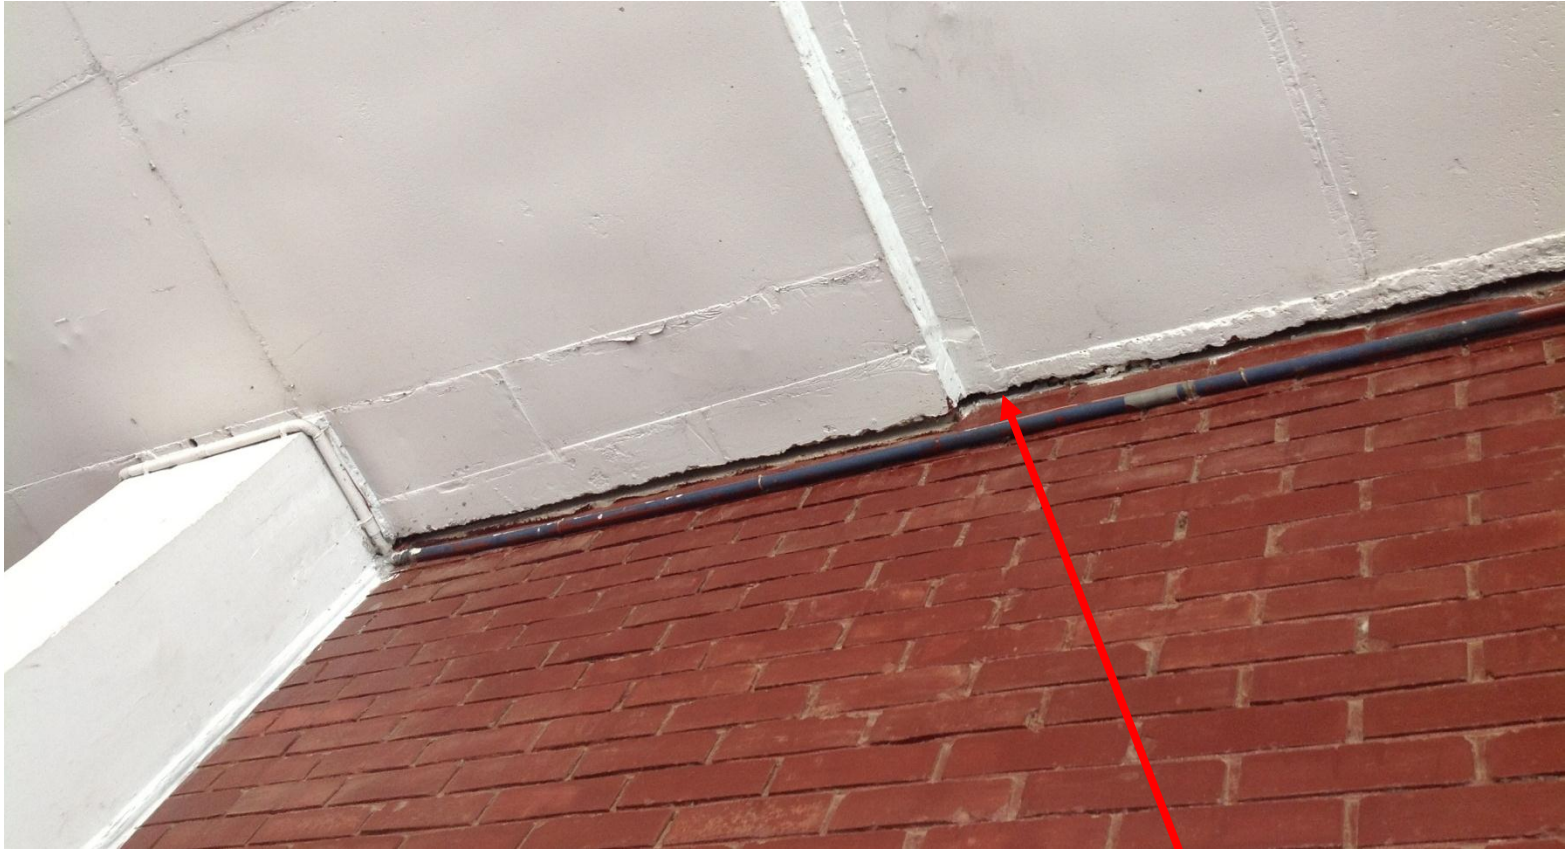
Cover for movement joint at ground floor

**Movement joint exposed
– cover to be installed**

Item No.	Observation	Recommended Action Plan	Recommended Timeline
13	Potential for material to fall out of movement joint in First Floor Slab and injure personnel below	Install suitable channel detail as per all other suspended levels	6-Weeks
