# Padma Satel Arab Fashions Ltd. P & K Fashion Ltd. Luna Fashion Ltd.

Luna Complex, Joybangla road, Borobari, Gazipur, Dhaka

29<sup>th</sup> June 2014

# Observations

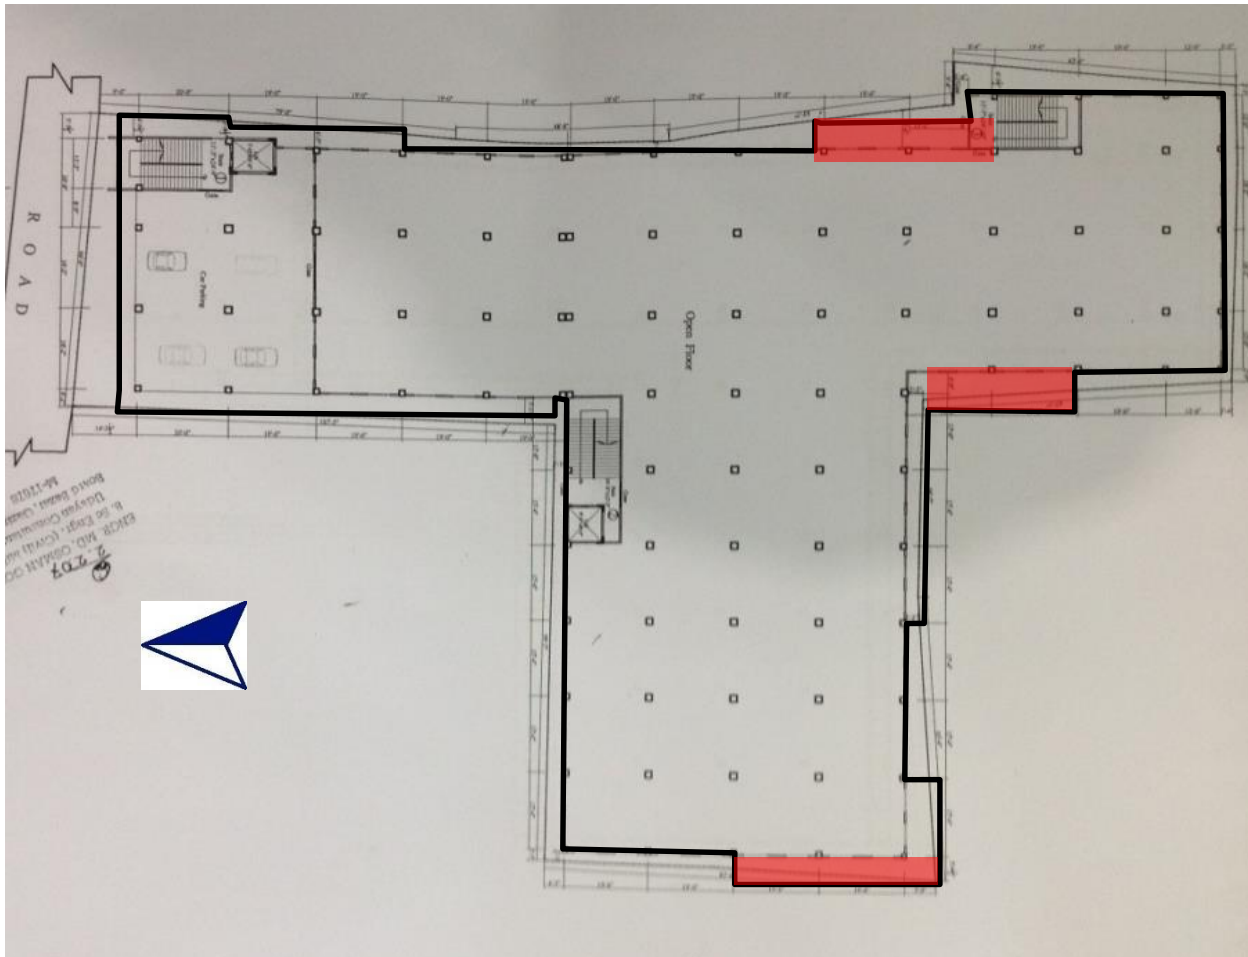
Typical floor layout

**Cursory calculations indicate column stresses are high**

Cursory calculations indicate that stresses are high in all columns. In particular, columns supporting cantilevers with toilet blocks are very highly stressed.

Item No.	Observation	Recommended Action Plan	Recommended Timeline
1	Cursory calculations indicate column stresses are high	Factory Engineer to review design, loads and column stresses for all columns.	<b>Immediate - Now</b>
2	Cursory calculations indicate column stresses are high	Verify insitu concrete strength using min. 4 no. 100mm dia. Cores taken from the ground floor columns (or existing cylinder strength data if available for 4 column locations).	<b>Immediate - Now</b>
3	Cursory calculations indicate column stresses are high	Verify existing reinforcement (steel grade, bar diameter and spacing) in columns.	<b>Immediate - Now</b>
4	Cursory calculations indicate column stresses are high	A Detailed Engineering Assessment of factory to be commenced, see attached scope	<b>Immediate - Now</b>
5	Cursory calculations indicate column stresses are high	Produce and actively manage a loading plan for all floor plates within the factory giving consideration to floor capacity and column capacity. This should include a safe level to which any water tanks can be filled.	<b>6-weeks</b>

6	Cursory calculations indicate column stresses are high	Detailed Engineering Assessment to be completed.	<b>6-weeks</b>
7	Cursory calculations indicate column stresses are high	Continue to implement load plan	<b>6-months</b>

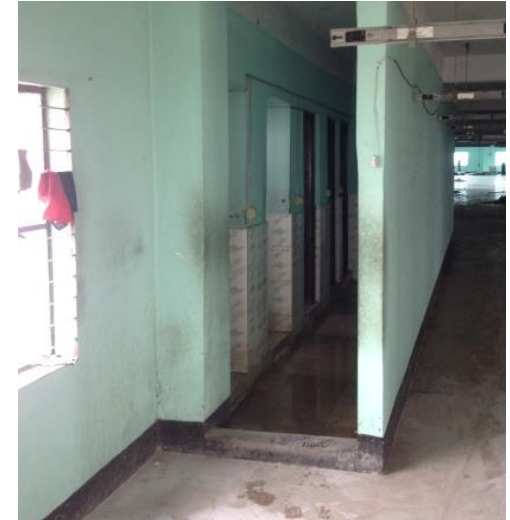
Typical toilet block

Toilet blocks supported by cantilever slabs

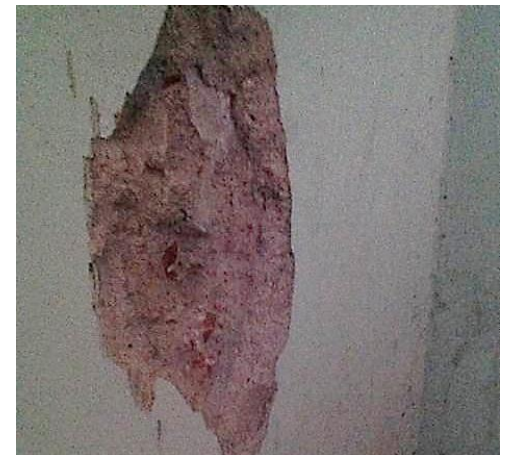
Brick aggregate

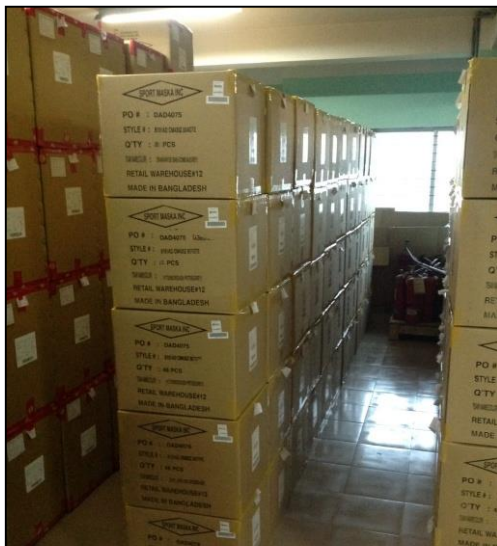
3<sup>rd</sup> floor – Finished goods store

Areas of high loading on structure including cantilevers. No load management plan available for the building.

Item No.	Observation	Recommended Action Plan	Recommended Timeline
8	No floor load management plan	Produce and actively manage a loading plan for all floor plates within the factory giving consideration to floor capacity and column capacity (refer to Item 1).	6-weeks
9	No floor load management plan	Continue to implement load management plan.	6-months
10	Apparently non-engineered steel fire escape stairs on southern elevation of the EW building	Building engineer to review capacity of steel stair giving consideration to overall stability, section sizes used, stair bearing details and quality of fabrication	6-weeks
11	Apparently non-engineered steel fire escape stairs on southern elevation of the EW building	Building engineer to propose an necessary alterations/strengthening works	6-weeks
12	Apparently non-engineered steel fire escape stairs on southern elevation of the EW building	Ensure any necessary remedial works as advised by the Building Engineer are undertaken.	6-months

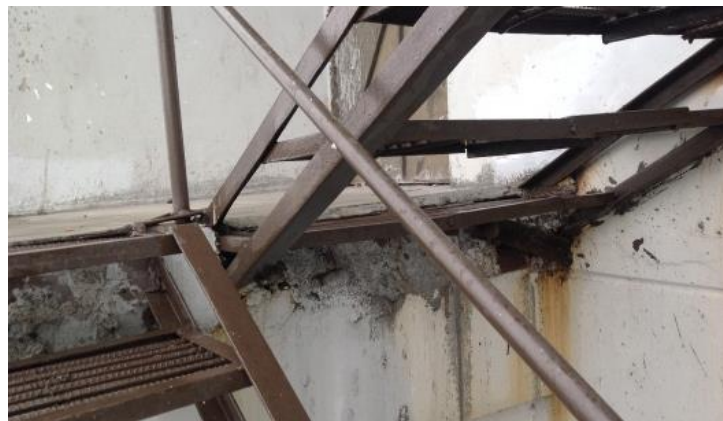
Bearing detail

The steel fire escape stairs appears to be non-engineered. The main issues observed are:

- Overall stability under vertical and horizontal loads does not appear to have been achieved
- Bearing of stair to concrete landing appears inadequate
- Section sizes appear to be slender
- Corrosion of the structure has lead to holes in the tube sections

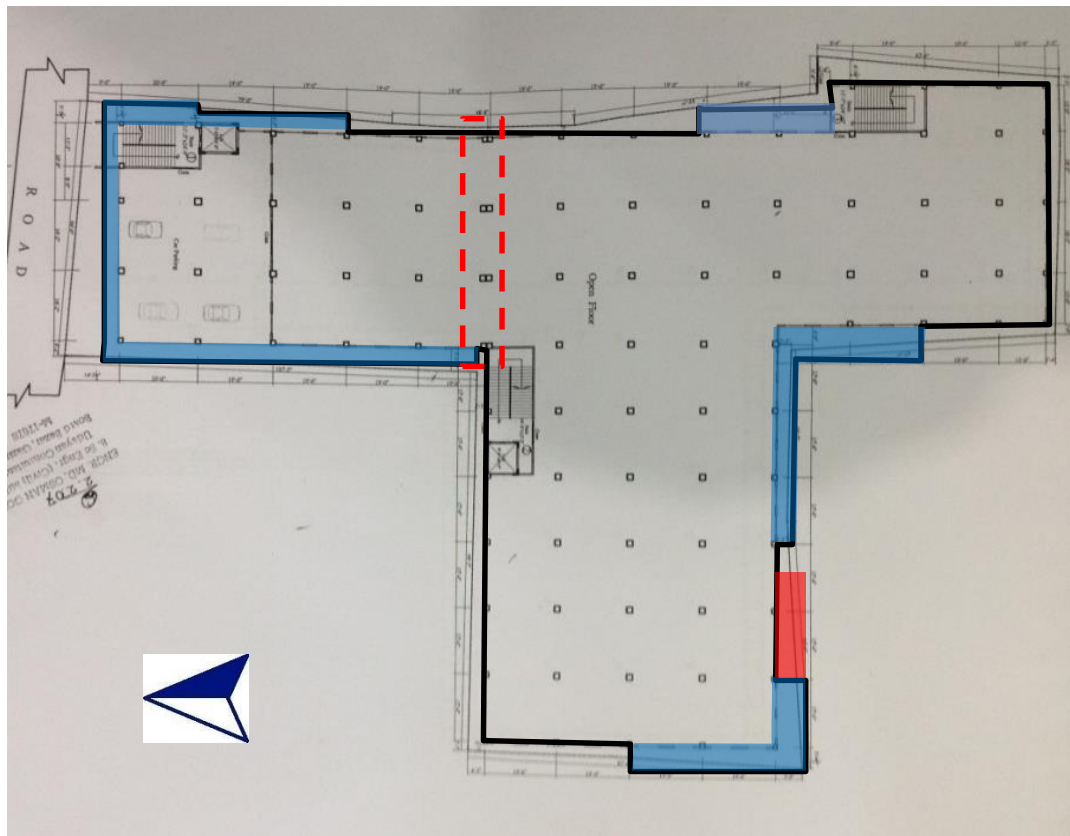
Typical floor Layout

- Double columns shown on drawings, single column built
- Cantilevers not on structural drawings
- Undocumented steel escape stairs
- Observed floor plate layout

13	Inconsistencies between structural drawings and as built construction	Building engineer to survey building and prepare As-Built drawings as part of the Detail Engineering Assessment (refer to Item 1).	6-weeks
14	Inconsistencies between structural drawings and as built construction	Building engineer to identify “as built” cantilever slab and supporting column reinforcement and confirm adequacy of the structural sections.	6-weeks
15	Column protection at ground floor delivery area	Building engineer to review capacity of column protection to vehicular impact and propose strengthening works if required	6-weeks

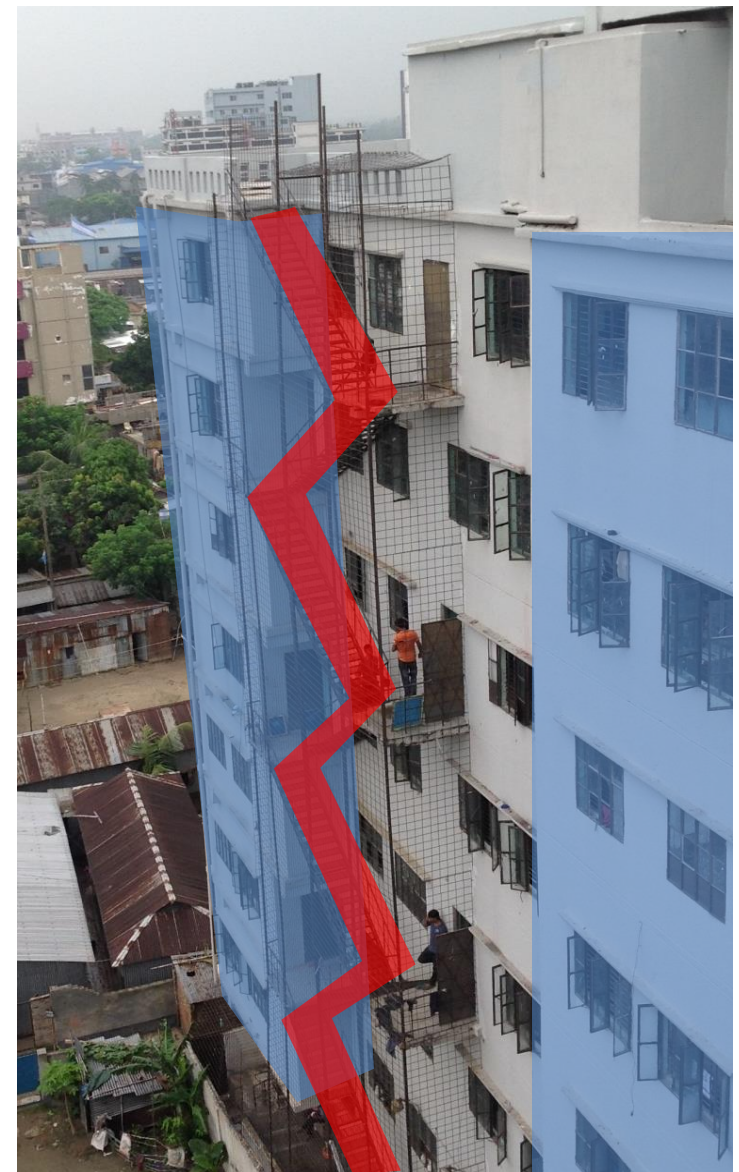
Steel escape stairs and cantilever structure to the south of E-W Building

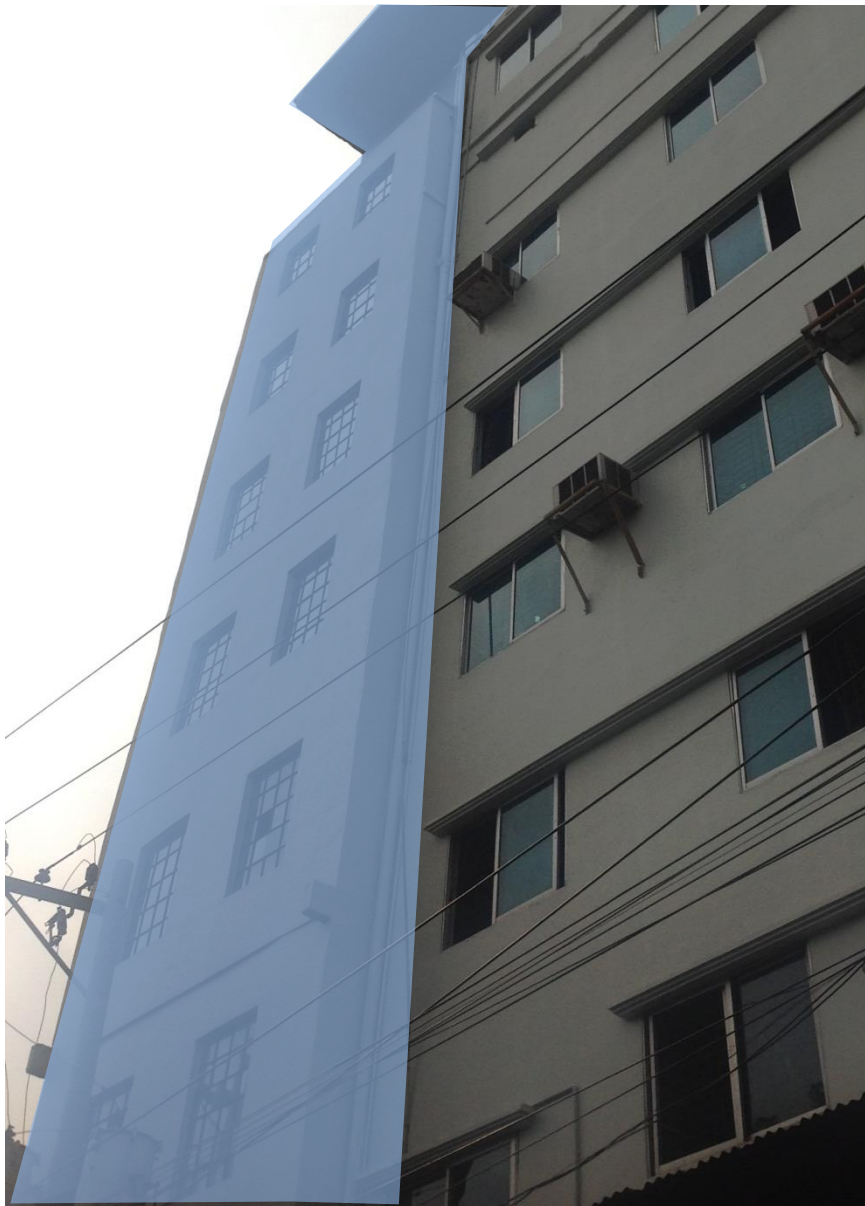
Cantilever structure to North of N-S Building

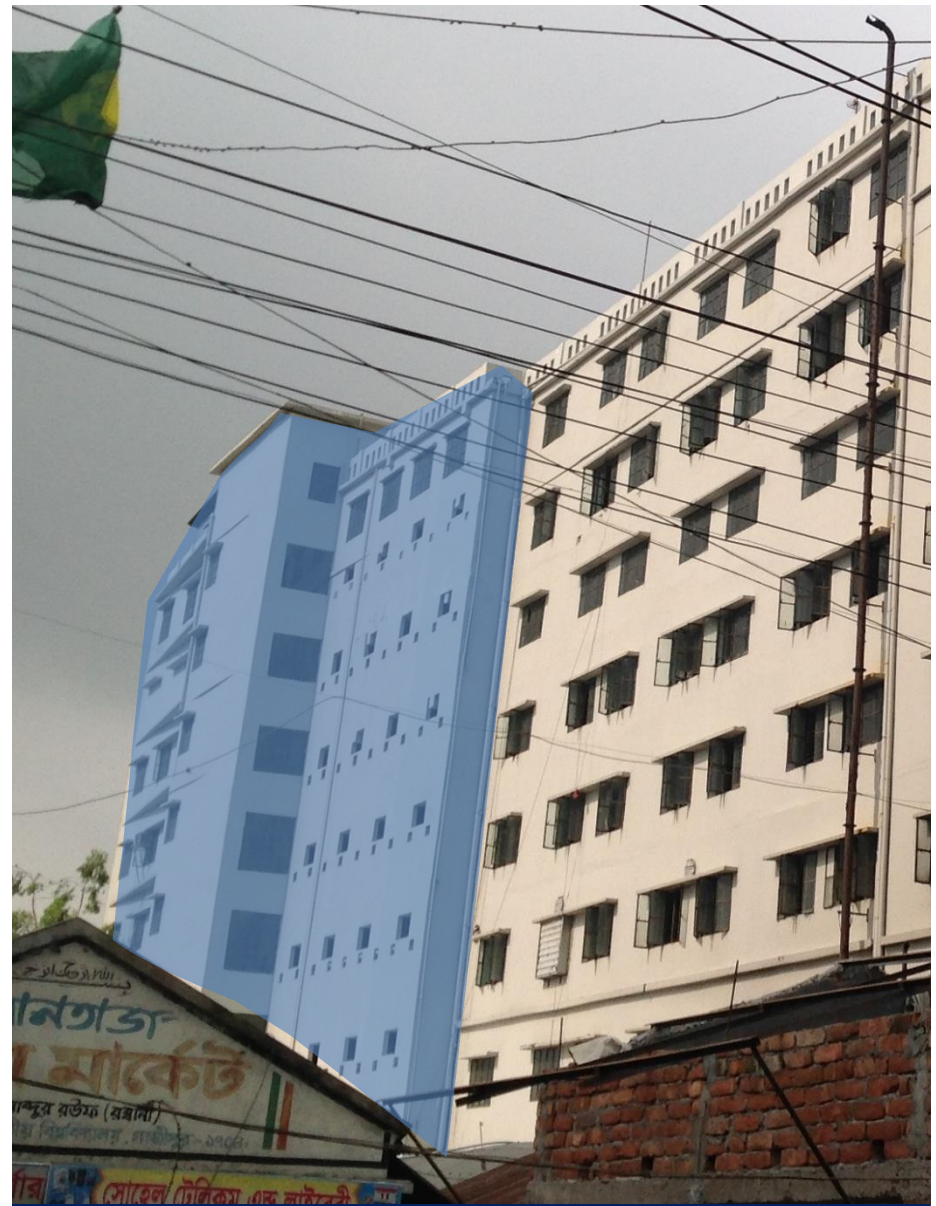
Cantilever structure to the Southwest of the N-S Building

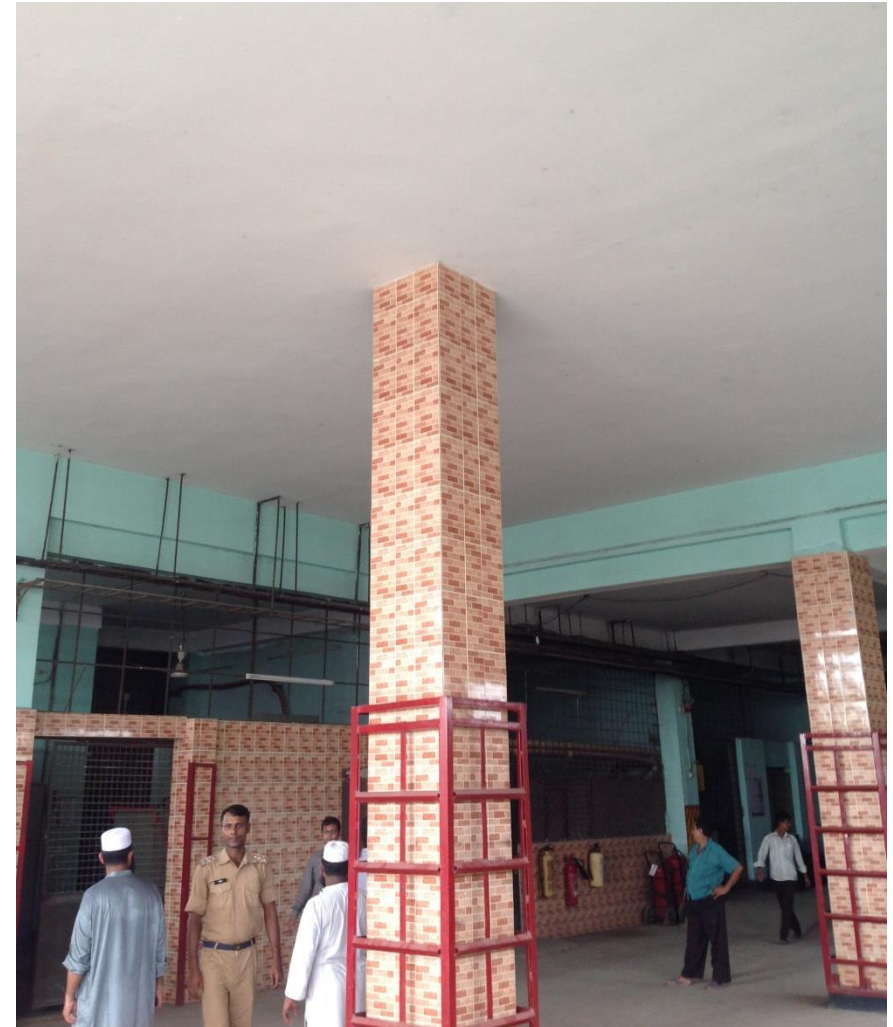
The ground floor columns in the parking/delivery area were partially surrounded by a metal angle frame. These frames appeared light and may provide little protection to the column if struck by a vehicle.

Angle steel frames at columns
