# Starlet Apparels Ltd. (11633)

Road # 01, Plot # B 223-224, BSCIC Hosiery Industries Estate, Fatullah, Narayanganj

05.August.2014

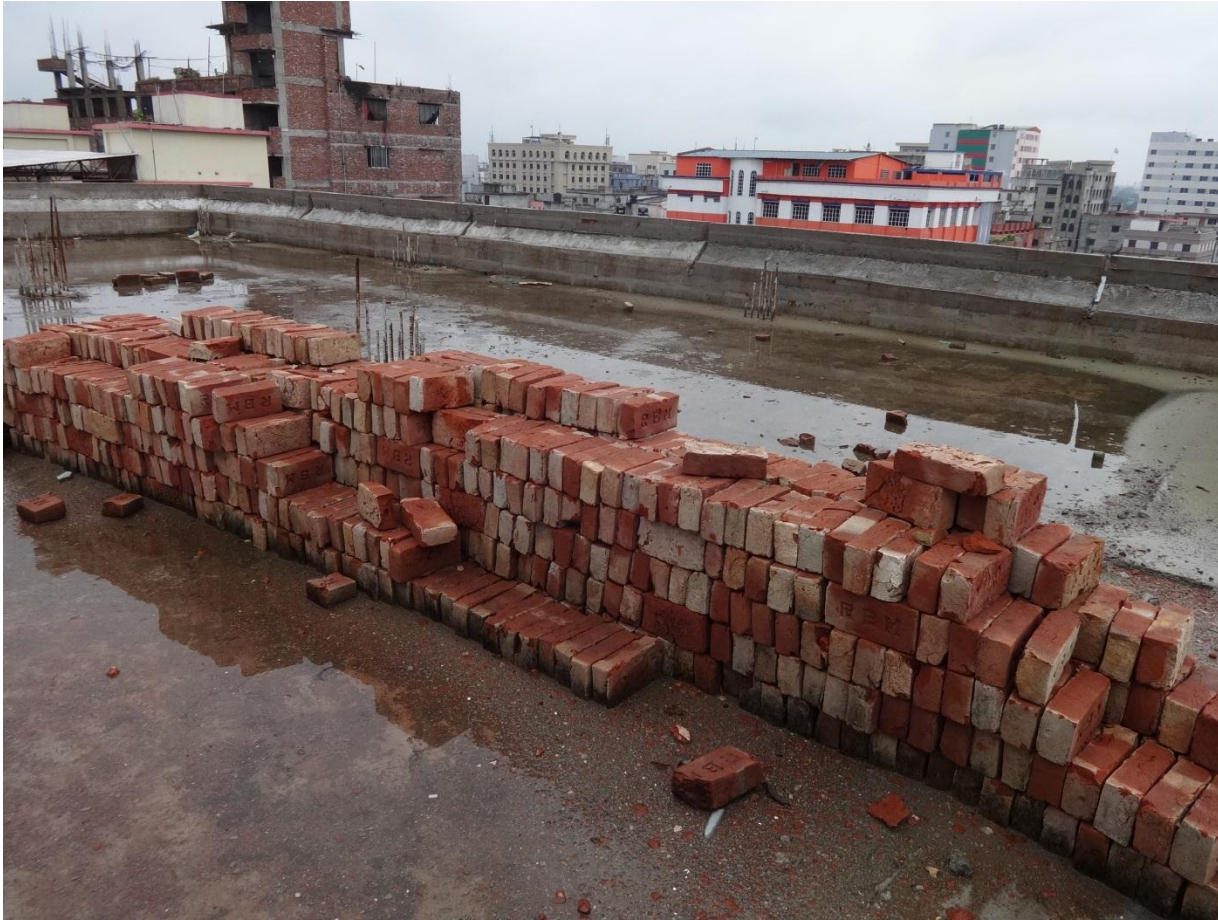
No loading plans exist for the building.

Minor stock piling of construction materials on the roof.

| Item No. | Observation | Recommended Action Plan | Recommended Timeline |
|---|---|---|---|
| 3 | Priority 2 - No loading plans exist for the building. | Ensure slabs are not loaded above 2.0kPa (40psf). | 6-weeks |
| 4 | Priority 2 - No loading plans exist for the building. | Produce loading plans for each level. Ensure these are displayed and managed at each level. | 6-months |

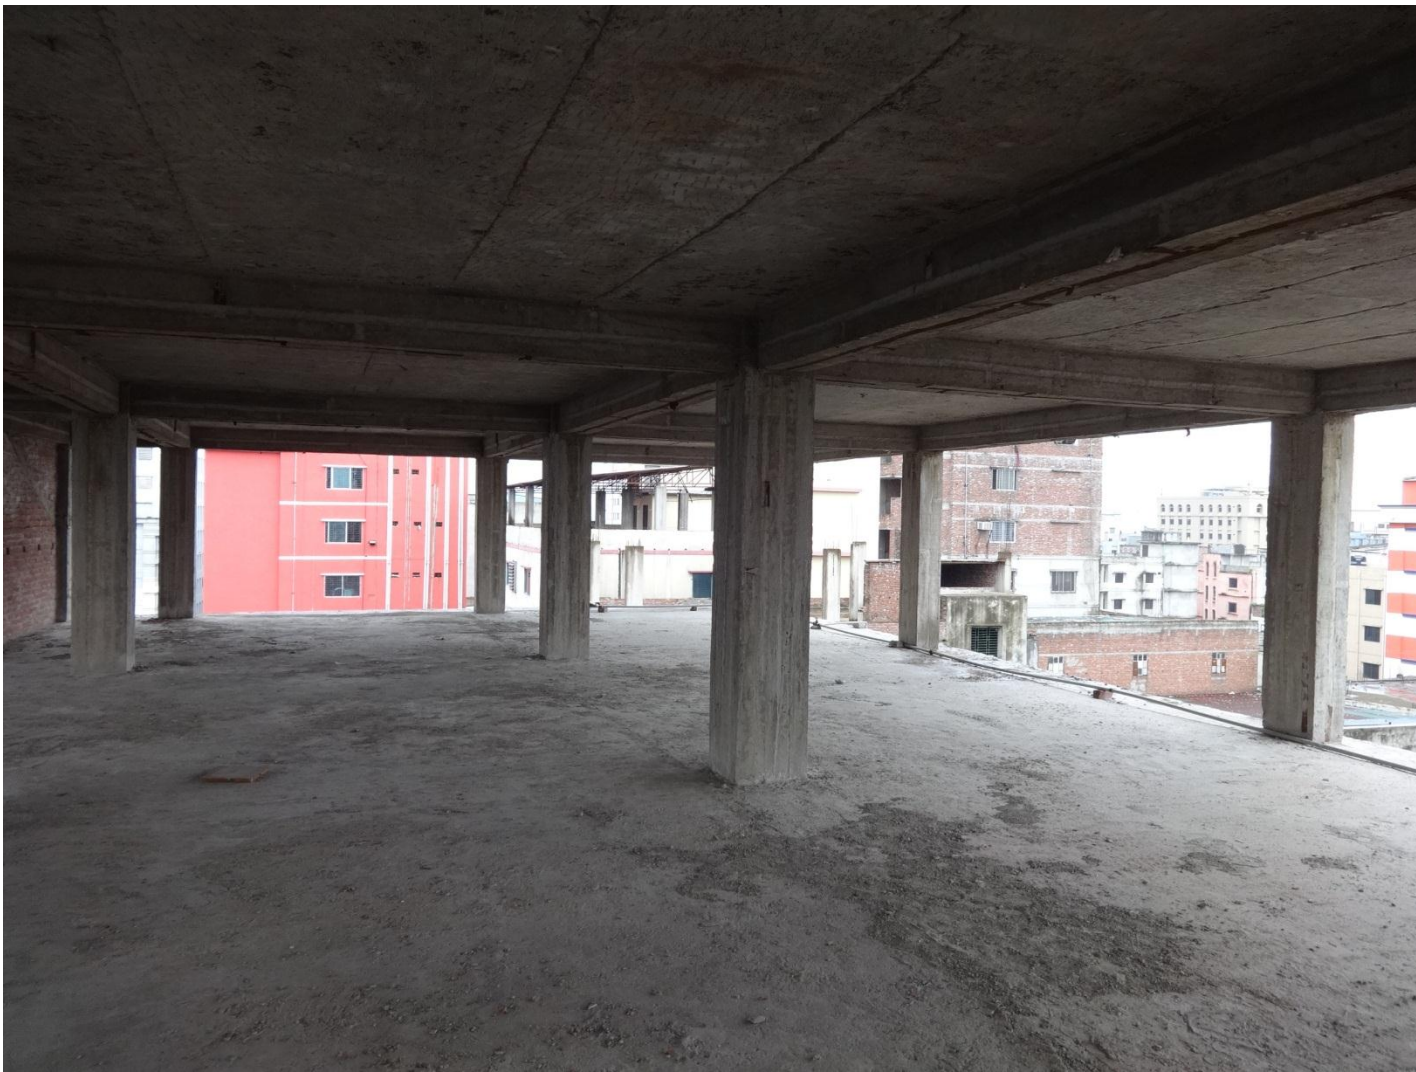
The building did not feature any core or shear walls. Stability was achieved through sway action between beams and columns and masonry infill walls.

We require that these items be investigated by an Engineering Assessment

| Item No. | Observation | Recommended Action Plan | Recommended Timeline |
|---|---|---|---|
| 1 | Priority 2 - The building contains no obvious stability system. | Carry out Engineering Assessment on the building to verify that it is stable under lateral loading. | 6-weeks |
| 2 | Priority 2 - The building contains no obvious stability system. | Carry out recommendations of Engineering Assessment. | 6-months |

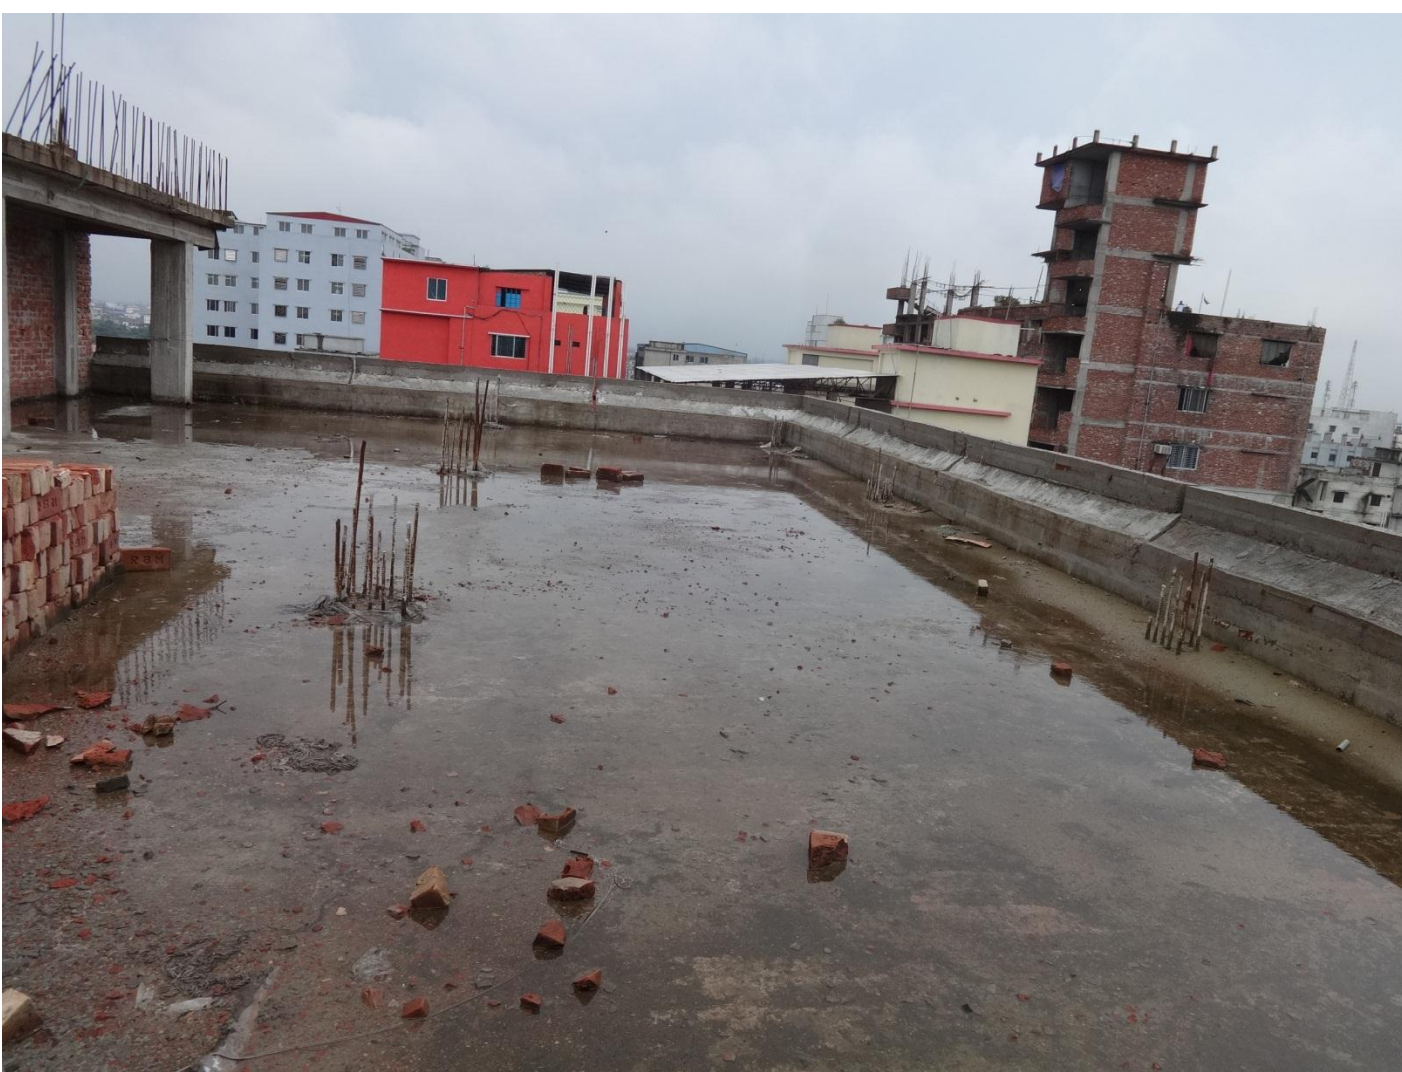
No waterproofing membrane was visible on the roof of the building. This means that any cracks in the surface finishes on the roof will allow water to seep into the concrete slab beneath the finishes, and cause corrosion of the reinforcing steel.

| Item No. | Observation | Recommended Action Plan | Recommended Timeline |
|---|---|---|---|
| 5 | Priority 3 - No waterproofing membrane on the roof. | Cover the concrete roof with a suitable waterproofing membrane, e.g. waterproof screed. | 6-months |
