# Jaroms Industries Ltd. (11719)

13/2 Abdus Satter Master Road, Gazipura

06.AUGUST.2014

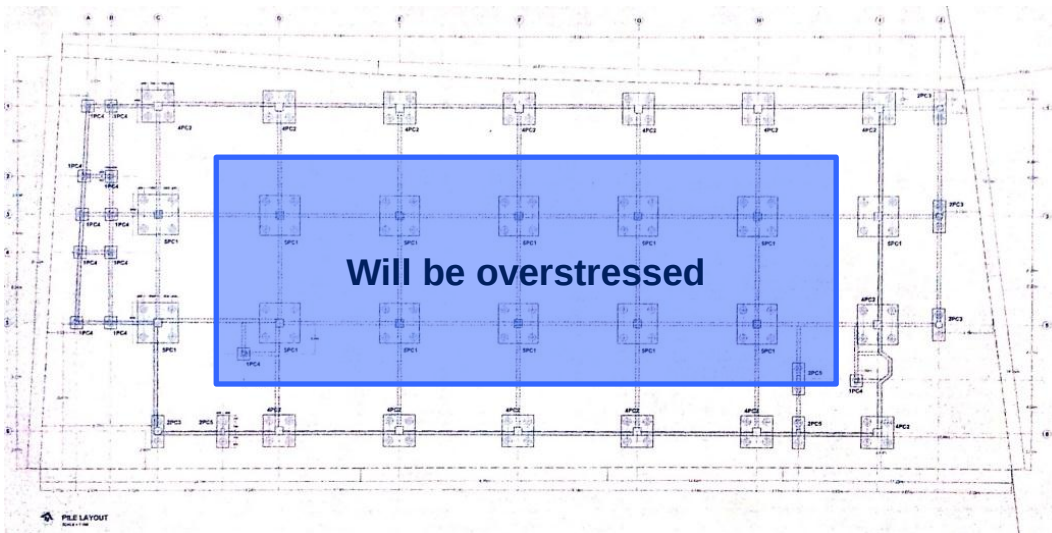
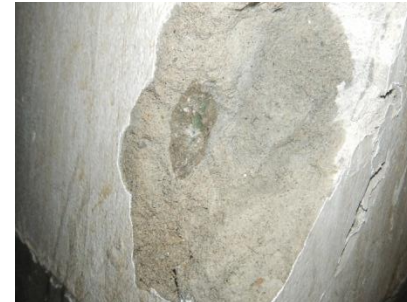
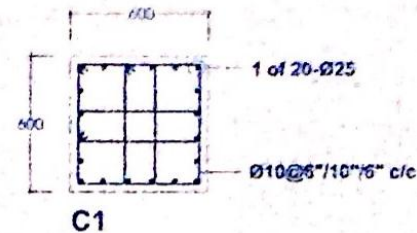
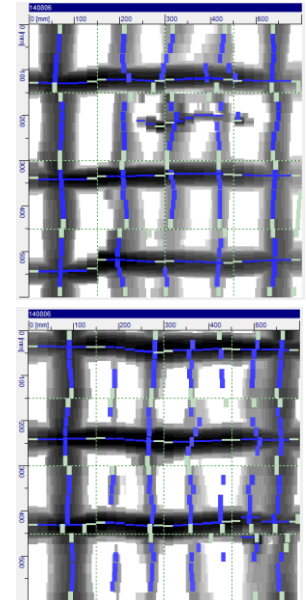
If the full construction of the 10 storeys is completed, the internal columns at basement level shown below will be overstressed. The size of these column is 600 x 600 mm at basement level and will carry a full 10 storeys of building with spans of 9.14 m and 8.23 m.

From the information above, for full construction, 10 storeys, the calculation check of these columns show that they will be overstressed (FoS = **1.18**).

**Remark:** The sizes of the column's rebar are assessed to be the same as those specified on the structural drawings.

| Item No. | Observation | Recommended Action Plan | Recommended Timeline |
|---|---|---|---|
| 1 | Priority 1 - If the full construction of 10 storeys takes place, the internal columns at basement level will be overstressed. | Factory Engineer to review design, loads and columns stresses in area identified above.<br>Verify in-situ concrete stresses either by cores or existing cylinder strength data for [the identified columns / cores from 4 columns].<br>A Detailed Engineering Assessment of Factory to be commenced immediately. | Immediate - Now |
| 2 | Priority 1 - If the full construction of 10 storeys takes place, the internal columns at basement level will be overstressed. | Produce and actively manage a loading plan for all floor plates within the factory giving consideration to floor capacity and column capacity.<br>The Detailed Engineering Assessment to be completed and any recommended actions completed. | 6-weeks |
| 3 | Priority 1 - If the full construction of 10 storeys takes place, the internal columns at basement level will be overstressed. | Maintain and continue to implement floor load plans.<br>If the main DEA recommendation is not to complete the full 10 storeys then this is to be followed. | 6-months |

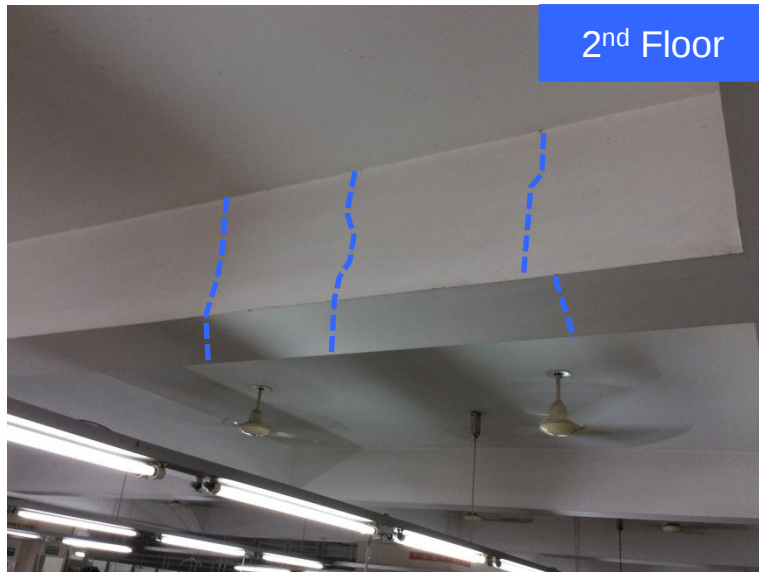
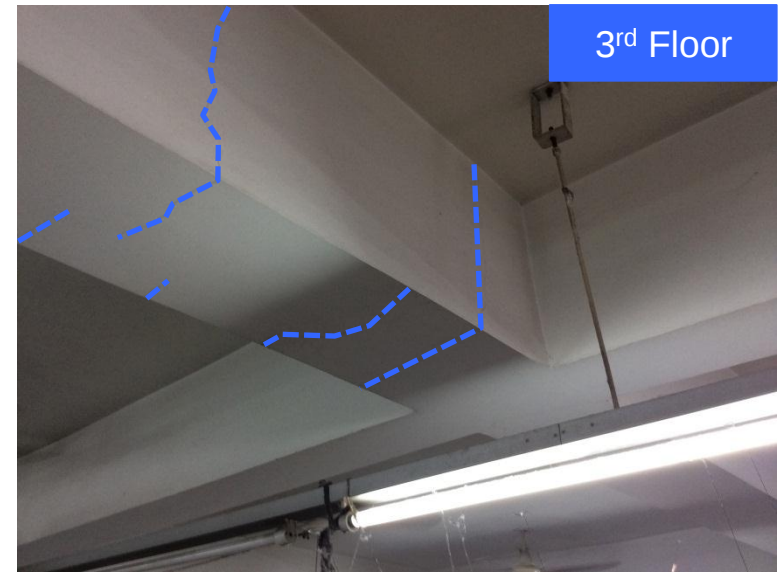
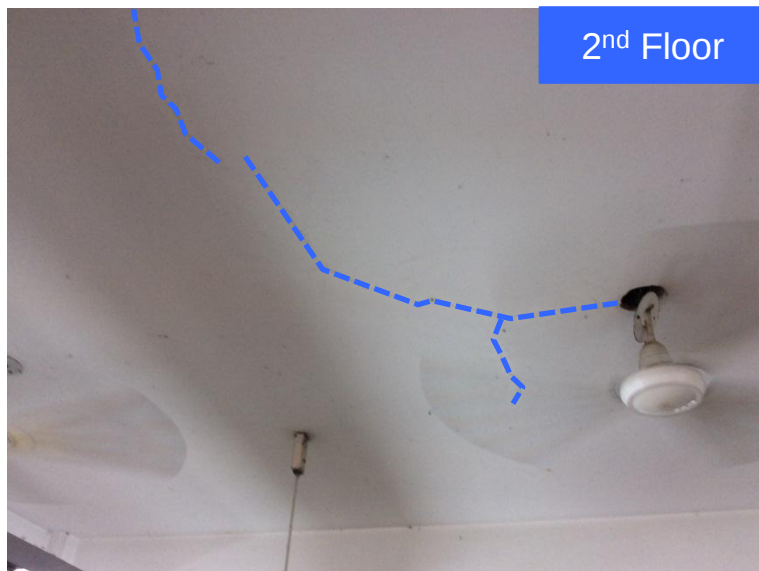
Cracks on ground floor, 1<sup>st</sup> floor, 2<sup>nd</sup> floor and 3<sup>rd</sup> floor beams and slab soffits. The cause of cracks should be investigated as part of a DEA, a Detailed Engineering Assessment.

| Item No. | Observation | Recommended Action Plan | Recommended Timeline |
|---|---|---|---|
| 4 | Priority 2 - Cracks on ground floor, 1st floor, 2nd floor and 3rd floor beams and slab soffits. | Investigate the cause of cracks as part of a Detailed Engineering Assessment.<br>The distress found is to be suitably rectified and then repaired. | 6-weeks |
| 5 | Priority 2 - Cracks on ground floor, 1st floor, 2nd floor and 3rd floor beams and slab soffits. | Create loading plans for each floor level.<br>Maintain standards of quality control to ensure that loading plan is correctly followed so that problems do not arise in the future.<br>Maintain and enforce the loading plans. | 6-months |

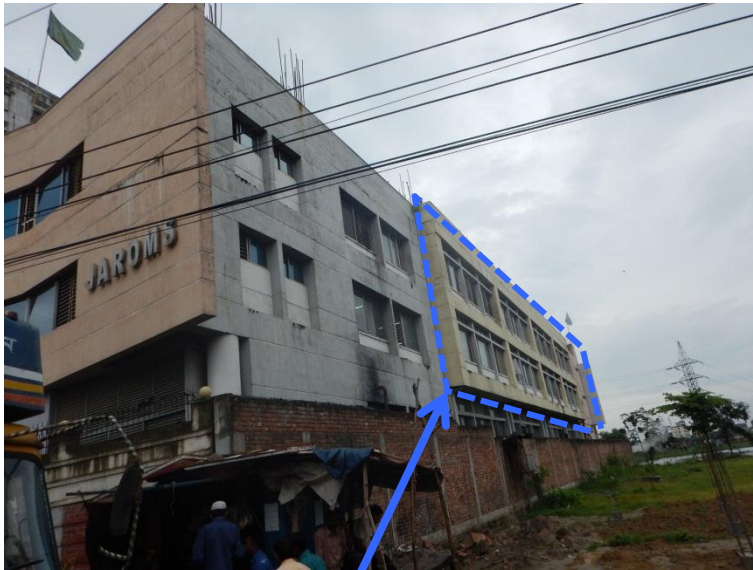
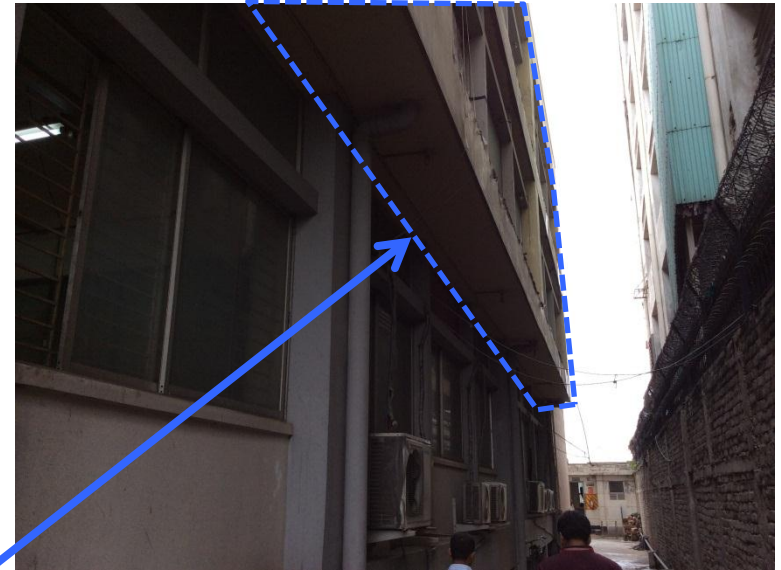
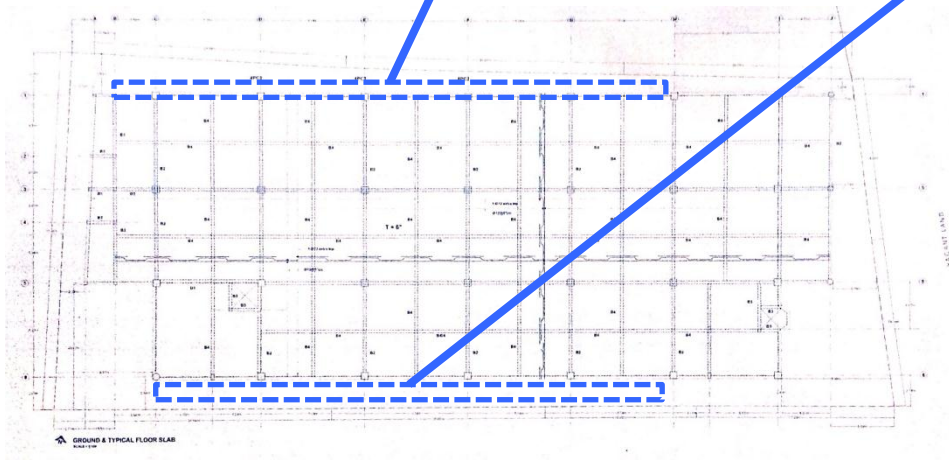
There are cantilevered slabs on 1<sup>st</sup> floor, 2<sup>nd</sup> floor and 3<sup>rd</sup> floor in areas as shown above. However, these cantilevers are not shown on the structural drawings. We recommend a survey of the actual conditions and revise the as-built drawings.

| Item No. | Observation | Recommended Action Plan | Recommended Timeline |
|---|---|---|---|
| 6 | Priority 2 - Inadequacies between the drawings and the actual as-built conditions. | Factory Engineer to survey the actual conditions and revise the drawings.<br>Any results of the Detailed Engineering Assessment which affect the structure should be taken on board. | 6-weeks |
| 7 | Priority 2 - Inadequacies between the drawings and the actual as-built conditions. | Continue to implement load plan. | 6-months |

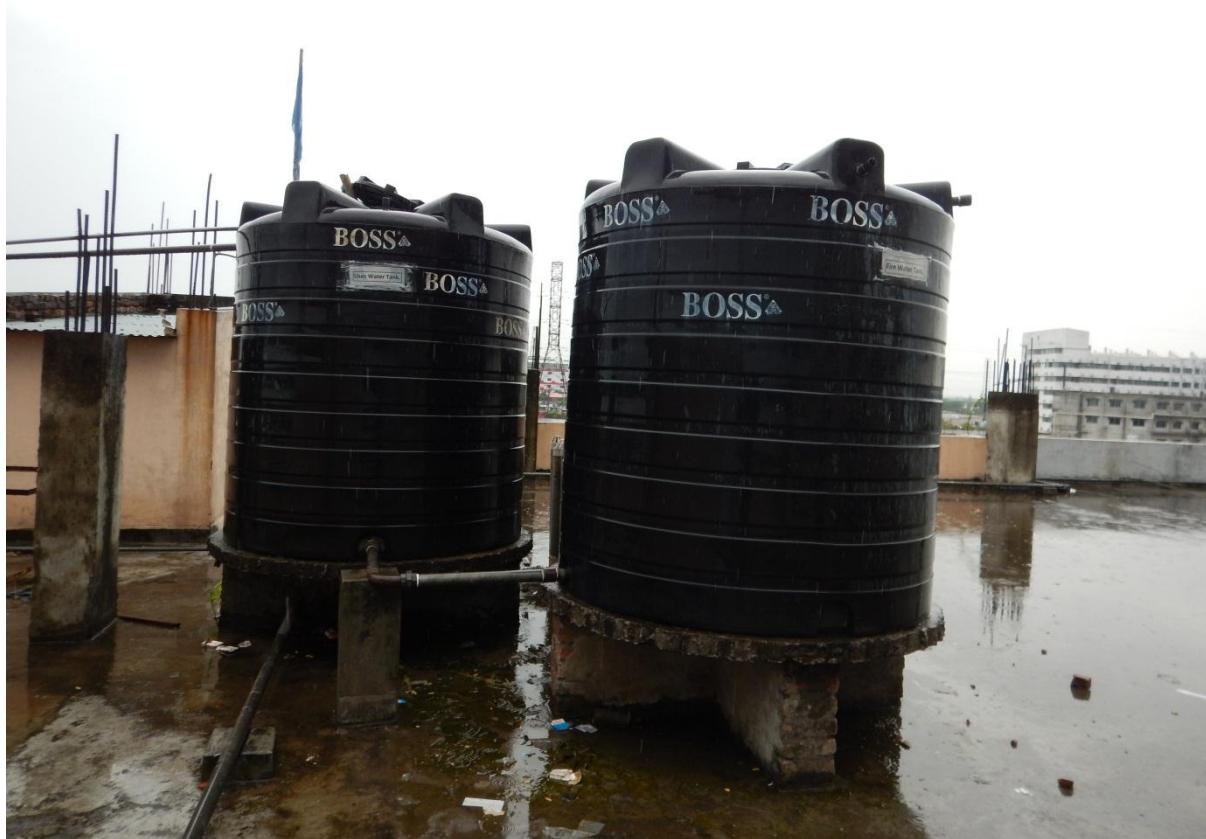
Concerns on the 3<sup>rd</sup> floor slab supporting water tanks. A capacity check of this slab and related elements needs to be carried out.

| Item No. | Observation | Recommended Action Plan | Recommended Timeline |
|---|---|---|---|
| 8 | Priority 2 - Capacity check of 3rd floor slab supporting water tanks. | Factory Engineer to review design, loads and related elements in area identified above to confirm capacity for this item. | 6-weeks |

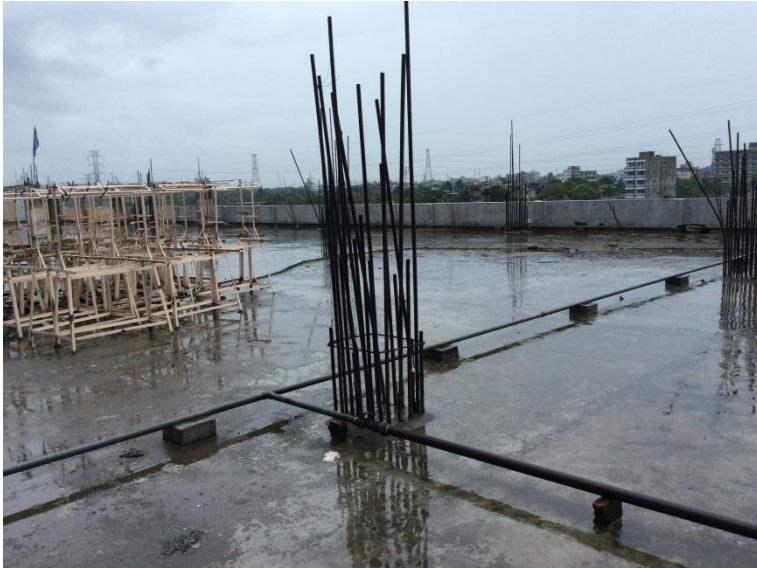
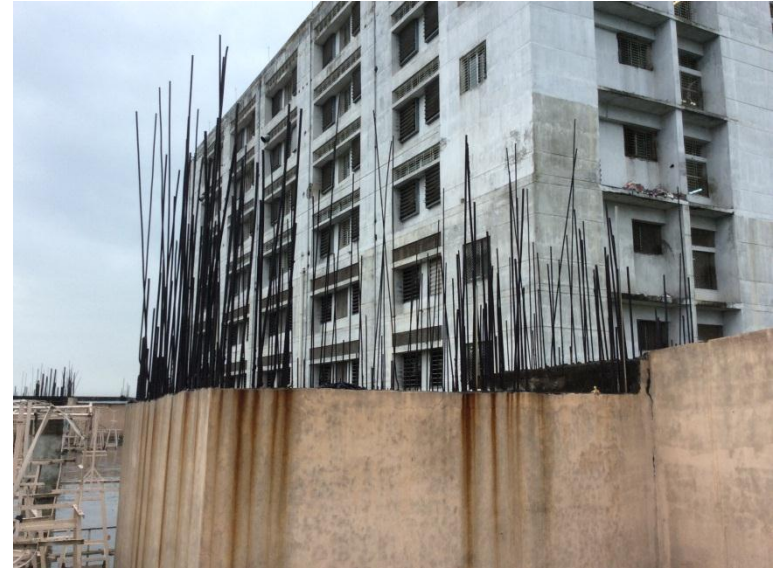
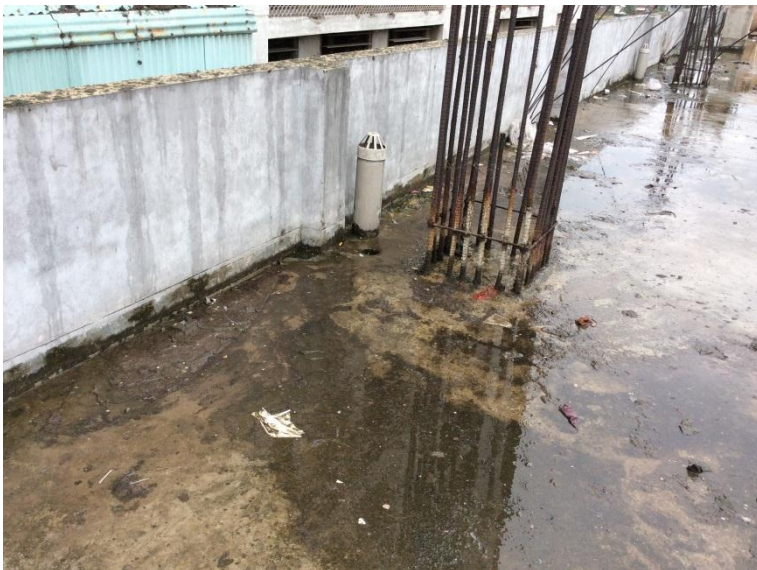
Reinforcement is left exposed at top level.

| Item No. | Observation | Recommended Action Plan | Recommended Timeline |
|---|---|---|---|
| 9 | Priority 3 - Reinforcement left exposed at top level. | Clean rebar before further construction.<br>For both durability and serviceability, rust proof paint or any appropriate methods is recommended. | 6-months |

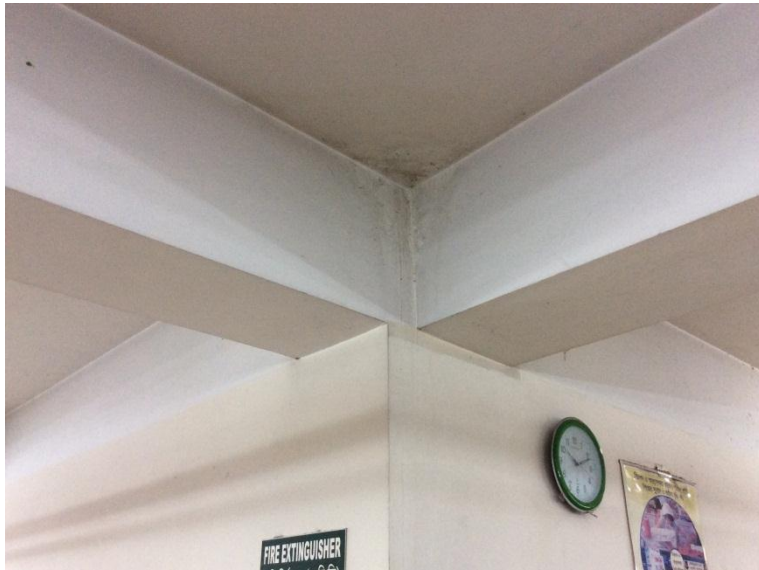
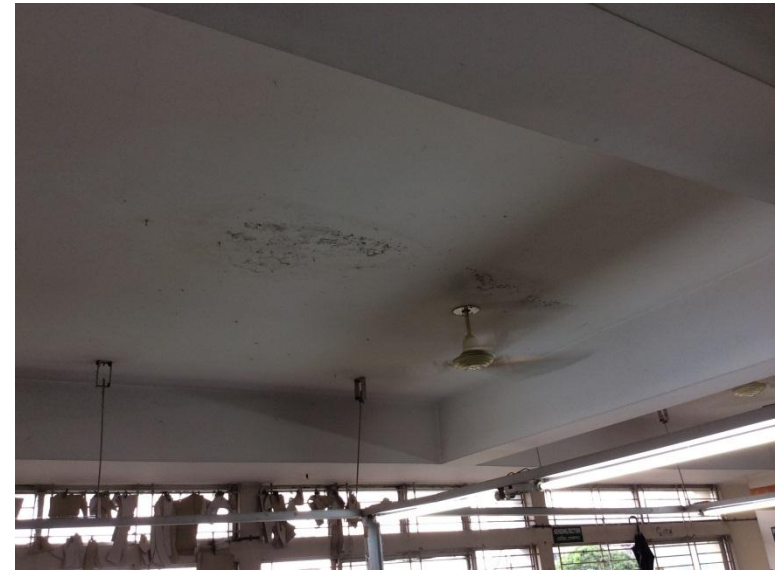
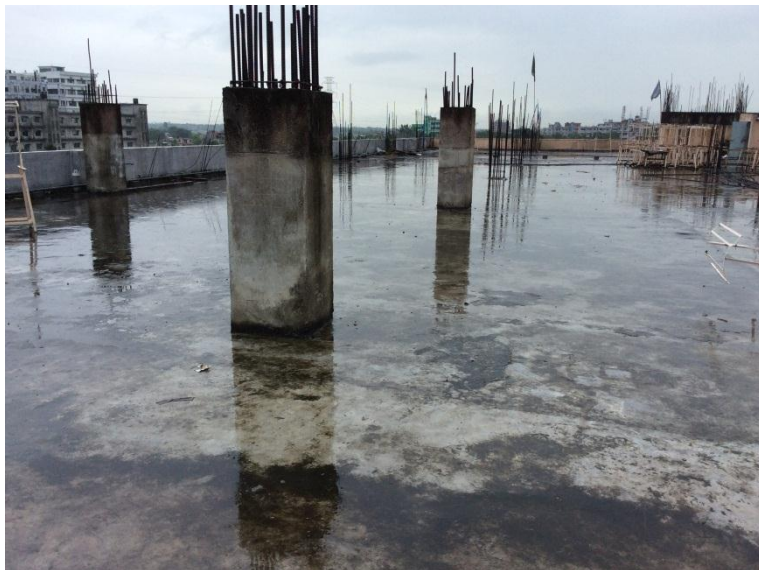
Water distress was noted on slabs, beams, columns and walls. Water ponding was found on the roof slab.

| Item No. | Observation | Recommended Action Plan | Recommended Timeline |
|---|---|---|---|
| 10 | Priority 3 - Distress due to water ingress. | Factory Engineer to inspect water damaged structures and repair with a suitable methods.<br>Waterproofing on the roof slab is to be applied. Moreover the roof slab drainage system should be investigated and improved. | 6-months |
