# FIRE SAFETY INSPECTION REPORT

**Factory Name: FNF Trend Fashion Ltd.**

**ACCORD ID: 12761**

**Date: 27 December, 2017.**

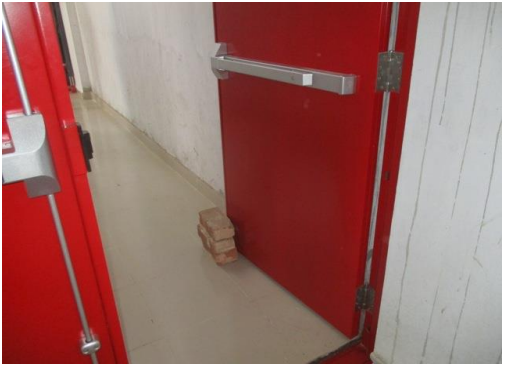
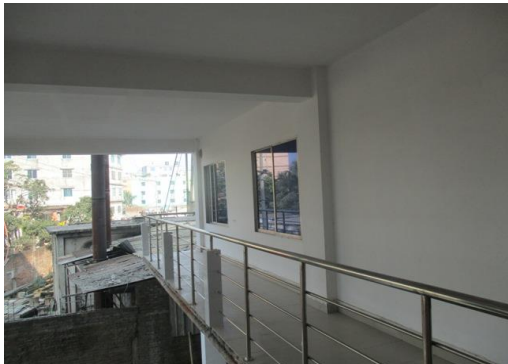
SI No.	Category	Findings	Required Action	Remediation Time Frame	Pictorial Evidence
1	Fire Rated Construction	The exterior exit stair is not separated from the building. Non rated wall & unprotected openings to external exit stairs have been observed. Installed Fire doors were observed to be tied up with uninterfaced external devices	<p>Exterior exit stairs shall be separated by minimum 2-hr fire-rated construction and The rating of the exterior wall shall extend 3.05 m (10 ft.) beyond the ends of the stair structure. Provide minimum 1.5-hr fire rated doors (if required) to separate the exit stairs from work areas and other building spaces on all floor levels. Ensure that the fire doors are self-closing, positive latching and that they are provided with fire exit (panic) hardware where serving production floors.</p> <p>If fire doors are required to be held open for functional reasons, provide automatic-closing devices tied to the fire alarm system.</p>	Within 3 Months

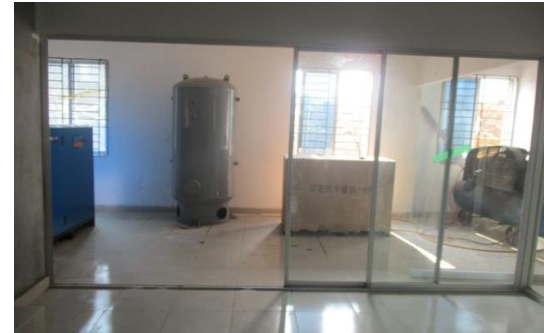
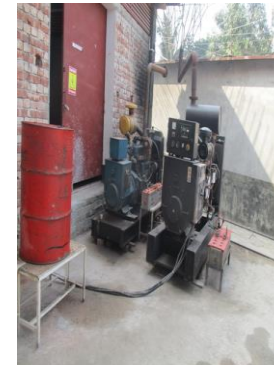
2

Boiler, Generator and compressor rooms are not separated from other occupancies

Boiler/Generator/Compressor room shall be separated from other occupancies by a minimum 2-hr fire rated construction (wall, floor, slab etc.). Seal all penetrations and openings (door, window etc.) should be protected by 1.5-hr fire rated materials to maintain the fire separation if required.

All exhaust systems shall discharge to the exterior of the building in a safe location.

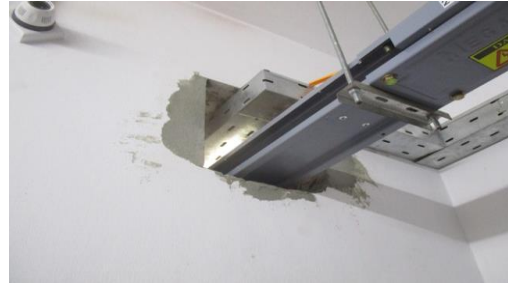
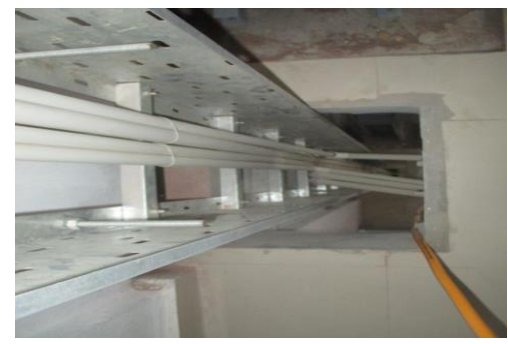
3

Unsealed penetrations and opening were found horizontally in a manner that opens to a vertical electrical shaft at all floors.

Seal all penetrations and openings in floor/ceiling (full thickness of the floor/ceiling) assemblies by fire rated materials to maintain the fire resistance rating.  
Or  
Provide a minimum 2-hr fire rated shaft to separate the utility risers from each floor

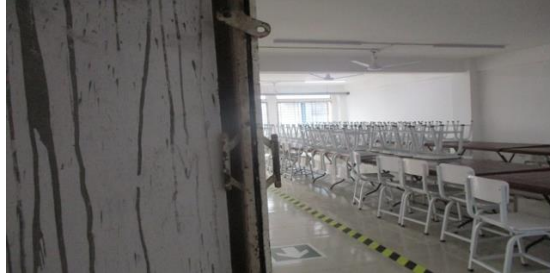
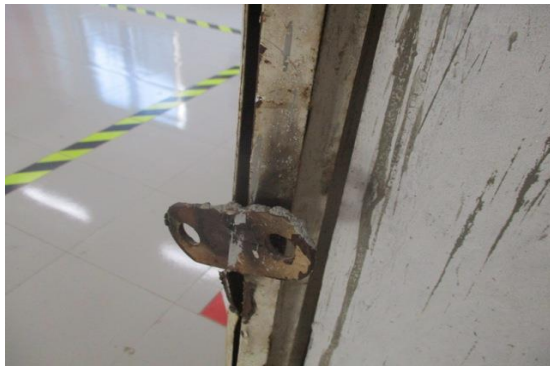
4

Collapsible gate with locking feature was found in the dinning area

Replace all collapsible/sliding/shutter type doors & gates by the side-hinged swinging type doors.

1. Remove all non compliant locking features from egress doors.
2. If locks are required for security reasons, utilize special door locking features complying with NFPA 101.
3. Doors may be locked where the latch and lock are disengaged with one motion where the occupant load does not exceed 49 persons.
4. Doors may be provided with locking hardware from the ingress side provided that a panic bar is installed on any door with an occupant load exceeding 49 persons.

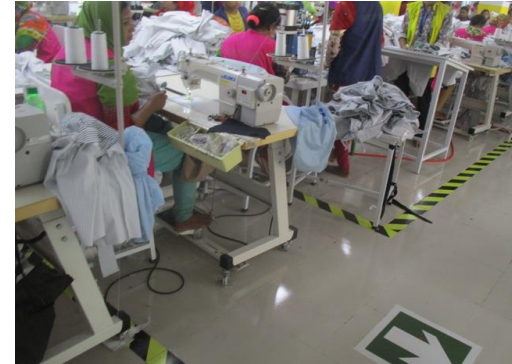
5	Egress	Aisles marks were missing or blocked at 5th and 6th floor near exit 1	Aisles shall be provided with a minimum unobstructed clear-width of 0.9 m (36 in.).	Immediate	
---	--------	---	---	-----------	--

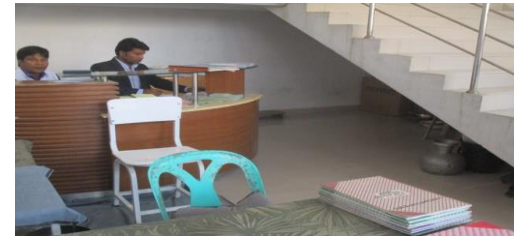
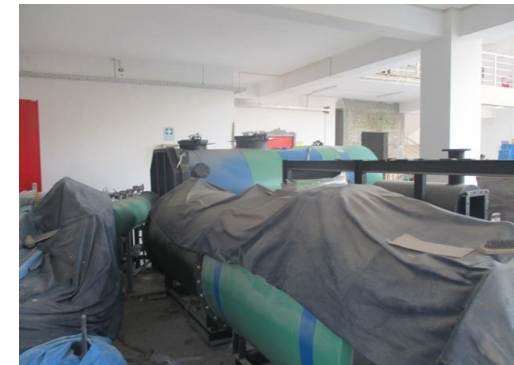
6

Reception, security post and storage were observed at and near exit stair at ground floor

Remove all storage from exit stair enclosure

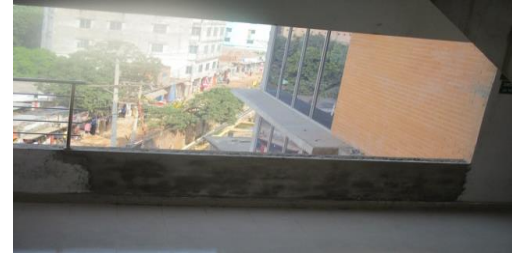
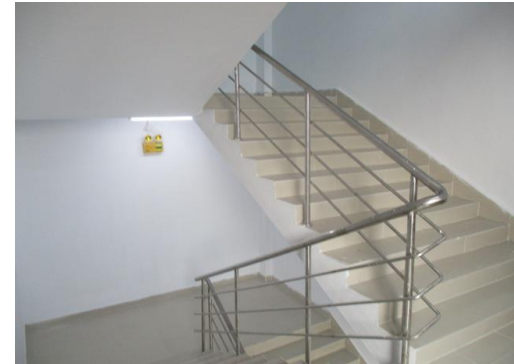
8

Handrails are not provided at exit stair 1 at both sides and at a certain area of 4th floor. Intermediate handrails were not available at stair 2

Provide handrails at both sides and intermediate location where applicable of the stair with a minimum height of 34 inches

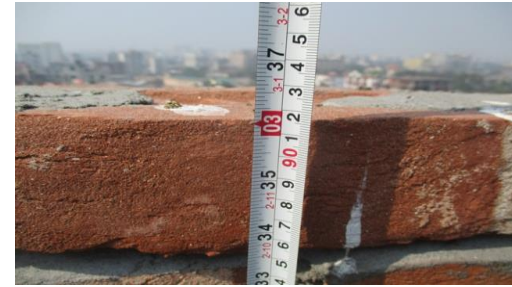
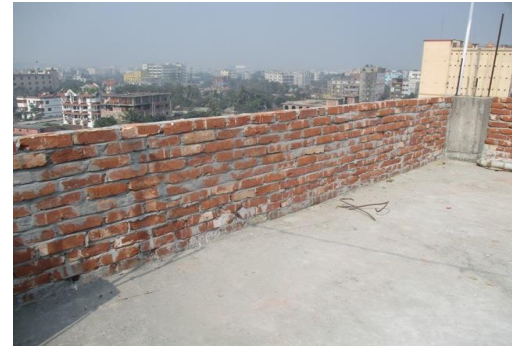
9

The size of the parapet at roof floor is 35 inches which is not adequate

Provide parapet with a minimum height of 42 inches as per accord standard.
