Carlos Leather Fashion Ltd. (10099)

Teknog Para, Chandona Chourasta, Joydebpur, Gazipur

21.AUGUST.2014

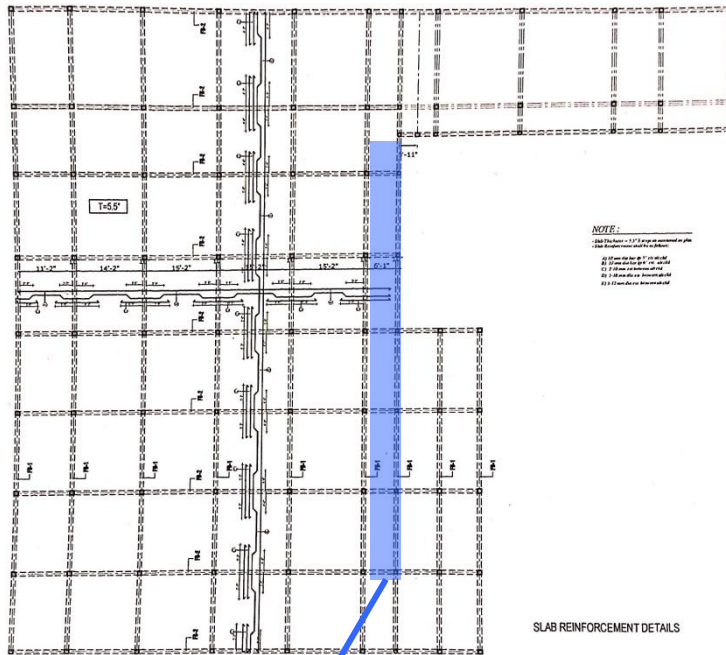
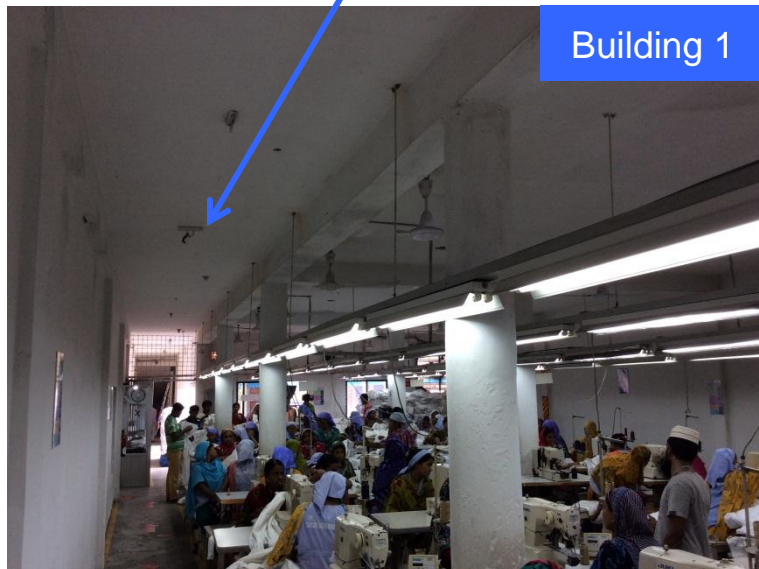
The beams specified in structural drawings shown on the left were not found.

There are also no structural drawings provided for the extension of Building 1 and Shed 1.

The structural drawings need to be revised.

Item No.	Observation	Recommended Action Plan	Recommended Timeline
1	Priority 2 - Inadequacies between the drawings and the actual as-built conditions.	Factory Engineer to survey the actual conditions and revise the drawings. Any results of the Engineering Assessment which affect the structure should be taken on board.	6-weeks
2	Priority 2 - Inadequacies between the drawings and the actual as-built conditions.	Continue to implement load plan.	6-months
3	Priority 2 - Stability and capacity of lightweight roof.	Factory Engineer to review design, loads and related elements in area identified above to confirm capacity and stability for these items.	6-weeks
4	Priority 2 - Stability and capacity of steel staircase on Building 1.	Factory Engineer to review design, loads and related elements in area identified above to confirm capacity and stability for these items. These items should be strengthened or replaced with appropriate permanent structural elements.	6-weeks

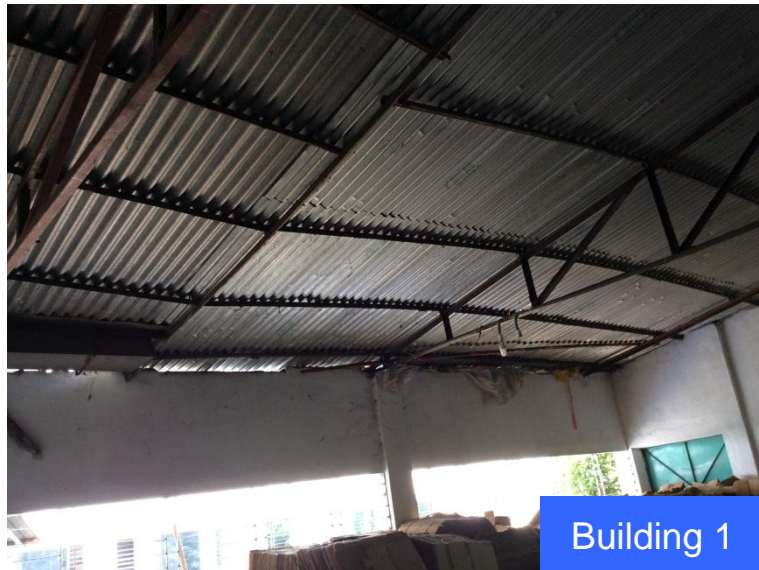
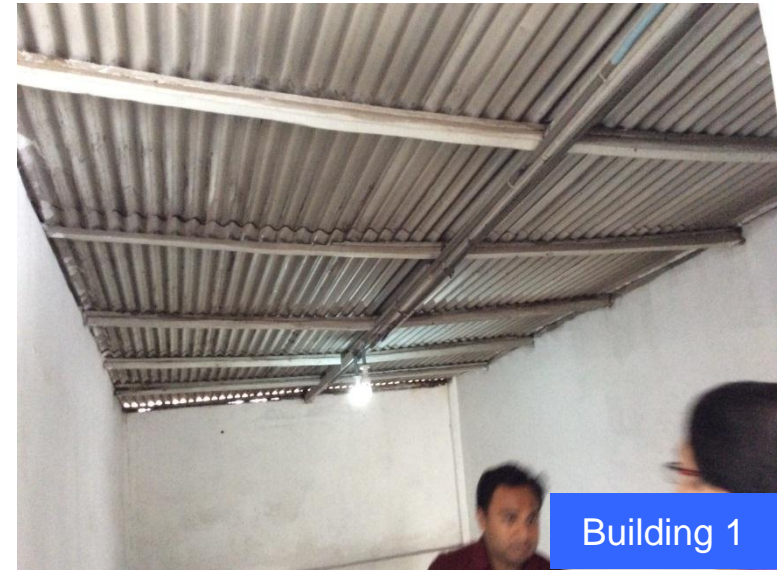
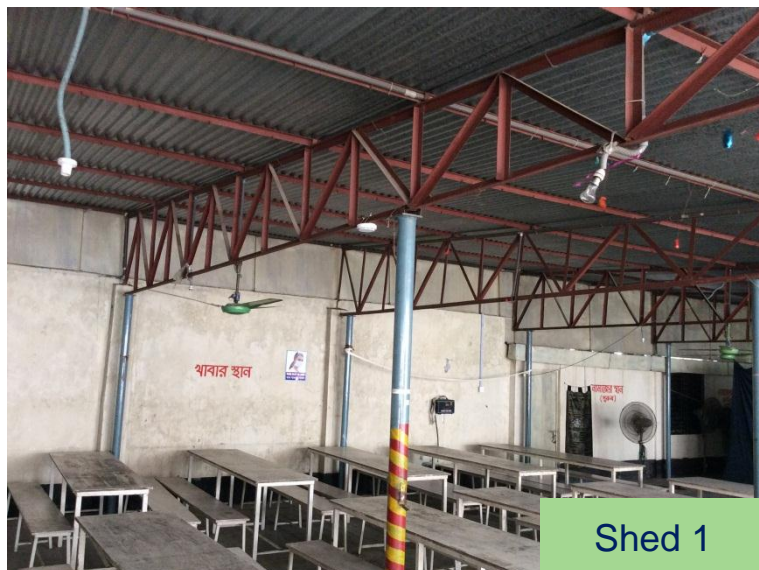
Concerns on the lightweight roof at Building 1. Stability and capacity must be checked especially the connections. Stability under wind uplift needs to be checked in particular.

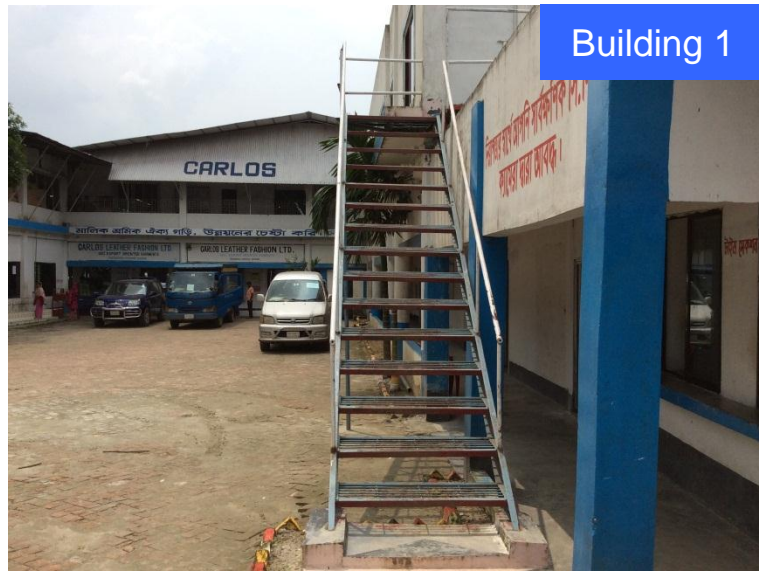
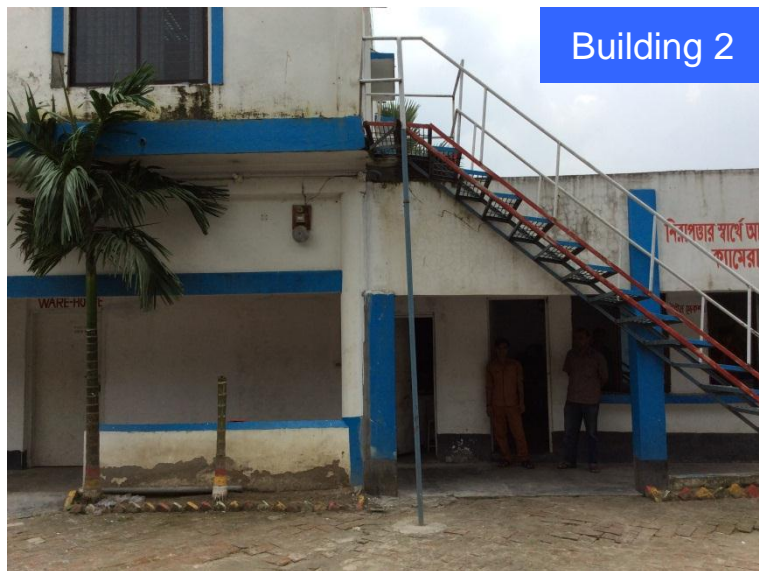
Concerns on stability and capacity of the steel stair on Building 1.

These should be investigated and/or strengthened.

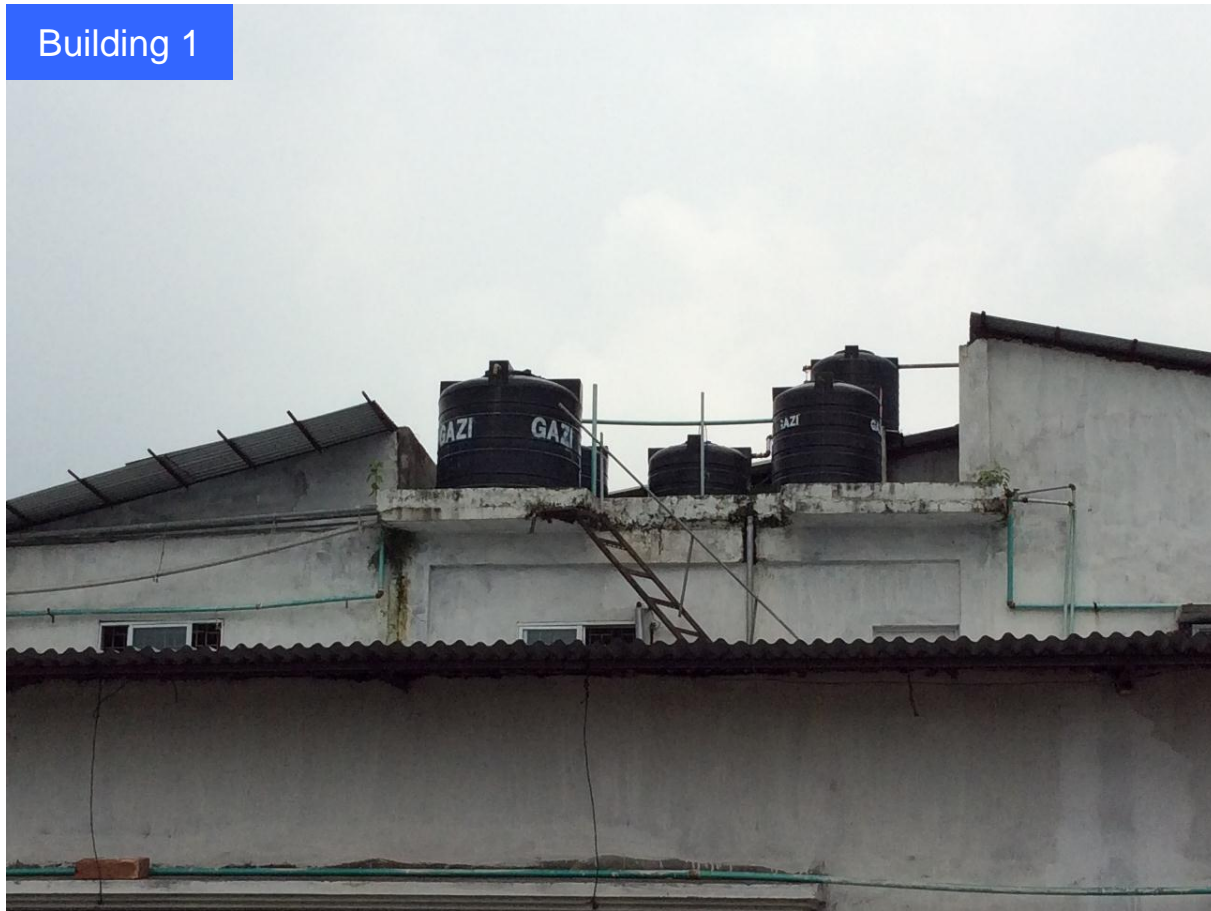
Building 1

Concerns on the roof slab supporting water tanks. A capacity check of this slab and all related elements need to be carried out.

5	Priority 2 - Capacity check of roof slab supporting water tanks on Building 1.	Factory Engineer to review design, loads and related elements in area identified above to confirm capacity for these items. Or The items in the area identified above should be removed.	6-weeks
6	Priority 2 - Overall stability system.	An Engineering Assessment of the overall building to be carried out and in particular, stability and foundation aspects should be investigated in detail.	6-weeks
7	Priority 3 - Distress due to water ingress on Building 1.	The Factory Engineer to investigate the cause by appropriate methods. Factory Engineer to inspect water damaged structures and repair with a suitable methods.	6-months
8	Priority 3 - No fireproofing material for structural steel elements (if required).	Fireproofing material for structural steel element is recommended as suggested in BNBC Codes. Maintain standard of quality control and protection of the fire protection.	6-months

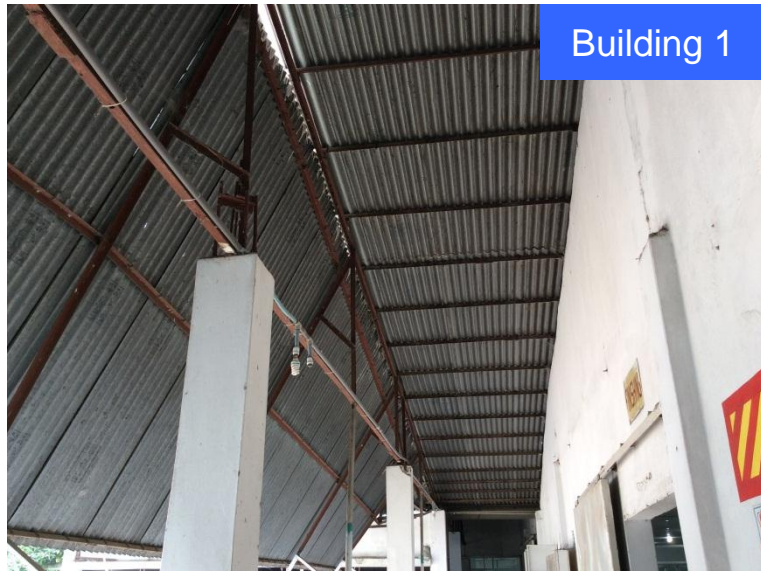
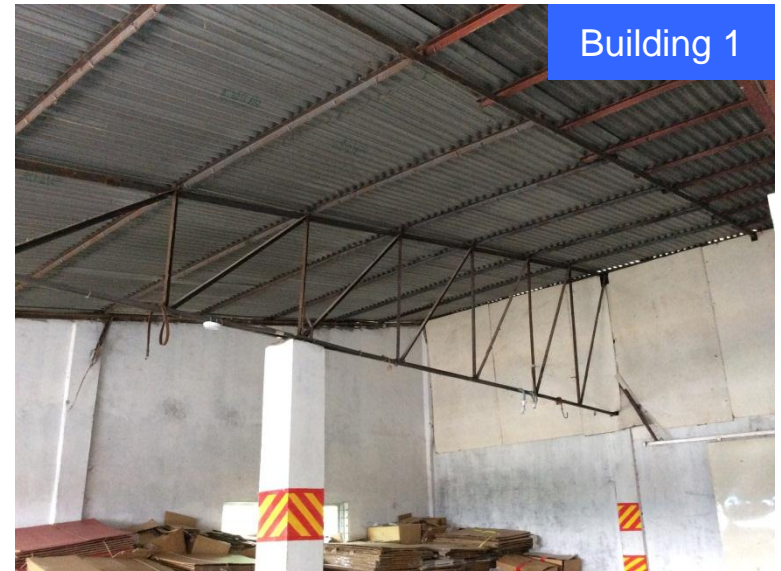
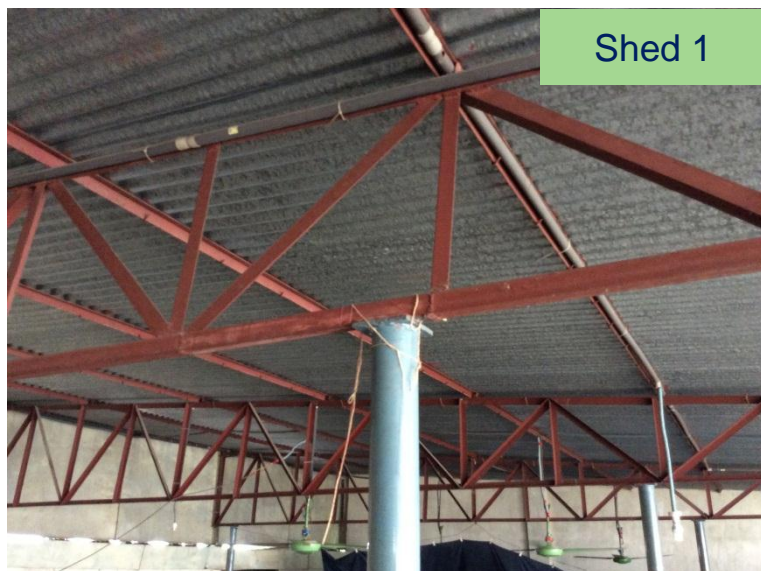
No fireproofing material was noted on structural steel elements (if required).

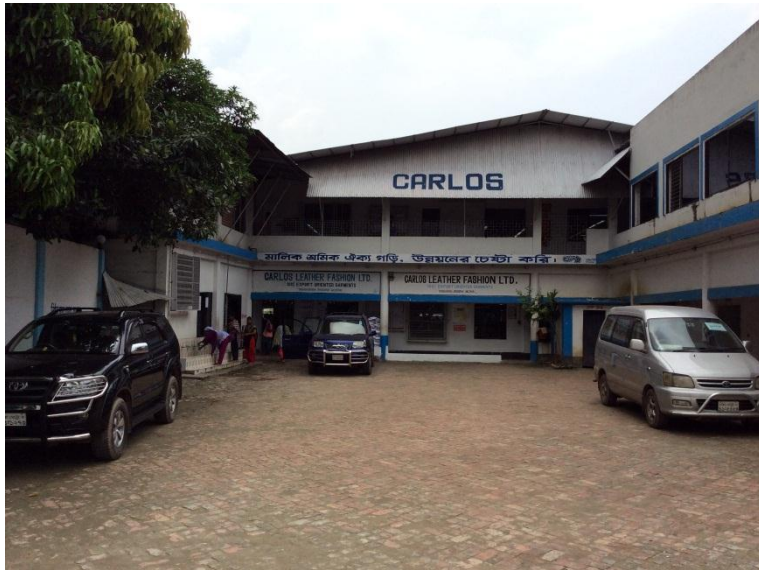
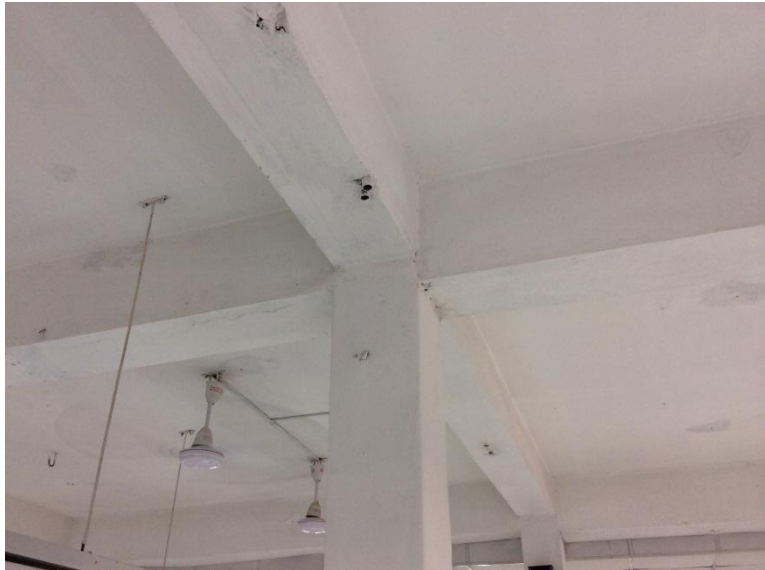
Overall Stability System

The lateral loading resistance for this 2-storey building is provided by moment frame action without any shear walls and the façade brickwork walls lack moment capacity due to their poor connections with the surrounding columns and beams.

We require that the stability of this building is investigated as part of an Engineering Assessment.

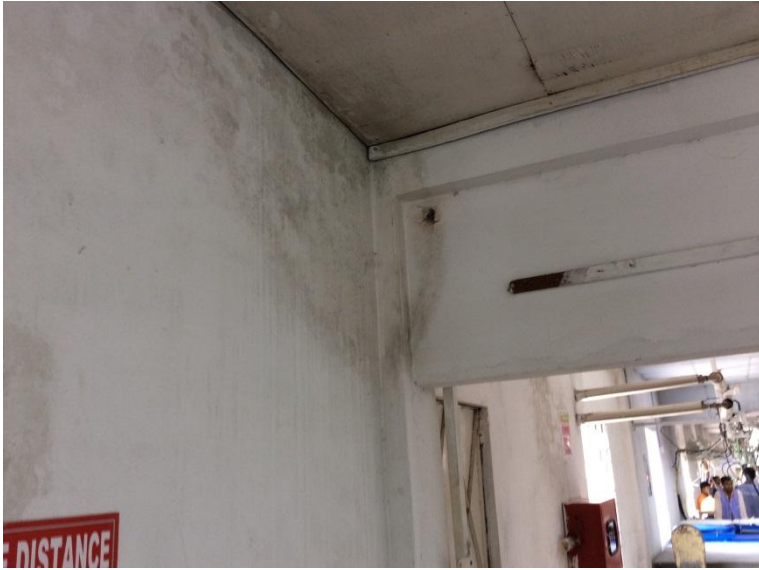
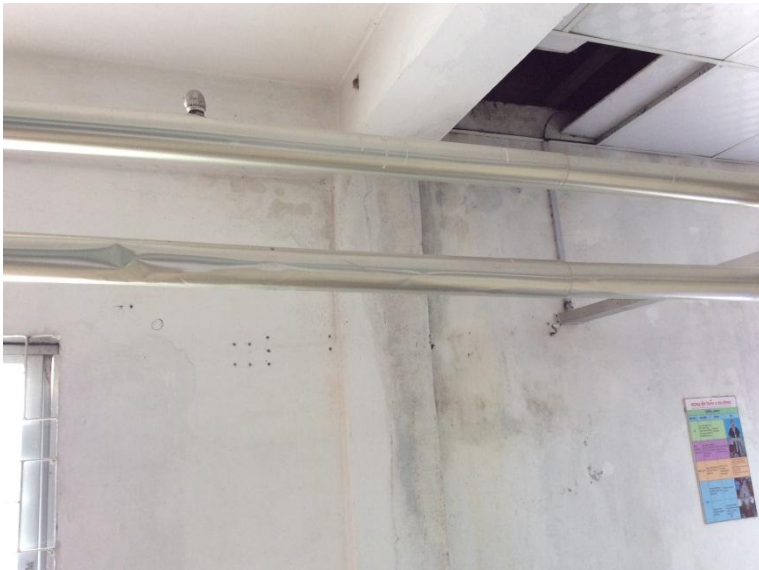
Water Ingress

Water distress was noted on beams, columns and walls.
