Renown Apparels Ltd. (11800)

Bhatiary Link Road (South Side), Barodighir Par, Hathazari, Chittagong – 4335

20.August.2014

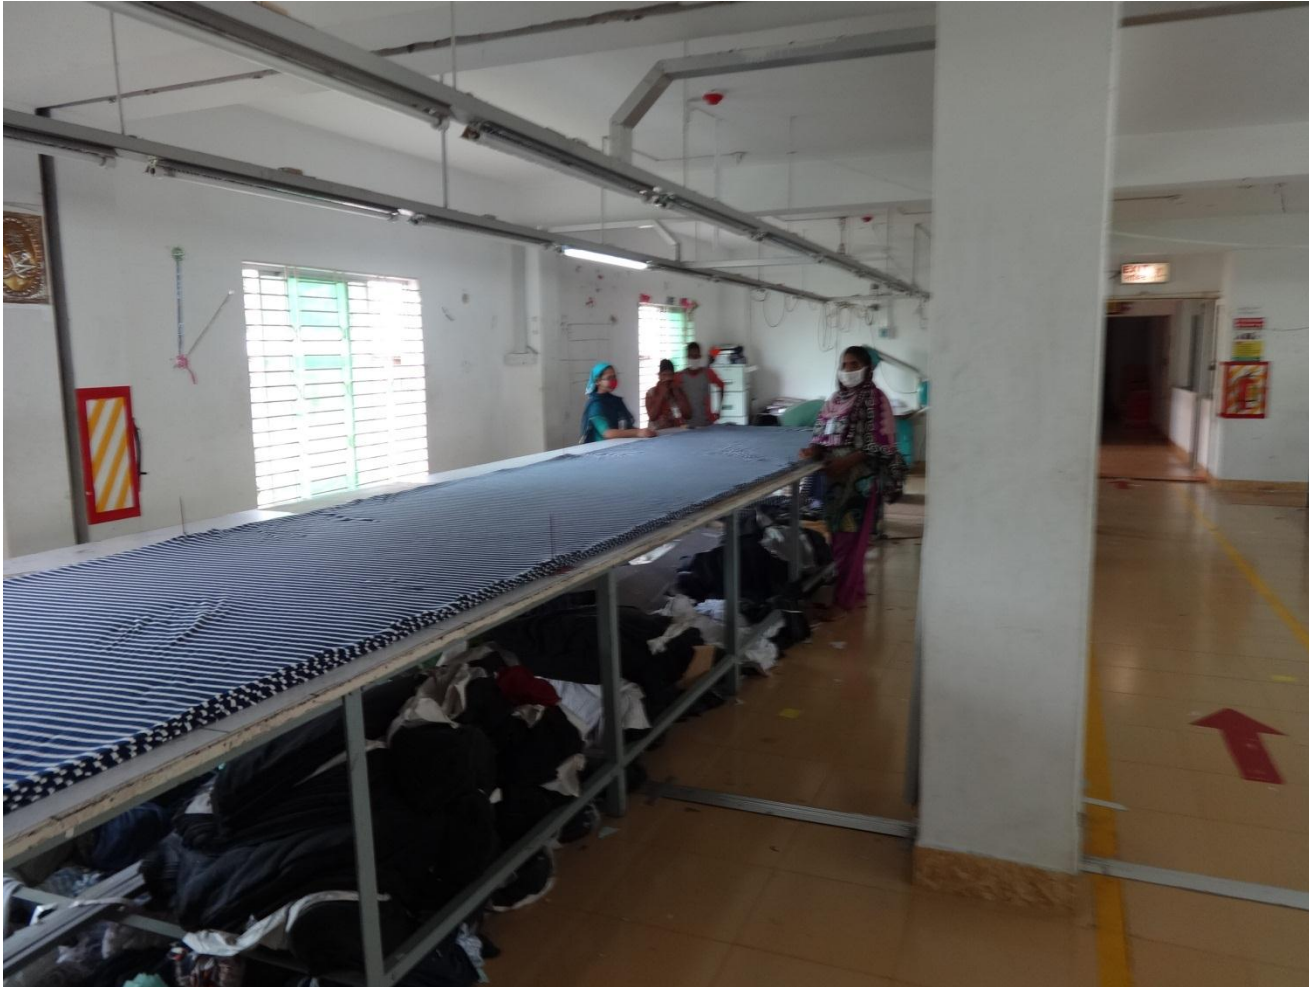
1st Priority 1 Concern

High stresses to internal columns, factor of safety between 1.25 & 1.50 based on current loading.

If all floors are loaded to 2kPa (40psf) the columns would still be overstressed.

Item No.	Observation	Recommended Action Plan	Recommended Timeline
1	Priority 1 - High stresses to internal columns, factor of safety between 1.5 & 1.86 based on current loading.	Ensure that the slabs are not loaded above 2.0kPa (40psf).	Immediate - Now
2	Priority 1 - High stresses to internal columns, factor of safety between 1.5 & 1.86 based on current loading.	Carry out a Detailed Engineering Assessment on the columns, taking 100mm core samples where necessary to establish the strength.	6-weeks
3	Priority 1 - High stresses to internal columns, factor of safety between 1.5 & 1.86 based on current loading.	Carry out any recommendations highlighted in the Detailed Engineering Assessment.	6-months
4	Priority 2 - Shear cracking observed at beam - beam connections.	Carry out a Detailed Engineering Assessment on the beams, removing plaster, to establish the extent of the cracks in the beams and what load they can safely support.	6-weeks

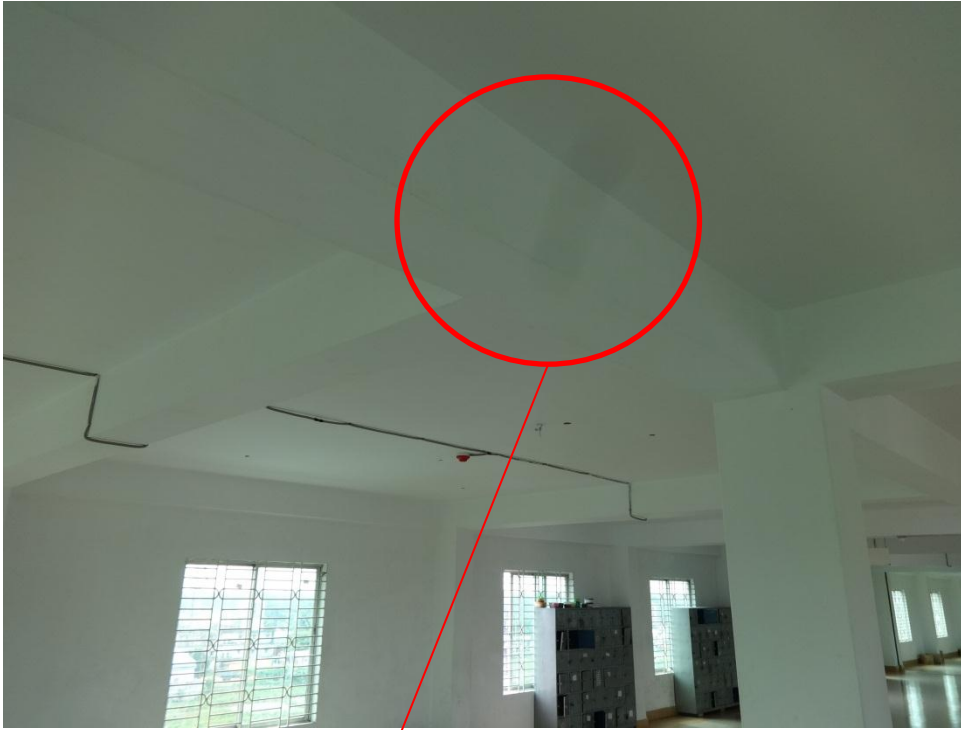
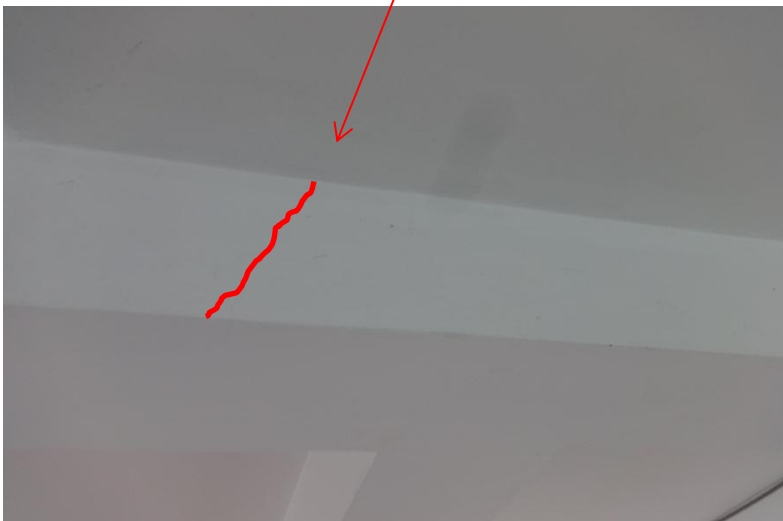
1st Priority 2 Concern

Shear cracking observed at beam – beam connections.

The column grid of the building is staggered resulting in multiple beam – beam connections.

5	Priority 2 - Shear cracking observed at beam - beam connections.	Carry out actions from the Detailed Engineering Assessment.	6-months
6	Priority 2 - Plinths have been constructed on the slab around wash room areas & cracks were observed in the beams below.	Carry out a Detailed Engineering Assessment to determine if the slab is adequate to support the higher dead load of the plinth.	6-weeks
7	Priority 2 - Plinths have been constructed on the slab around wash room areas & cracks were observed in the beams below.	Carry out actions highlighted in the Detailed Engineering Assessment, removing or lowering the heights of the plinths as required.	6-months

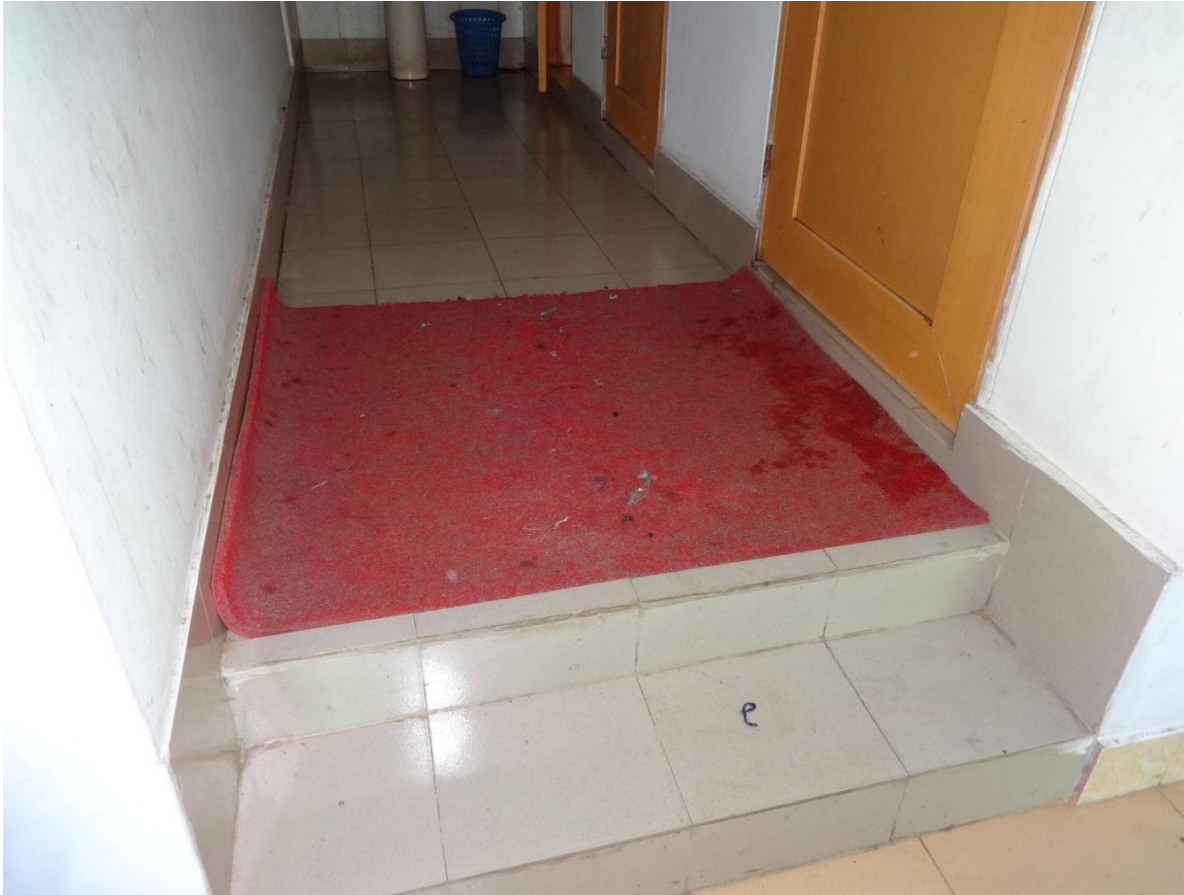
2nd Priority 2 Concern

Plinths have been constructed on the slab around wash room areas & cracks were observed in the beams below.

150mm – 250mm
plinths constructed
on slab around the
washing area

The plinth will weigh up to
5.0kPa.
 $(250/1000) \times 20 = 5.0\text{kPa}$

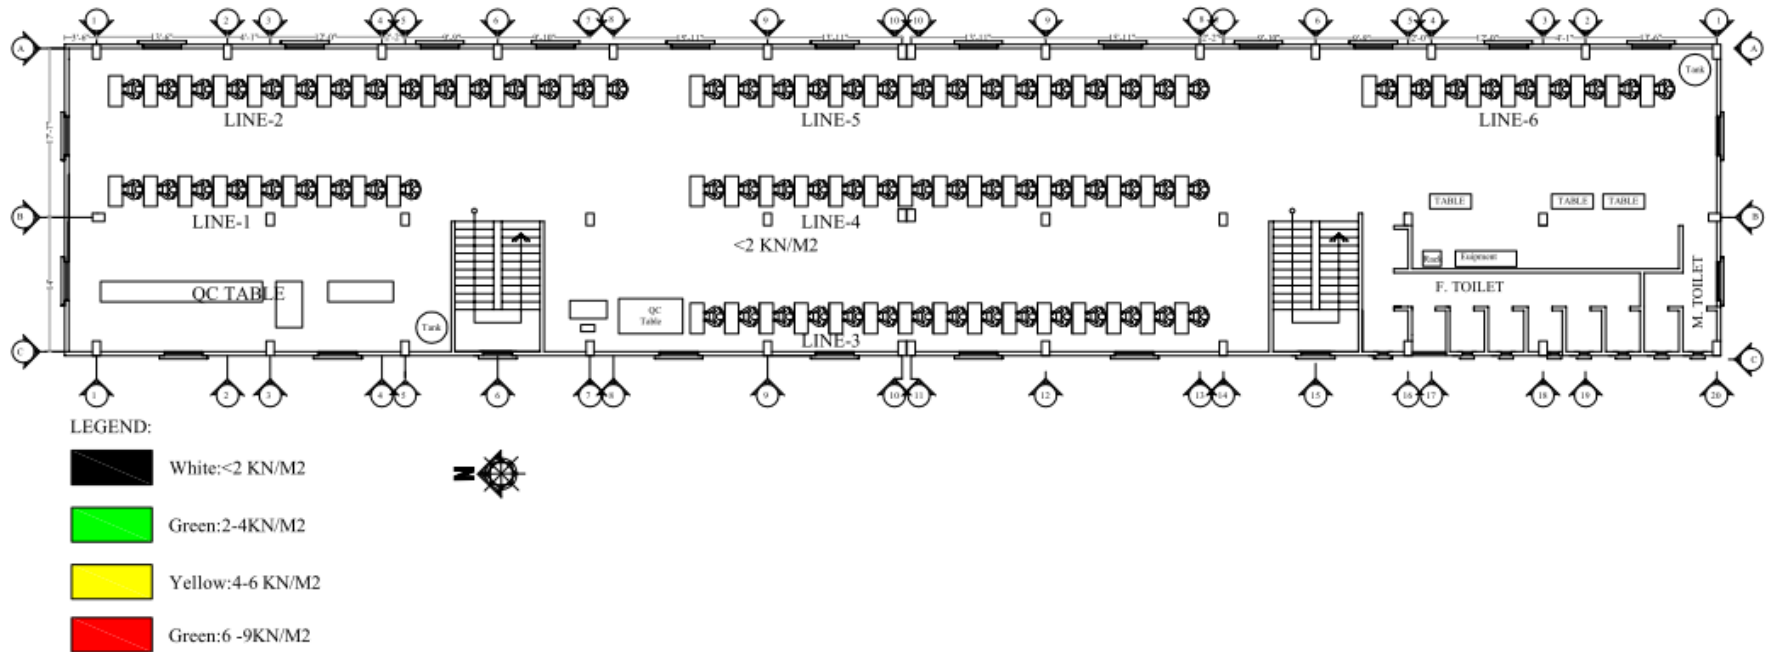
TITLE:-
2nd & 3rd Floor Load Plan
LOCATION:-
BHATIARY LINK ROAD, BARDHEGHIR PAR,
HATHAZARI, CHITTAGONG

Loading plans exist for the structure, but are not displayed.

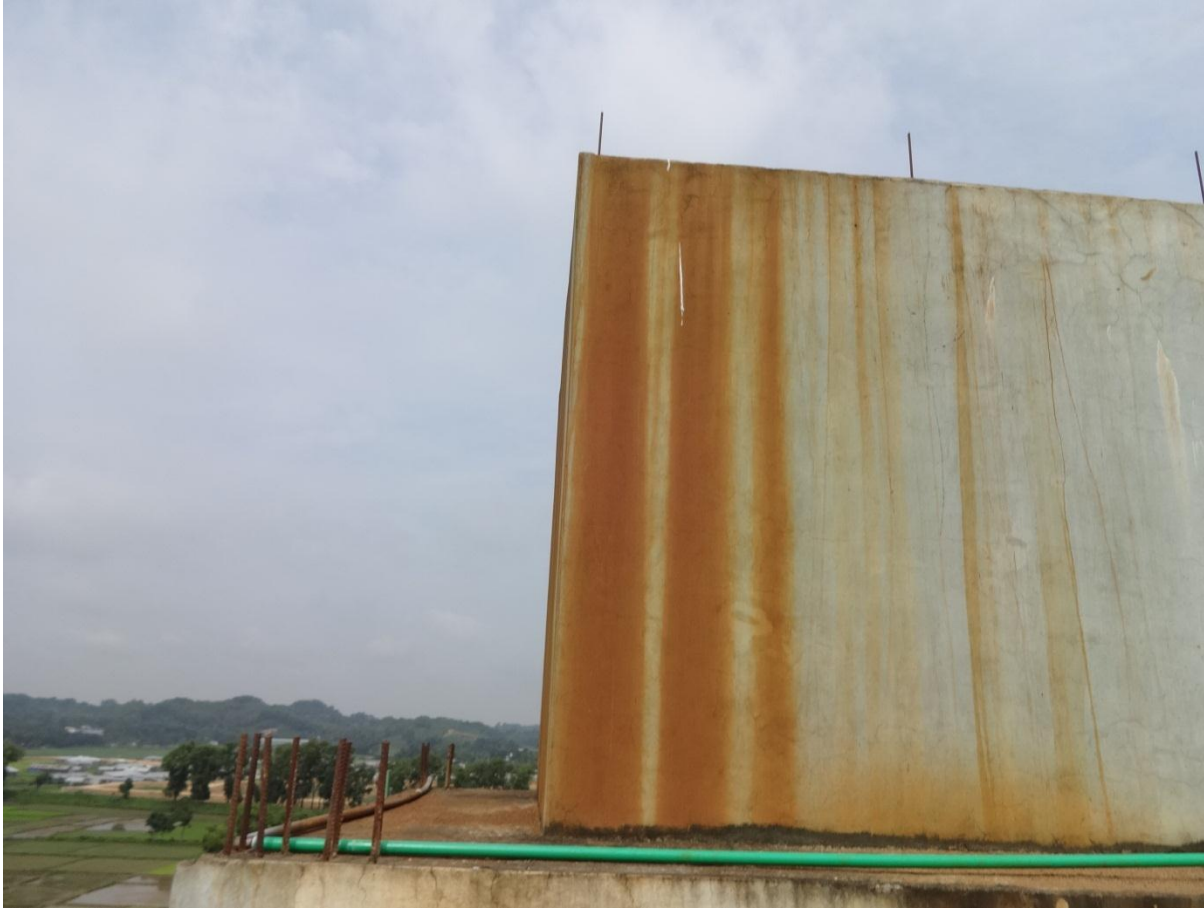
1st Priority 3 Concern

The 30,000 litre water tank on the roof is leaking or overflowing.

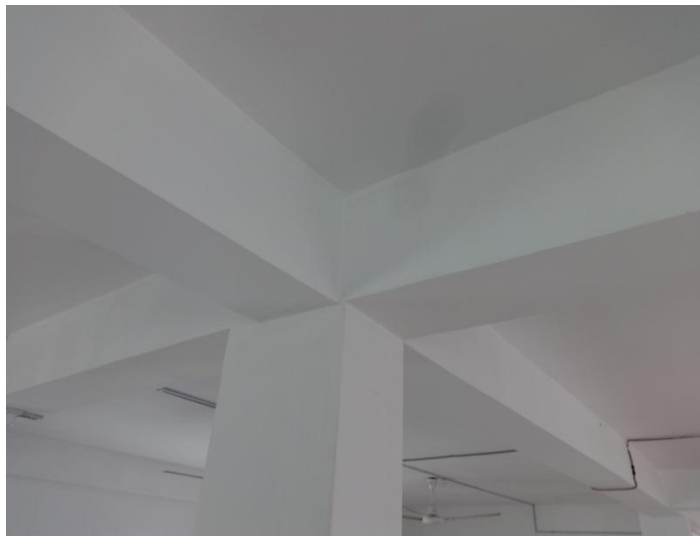
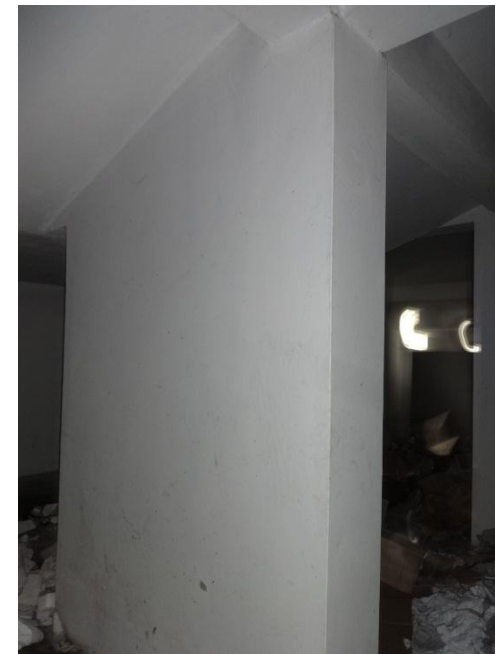
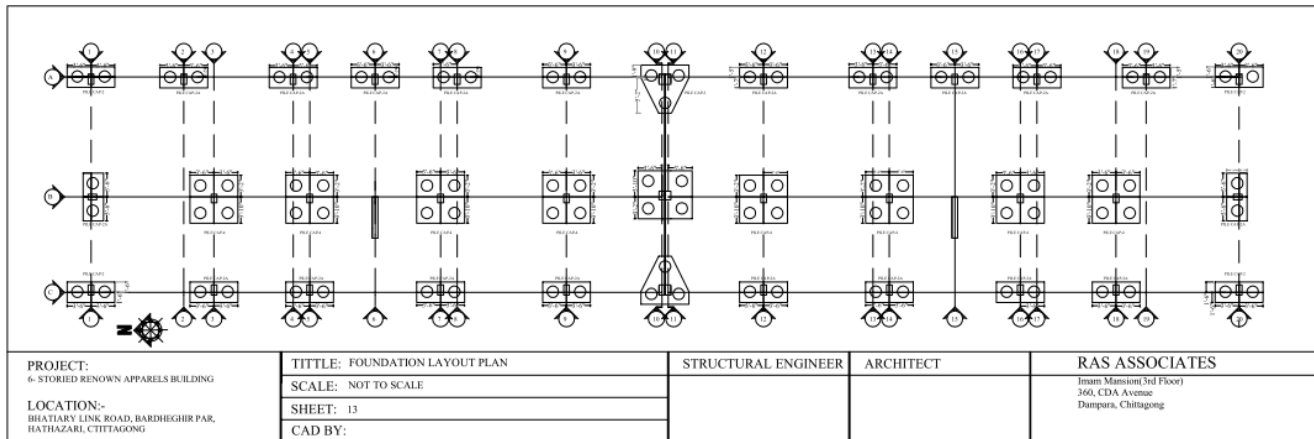
Overall Stability System

The building appeared to feature two shear walls between basement and ground floors, however, these did not correspond with foundations and do not run the height of the building. Therefore will have no discernable contribution towards overall stability. Stability was achieved through sway action between beams and columns and masonry infill walls.

We require that these items be investigated in a Detailed Engineering Assessment.

Item No.	Observation	Recommended Action Plan	Recommended Timeline
8	Priority 2 - There is no obvious stability system for the building.	Carry out a Detailed Engineering Assessment on the building to verify that it is stable under lateral loading.	6-weeks
9	Priority 2 - There is no obvious stability system for the building.	Carry out all recommendations of the Detailed Engineering Assessment.	6-months
10	Priority 2 - Loading plans exist for the structure, but are not displayed.	Ensure loading plans are displayed and actively managed at each level.	6-weeks
11	Priority 3 - The 30,000 litre water tank on the roof is leaking or overflowing.	If the tank is to remain repair the tank appropriately, draining the tank if necessary to facilitate the repair.	6-months
12	Priority 3 - There is no waterproof membrane on the roof.	Cover the concrete roofs with a suitable waterproofing membrane, e.g. waterproof screed.	6-months

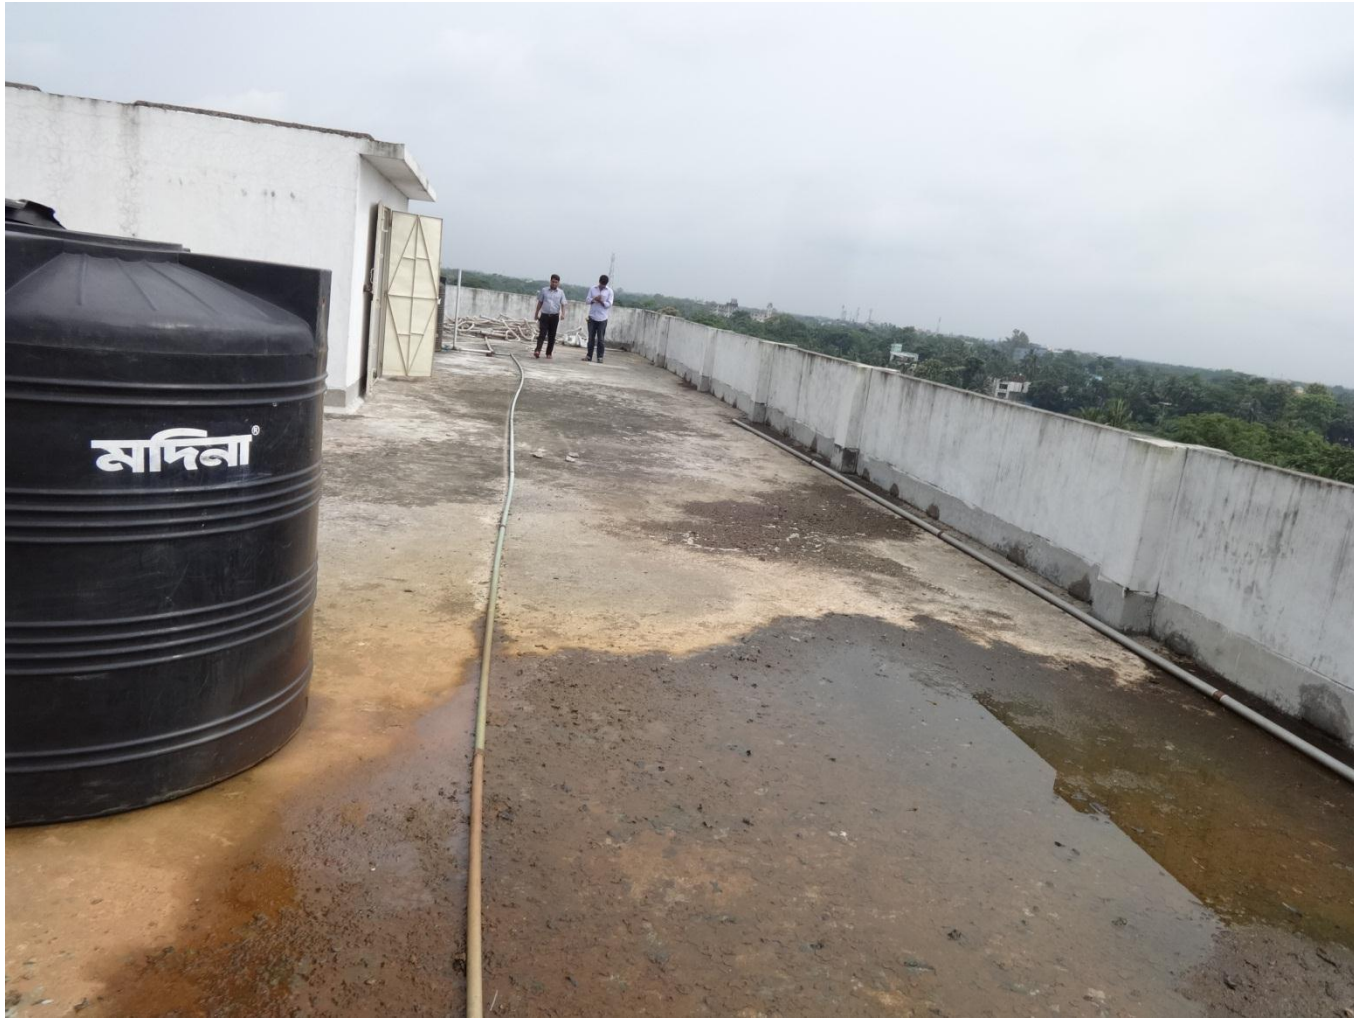
Water Ingress at Roof Level

No waterproofing membrane was visible on the roof of the building. This means that any cracks in the surface finishes on the roof will allow water to seep into the concrete slab beneath the finishes, and cause corrosion of the reinforcing steel.
