# Radiant Sweater Ind. Ltd. (9945)

## Sayem Fashions Ltd. (11476)

Kamarjuri, National University, Gazipur

19.AUGUST.2014

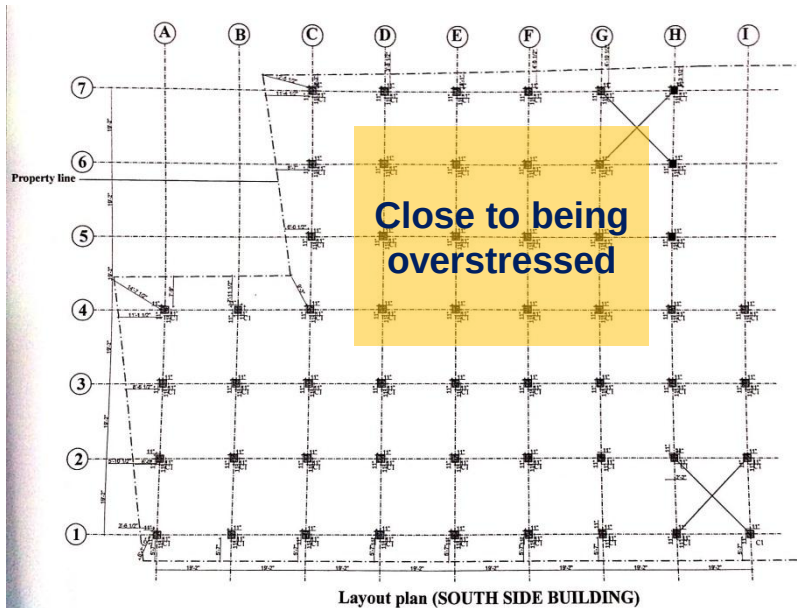
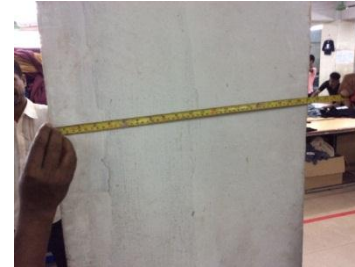
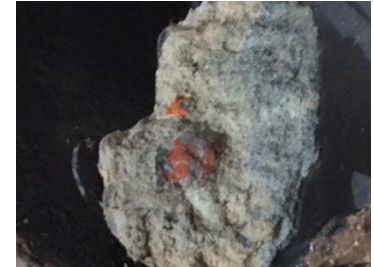
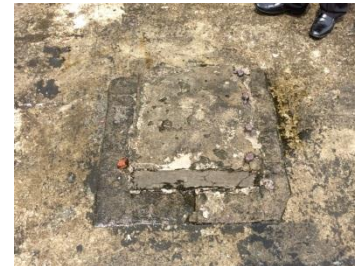
The internal columns at ground level at Building 1 shown below are close to being overstressed. The size of these column is 500 x 500 mm at ground level and carry 8 storeys of Building 1 with 5.75 m and 5.75 m length spans. Uncontrolled heavy storage loading of 4.1 kPa and 6.1 kPa was also found on 2<sup>nd</sup> floor and 4<sup>th</sup> floor respectively.

From the information above, for Building 1, 8 storeys, the calculation check of these columns show that they are close to being overstressed (FoS = **1.37**).

**Remark:** The sizes of the column's rebar are assessed to be similar to those specified on the structural drawings.

| Item No. | Observation | Recommended Action Plan | Recommended Timeline |
|---|---|---|---|
| 1 | Priority 1 - The internal columns at ground level are close to being overstressed in Building 1. | Maintain and control the floor loading on every floor to ensure the total load does not exceed 2.0 kPa.<br>Factory Engineer to review design, loads and columns stresses in area identified above.<br>Verify in-situ concrete stresses either by cores or existing cylinder strength data for [the identified columns / cores from 4 columns].<br>A Detailed Engineering Assessment of Factory to be commenced immediately. | Immediate - Now |

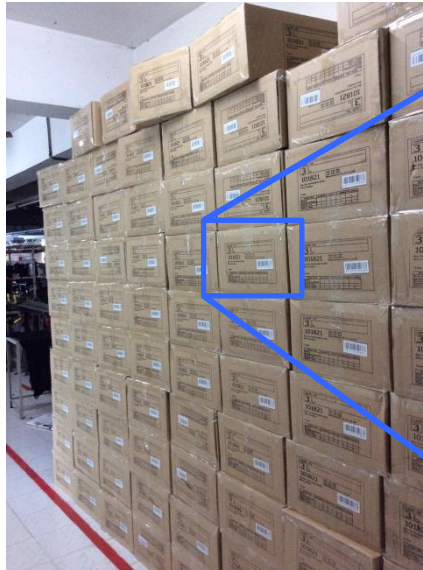
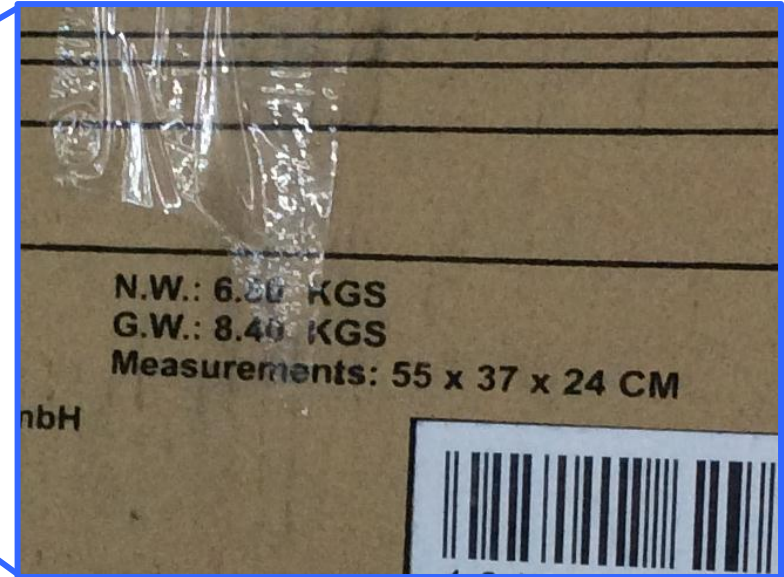
2<sup>nd</sup> Fl.

Uncontrolled heavy storage loading was found on 2<sup>nd</sup> floor and 4<sup>th</sup> floor in Building 1. We believe the loading on 2<sup>nd</sup> floor and 4<sup>th</sup> floor to be 4.1 kPa and 6.1 kPa respectively. Loading in these areas should be reduced to 2.0 kPa and we require that these items be investigated in a Detailed Engineering Assessment. Loading plans should be developed and displayed in all areas.

| Item No. | Observation | Recommended Action Plan | Recommended Timeline |
|---|---|---|---|
| 4 | Priority 1 - Uncontrolled heavy storage loading in Building 1. | Reduce stacking height to ensure total load does not exceed 2.0 kPa.<br>A Detailed Engineering Assessment is required to review the design and loads.<br>Factory Engineer to state the maximum weight that is allowed per square meter. Suggest that state the value on notice boards in these areas. (Loading Plans). | Immediate - Now |

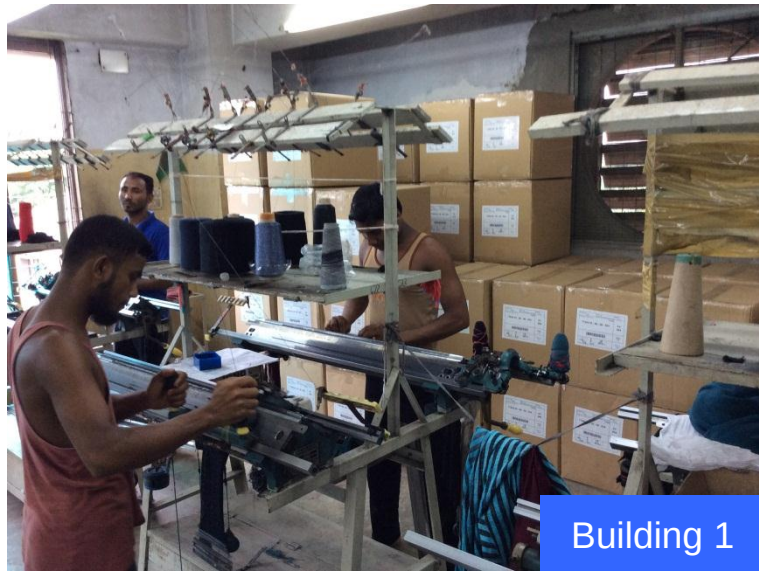
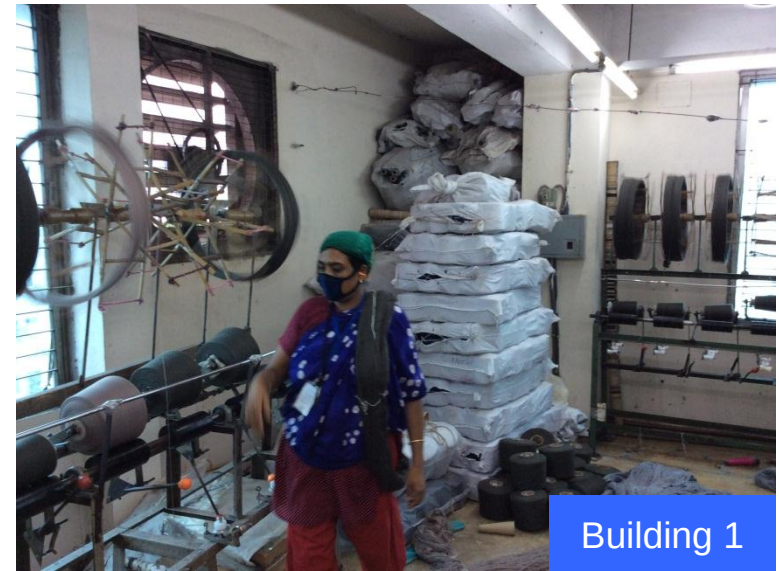
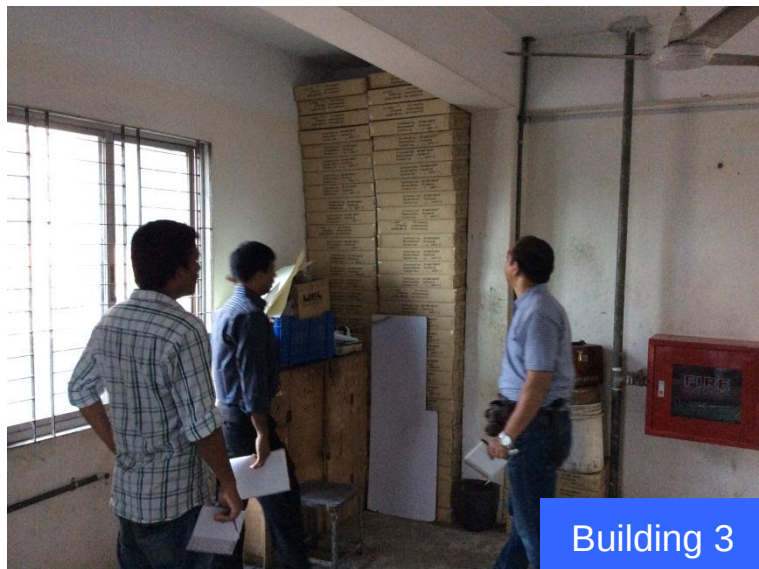
Uncontrolled heavy storage loading was found on cantilevered slabs at every floor level of Building 1 and 2<sup>nd</sup> floor and 3<sup>rd</sup> floor at Building 3. The loading was also leaning on the brick walls that lack lateral load resistance. Loading in these areas should be removed and we require that these items be investigated in the Detailed Engineering Assessment.

| Item No. | Observation | Recommended Action Plan | Recommended Timeline |
|---|---|---|---|
| 7 | Priority 1 - Uncontrolled heavy storage loading on cantilevered slabs in Building 1 and Building 3. | Remove heavy storage loading in the area identified above.<br>A Detailed Engineering Assessment is required to review the design and loads.<br>Factory Engineer to state the maximum weight that is allowed per square meter. Suggest that state the value on notice boards in these areas. (Loading Plans). | Immediate - Now |

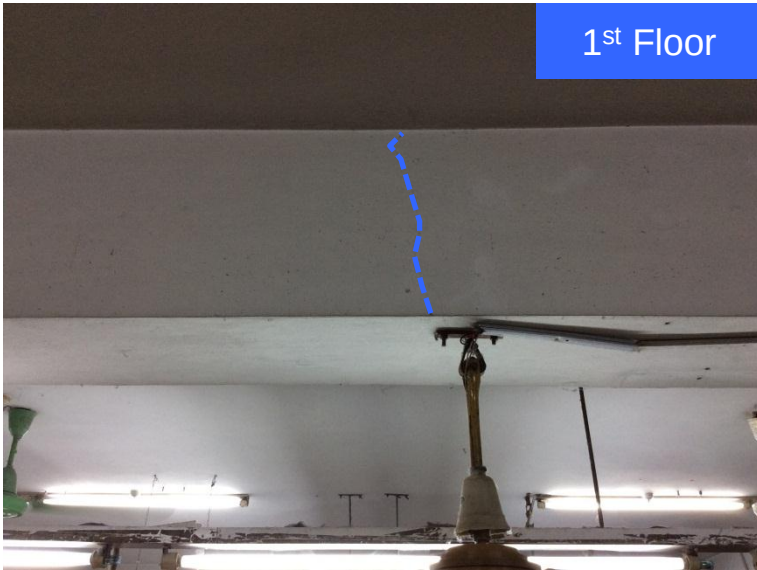
1<sup>st</sup> Floor

Cracks on 1<sup>st</sup> floor, 3<sup>rd</sup> floor and 4<sup>th</sup> floor beams in Building 1. The cause of cracks should be investigated by appropriate methods and then repaired.

| Item No. | Observation | Recommended Action Plan | Recommended Timeline |
|---|---|---|---|
| 10 | Priority 2 - Cracks on beams of Building 1. | The Factory Engineer to investigate the cause of cracks by appropriate methods.<br>The distress found is to be suitably rectified and then repaired. | 6-weeks |

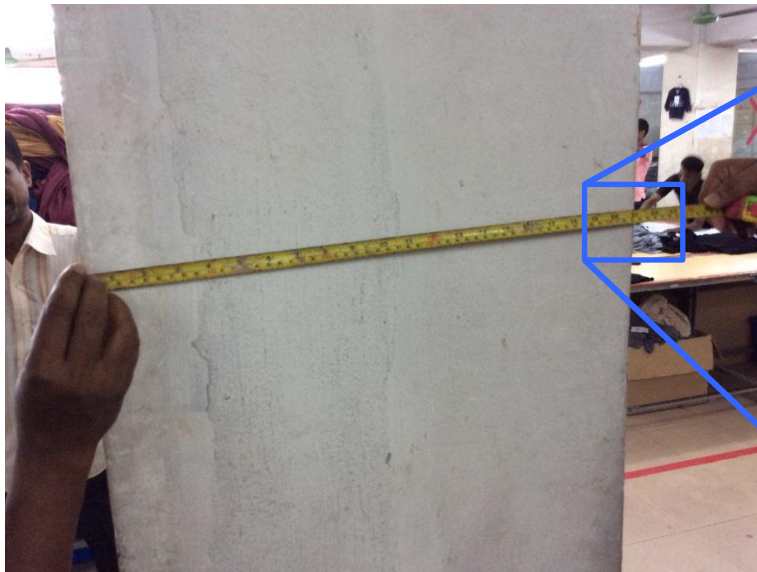
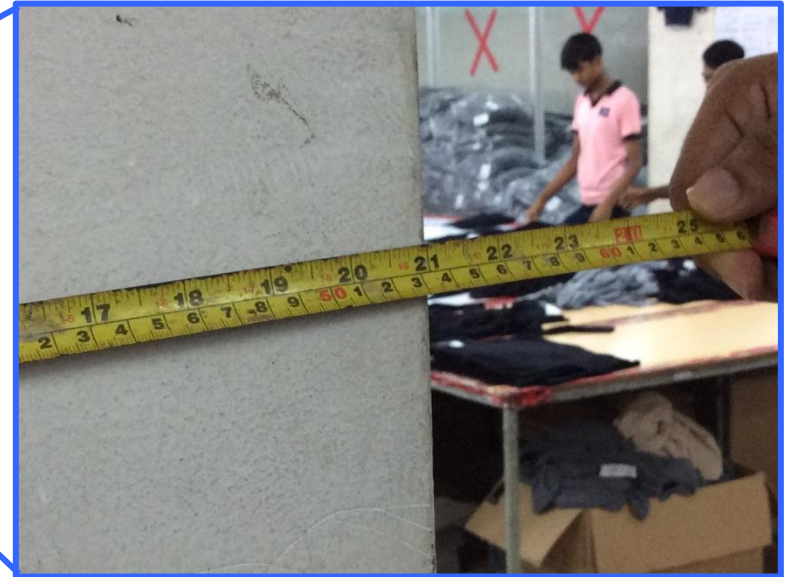
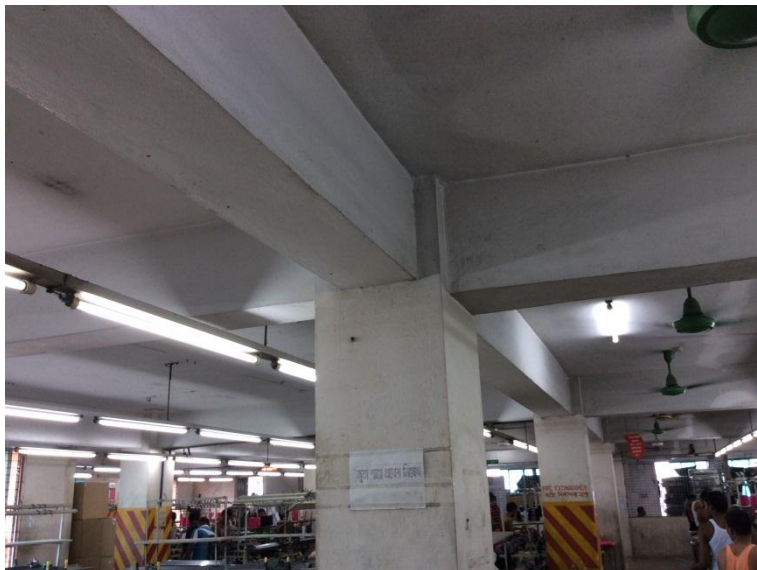
The sizes of columns and beams measured in situ are smaller than those specified in structural drawings.

The actual conditions need to be surveyed and then the structural drawings revised.

| Item No. | Observation | Recommended Action Plan | Recommended Timeline |
|---|---|---|---|
| 11 | Priority 2 - Inadequacies between the drawings and the actual as-built conditions. | Factory Engineer to survey the actual conditions and revise the drawings.<br>Any results of the Detailed Engineering Assessment which affect the structure should be taken on board. | 6-weeks |

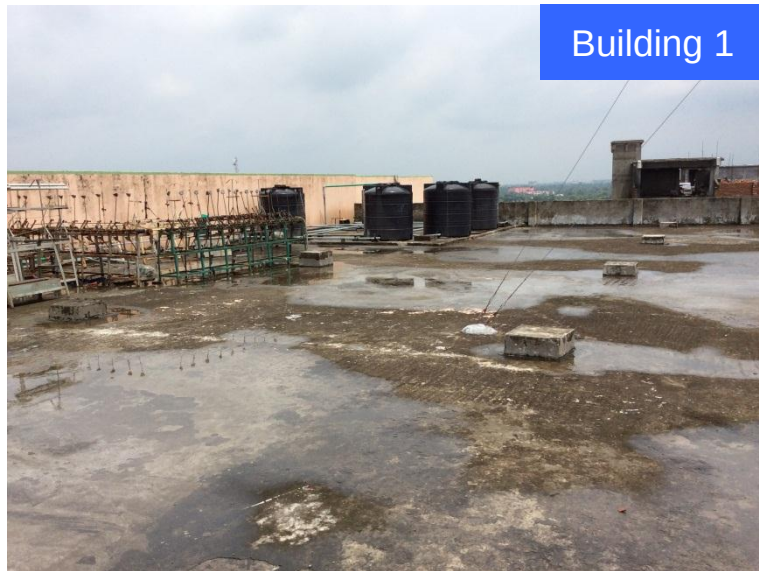
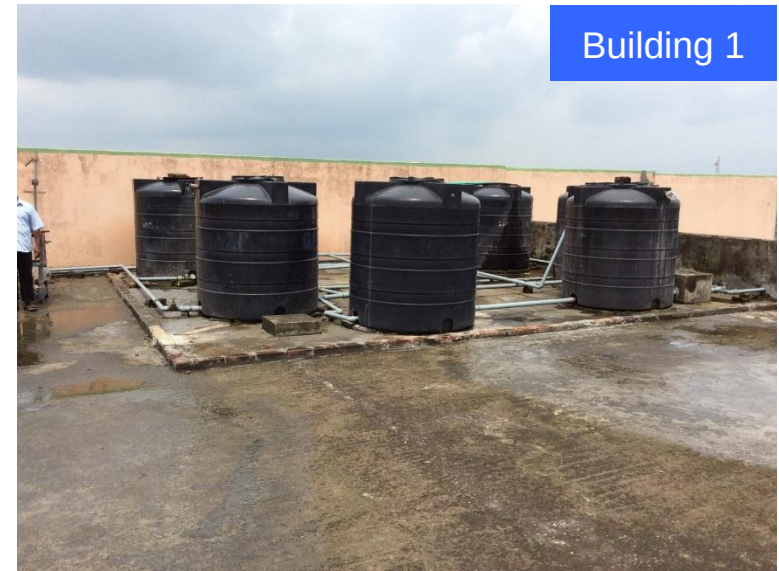
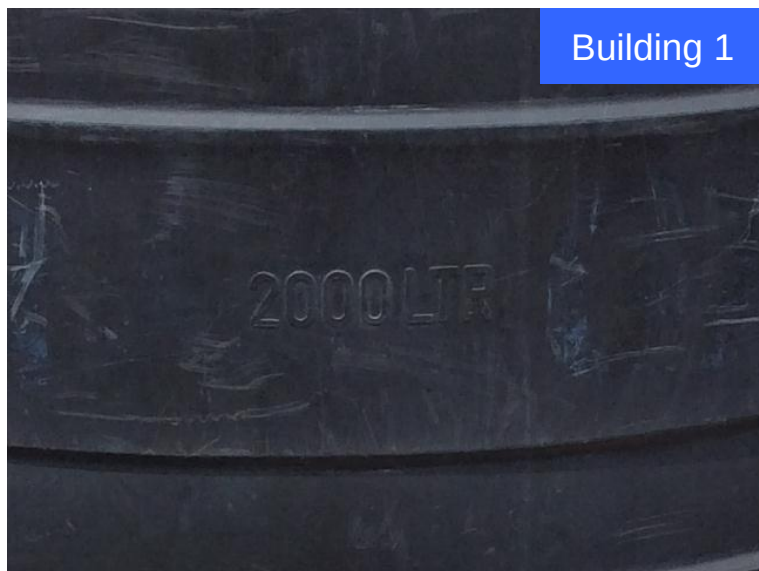
Concerns with the roof slab supporting 2000 Litre water tanks on Building 1. A capacity check of these slabs and all related elements needs to be carried out.

| Item No. | Observation | Recommended Action Plan | Recommended Timeline |
|---|---|---|---|
| 13 | Priority 2 - Capacity check of roof slab supporting water tanks on Building 1. | Factory Engineer to review design, loads and related elements in area identified above to confirm capacity for these items.<br>Or<br>The items in the area identified above should be removed. | 6-weeks |

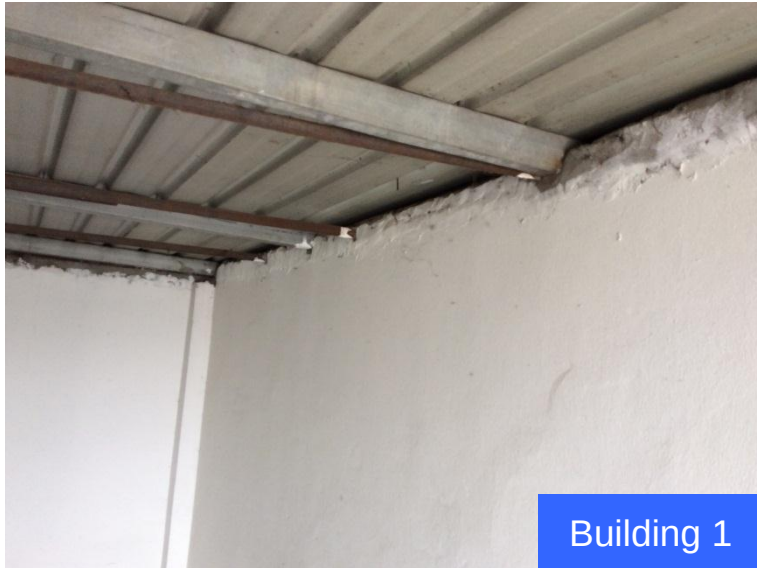
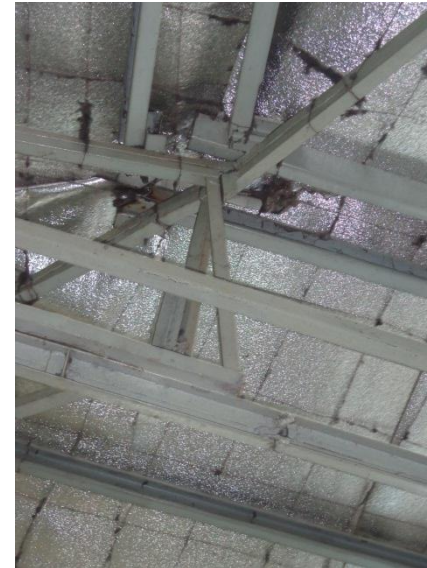
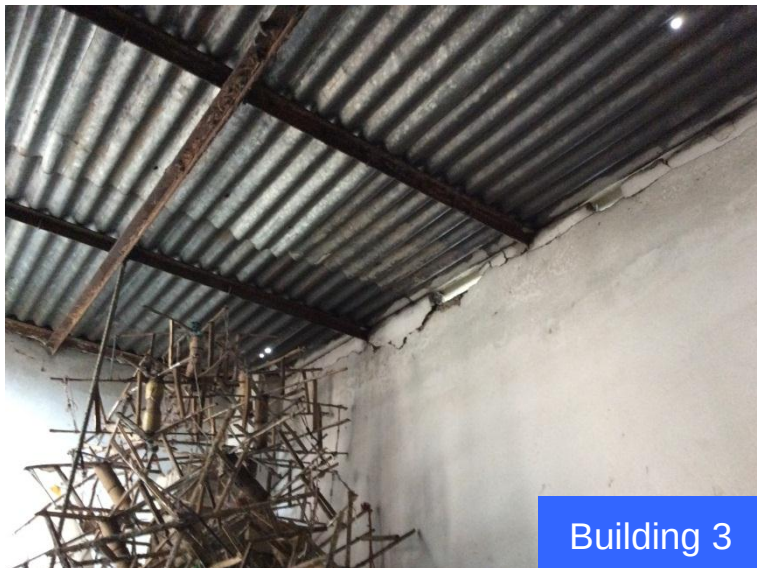
Concerns with the lightweight roof at the top level of these buildings. Stability and capacity must be checked especially with the connections. Stability under wind uplift needs to be checked in particular.

| Item No. | Observation | Recommended Action Plan | Recommended Timeline |
|---|---|---|---|
| 14 | Priority 2 - Stability and capacity of lightweight roofs. | Factory Engineer to review design, loads and related elements in area identified above to confirm capacity and stability for these items. | 6-weeks |

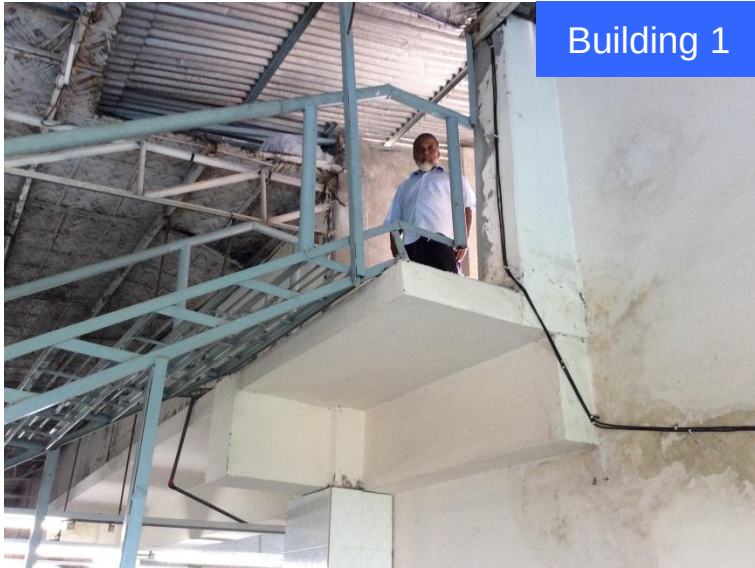
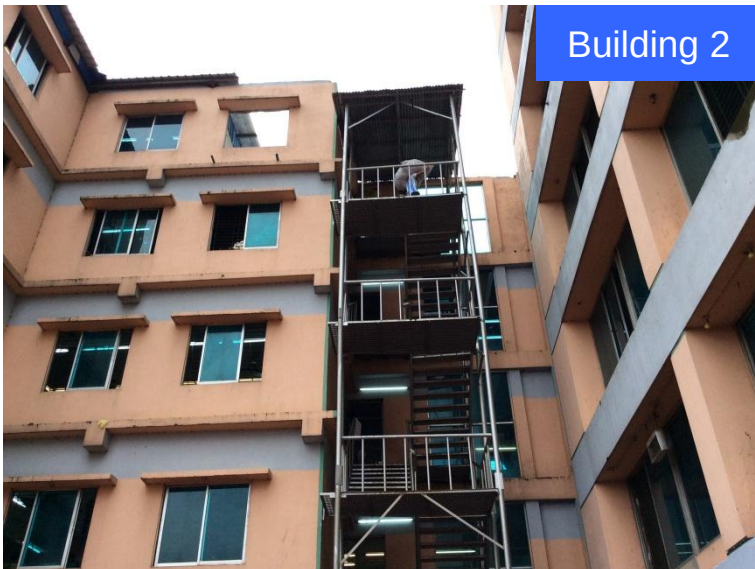
Concerns with stability and capacity of the steel stair on the 7<sup>th</sup> floor of Building 1 and the steel stair in front of Building 2.

These should be investigated and/or strengthened.

| Item No. | Observation | Recommended Action Plan | Recommended Timeline |
|---|---|---|---|
| 15 | Priority 2 - Stability and capacity of steel staircases in Building 1 and Building 2. | Factory Engineer to review design, loads and related elements in area identified above to confirm capacity and stability for these items. These items should be strengthened or replaced with appropriate permanent structural elements. | 6-weeks |

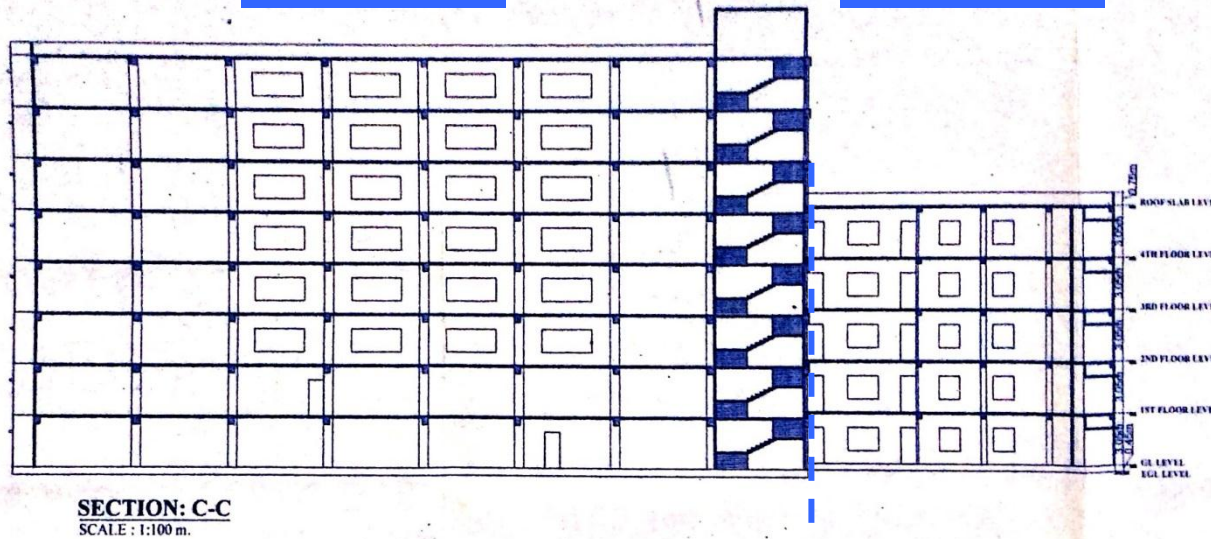
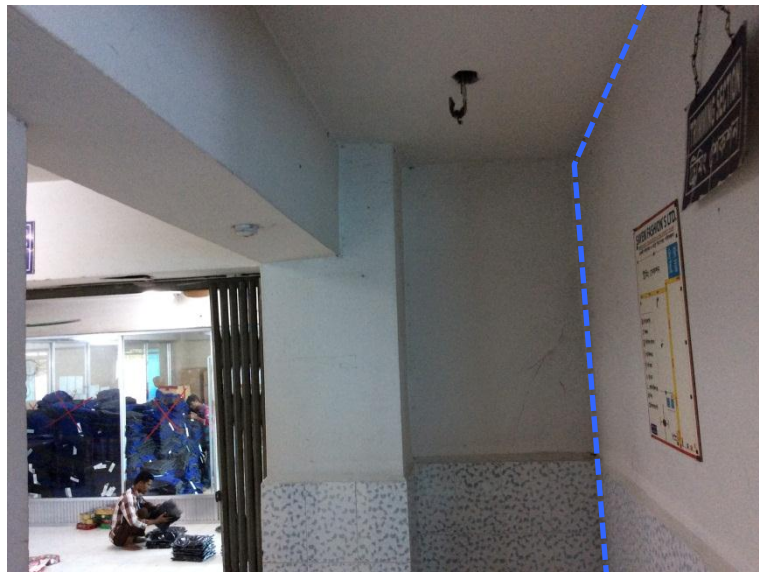
Building 1 and Building 2 were partially connected together. The movement joint should be established properly where shown.

| Item No. | Observation | Recommended Action Plan | Recommended Timeline |
|---|---|---|---|
| 16 | Priority 2 - Movement joint to be properly established between Building 1 and Building 2. | The Factory Engineer should investigate to prove the capacity of the building in its existing state, a further building approval should be gained for the building as it exists, as altered since the original approval. Alternatively, the extension building should be separated by a non-structural joint and allowed to act as a fully structurally independent structure. | 6-weeks |

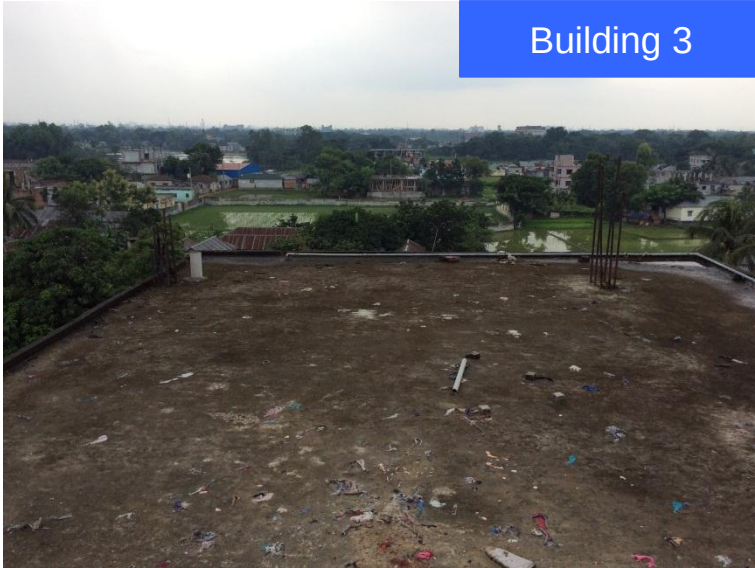
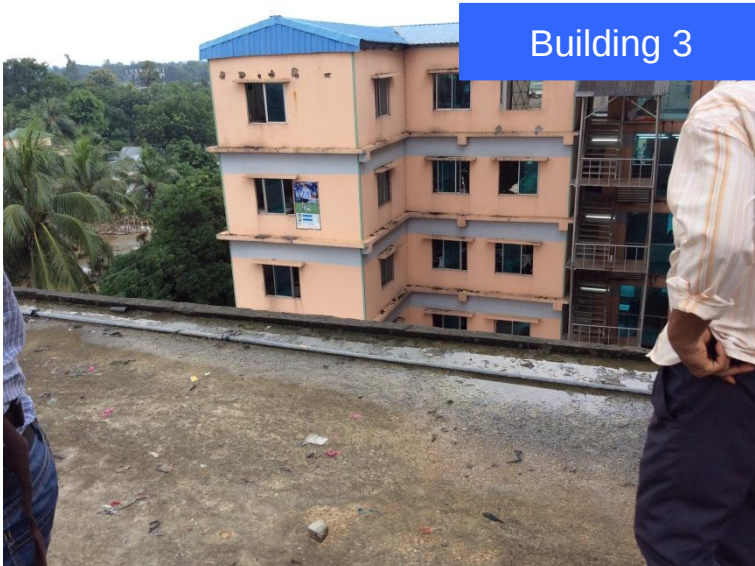
Building 3

There is no parapet wall around the perimeter of top level of Building 3.

Whilst not a structural issue, this is a significant health and safety risk and should be rectified.

| Item No. | Observation | Recommended Action Plan | Recommended Timeline |
|---|---|---|---|
| 20 | Priority 3 - No parapet wall or guardrail present at top level on Building 3. | A suitable perimeter parapet wall or guardrail should be constructed along the building perimeter. | 6-months |

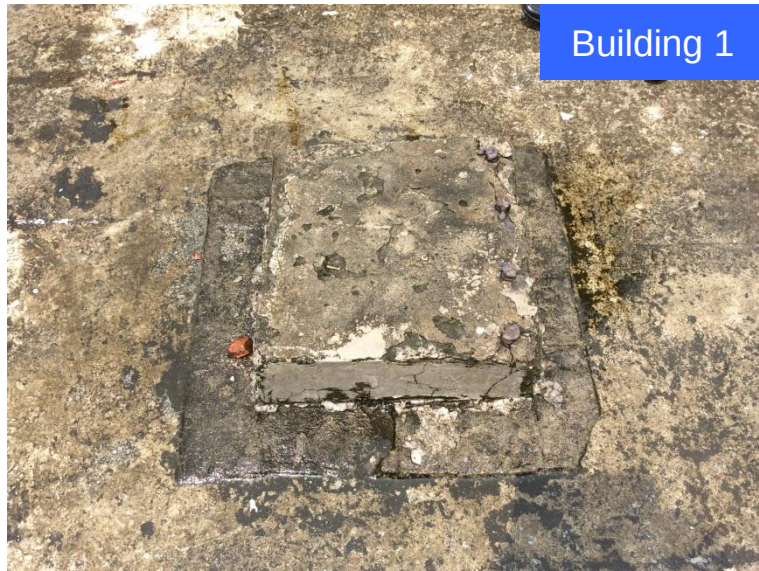
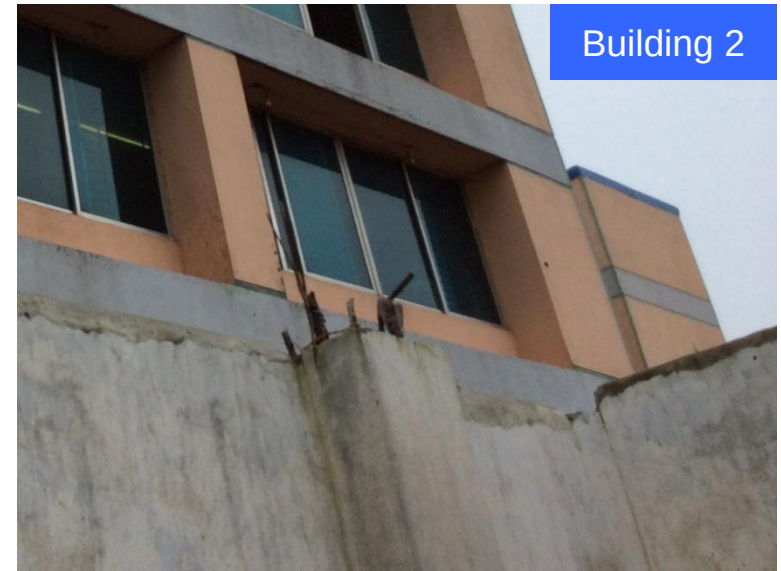
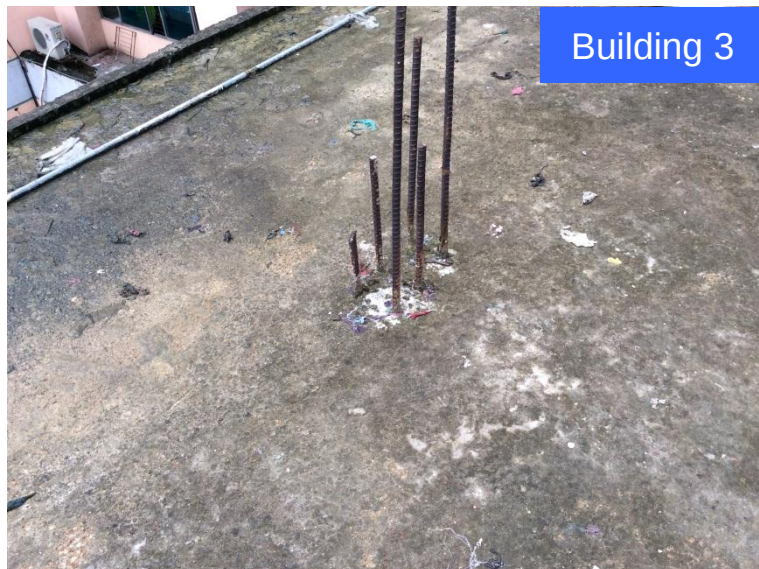
Reinforcement is left exposed at top level of Building 1, Building 2 and Building 3.

| Item No. | Observation | Recommended Action Plan | Recommended Timeline |
|---|---|---|---|
| 21 | Priority 3 - Reinforcement left exposed at top level. | For both durability and serviceability, rust proof paint or any appropriate methods is recommended. | 6-months |

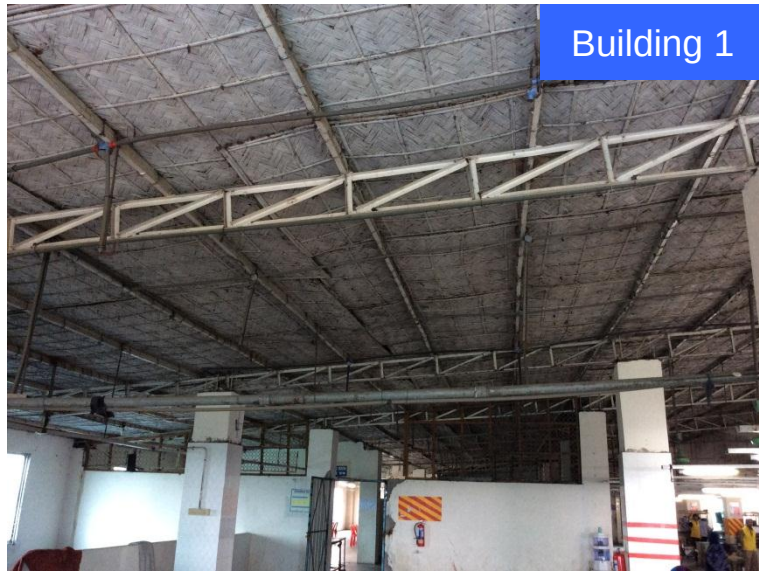
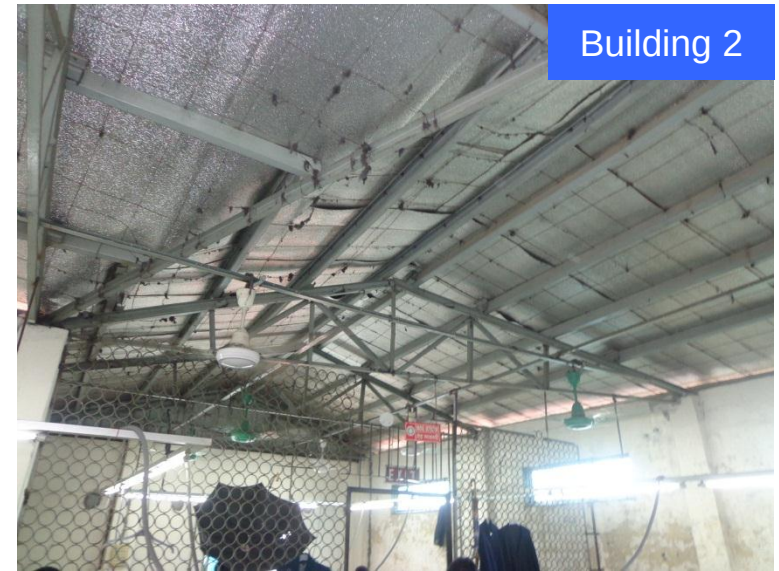
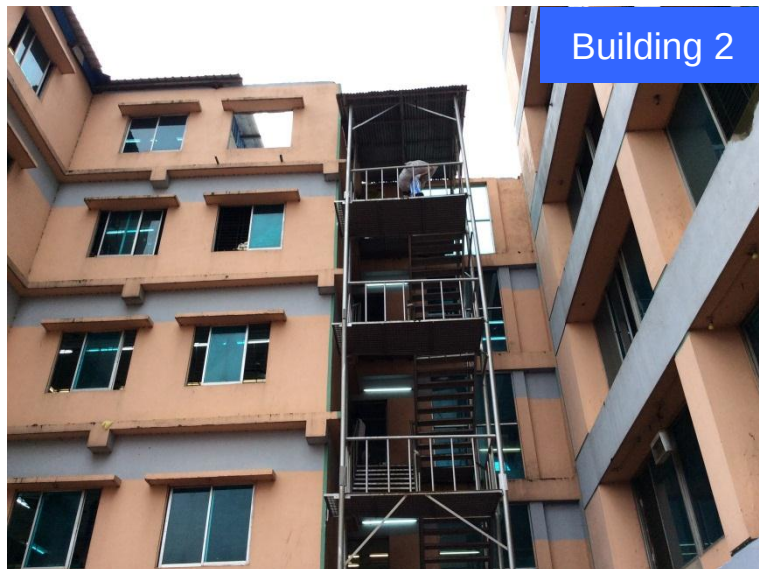
No fireproofing material was noted on any structural steel elements (if required).

| Item No. | Observation | Recommended Action Plan | Recommended Timeline |
|---|---|---|---|
| 22 | Priority 3 - No fireproofing material for structural steel elements (if required). | Fireproofing material for structural steel element is recommended as suggested in BNBC Codes. Maintain standard of quality control and protection of the fire protection. | 6-months |

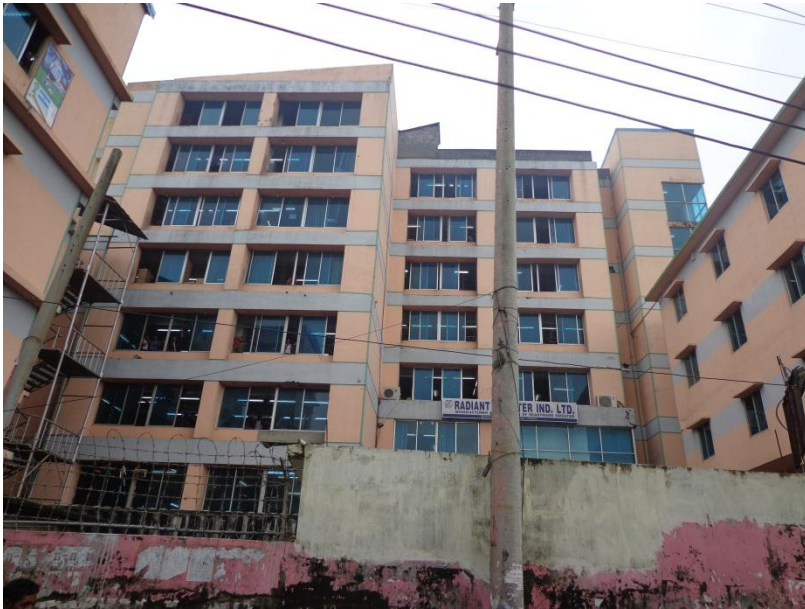
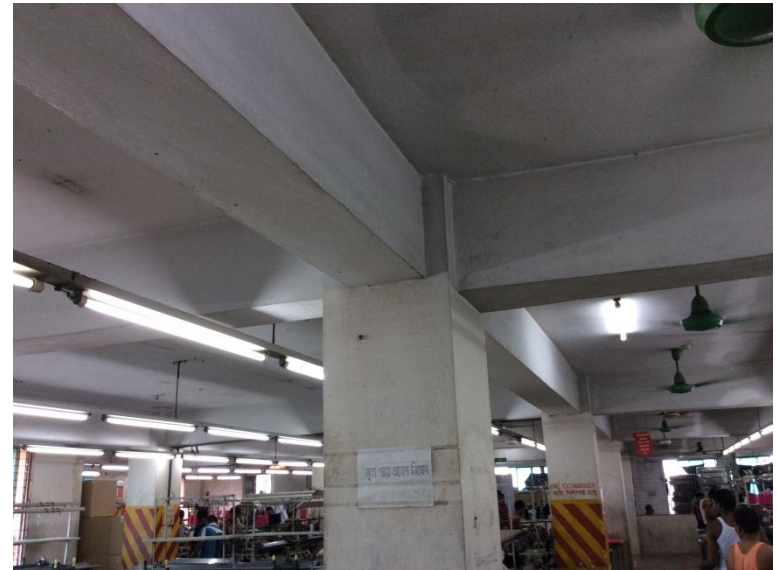
The lateral loading resistance for Building 1, 8-storey building, Building 2 and Building 3; 5-storey buildings are provided by moment frame action without any shear wall and the façade brickwork walls lack moment capacity due to their poor connections with the surrounding columns and beams.

We require that the stability of these buildings is investigated as part of a Detailed Engineering Assessment.

| Item No. | Observation | Recommended Action Plan | Recommended Timeline |
|---|---|---|---|
| 18 | Priority 2 - Overall stability systems. | A Detailed Engineering Assessment of the overall building to be carried out and in particular, stability and foundation aspects should be investigated in detail. | 6-weeks |

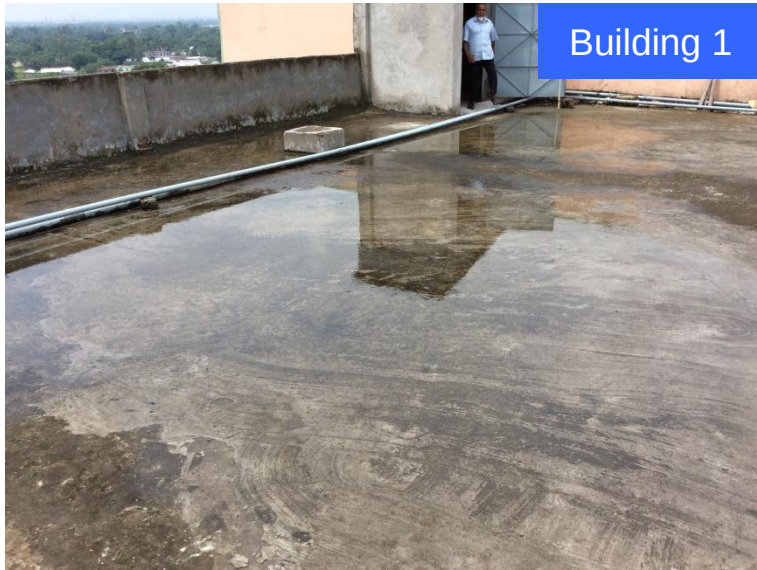
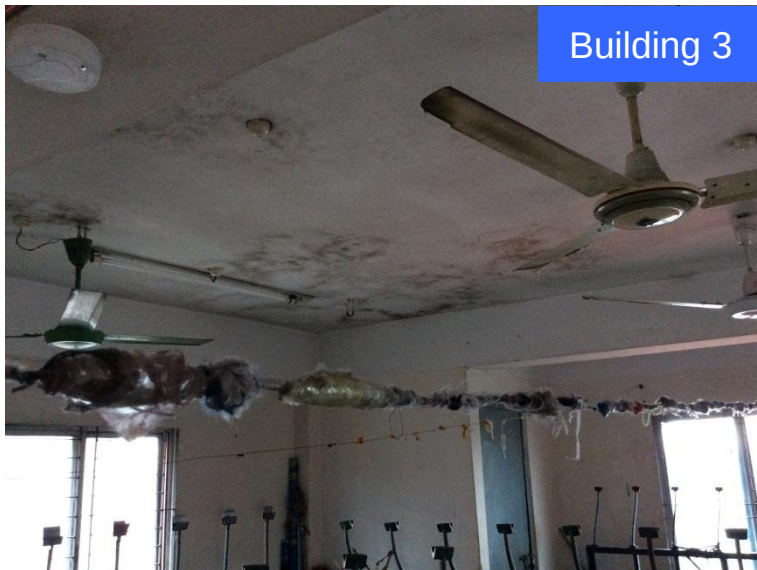
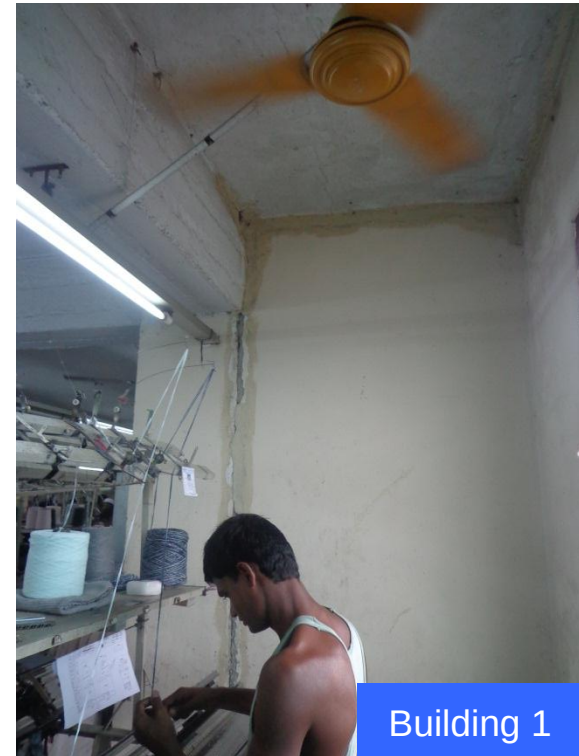
Water distress was noted on slabs, beams, columns and walls of these buildings. Water ponding was also found on the top level.

| Item No. | Observation | Recommended Action Plan | Recommended Timeline |
|---|---|---|---|
| 19 | Priority 3 - Distress due to water ingress. | Waterproofing on the roof slab is to be applied. Moreover the roof slab drainage system should be investigated and improved. | 6-months |
