# Parkview Dresses Ltd. (9902)

30/2, Darail Sataish, Gazipura, Gazipur .

19.AUGUST.2014

# Identified Priority 3 Concerns

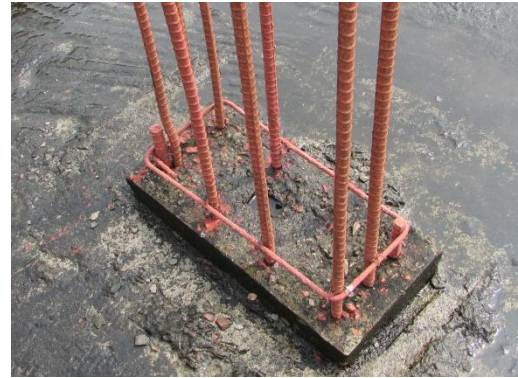
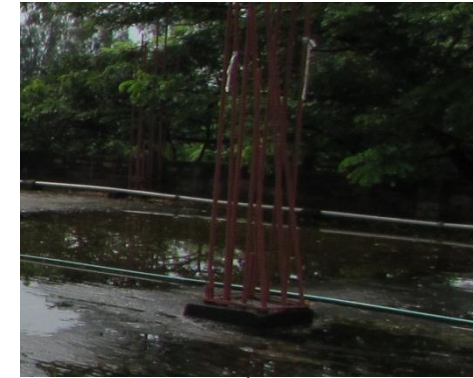
**COLUMNS SCHEDULE**

Column sizes and number of bars shown on the drawing available did not match with what was seen on site.

The As-built drawings need to be revised to more accurately represent the actual existing construction.

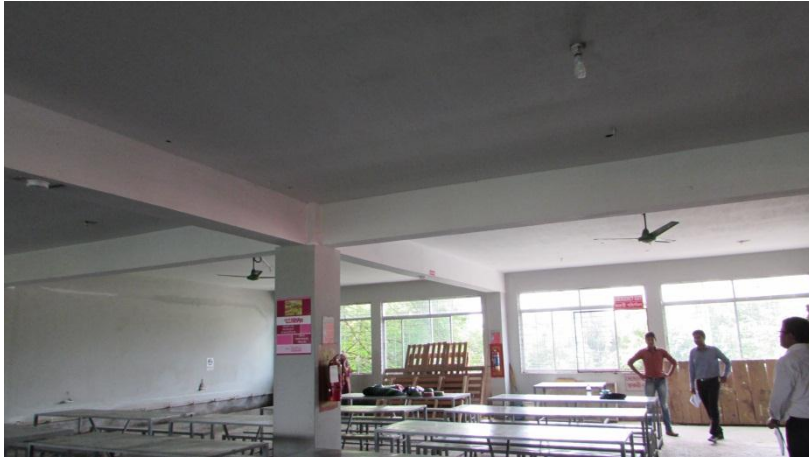
Main building

There is no structural drawing showing the typical framing layout.

The As-built drawings need to be updated and supplemented where necessary to more accurately reflect the actual existing construction.

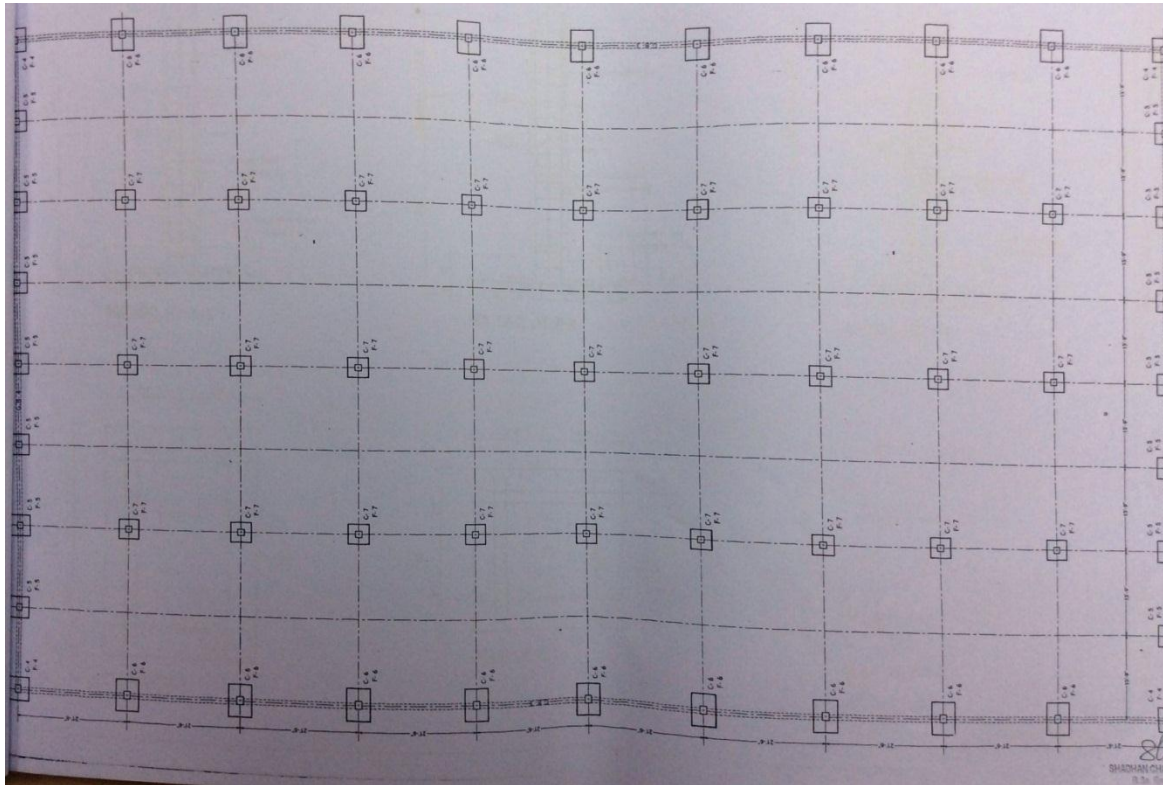
The foundations on the structural drawing are very small and appear inadequate.

The factory's Structural Engineer needs to investigate this in more detail and should determine exactly the dimension of the foundations and therefore their adequacy as soon as possible.

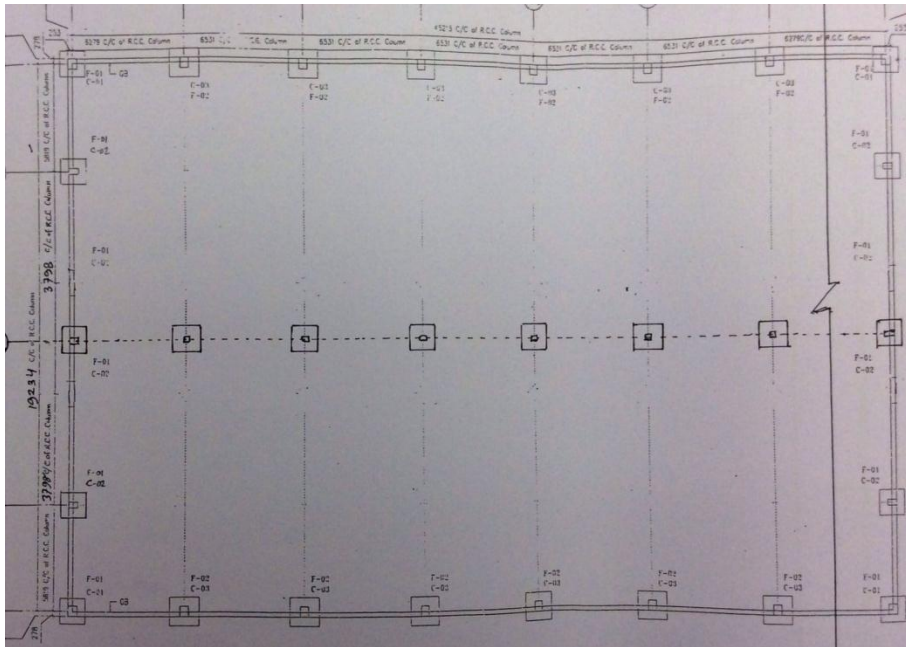
Foundation and Column Layout Plan

The number of columns shown on the drawing does not match what is on site.

The As-built drawings need to be updated and supplemented where necessary to more accurately reflect the actual existing construction.

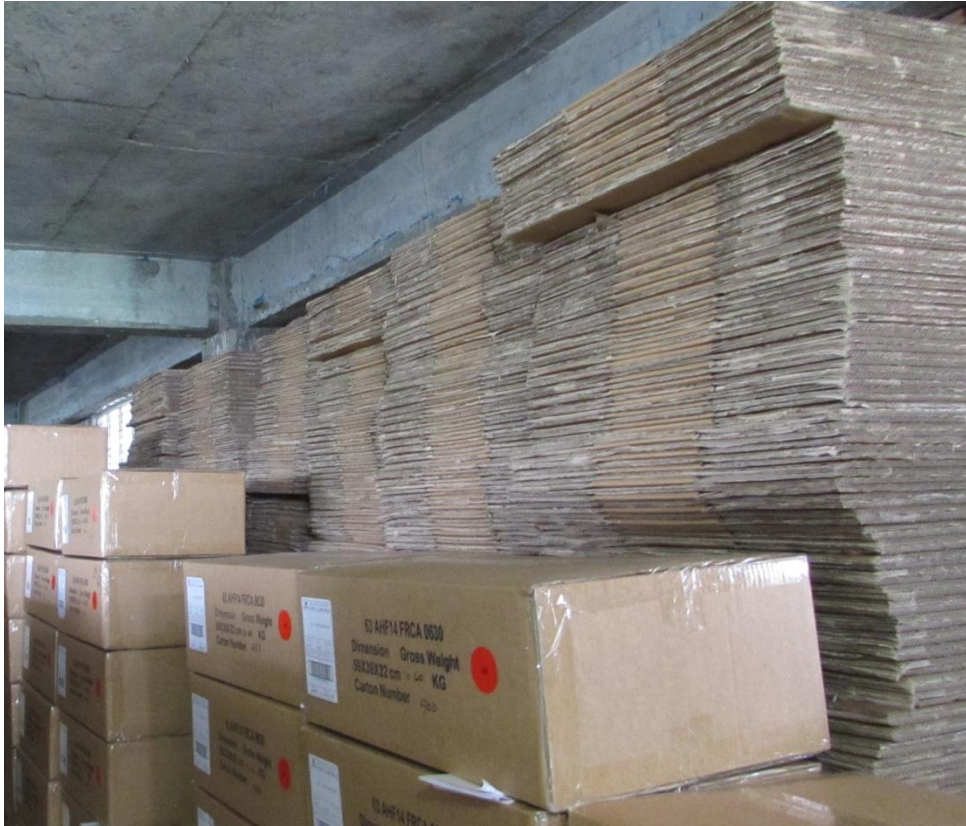
The weight of stored cardboard boxes on level 1 is higher than the designed load. The designed live load should be around 3.0 kPa. Each stack is estimated to impose a load of around 3.33 kPa.

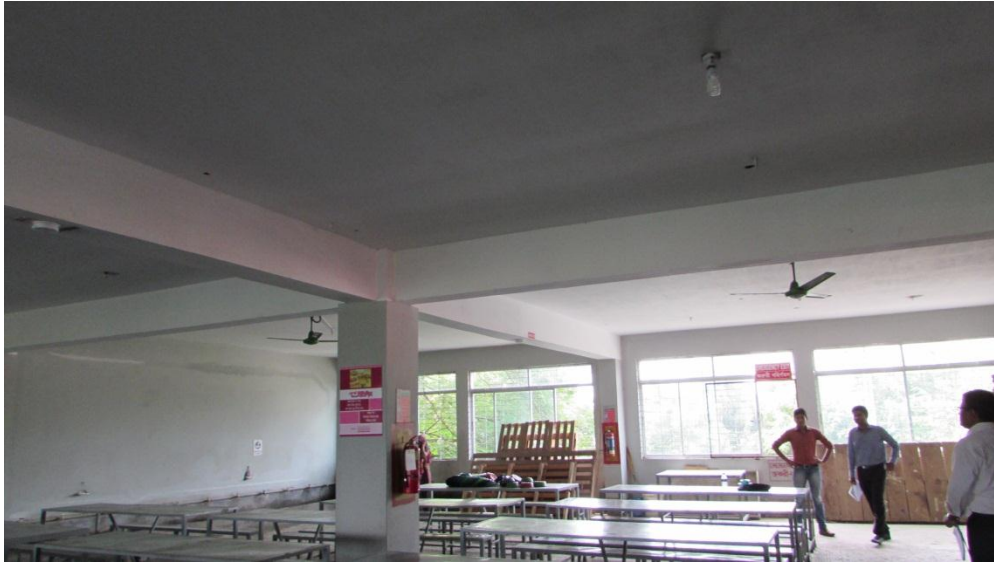
Main building

R.C Beam and column frame with a 2-way solid slab  
Stability provided by moment frame system only.

Slab Thickness 160mm  
Column Size 500x500mm (typ.)  
Beam Size 330x590mm(typ.)

Grid 6.55m x 7.47m.

This type of structural framing is appropriate for a building lower than 10 storeys high with a large plan area. It is therefore recommended that an Engineer reviews and checks the overall lateral stability of the building.

We require that this item is investigated in an Engineering Assessment

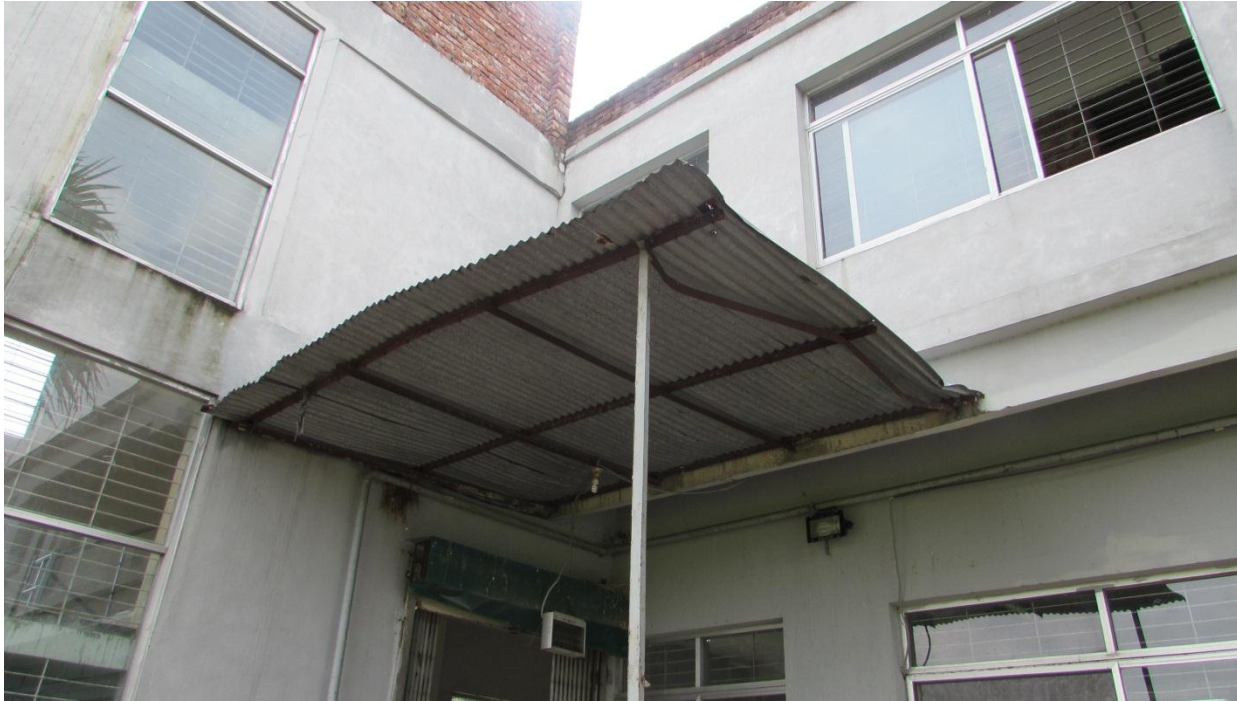
A canopy in the corner of the Main building is poorly built and members appear to have already failed.

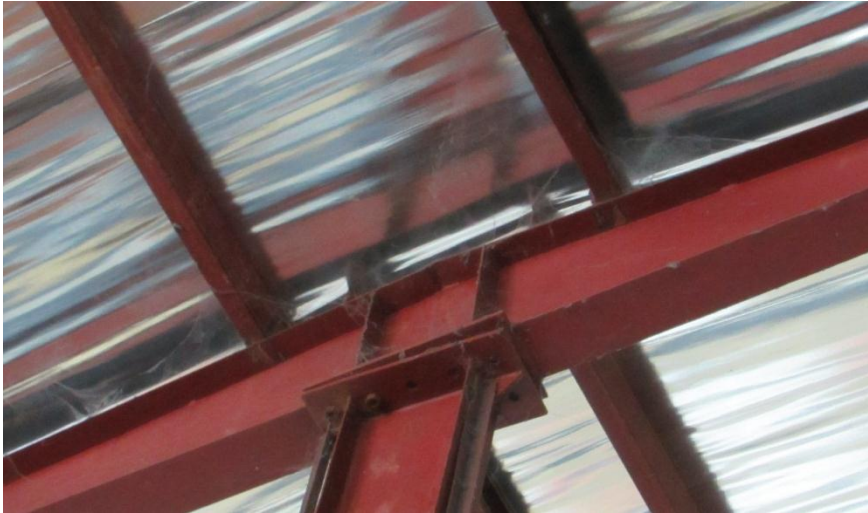
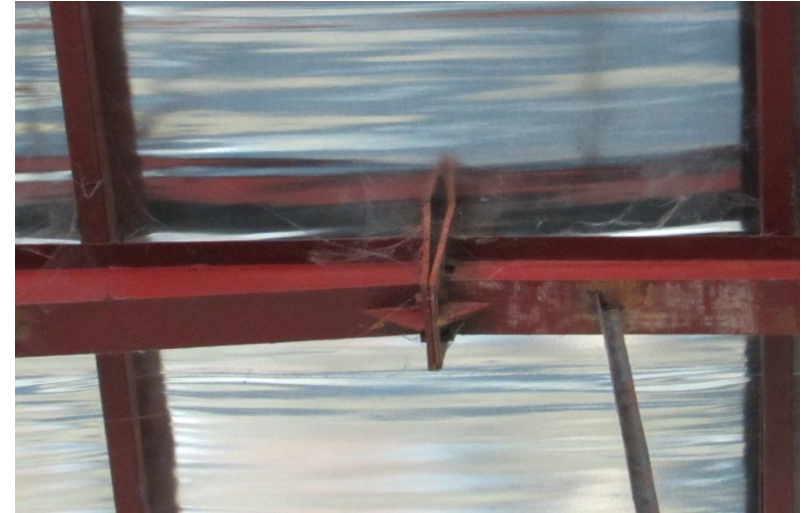
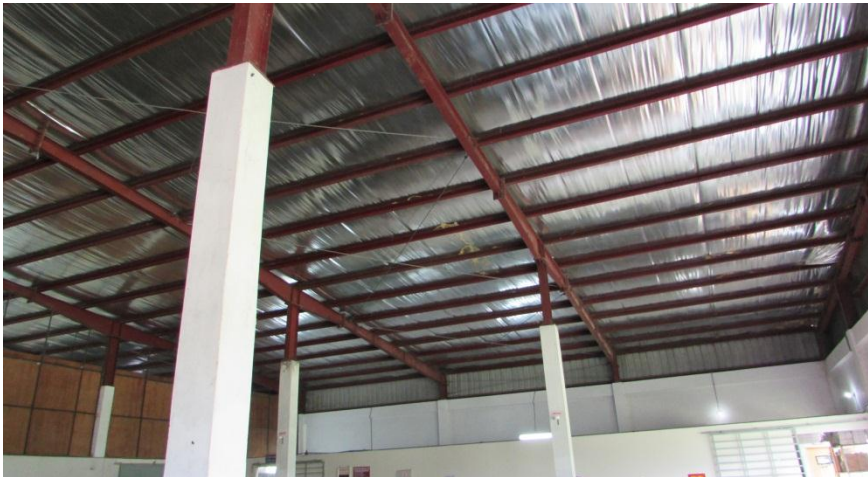
Shed building

Some steel connections appear incomplete.

The purlins should be provided with restraining tie rods.

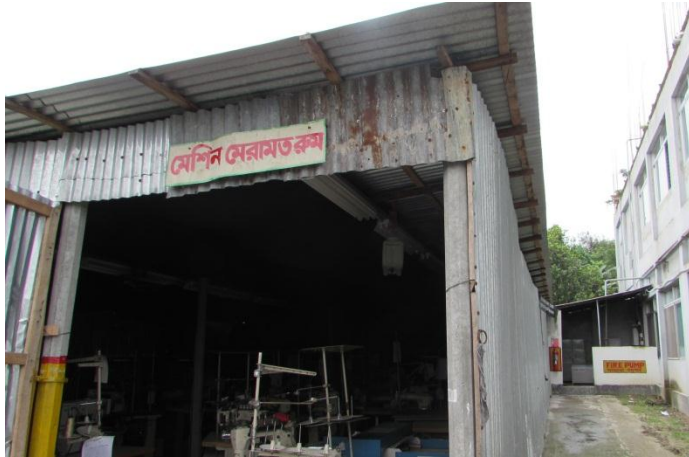
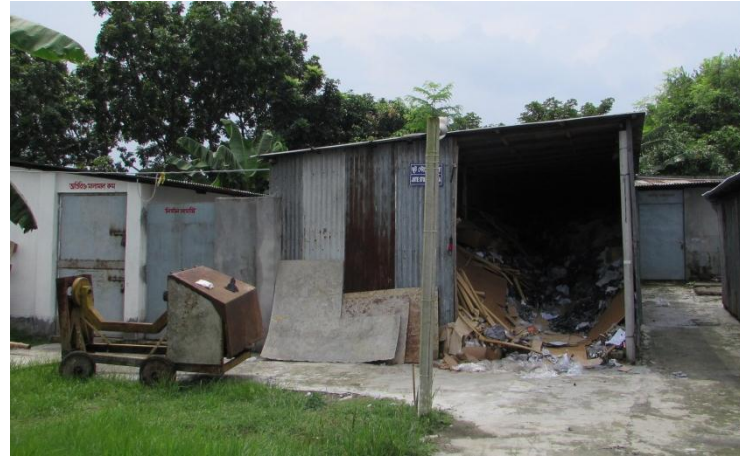
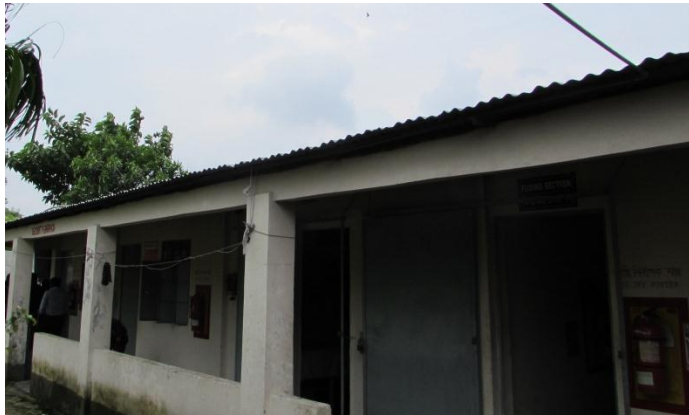
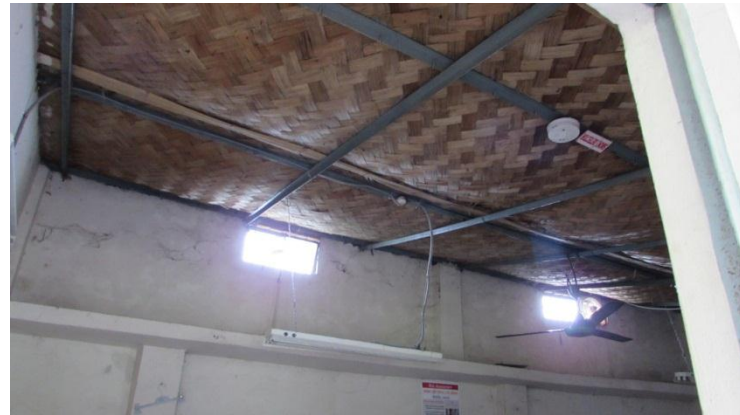
Temporary steel sheds used for storage, Generator, Kitchen and Dining are made of various materials and don't appear to be adequately designed or detailed.
