# Sabarang Fashions Ltd. (9709)

Plot – 85, 86, Block – K, Rupnagar I/A., Section 2, Mirpur, Dhaka-1216

18.AUGUST.2014

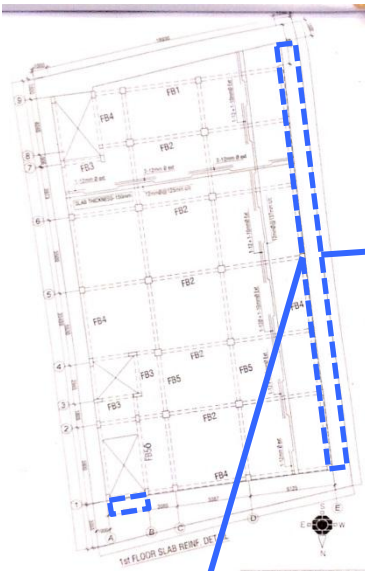
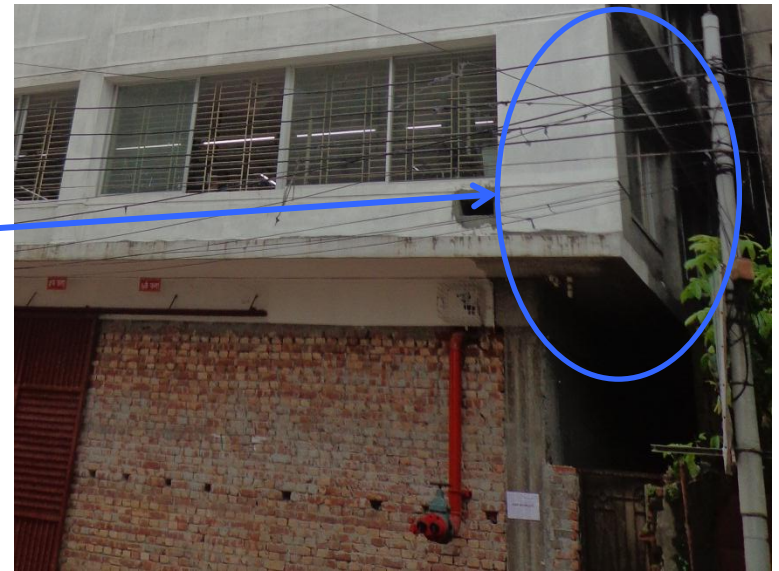
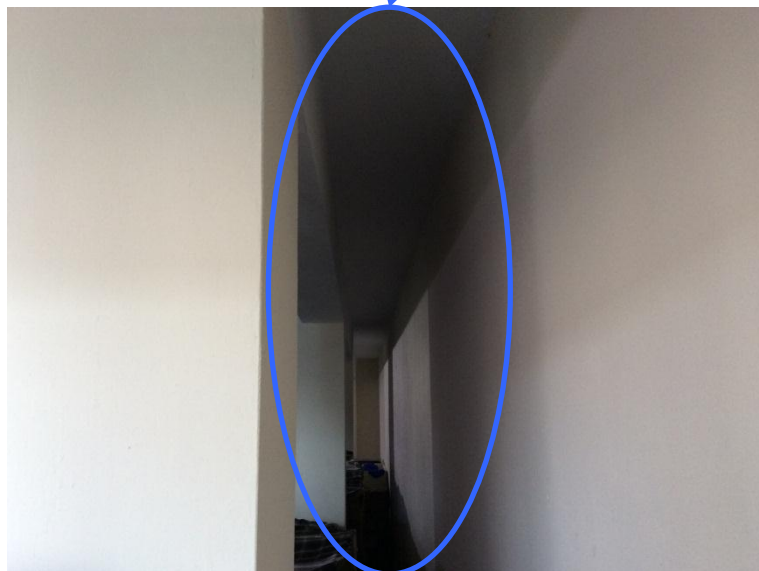
There are cantilevered slabs noted in area shown on the pictures. These do not match the structural drawings.

Floor plans and slab details need to be revised.

| Item No. | Observation | Recommended Action Plan | Recommended Timeline |
|---|---|---|---|
| 1 | Priority 2 - Inadequacies between the drawings and the actual as-built conditions. | Factory Engineer to survey the actual conditions and revise the drawings.<br>Any results of the Engineering Assessment which affect the structure should be taken on board. | 6-weeks |

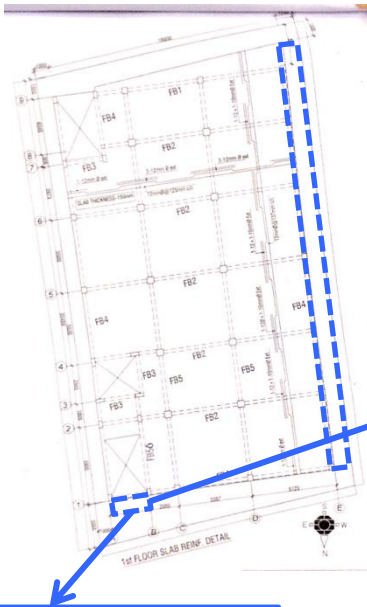
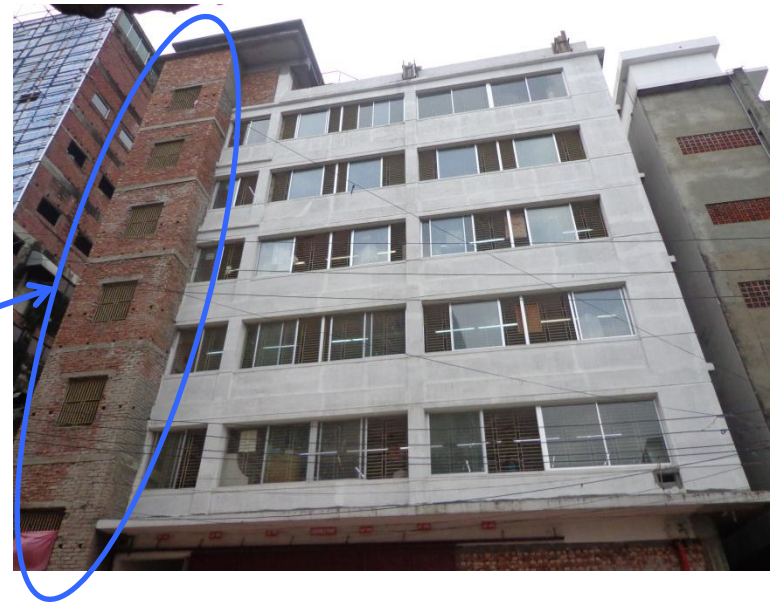
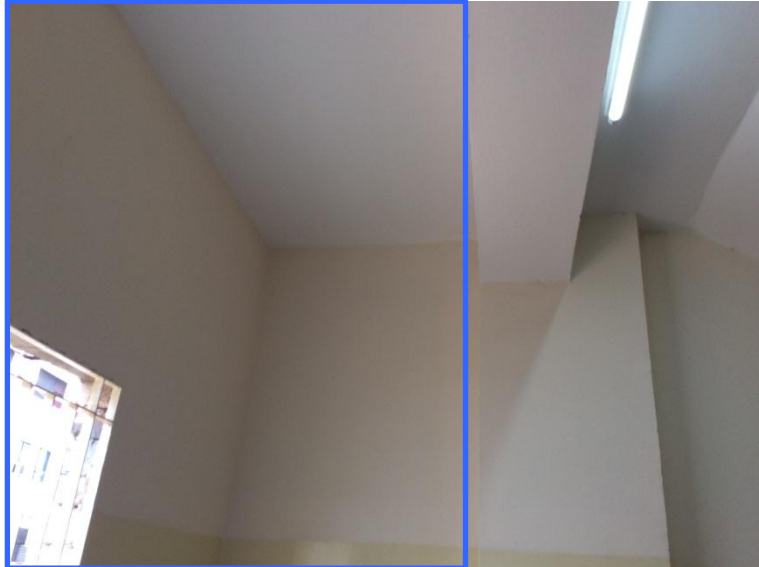
There are cantilevered slabs noted in area shown on the pictures. These do not match the structural drawings.

Floor plans and slab details need to be revised.

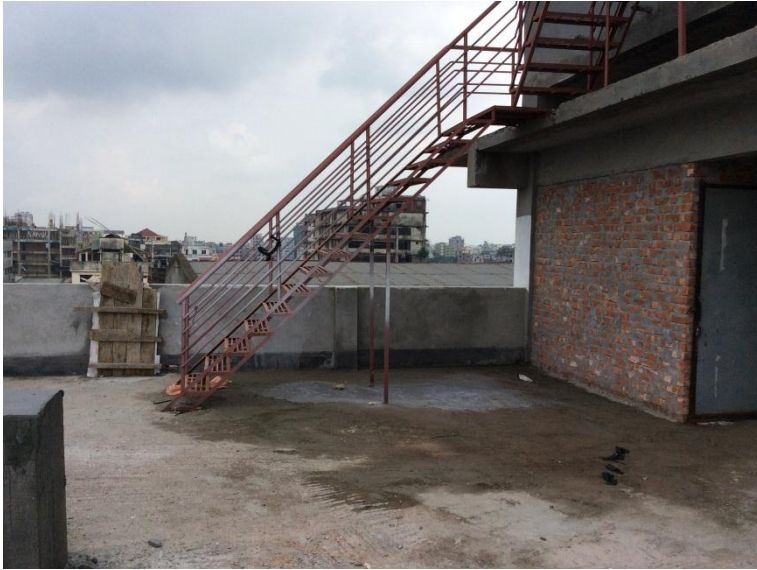
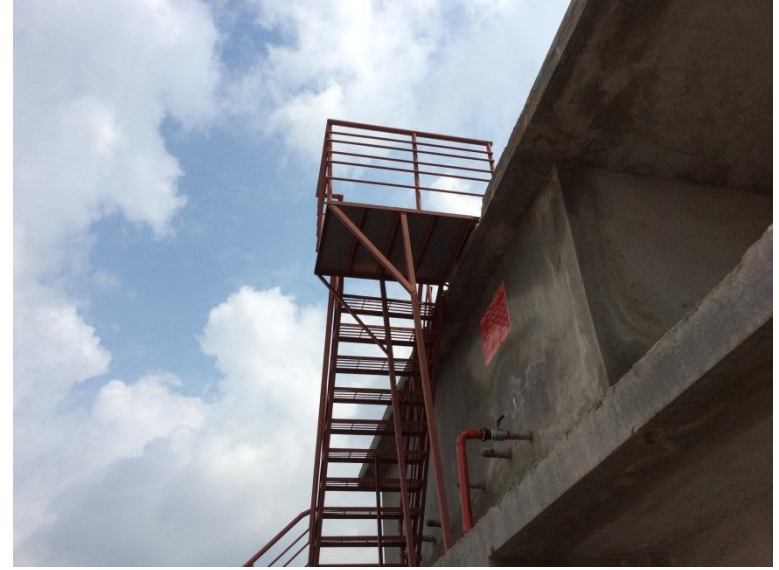
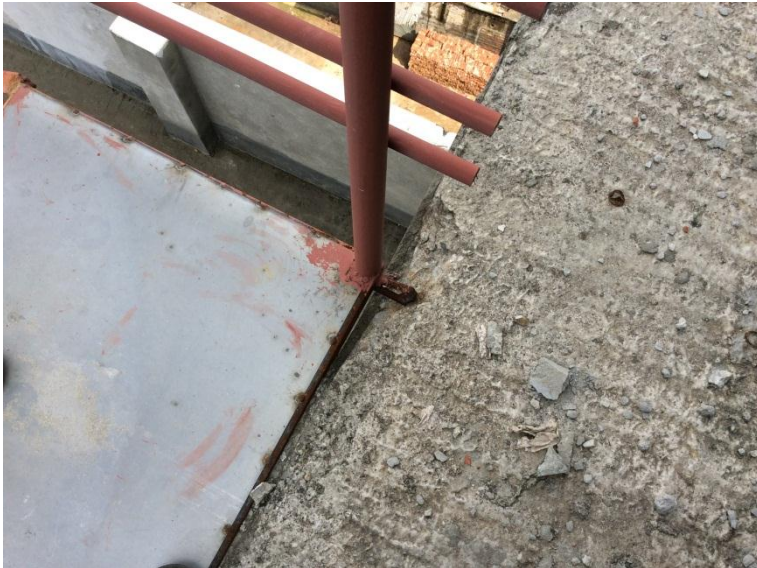
Concerns on stability and capacity of the steel stair at top level. This should be investigated and strengthened or replaced.

| Item No. | Observation | Recommended Action Plan | Recommended Timeline |
|---|---|---|---|
| 3 | Priority 2 - Stability and capacity of steel staircase at top level. | Factory Engineer to review design, loads and related elements in area identified above to confirm capacity and stability for these items.<br>These items should be strengthened or replaced with appropriate permanent structural elements. | 6-weeks |

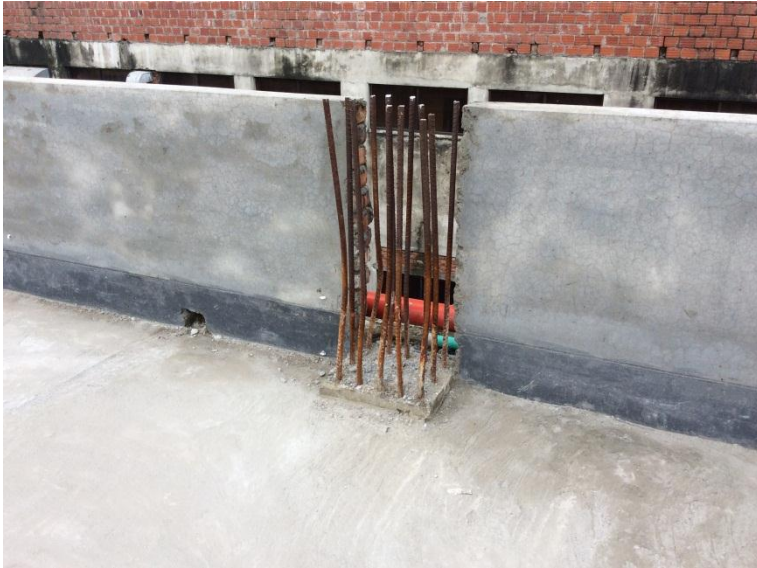
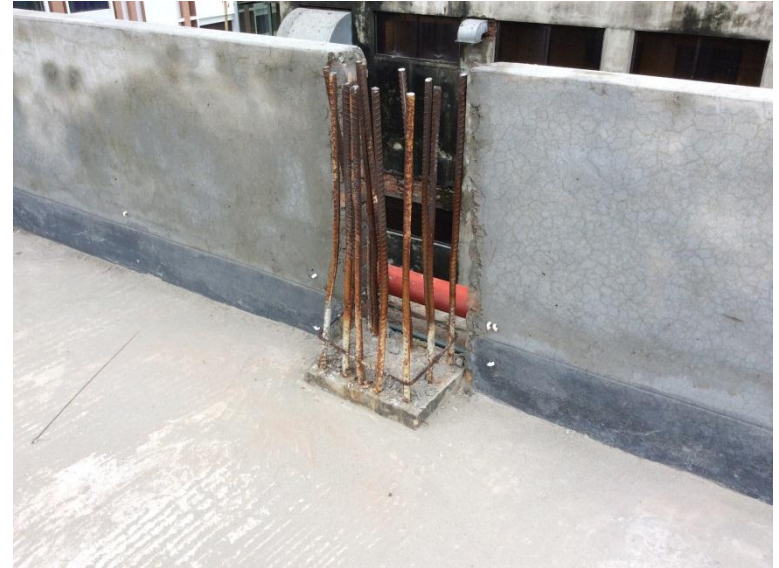
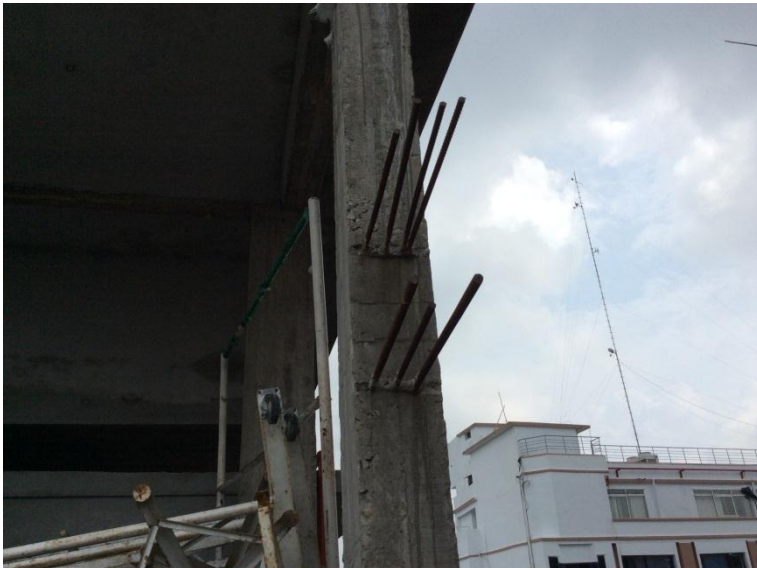
Reinforcement is left exposed at top level of building.

| Item No. | Observation | Recommended Action Plan | Recommended Timeline |
|---|---|---|---|
| 6 | Priority 3 - Reinforcement left exposed at top level. | For both durability and serviceability, rust proof paint or any appropriate methods is recommended. | 6-months |

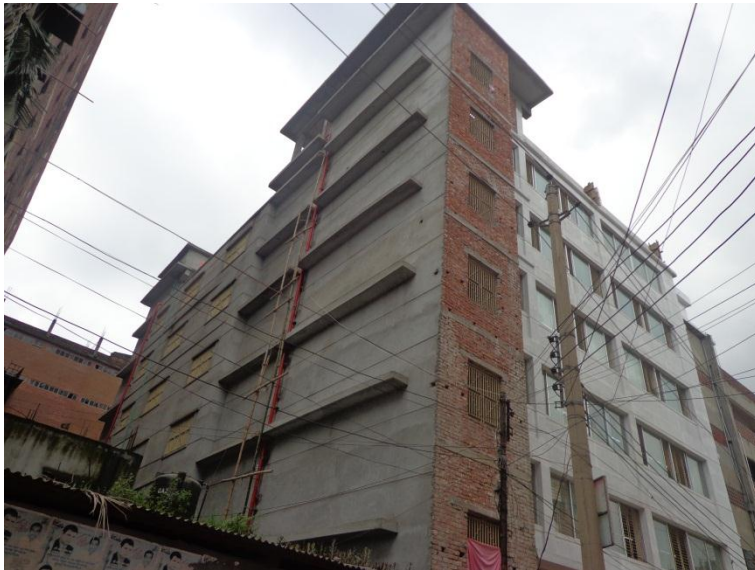
The lateral loading resistance for this 6-storey building is provided by moment frame action without any shear walls and the façade brickwork walls lack moment capacity due to their poor connections with the surrounding columns and beams.

We require that the stability of this building is investigated as part of an Engineering Assessment.

| Item No. | Observation | Recommended Action Plan | Recommended Timeline |
|---|---|---|---|
| 4 | Priority 2 - Overall stability system. | An Engineering Assessment of the overall building to be carried out and in particular, stability and foundation aspects should be investigated in detail. | 6-weeks |

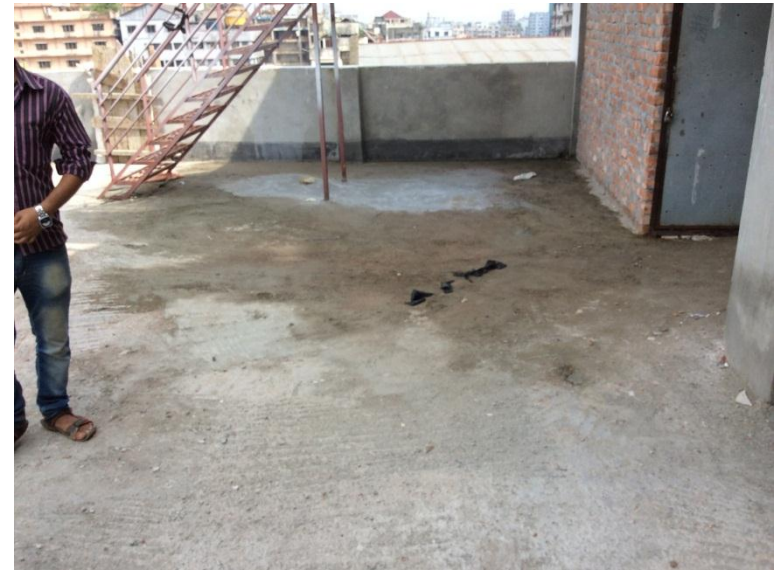
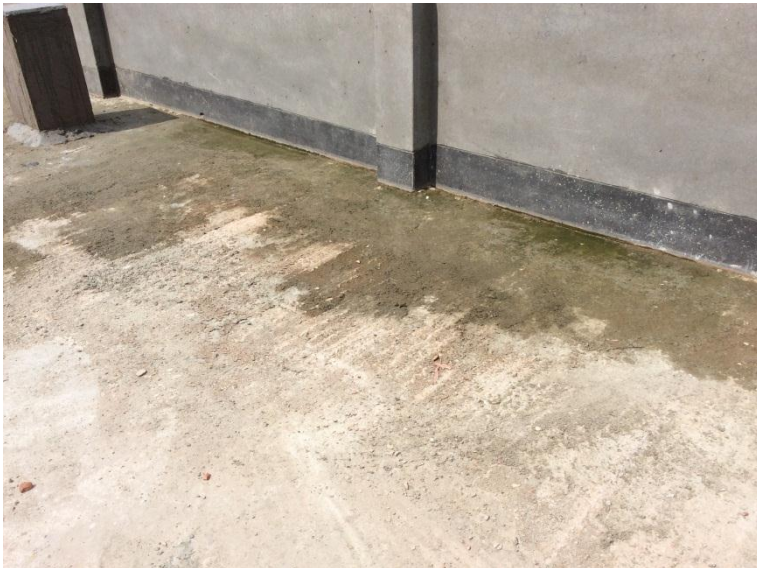
There was no water distress noted on any slabs, beams and columns during our inspection. However, water ponding was found on the top level of the building.

| Item No. | Observation | Recommended Action Plan | Recommended Timeline |
|---|---|---|---|
| 5 | Priority 3 - No waterproofing materials. | Waterproofing on the roof slab is to be applied. Moreover the roof slab drainage system should be investigated and improved. | 6-months |
