# Century Apparels Ltd. (11059)

18.AUGUST.2014

# Identified Priority 3 Concerns

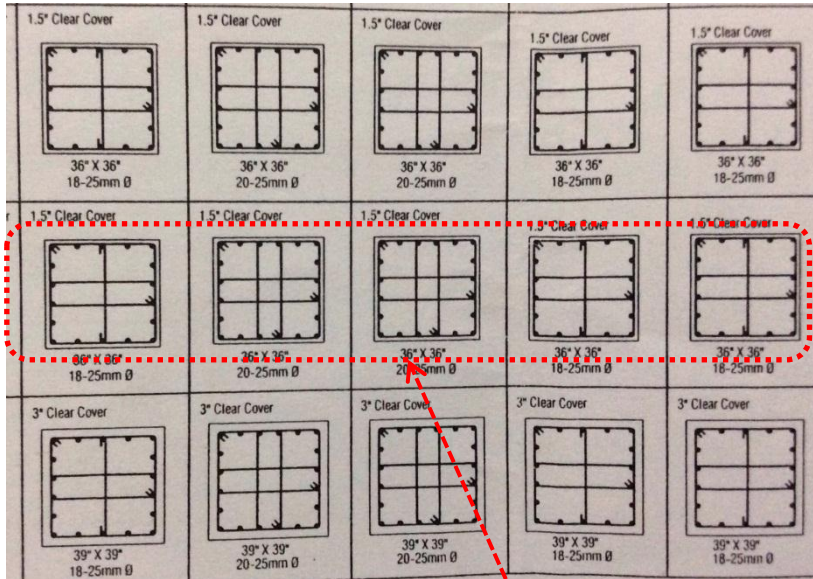
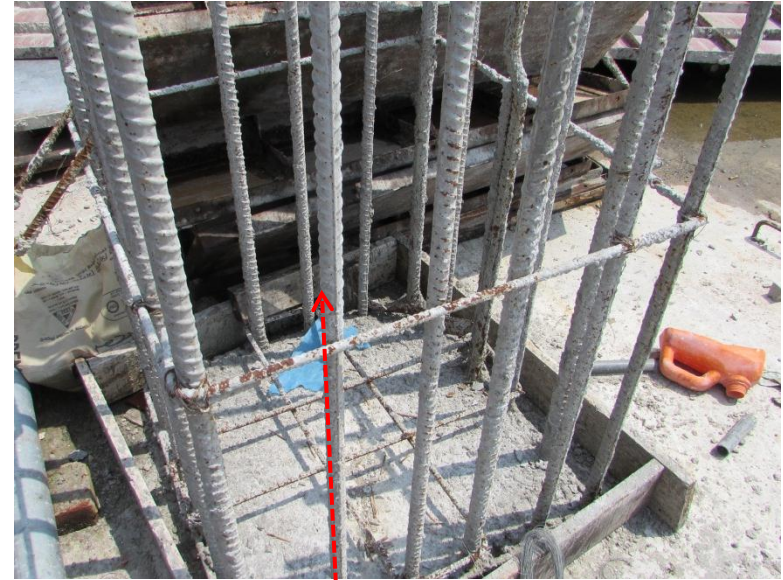
## 1<sup>st</sup> Priority 3 Concern

The designed or drawn column sizes C9 to C15 do not match the column sizes as-built.

There are inconsistencies with the number of bars between the as-built columns and designed or drawn ones at 5<sup>th</sup> floor level.

The As-built drawings need to be produced as per existing construction.

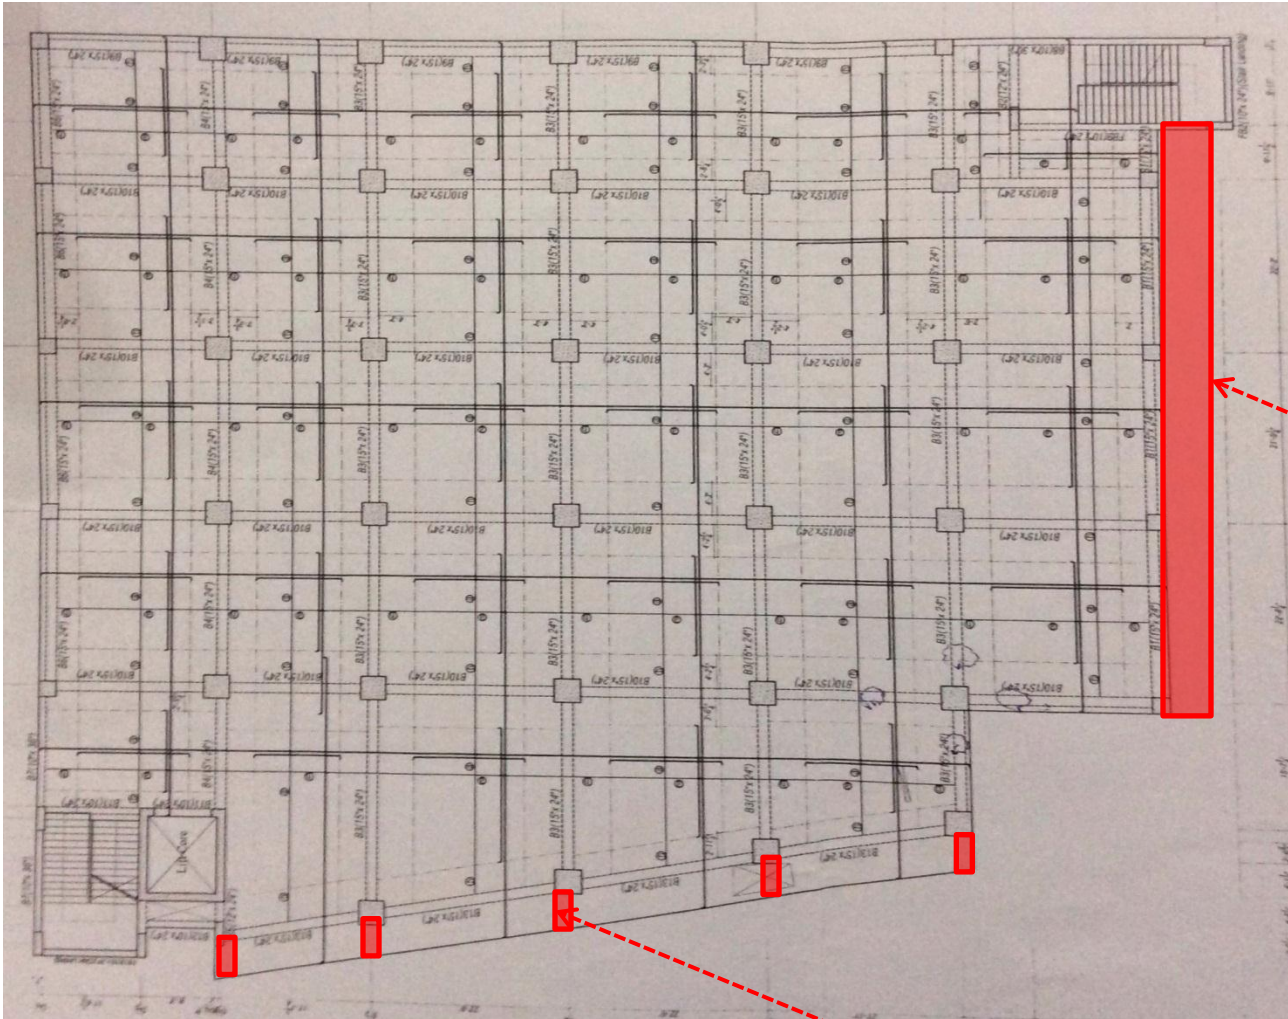
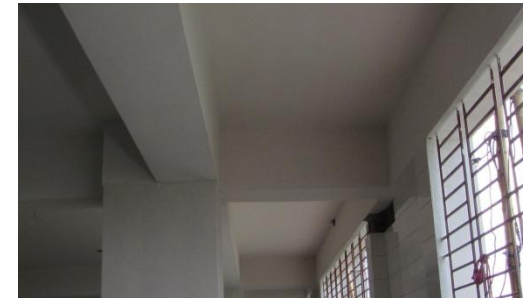
## 2<sup>nd</sup> Priority 3 Concern

Extra cantilevered beams and slabs were not shown on the construction drawings

The As-built drawings need to be revised to represent the actual existing construction.

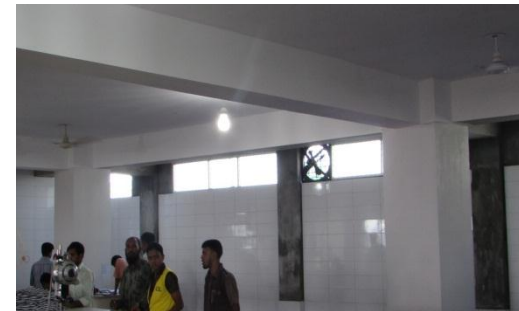
Typical Floor plan

these cantilevered beams were not shown on the construction drawings.

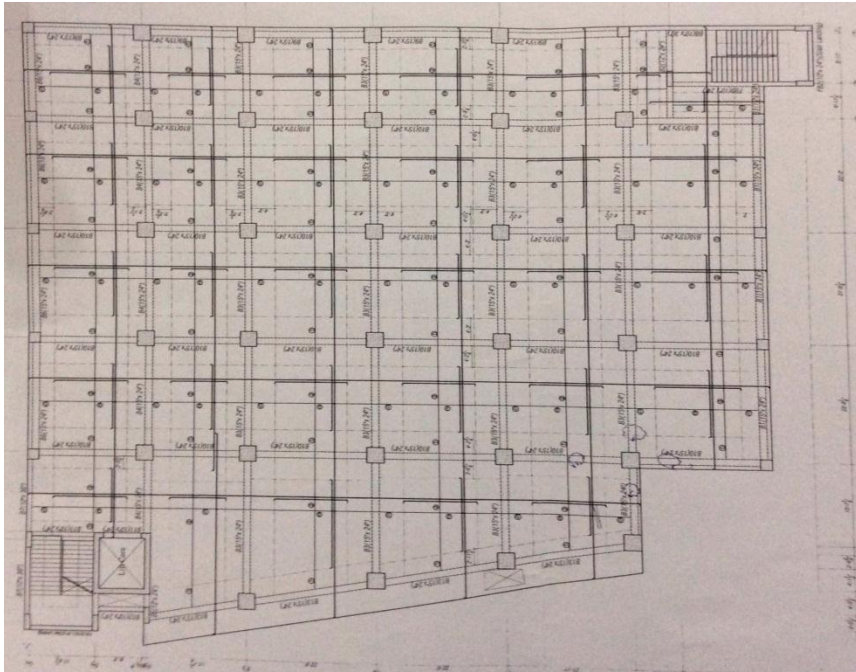
# Overall Stability System

R.C Beam and column frame with a 2-way solid slab.

A set of core walls of 300mm thickness is located on one corner of the building. Because it is some distance from the centre of the building, the walls will not work effectively under lateral loading. For this reason, the lateral load resisting capacity for this building still relies mainly on the moment frame system.

This type of structural framing is appropriate for a building lower than 10 storeys high and with the large plan area. However, in this case is recommended that an Engineer reviews and checks the building stability under wind and seismic loads.
