# FIRE SAFETY INSPECTION REPORT

**GOLDSTAR FASHIONS LTD.**

**ACCORD ID: 22982**

**Date:** 27 November, 2017

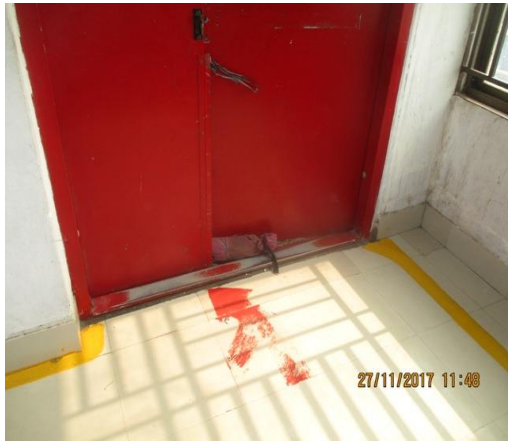
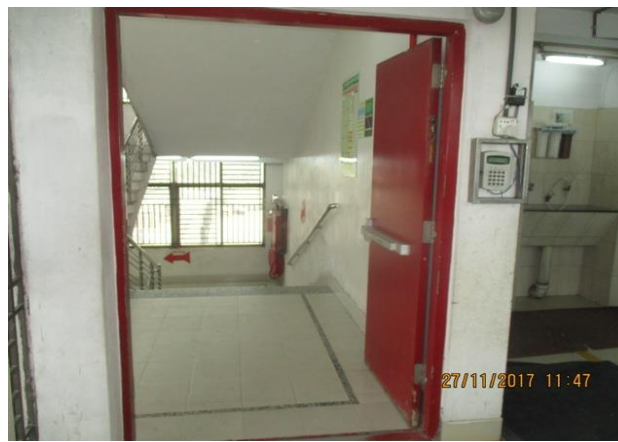
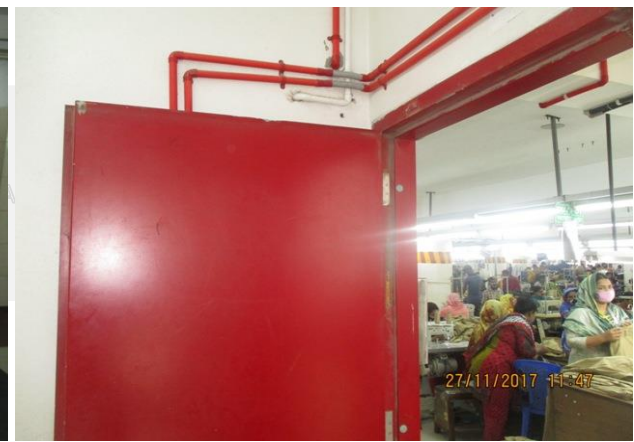
| SI No. | Category | Findings | Required Action | Remediation Time Frame |
|---|---|---|---|---|
| 1 | Fire Rated Construction | The exit stairs are not separated from work areas and other spaces on each floor by fire-rated construction. | Provide minimum 1-hr rated doors for buildings with 3 or fewer stories and 1.5-hr fire rated doors for buildings that are 4 or more stories. Seal all unprotected openings to separate the exit stairs from work areas and other building spaces on all floor levels. Ensure that the fire doors are self-closing and positive latching and that they are provided with fire exit (panic) hardware where serving production floors. If fire doors are required to be held open for functional reasons, provide automatic closing devices tied to the fire alarm system. Once fire doors are installed, every door in a stair enclosure serving more than 5 stories shall be provided with re-entry unless it meets. | Within 3 months |

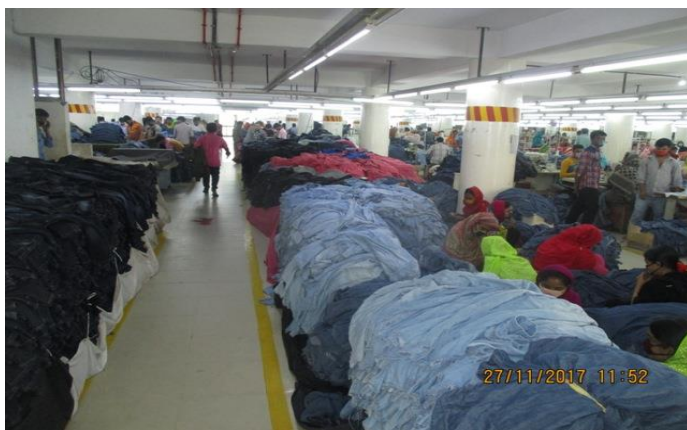
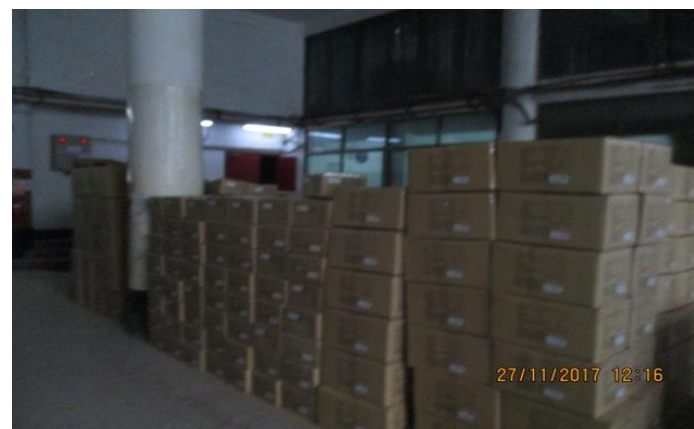
| 2 | Fire Rated Construction | Areas used for combustible storage are not separated by fire rated construction. | <p>Provide dedicated storage rooms separated by minimum 1-hr fire-rated construction.</p> <p>Or</p> <p>Where separate storage rooms are not feasible, provide defined storage areas and limit the storage arrangement as follows:</p> <ul style="list-style-type: none"> <li>- Maximum height of 2.4m and maximum area of 23m<sup>2</sup></li> <li>- If sprinkler protected: maximum height of 3.66m and maximum area of 93m<sup>2</sup></li> </ul> <p>Separate areas of unenclosed combustible storage by a minimum clear distance of 3m.</p> | Within 3 months |

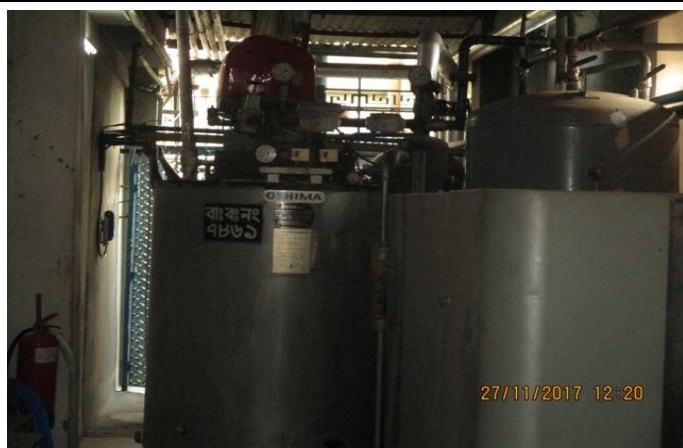
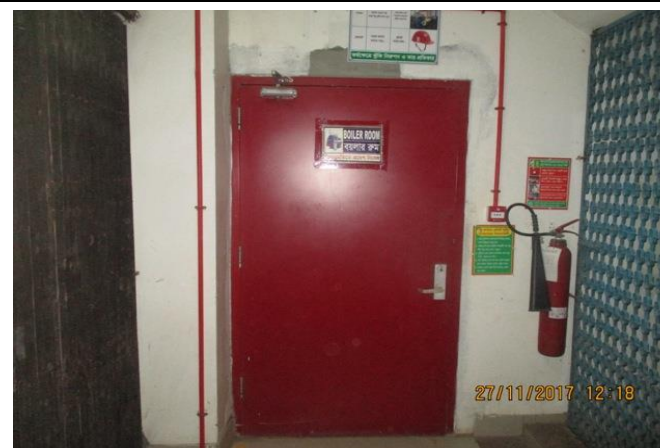
| 3 | Fire Rated Construction | Boiler rooms are not properly separated from wastage storage area by fire rated construction. | Separate boiler rooms by a minimum 2-hr fire-rated construction from each other. Seal and/or protect all openings to maintain the required fire separations. Provide proper ventilation and consult a qualified engineer. | Within 3 months |

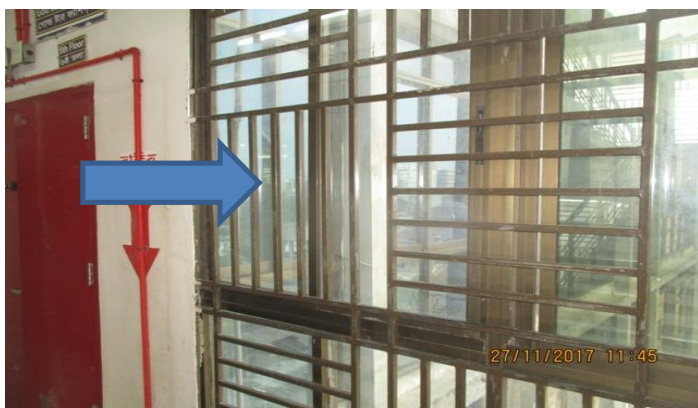
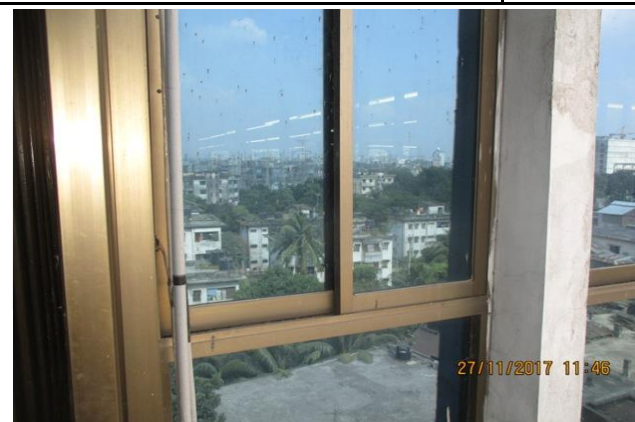
| 4 | Fire Rated Construction | Unsealed penetrations and openings are located in the fire rated floor/ceiling assemblies. | Seal all penetrations and openings in floors/ceiling assemblies to maintain the fire separation. | Within 3 months |

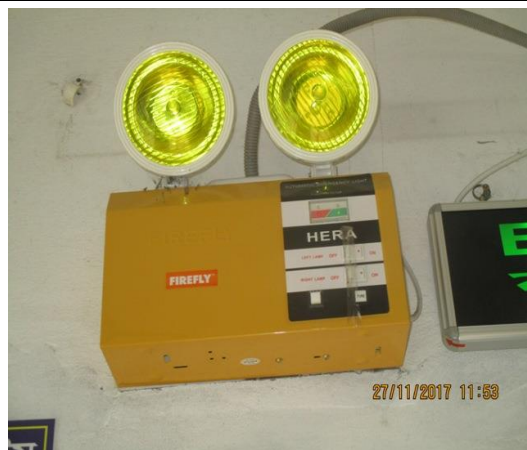
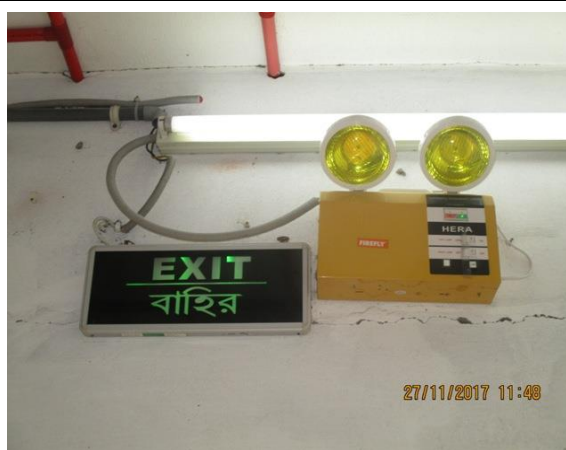
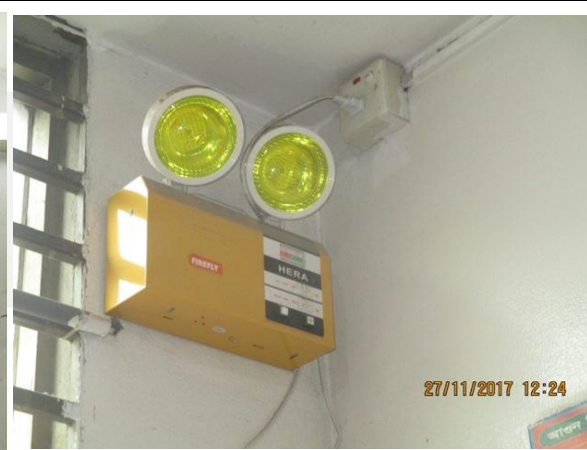
| 6 | Egress Lighting | Manual on-off switch is provided for [emergency lighting / exit signage] units. | Remove manual on/off switches from emergency lighting / exit signage units to prevent them from being switched off. | Within 3 months |

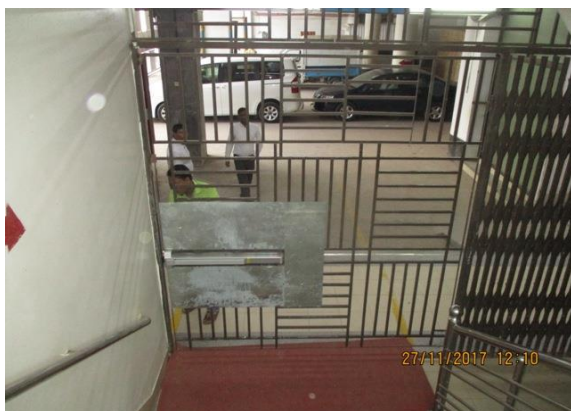
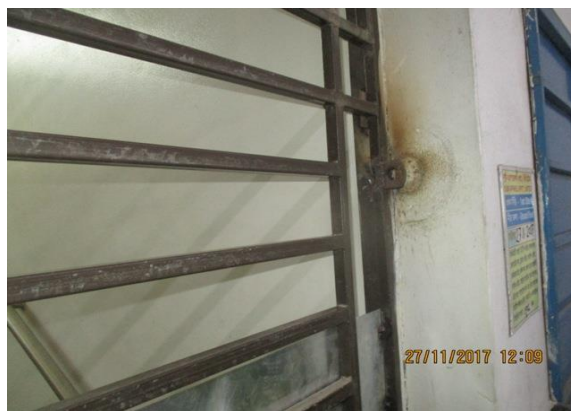
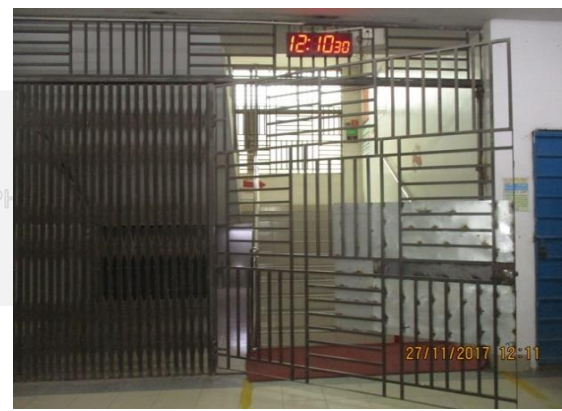
| 7 | Egress | Non compliant doors (With locking features) are provided at building exits.<br><b>Location:</b> Ground floor stair discharges. | Replace all non complaint doors along the means of egress with side-hinged, swinging egress doors. If locks are required for security reasons, utilize specialized door locking features complying with NFPA101. | Within 1 month |

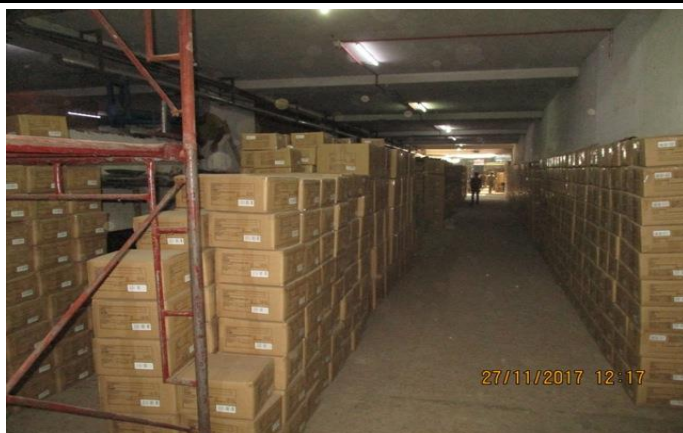
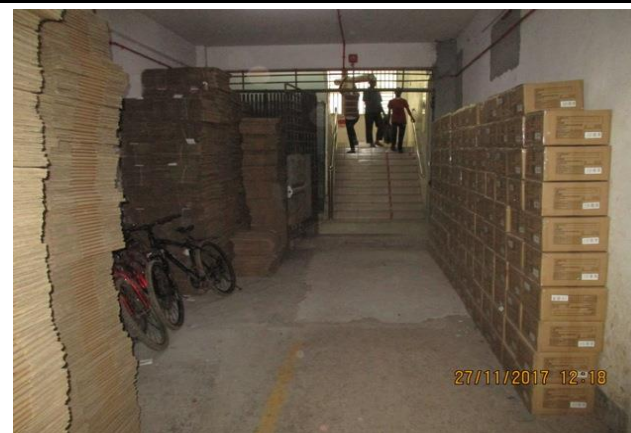
| 8 | Egress | The egress path along means of egress has interrupted by obstruction/storage. Location: Ground floor; Parking area ( Exit Stair discharges). | Remove storage from the exit stairs and egress path | Immediate |

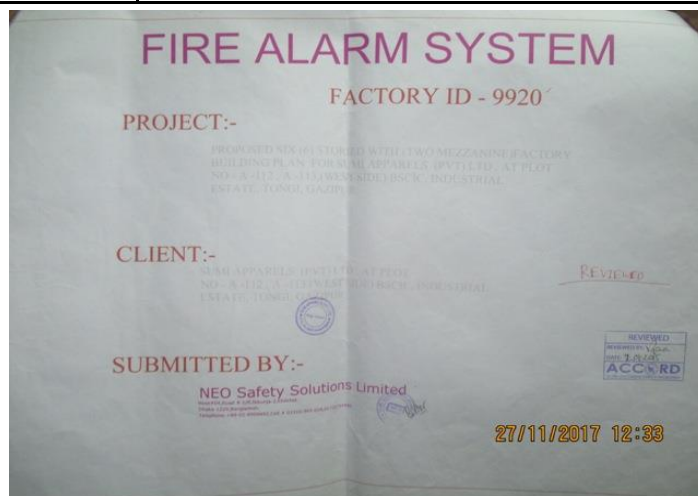
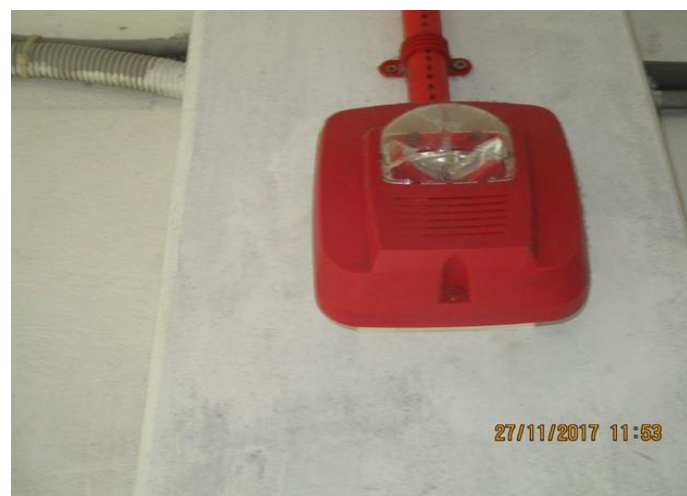
| 10 | Fire Alarm & Detection System | Submit the as-built design of fire alarm system to Accord in accordance with NFPA 72. Installation shall be as per the reviewed design with a listed Addressable Fire Alarm System. | Submit the as-built design of fire alarm system to Accord in accordance with NFPA 72. Installation/modifications shall be as per the reviewed design with a listed Addressable Fire Alarm System. | Within 6 months |

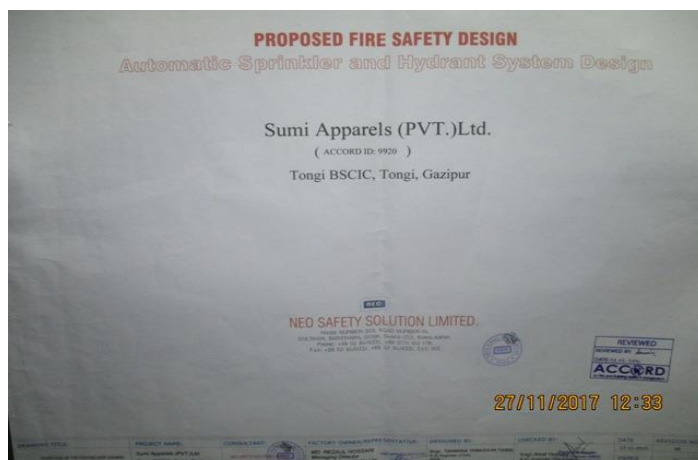
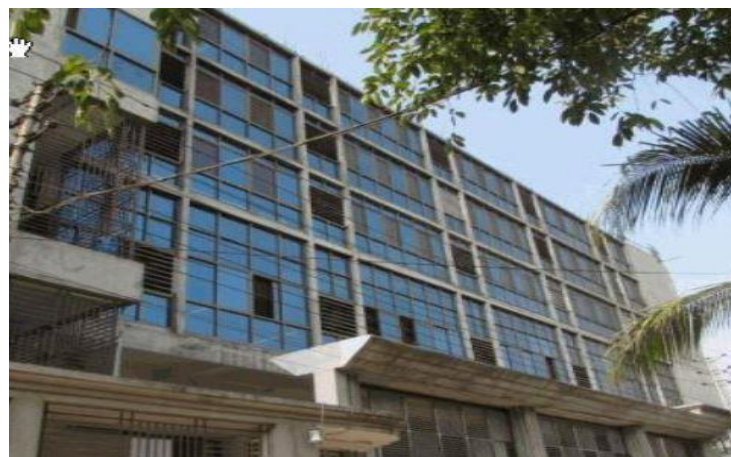
| 11 | Fire Protection System | The existing building has an occupied floor greater than 10 meter (33 feet) and is not provided with proper standpipe protection. | Install a new standpipe system, fire pump & fire department connection in accordance with NFPA 14,20,22 & 24. | Design within 4 months, Install within 9 months |

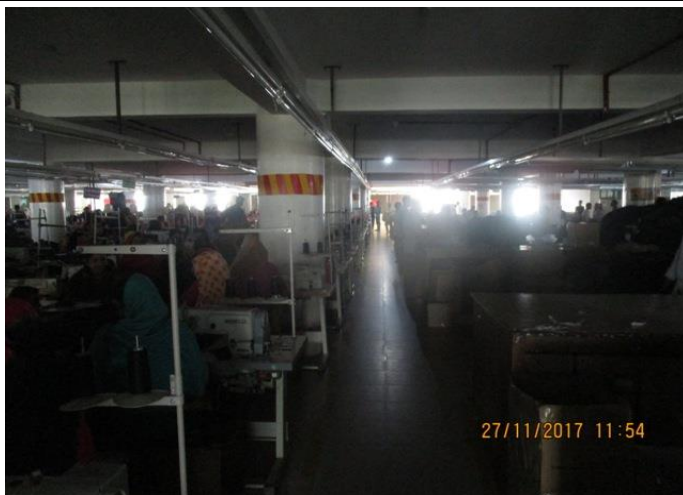
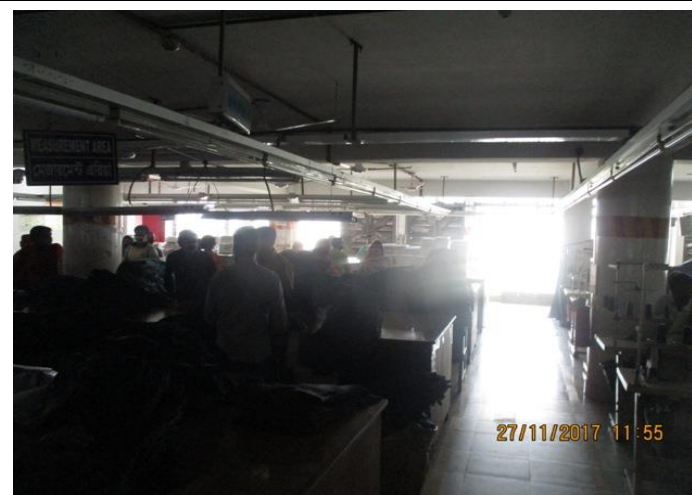
| 14 | Egress Lighting | Based on the number and location of emergency lights/exit signs observed, adequate illumination levels are not anticipated along egress routes. | Test the emergency lighting system on each floor and provide additional emergency fixtures to provide adequate illumination along the means of egress. Provide a minimum illumination of 10 lux at the floor level within exit stairs and exit discharge paths and minimum 2.5 lux along exit access aisles. | Within 3 months |
