Susuka Knit Ltd. (10831)

Yousuf Market, Yearpur, Ashulia, Dhaka.

13.AUGUST.2014

Identified Priority 3 Concerns

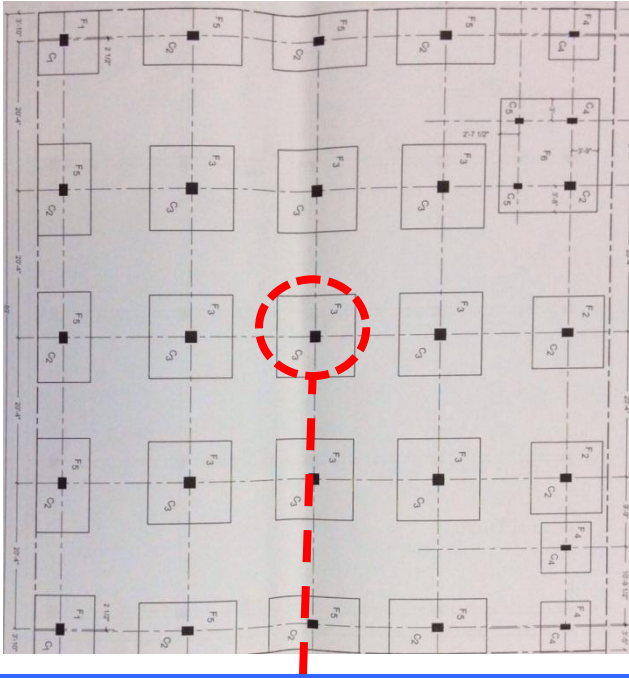
1st Priority 3 Concern

The column to be checked.

Based on the drawings and the Ferro-scan results, the column reinforcement appears to be consistent with the rebar arrangement at the ground level of the structural drawing.

According to the load rundown calculation for the existing 3 storeys and in the future case with 6 storeys, the column has been found to possess enough capacity to be acceptable.

According to the load rundown calculation for 8 storeys as per the secondary Construction drawing, the columns have been found to possess low factors of safety and have a YELLOW rating. If it is ever intended to construct the addition levels on this building then a full Detailed Engineering Assessment should be carried out first.

- ITEM 1: (1st Priority 3) The building should not be constructed up to 8 storeys high without a full Detailed Engineering Assessment.**
- ITEM 2: (2nd Priority 3) The roof needs to be protected with a water proofing layer if the construction is not to continue within three months.**

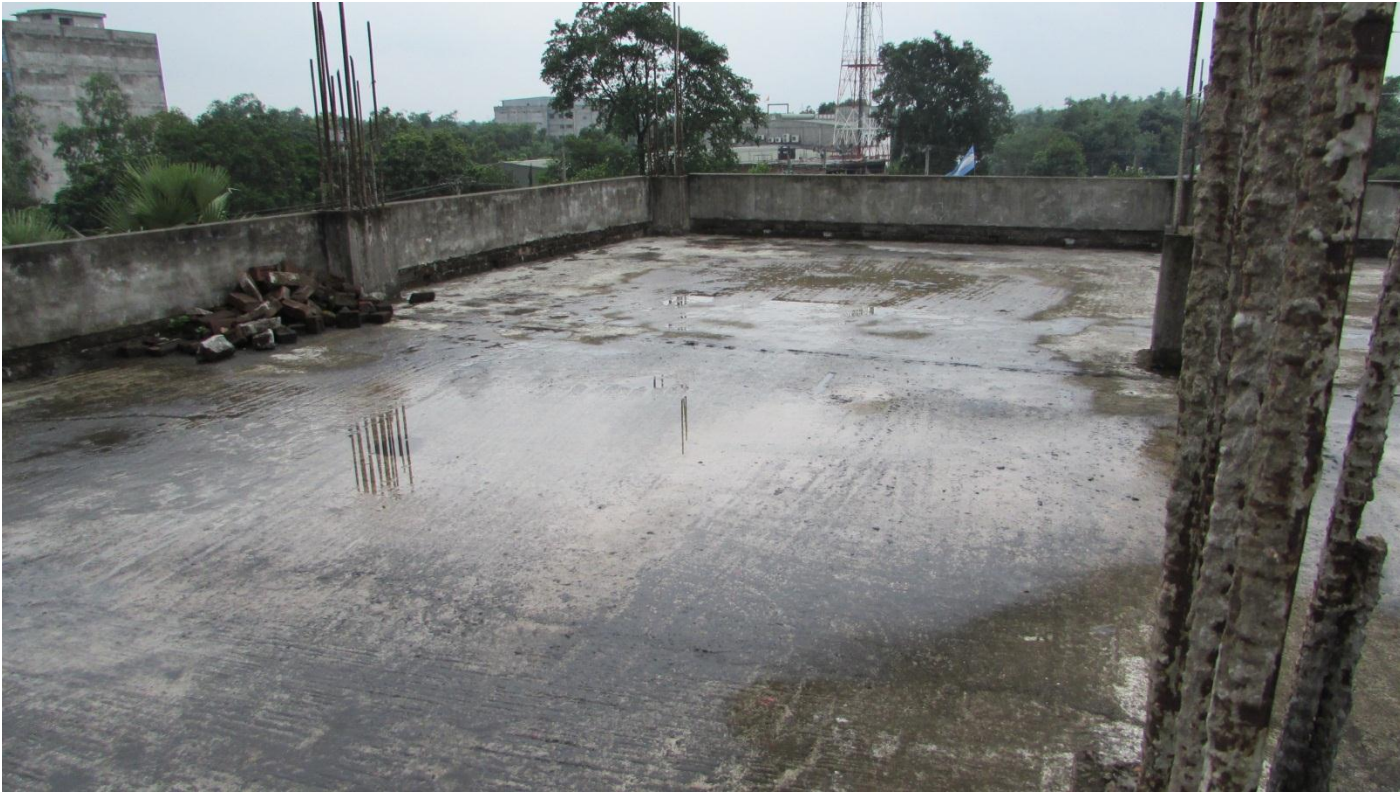
2nd Priority 3 Concern

The current roof level needs to be protected with a water proofing layer if construction is not continued within the next three months.

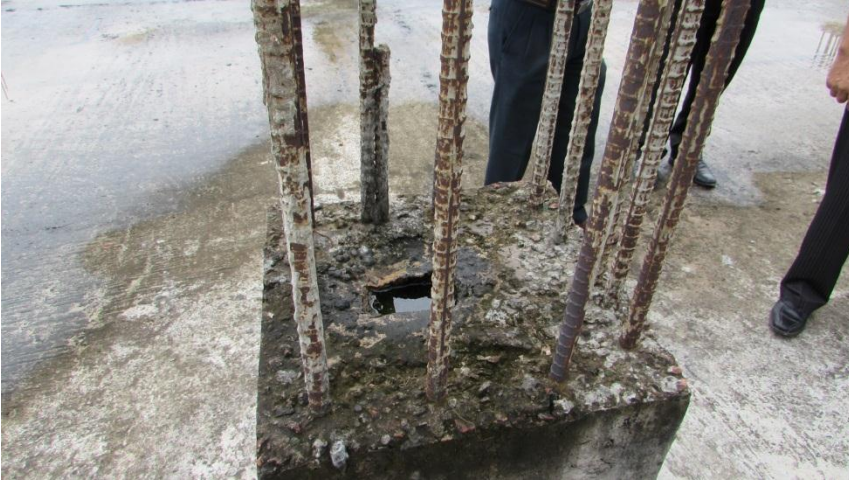
3rd Priority 3 Concern

The starter bars of the columns on the 3th floor need to be painted to prevent the corrosion of steel for future use.

- ITEM 3: (3rd Priority 3) The starter bars of the columns on the 3rd floor need to be painted to prevent the corrosion for future use.**
- ITEM 4: (4th Priority 3) The cracks on the 3rd floor beams and slabs need to be investigated to determine if they are plaster cracks or structural cracks.**

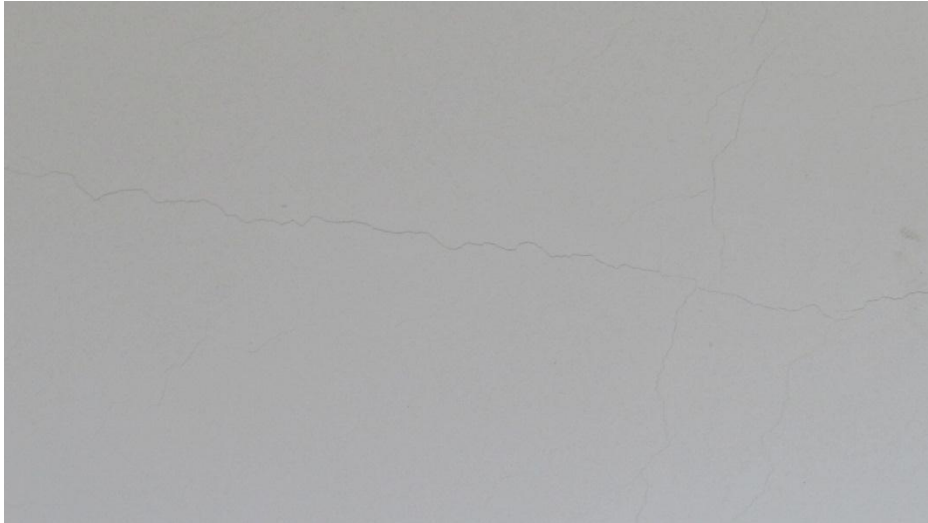
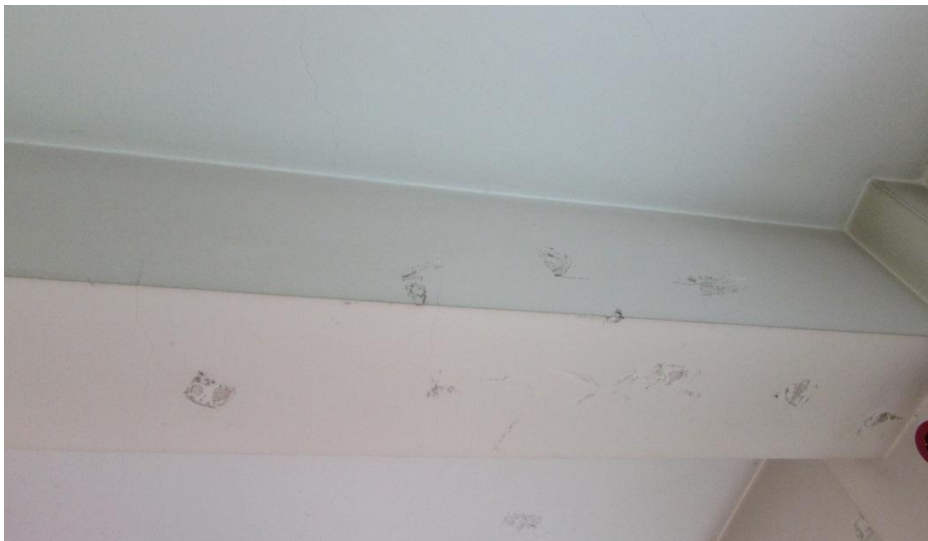
4th Priority 3 Concern

The cracking on the 3rd floor beams and slabs needs to be investigated to determine whether they are plaster cracks or structural cracks.

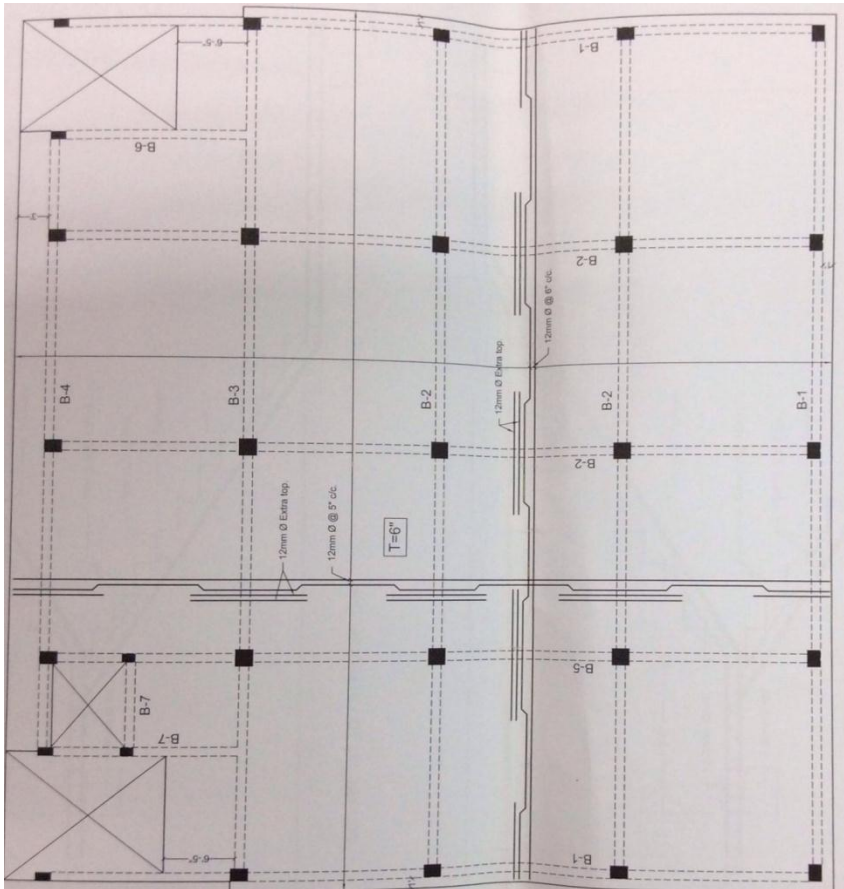
5th Priority 3 Concern

We require that these items be investigated in an Engineering Assessment.

R.C Beam and column frame, with a 2-way solid slab. Stability provided by moment frame system only.

Slab Thickness 152.4mm
Column Size 508x508mm (typ.)
Beam Size 254x508mm(typ.)

Grid 6.2m x 5.56m.

This type of structural framing is appropriate for a building lower than 10 storeys and with the large plan area. However, it is required that the factory's Structural Engineer reviews and checks the overall stability and horizontal deflections under wind and seismic loading.

- ITEM 5: (5th Priority 3) The factory's Structure Engineer needs to check the overall lateral stability system under lateral wind and seismic loads as part of an Engineering Assessment.**

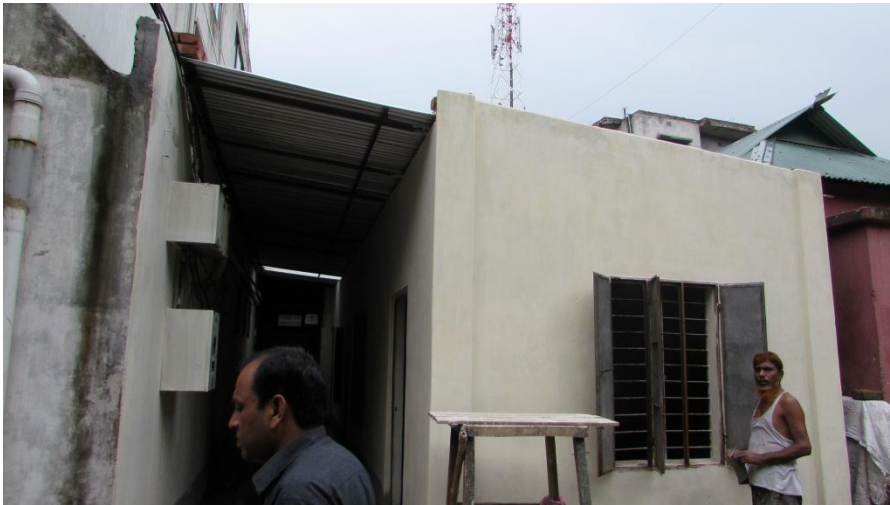
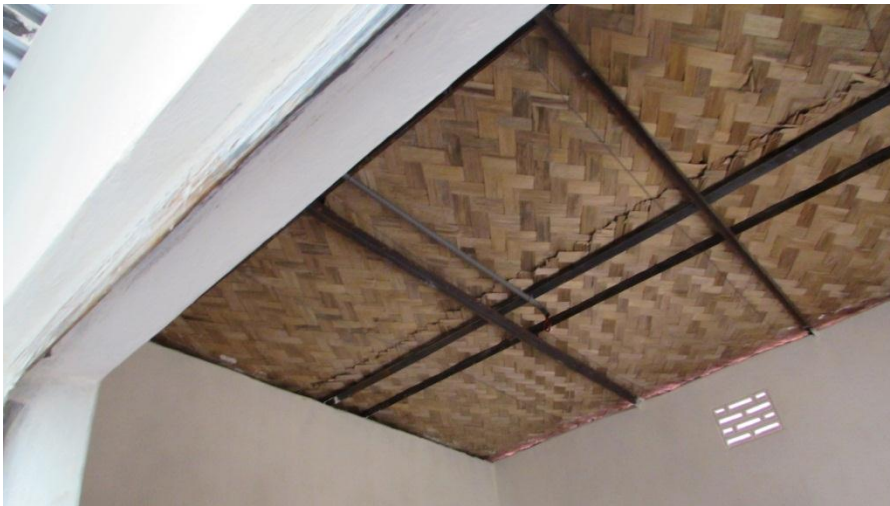
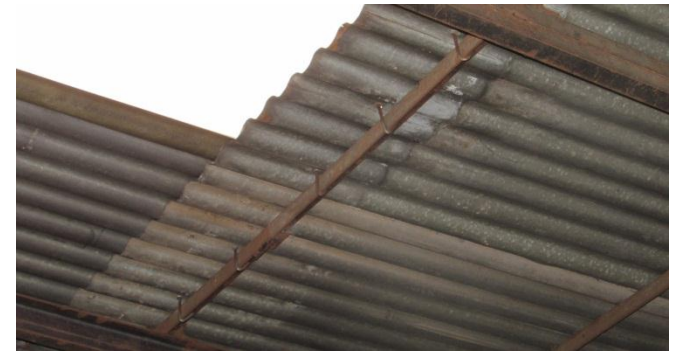
6th Priority 3 Concern

Temporary steel sheds for Security and Generator housing are poorly built with simple connections.

The Structure Engineer needs to review the design and detailing with applied wind loads and check the steel structure under uplift wind forces in particular.

- ITEM 6: (6th Priority 3) The 'temporary' steel sheds for Security and Generator housing need to be checked/reviewed for their structural stability.**
