# Sadma Fashion Wear Ltd. (9458)

## Bunon Knit Wear Ltd.

Mouchak, Kaliakoir, Gazipur

10.AUGUST.2014

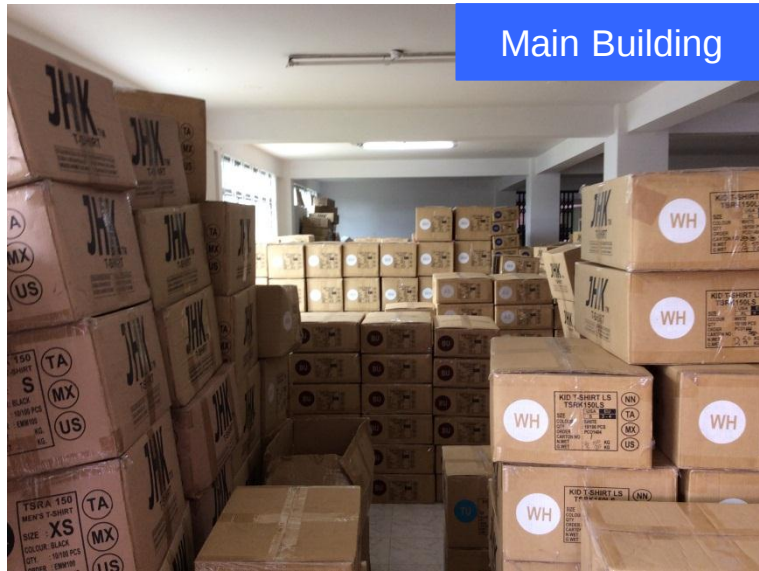
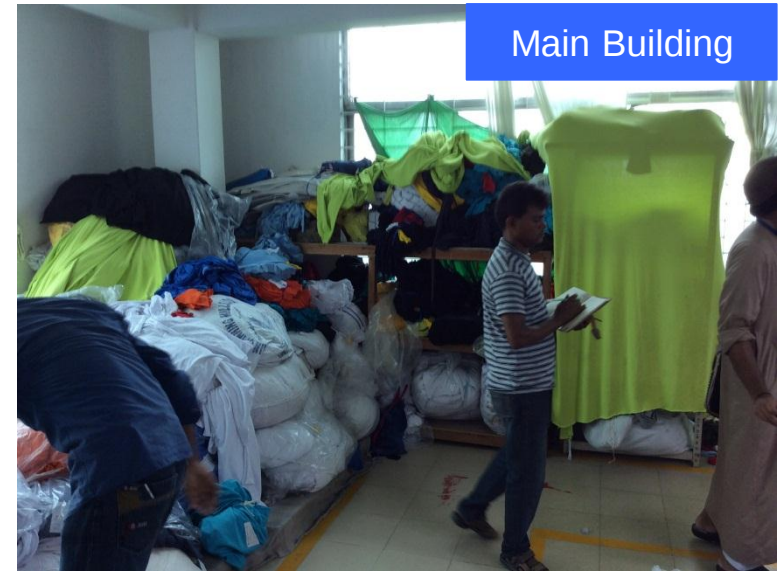
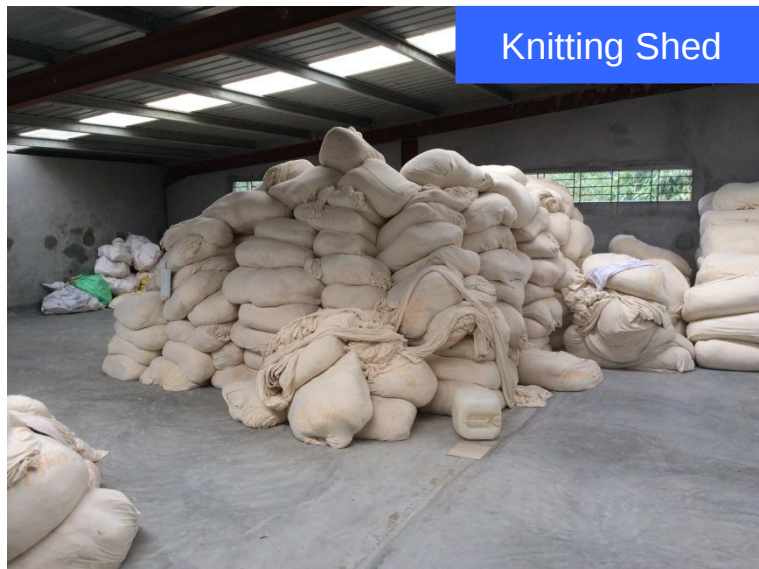
There are no loading plans for the structure in any area.

| Item No. | Observation | Recommended Action Plan | Recommended Timeline |
|---|---|---|---|
| 1 | Priority 2 - No loading plans exist for the structure. | An Engineering Assessment is required to review the design and loads. Factory Engineer to state the maximum weight that is allowed per square meter. State the values clearly on notice boards in these areas. (Loading Plans). | 6-weeks |
| 2 | Priority 2 - No loading plans exist for the structure. | Maintain standards of quality control to ensure that storage procedures are correctly followed. | 6-months |

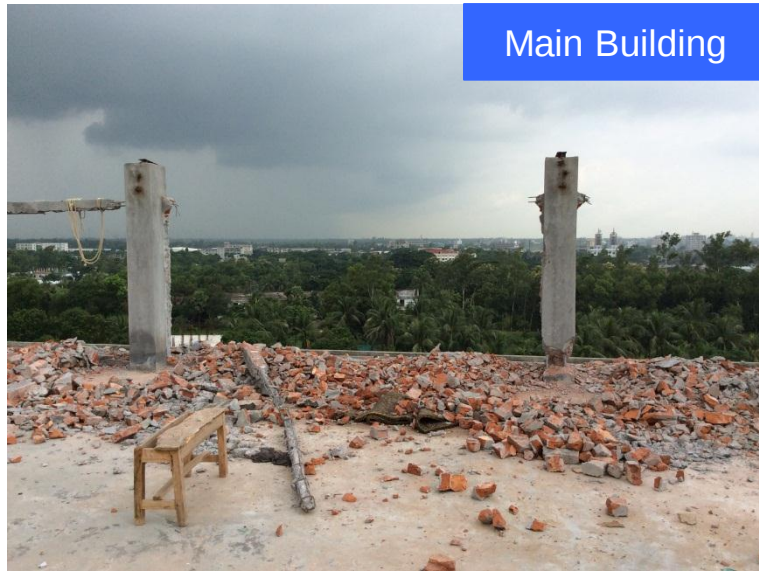
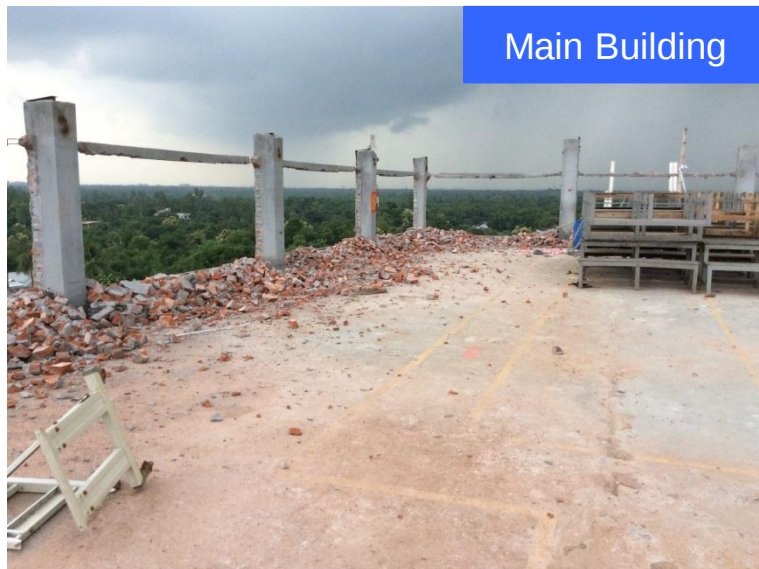
There is no parapet wall around the top level perimeter of Main Building.

Whilst not a structural issue, this is a significant health and safety risk and should be rectified.

| Item No. | Observation | Recommended Action Plan | Recommended Timeline |
|---|---|---|---|
| 5 | Priority 3 - No parapet wall or guardrail present at top level of Main Building. | A suitable perimeter parapet wall or guardrail should be constructed along the building perimeter. | 6-months |

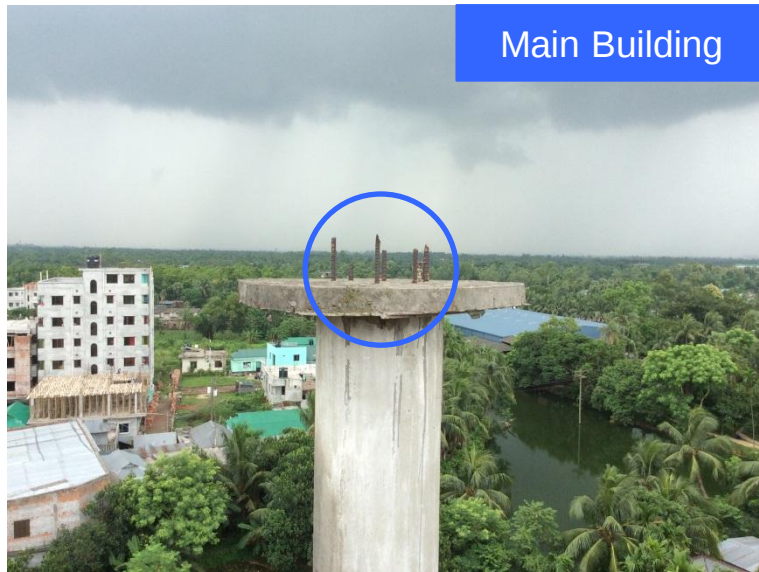
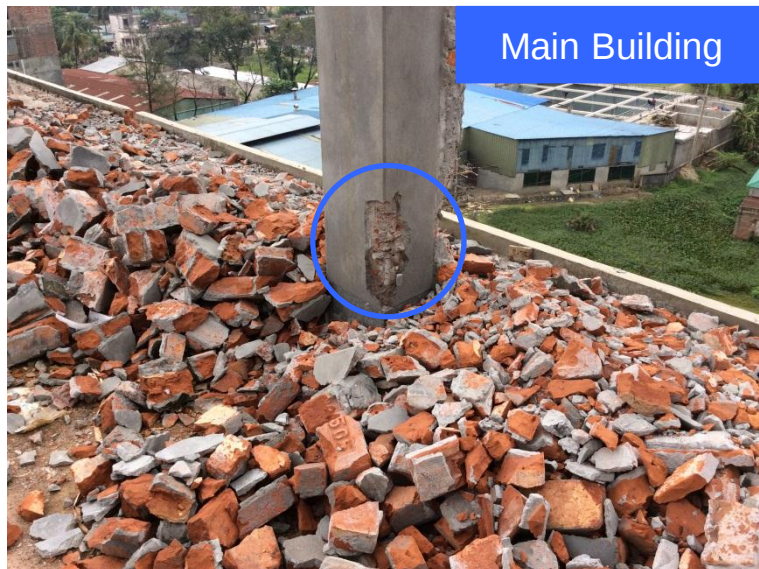
Reinforcement is left exposed at top level of Main Building.

| Item No. | Observation | Recommended Action Plan | Recommended Timeline |
|---|---|---|---|
| 6 | Priority 3 - Reinforcement left exposed at top level of Main Building. | For both durability and serviceability, rust proof paint or any appropriate methods is recommended. | 6-months |

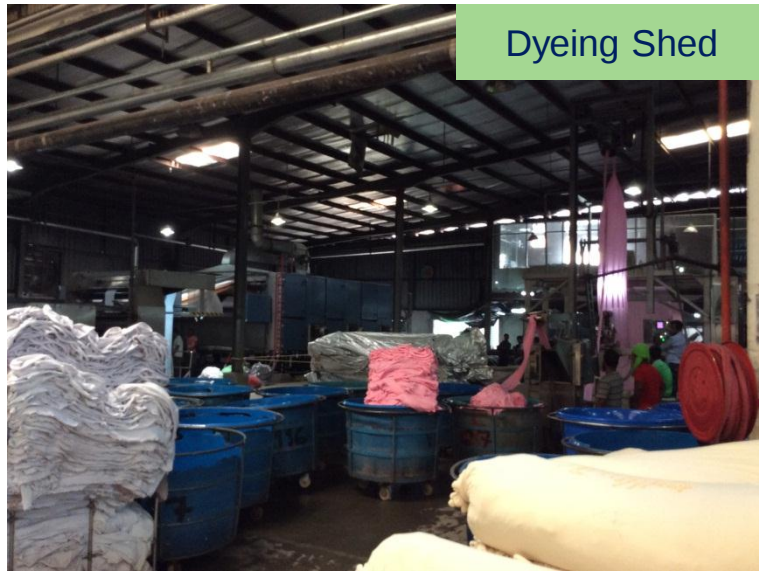
No fireproofing material was noted on structural steel elements at Dyeing Shed and Knitting Shed (if required).

| Item No. | Observation | Recommended Action Plan | Recommended Timeline |
|---|---|---|---|
| 7 | Priority 3 - No fireproofing material for structural steel elements at Dyeing Shed and Knitting Shed (if required). | Fireproofing material for structural steel element is recommended as suggested in BNBC Codes. Maintain standard of quality control and protection of the fire protection. | 6-months |

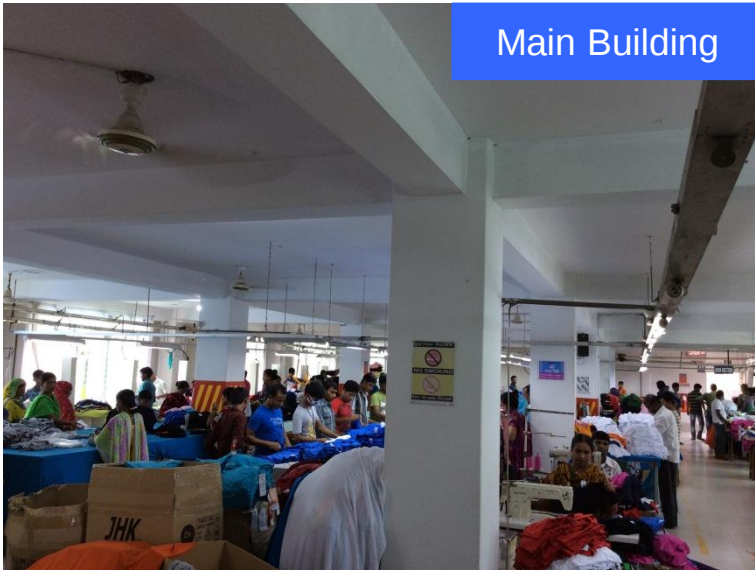
Main Building

The lateral loading resistance for Main Building, 7 storeys, is provided by moment frame action without any shear walls and the façade brickwork walls lack moment capacity due to their poor connections with the surrounding columns and beams. This building also has one very tall unbraced column at the North-West corner.

| Item No. | Observation | Recommended Action Plan | Recommended Timeline |
|---|---|---|---|
| 3 | Priority 2 - Overall stability system. | An Engineering Assessment of the overall building to be carried out and in particular, stability and foundation aspects should be investigated in detail. | 6-weeks |

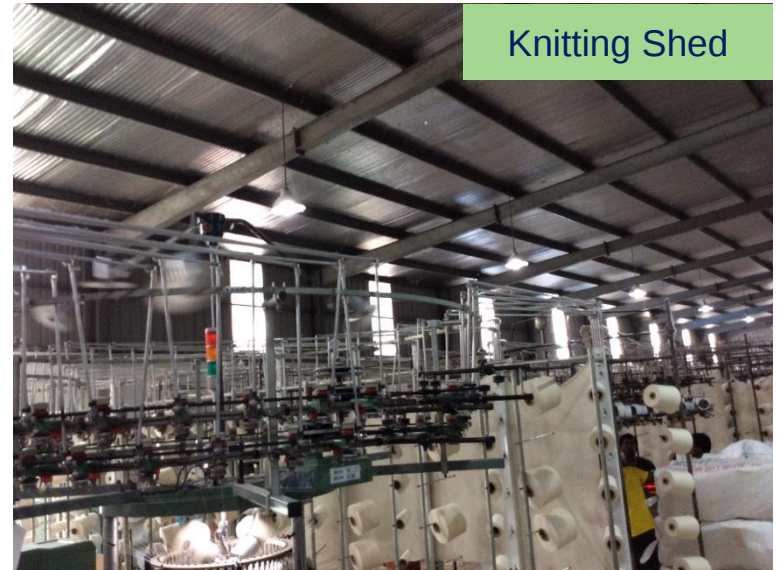
Knitting Shed

Concerns on the stability system for lateral loading for sheds. The lateral loading resistance is provided by moment frame action in one direction but braces that you would expect to find in the other direction were not found. Stability and capacity must be checked especially the connections. And stability under wind uplift needs to be checked in particular.

We require that the stability of these buildings is investigated as part of a Engineering Assessment.

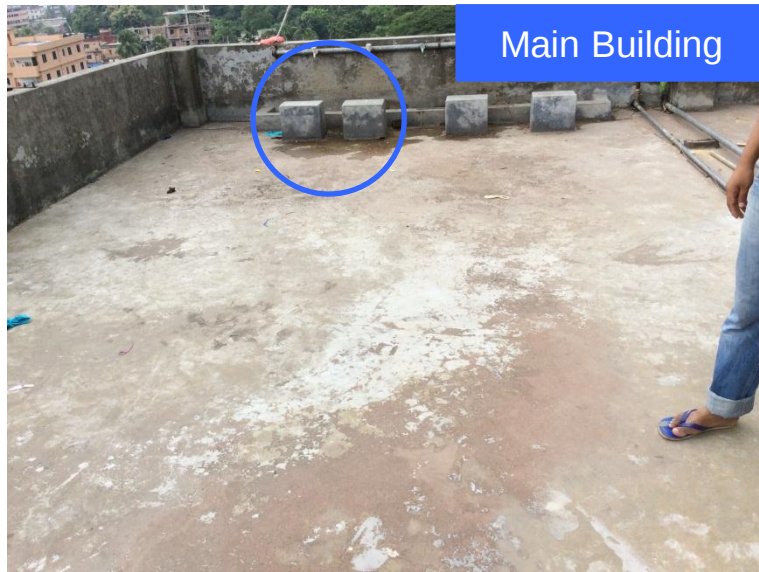
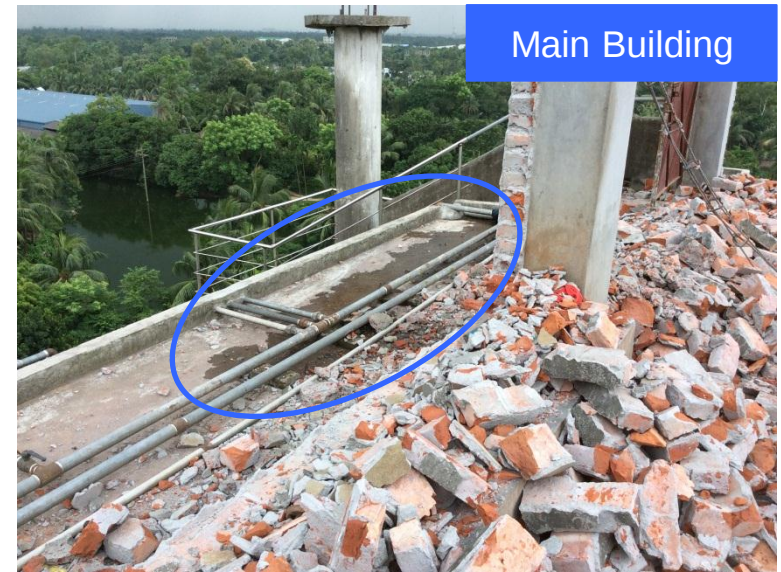
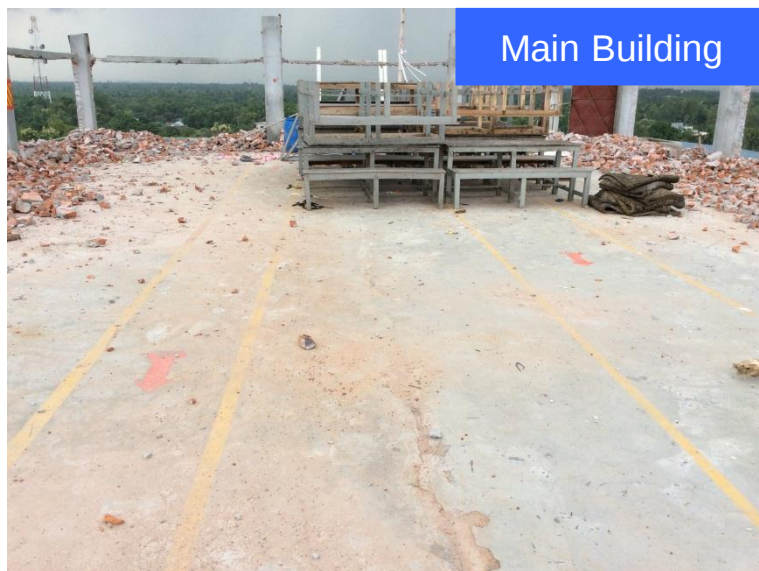
Water ponding was found at top level of Main Building. Cracking and spalling was found on cementitious floor screeding.

| Item No. | Observation | Recommended Action Plan | Recommended Timeline |
|---|---|---|---|
| 4 | Priority 3 - No waterproofing material on the Main Building. | Waterproofing on the roof slab is to be applied. Moreover the roof slab drainage system should be investigated and improved. | 6-months |
