# Gildan Shahriyar Fabrics Ind. (11479)

Palashbari, Ashulia, Savar, Dhaka

10.August.2014

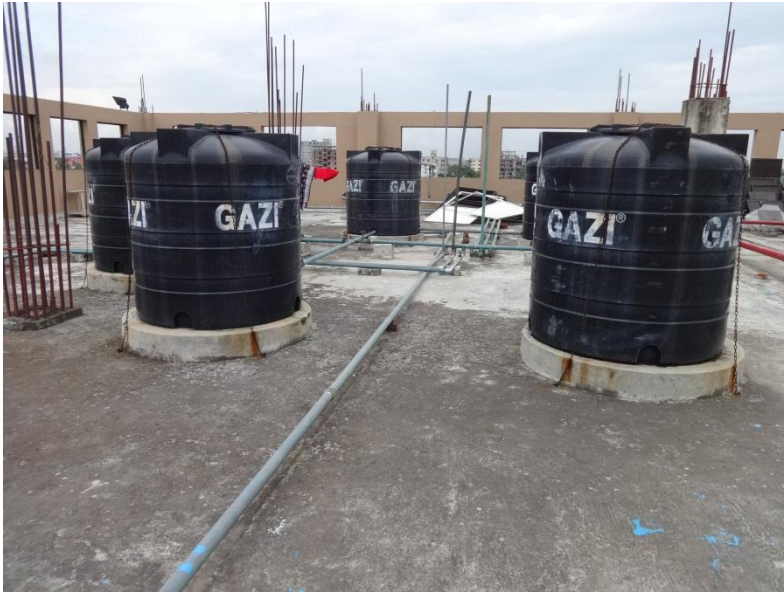
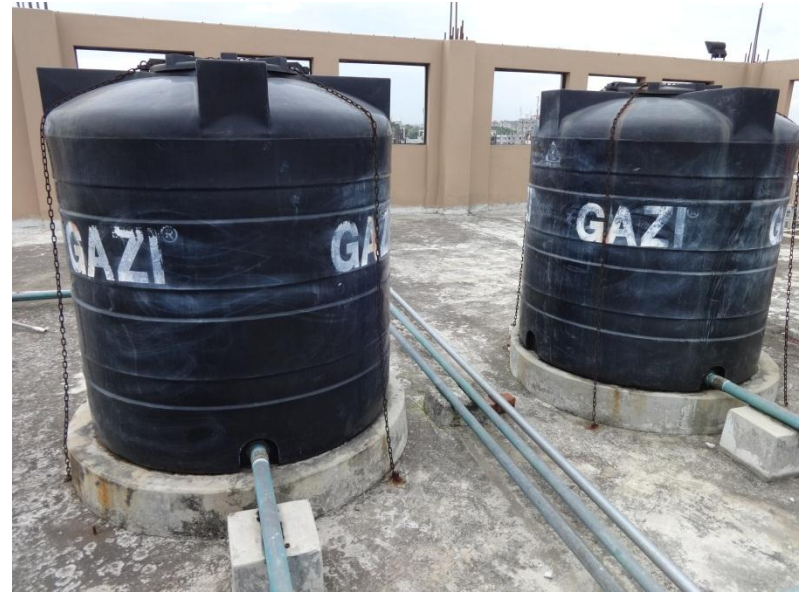
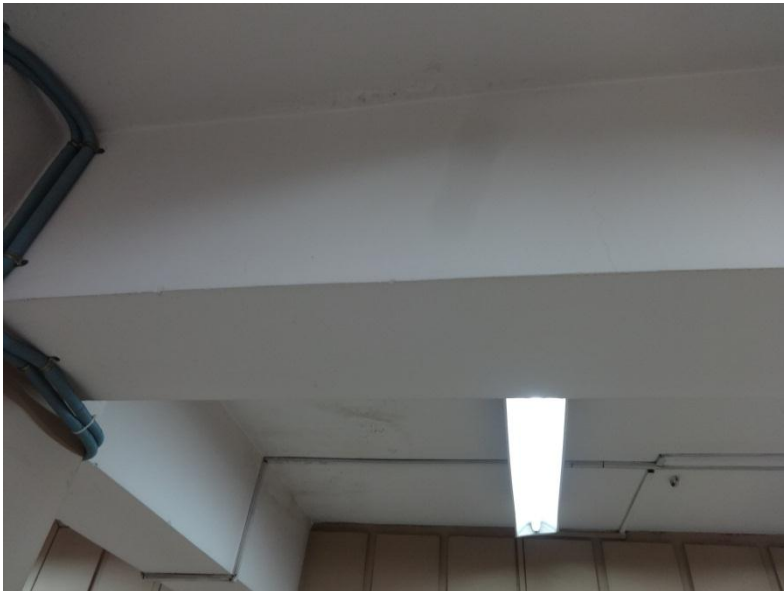
## 1<sup>st</sup> Priority 2 Concern

Cracking in beams  
under water tanks in  
building 4.

| Item No. | Observation | Recommended Action Plan | Recommended Timeline |
|---|---|---|---|
| 1 | Priority 2 - Cracking in beams under water tanks in building 4. | Factory engineer to survey the beams, removing plaster, to establish the extent of the cracks in the beams. | 6-weeks |
| 2 | Priority 2 - Cracking in beams under water tanks in building 4. | Relocate the water tanks closer to columns if the cracks are in the concrete. | 6-months |

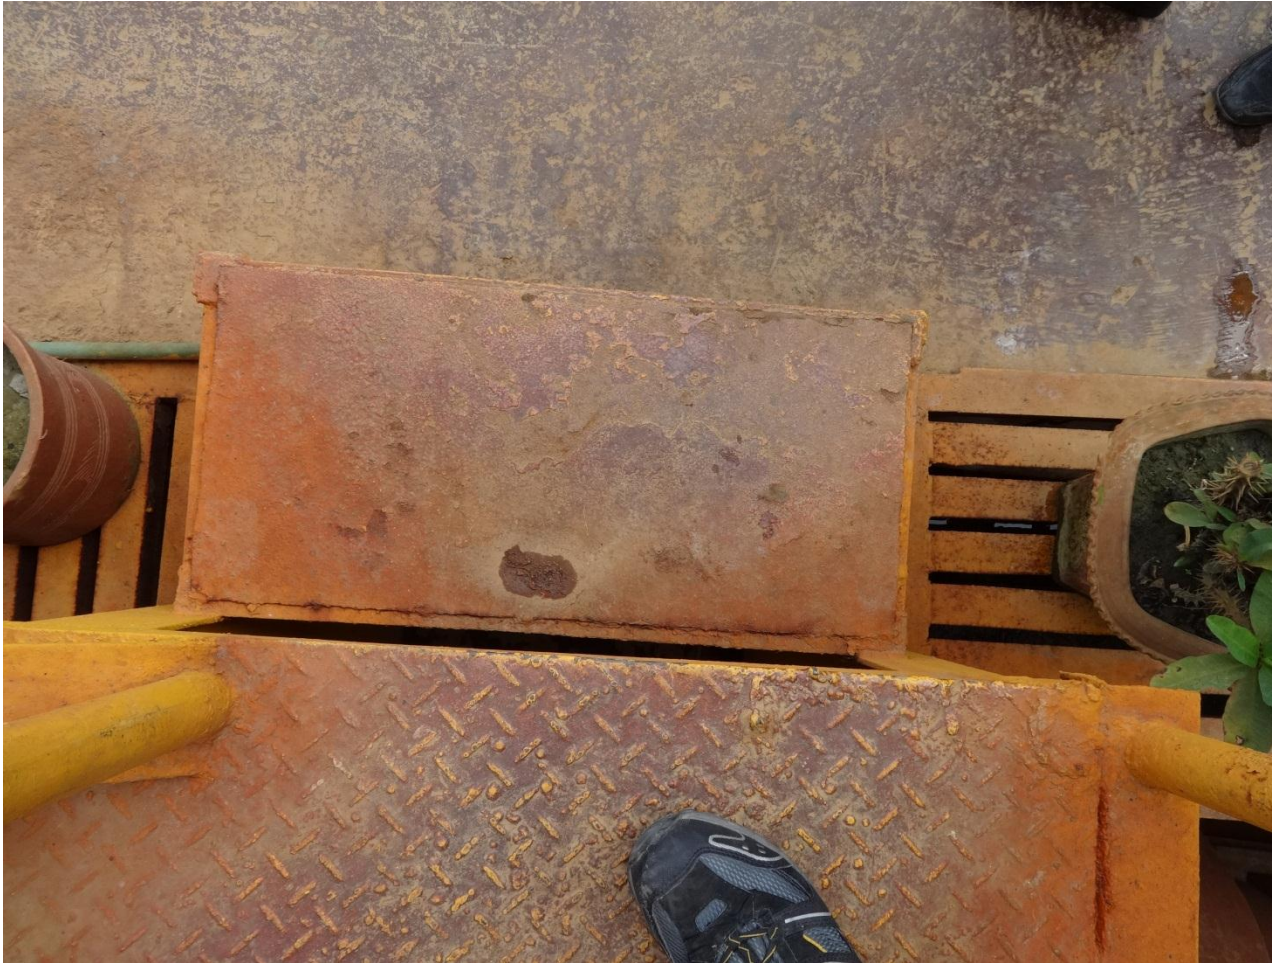
## 2<sup>nd</sup> Priority 2 Concern

Steel stairs around  
ETP are corroded.

| Item No. | Observation | Recommended Action Plan | Recommended Timeline |
|---|---|---|---|
| 3 | Priority 2 - Steel stairs around ETP are corroded. | Factory engineer to survey the steel stairs to determine the extent of treads requiring replacement. | 6-weeks |
| 4 | Priority 2 - Steel stairs around ETP are corroded. | Replace stringers as required, repaint steelwork and form maintenance regime for steelwork over the ETP. | 6-months |

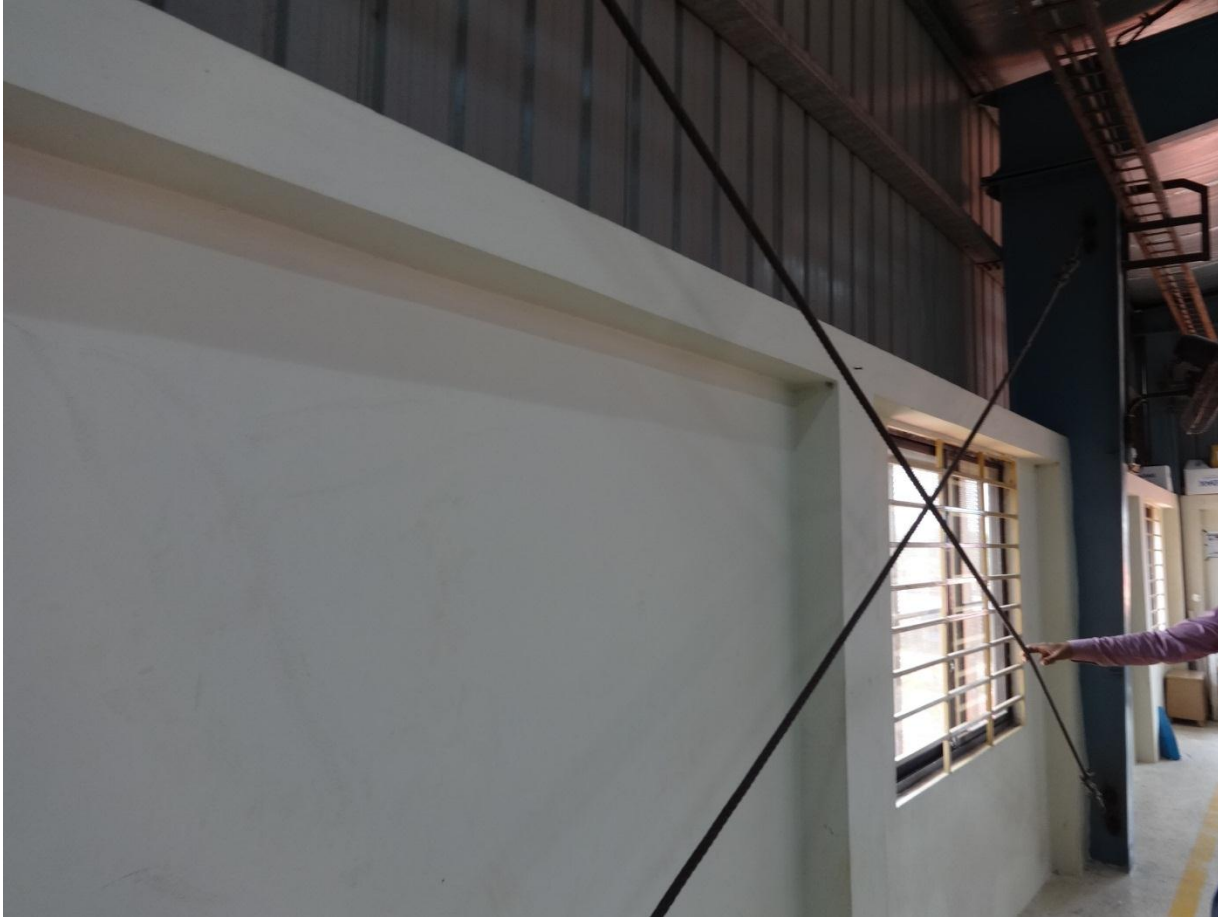
### 3<sup>rd</sup> Priority 2 Concern

Overall stability system of all steel sheds.

The wire cross brace, where installed, are not correctly tensioned.

| Item No. | Observation | Recommended Action Plan | Recommended Timeline |
|---|---|---|---|
| 5 | Priority 2 - Overall stability system of factory buildings and steel sheds. | Carry out an Engineering Assessment on the buildings and sheds to verify that they are stable under lateral loading. | 6-weeks |
| 6 | Priority 2 - Overall stability system of factory buildings and steel sheds. | Carry out all recommendations of the Engineering Assessment. | 6-months |

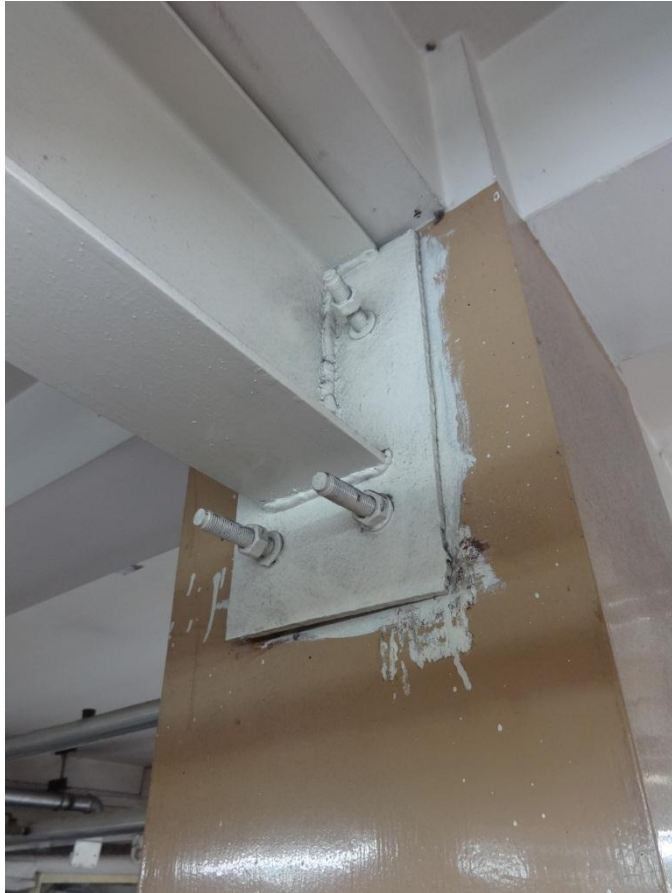
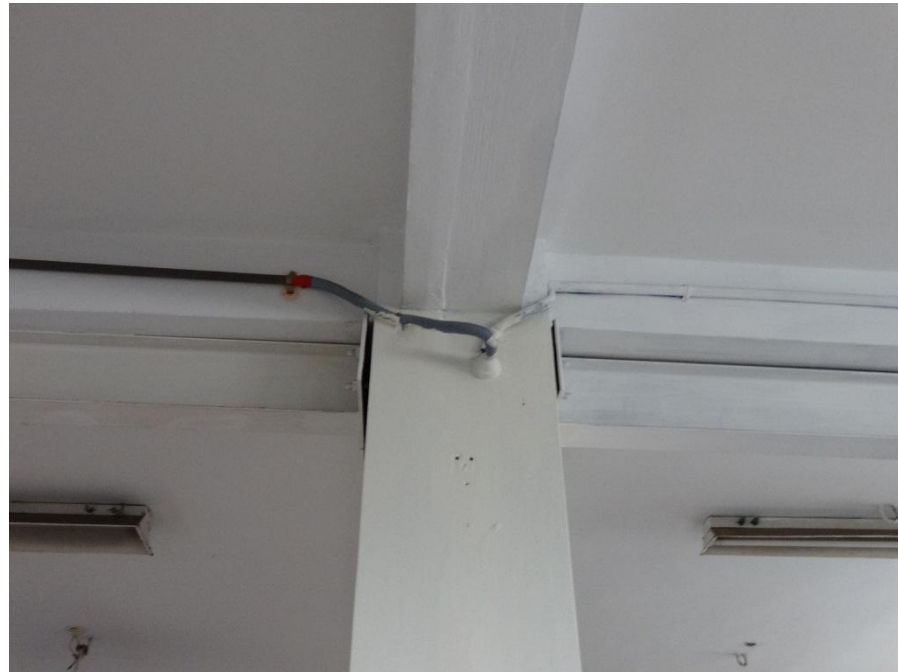
## 4<sup>th</sup> Priority 2 Concern

Connection  
between steel  
beams and  
concrete columns in  
building 2.

| Item No. | Observation | Recommended Action Plan | Recommended Timeline |
|---|---|---|---|
| 7 | Priority 2 - Connection between steel beams and concrete columns in building 2. | Factory engineer to survey steel – concrete connections to verify the extent requiring strengthening. | 6-weeks |
| 8 | Priority 2 - Connection between steel beams and concrete columns in building 2. | Strengthen the connections using shim plates between the end plates and columns and tighten up the bolts on the connections. | 6-months |

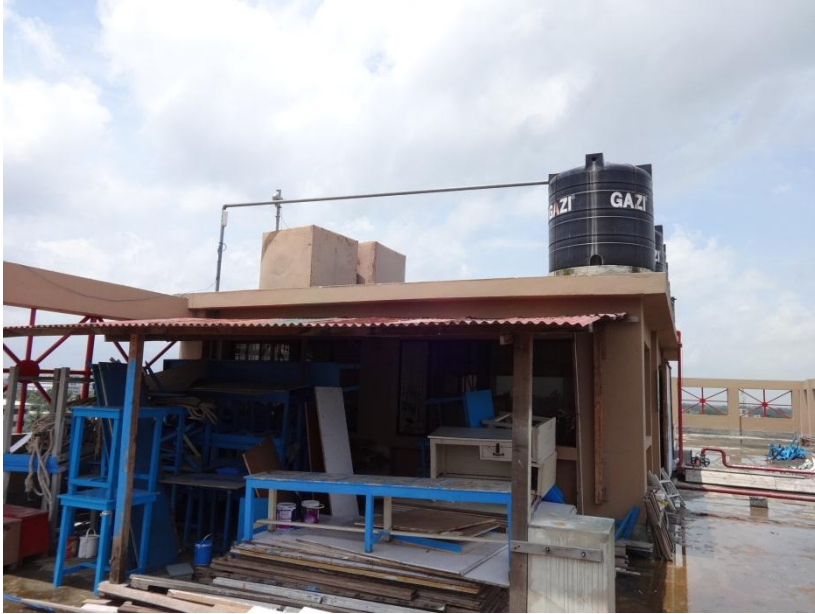
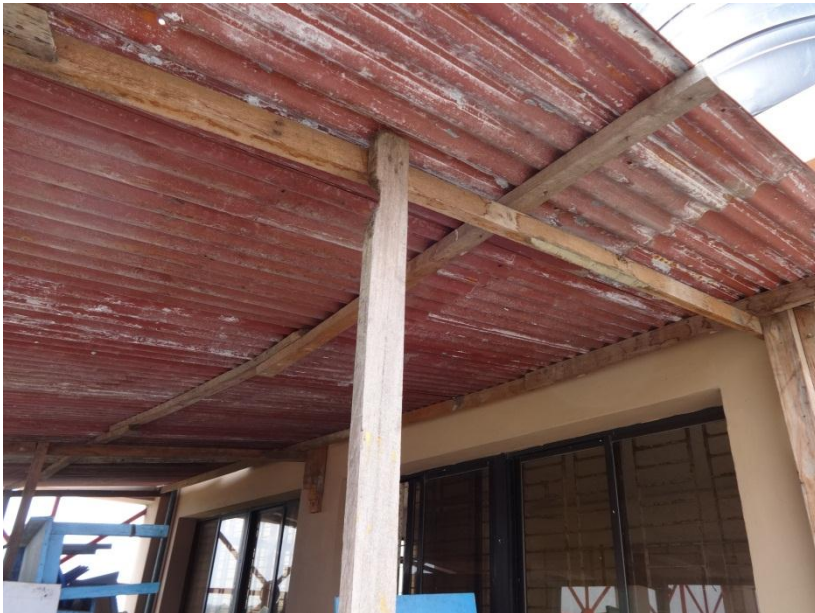
## 5<sup>th</sup> Priority 2 Concern

Steel and timber detailing to roofs over stairwells in main factories.

| Item No. | Observation | Recommended Action Plan | Recommended Timeline |
|---|---|---|---|
| 9 | Priority 2 - Steel and timber detailing to roofs over stairwells in main factories. | Carry out Engineering Assessment on steel roofs around the main factory to determine what strengthening works are required. | 6-weeks |
| 10 | Priority 2 - Steel and timber detailing to roofs over stairwells in main factories. | Carry out recommendations highlighted in Engineering Assessment. | 6-months |

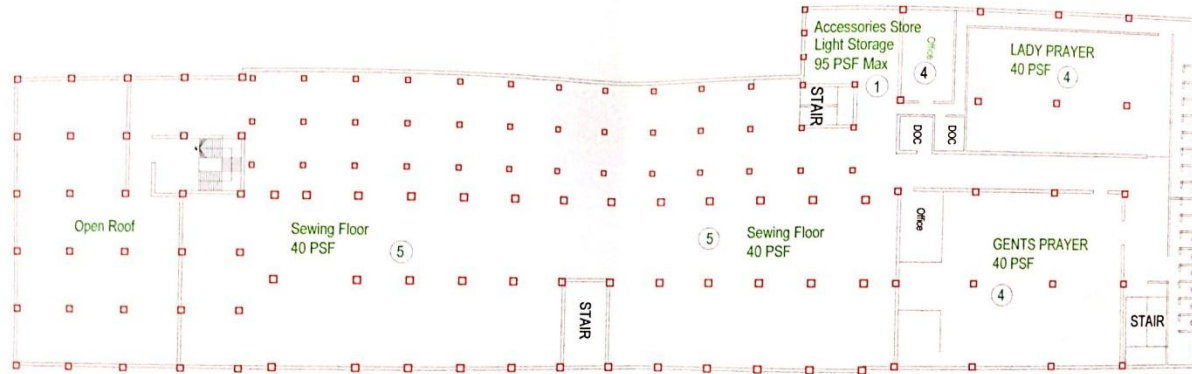
## 6th Priority 2 Concern

Loading plans  
require displaying at  
all upper floors.

| Item No. | Observation | Recommended Action Plan | Recommended Timeline |
|---|---|---|---|
| 11 | Priority 2 - Loading plans require displaying at all upper floors. | Print loading plans out for all buildings and display around the buildings as required. | 6-weeks |
| 12 | Priority 2 - Loading plans require displaying at all upper floors. | Ensure that the loading plans are actioned. | 6-months |

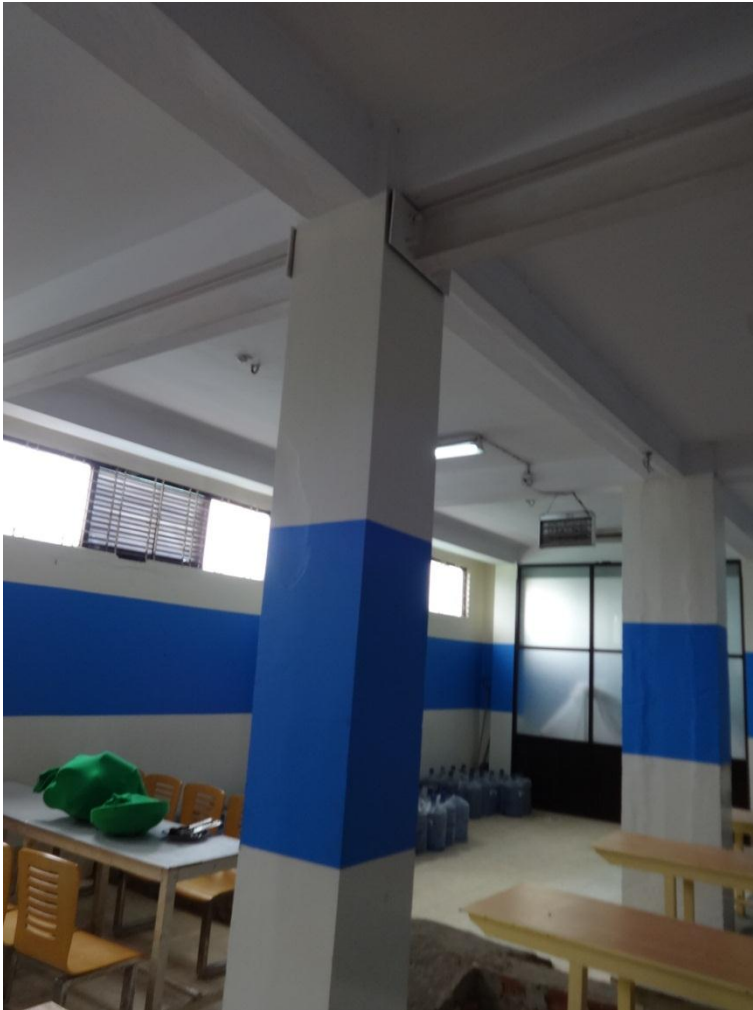
## Main Factory Buildings 1-4

The buildings did not feature any core or shear walls. Stability was achieved through sway action between beams and columns and masonry infill walls. Several columns have been strengthened to provide additional lateral resistance in building 2, shown above.

We require that these items be investigated in an Engineering Assessment

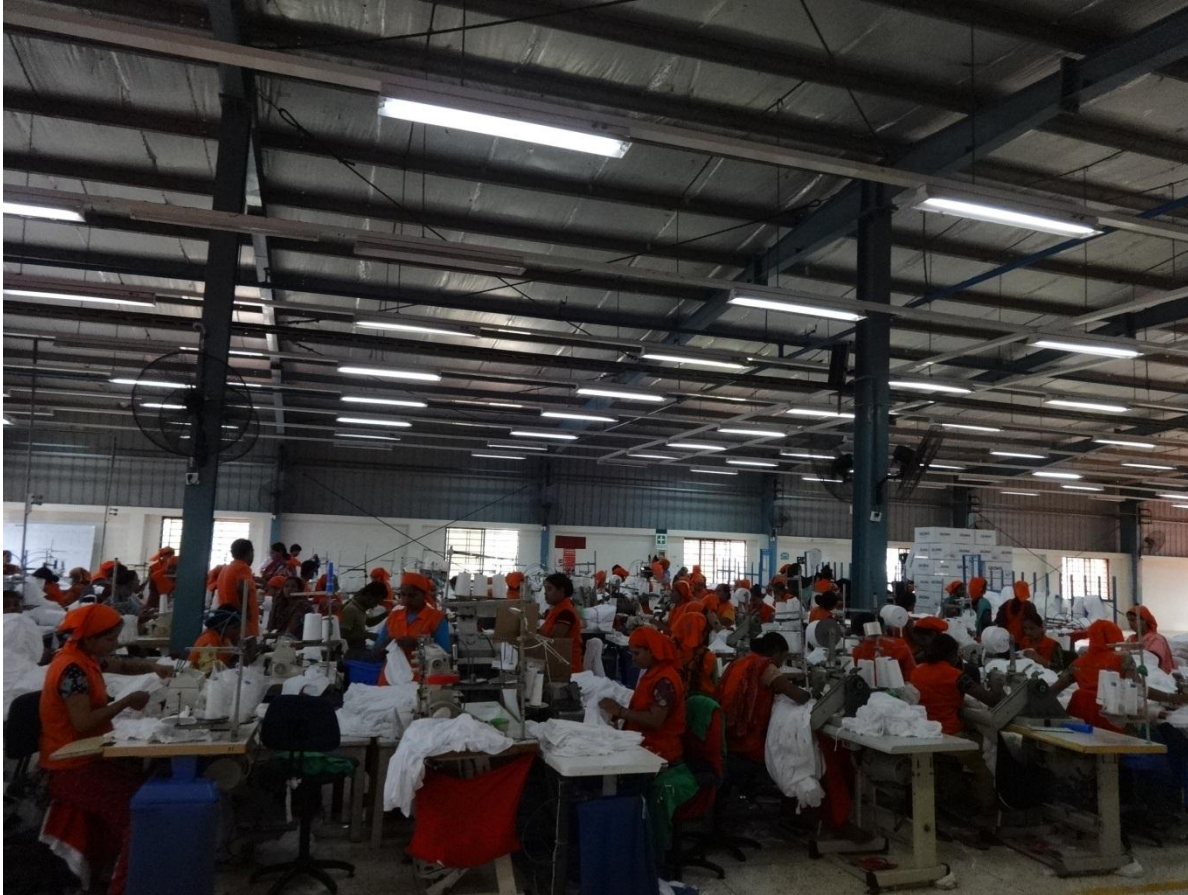
## Shed Buildings 1-8

The shed building were a mixture of portal frames and unbraced steel frames. Where stability systems exist it was in the form of wire cross bracing and portal frames. Several smaller shed buildings did not appear to feature any obvious stability system.

We require that these items be investigated in an Engineering Assessment

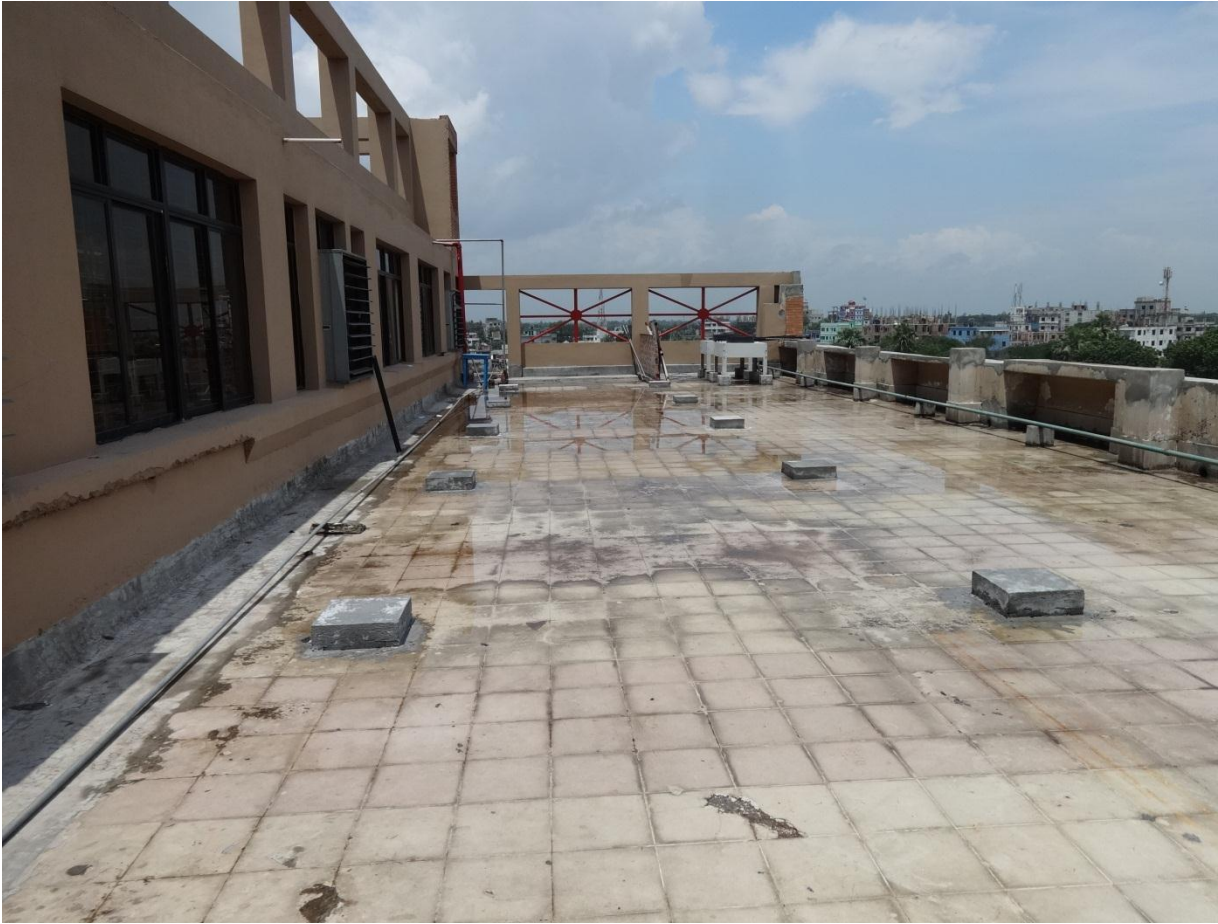
## Main Factory Buildings 1-4

No waterproofing membrane was visible on the roof of the building. This means that any cracks in the surface finishes on the roof will allow water to seep into the concrete slab beneath the finishes, and cause corrosion of the reinforcing steel.

| Item No. | Observation | Recommended Action Plan | Recommended Timeline |
|---|---|---|---|
| 13 | Priority 3 - No waterproof membrane to concrete roofs. | Cover the concrete roofs with a suitable waterproofing membrane, e.g. waterproof screed. | 6-months |
